Better Back Roads Program Review

December 2015

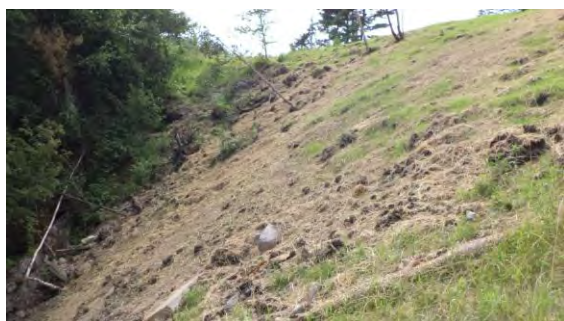
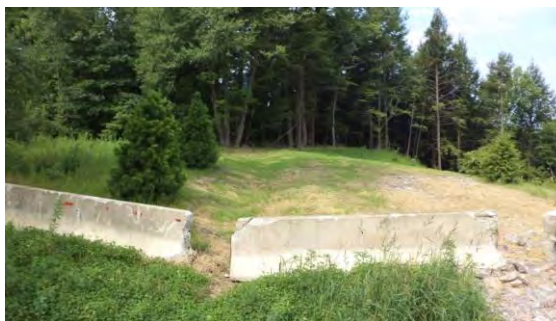
Site 1

Work Description: Failed stormwater system caused bank erosion which leads into Class 2 wetland and an impaired stream (Allen Brook).

1. Were BMP's identified in the BBR manual proposed for the repair and were they properly applied?
Yes. Slope was stabilized and seeded and mulched.
2. Effectiveness of BMP
Slope stabilization work was effective, although woodier vegetation could have been used to further stabilize slope.
3. Could additional funds be utilized at this site?
No, this was a federal grant and did not have the same capped amount as a Better Backroads grant.

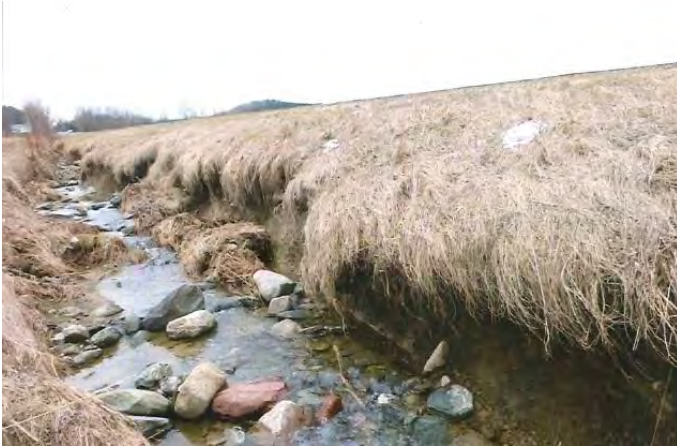
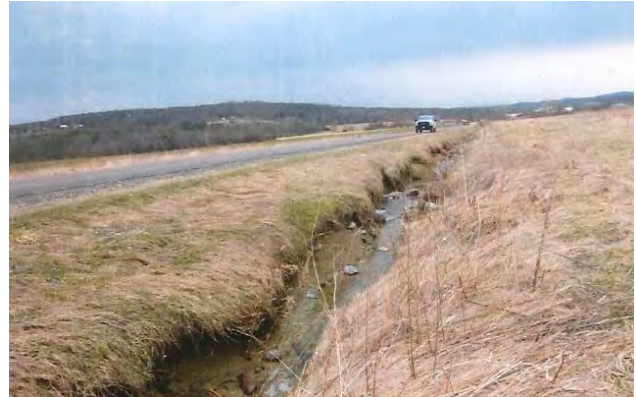
Site 2

Work Description: Repair eroded ditch and stone line it to slow down water velocity and treat water that entered a tributary to the impaired Allen Brook.

1. Were BMP's identified in the BBR manual proposed for the repair and were they properly applied?
According to the manual, we recommend a grass ditch for under 5% slope, but with the flow at this site, the town adjusted and is placing a rock lined ditch. We agree with this method and suggest updating the manual to recommend ditch material type based on slope and runoff volume, but not make it a requirement to place a material based solely on these two factors.
2. Effectiveness of BMP
N/A, project has not been constructed yet.
3. Could additional funds be utilized at this site?
Yes, additional funds could have been used so the town didn't have to segment the project or wait for extra grant money to construct. We would also suggest if extra funds were available that the town look at off site attenuation/detention as this could be beneficial at this site.

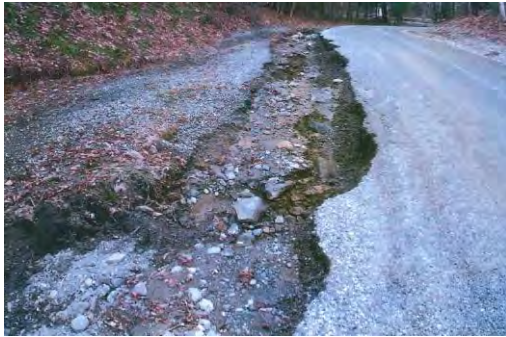
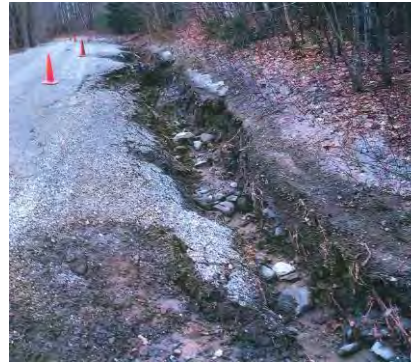
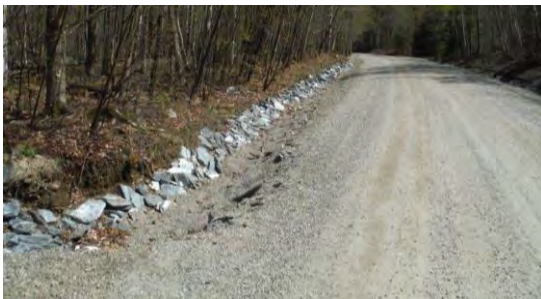
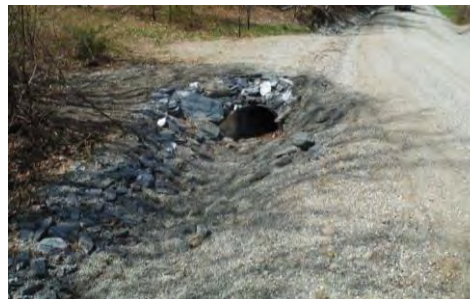
Site 3

Work Description: Steep grades have caused approximately 1,300 feet of ditch and road bank erosion on both sides of the road.

1. Were BMP's identified in the BBR manual proposed for the repair and were they properly applied?
BMP's were used properly, but better assistance from VTtrans could have provided for a better fix. The town has good intentions placing stone in ditches and fixing the road to get it open for the public with limited resources and staff. Ditches could have been a bit deeper, and a different road surface material choice, if used could have enhanced the project as much of the material ended up in the ditch. However, the current program parameters don't allow for road surface gravel, so the town did the best with the money they had.

2. Effectiveness of BMP
The BMP's were not 100% effective at this site as the rock used was smooth, allowing water to flow rapidly through the ditch. We suggest adding guidance in the manual on ditch depth, material size and type, and ditch roughness to slow down water. We also suggest aligning guidance in the manual with state specs and drawings.

3. Could additional funds be utilized at this site?
Yes, if the grant program paid for surface material, a better material could have been laid on the roadway.

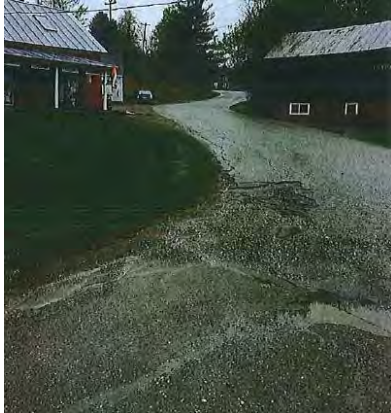
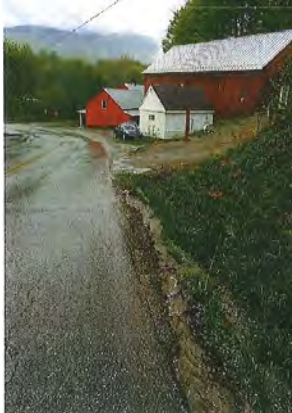
Site 4

Work Description: Gravel and sediment from roadway and shoulder continuously wash into VT 15 and Foote Brook, which leads to the Lamoille River. Rains cause pavement and shoulder washouts.

1. Were BMP's identified in the BBR manual proposed for the repair and were they properly applied?
Not all proposed BMP's will be used correctly as there was no outlet treatment planned, as suggested in the BBR manual to prevent outlet erosion and undermining. Upon mention to the town, they now plan on fixing this issue. This was caught by the selection committee, and we recommend continued stringent review of applications and ensuring that all applicable information is included so the committee gets a good idea of how the problem will be fixed. Other BMP's, such as stone lined ditches, will be used properly. When this project was awarded grant money, additional requirements were imposed by the selection committee for an overall better project. The town recognized the value of these additions and plans to implement these added BMP's.

2. Effectiveness of BMP
N/A, project has not been completed yet.
3. Could additional funds be utilized at this site?
Additional funds could have been used at this site to create a better project for add in more cross pipes for flow relief and additional stone lining of their ditches.

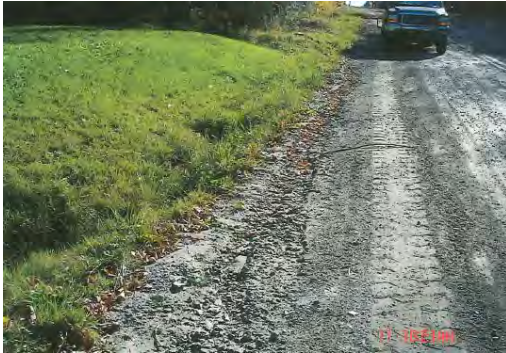
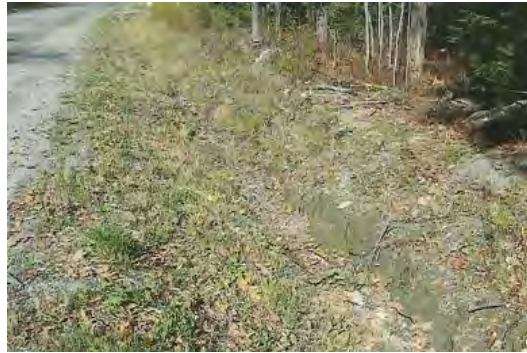
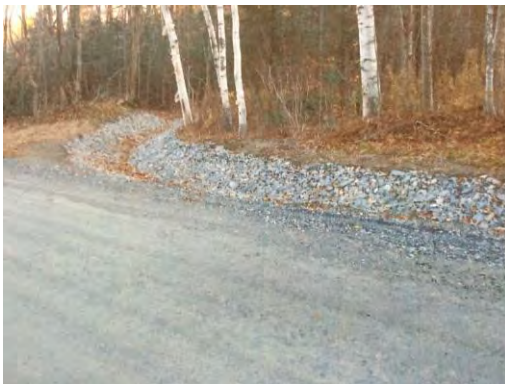
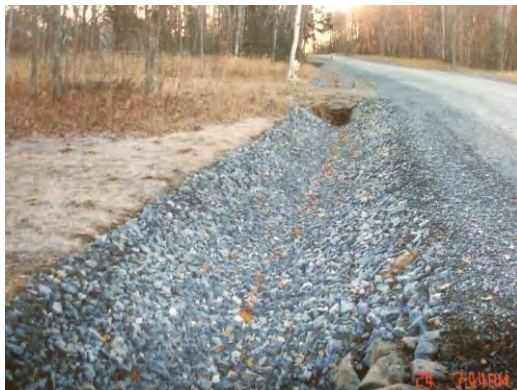
Site 5

1. Were BMP's identified in the BBR manual proposed for the repair and were they properly applied?
Yes, ditches were lined well and turnouts were used to control the flow of water on these sites.
2. Effectiveness of BMP
BMP's were effective as the foreman was cleaning ditches for the first time after 10 years of service. We would like to see larger stone in the ditches to slow the flow of water during high runoff events.
3. Could additional funds be utilized at this site?
Yes, with more funding the town could have stone lined and ditched both sides of the road.

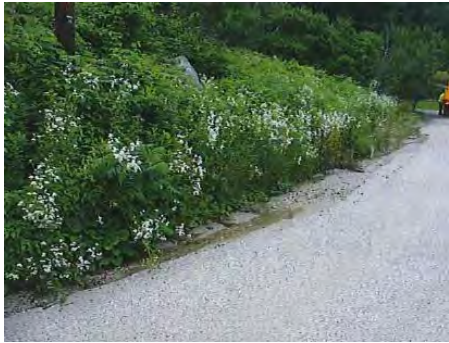
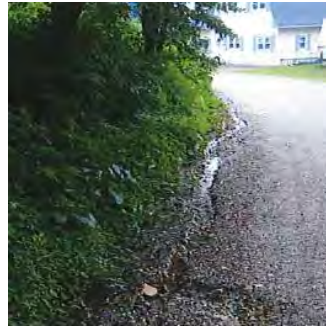
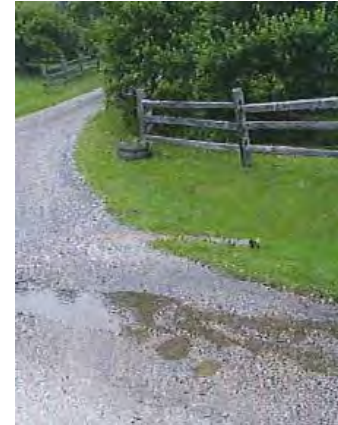
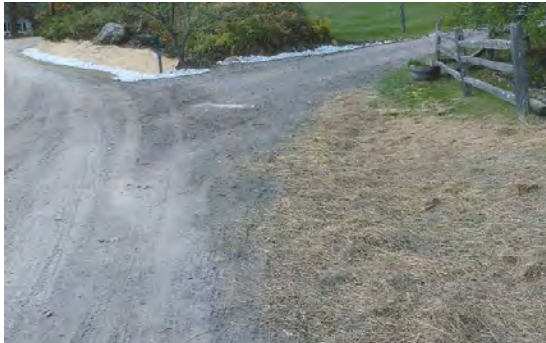
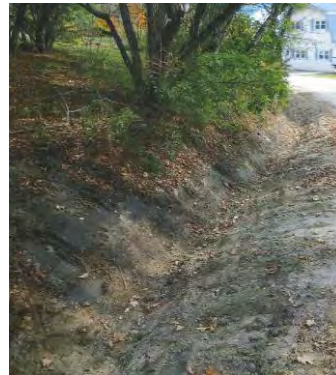
Work Description: Lack of appropriate ditches caused erosion and sediment entered into the Rutland City watershed.

1. Were BMP's identified in the BBR manual proposed for the repair and were they properly applied?
BMP's were used, but ditches could have been deeper, as the water didn't sheet flow off the downhill side of the road. A couple of passes with a grader to change the cross slope of the road would fix this situation.
2. Effectiveness of BMP
BMP's were effective, but maintenance was not taken into consideration, especially with the placement of a catch basin on a dirt roadway.
3. Could additional funds be utilized at this site?
It appeared that the funding available was adequate for this site.

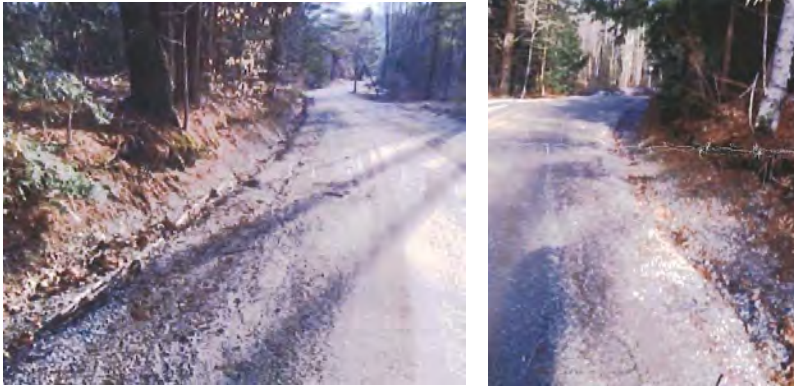
Work Description: Repair eroded ditch and stone line it to slow down water velocity and treat sediment issues.

1. Were BMP's identified in the BBR manual proposed for the repair and were they properly applied?
The town intended to use BMP's, but as they had not received technical guidance from VTrans, and instead were receiving guidance from another town. The town originally planned to complete the project by starting at the bottom of the hill and working their way up, but upon suggestion from the group, the town will now be starting their work at the top of the hill as opposed to the bottom. This clearly shows a gap in education that VTrans needs to provide, as the town had the best intentions, but was missing VTrans technical support. We also suggest adding guidance to the manual regarding starting work at the highest point of a project as opposed to the lowest in case of storm events.

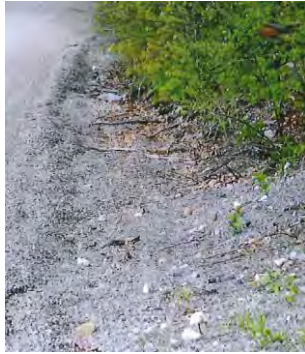
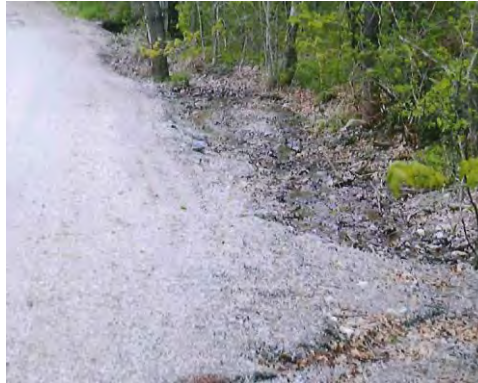
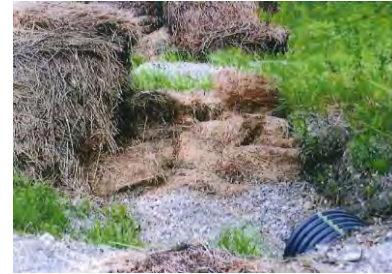
Work Description: Ditch, roadway, and bank erosion has caused issues on this road.

1. Were BMP's identified in the BBR manual proposed for the repair and were they properly applied?
Some BMP's will be used properly such as check dams and turn outs, but some additional consideration for outlet protection would enhance the project.
2. Effectiveness of BMP
N/A, project has not been constructed yet.
3. Could additional funds be utilized at this site?
Yes. Town was completing project in segments, and while they were doing the work in the correct order, it would have been best to do the work all at once.

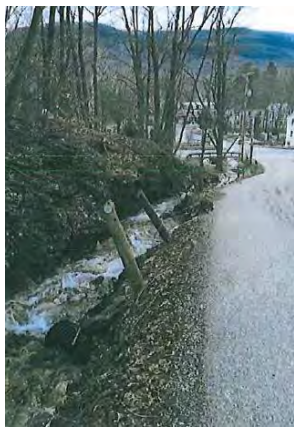
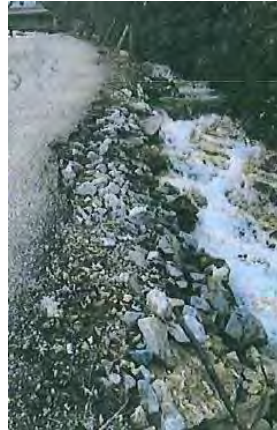
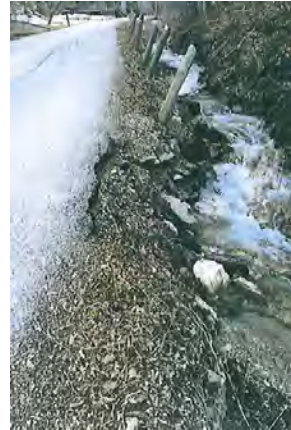
Work Description: Nearby stream has caused shoulder and roadway erosion due to bedrock, leaving nowhere for the stream to go but the road.

1. Were BMP's identified in the BBR manual proposed for the repair and were they properly applied?
BMP's were not applicable to this project as it was a unique fix to a difficult situation. In the future we suggest adding guidance to the manual regarding retaining walls, weep holes, and stream alteration, including looking beyond the project when repairs are made and more consultation with river engineers.

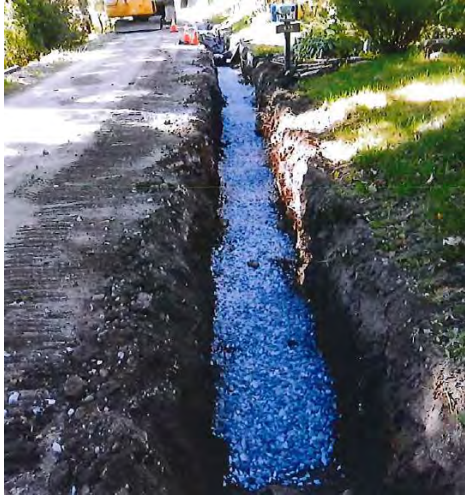
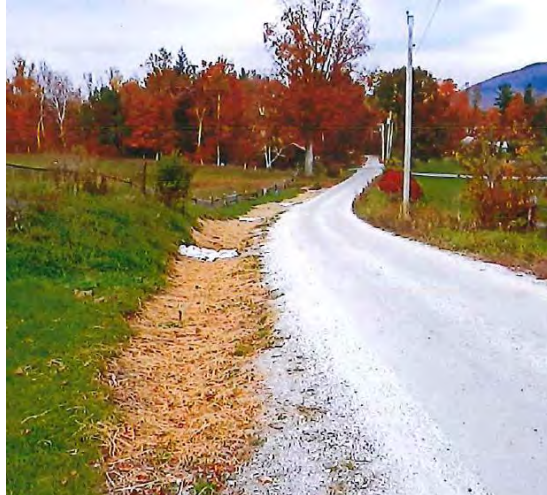
Work Description: Narrow roadway and ditches caused roadway erosion.

1. Were BMP's identified in the BBR manual proposed for the repair and were they properly applied?
BMP's were not used as there is no BMP for french drains in the Better Backroads manual. Consideration will be made to assess subsurface features such as this in the manual update.
2. Effectiveness of BMP
While the work completed was effective, we believe maintenance will be an issue with this site in the future. Given the lack of ROW this may have been the best fix for this site with the grant funds awarded.
3. Could additional funds be utilized at this site?
Yes, if ROW expenses are allowed in the future as they are currently not allowed in the program. With additional funding the town could have acquired additional ROW and used that space to place a properly sized ditch and driveway culvert.

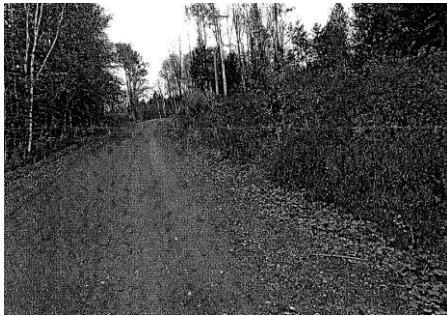
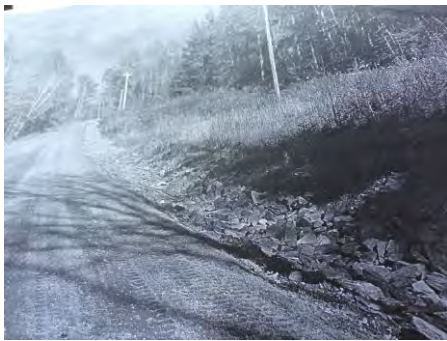
Orange, Preston & Brisson Rd

Work Description: Poorly shaped and unlined ditches cause erosion, sedimentation, and road washout issues.

1. Were BMP's identified in the BBR manual proposed for the repair and were they properly applied?
BMP's were used properly, but as suggested previously, there should be some guidance in the Better Backroads manual regarding shape of stones placed in ditches. It is also suggested that some water turnouts of stone check dams be placed to dissipate the velocity of the water in the ditch.

2. Effectiveness of BMP
BMP's were somewhat effective. We suggest modifying the Better Backroads manual to allow for grader maintenance on stone lined ditches. Stone on the roadway side of ditches should extend to just below the road bed so a grader blade may scrape off the berm without concern of hitting stone in the ditch. While many BMP's were used properly, the presence of berms was noted and some grader work to take the berms down would greatly reduce maintenance issues at this site. It is also acknowledged that berms occur on every roadway due to winter maintenance and may not be a realistic maintenance goal for every town.

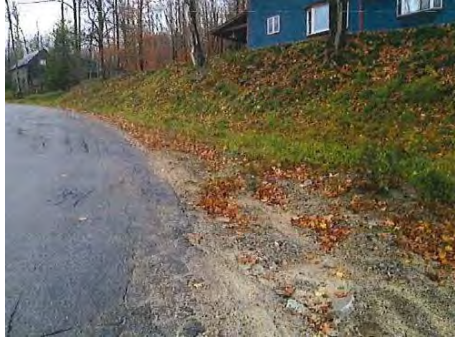
Work Description: Repair eroded ditch and stone line it to slow down water velocity and treat sediment issues.

1. Were BMP's identified in the BBR manual proposed for the repair and were they properly applied?
BMP's will be used at this site and while it is a quality project, upstream property owners need to be held accountable by the town or ANR for their contributions to water quality as well. The property owner upstream of this site has a wide open site that drains a dirt lot directly in the road. We suggest the town try to remedy this situation with the property owner as well to truly fix the issue.
2. Effectiveness of BMP
N/A. Project has not been constructed yet.
3. Could additional funds be utilized at this site?
No, we believe the fix is appropriate and additional money would not impact the repairs to be completed at this site.

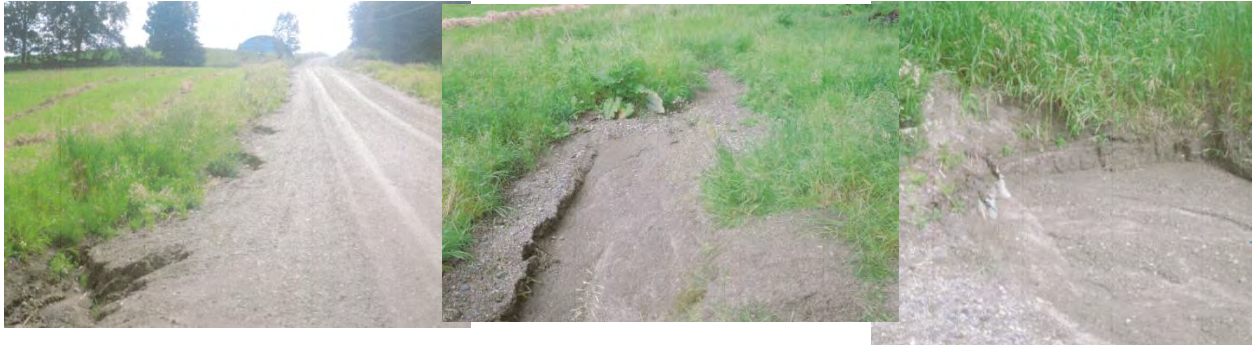
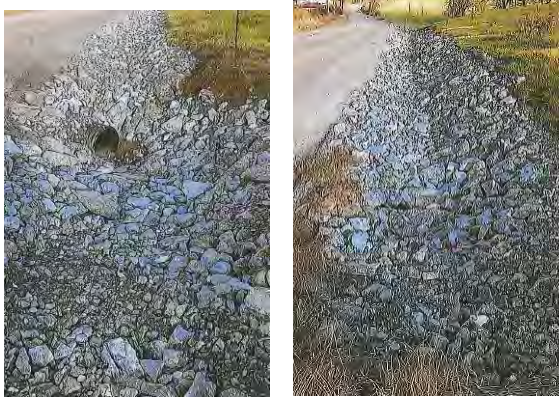
Work Description: Lack of cross pipe on hill causes ditch erosion and downhill culvert sedimentation and plugging.

1. Were BMP's identified in the BBR manual proposed for the repair and were they properly applied?
BMP's were used properly on this site and the outlet structure had an excellent splash pool that was working well.
2. Effectiveness of BMP
BMP's were effective and the town did an excellent job of repairing this site and creating a quality and lasting fix. Check dams or another form of energy dissipation could have been used on this site and would have been a good idea to look into. The Better Backroads manual should also be edited to include suggested situations for using energy dissipation techniques on sites.
3. Could additional funds be utilized at this site?
Yes, additional funding would have helped the town as they would have had to contribute less money to the project.

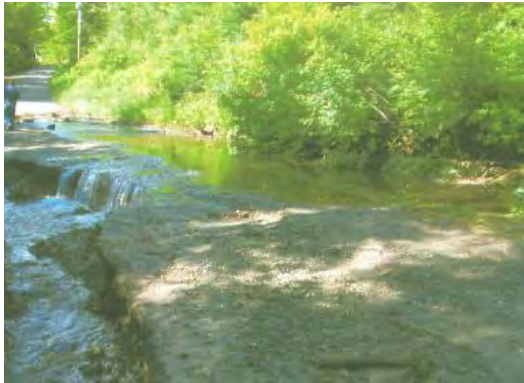
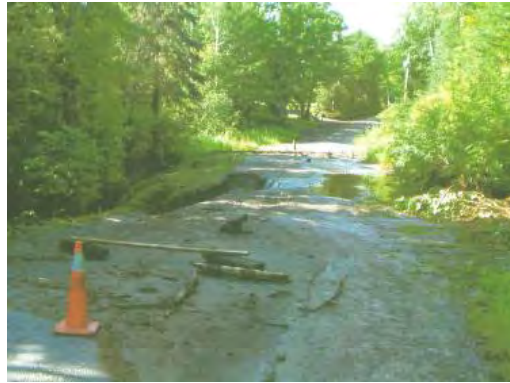
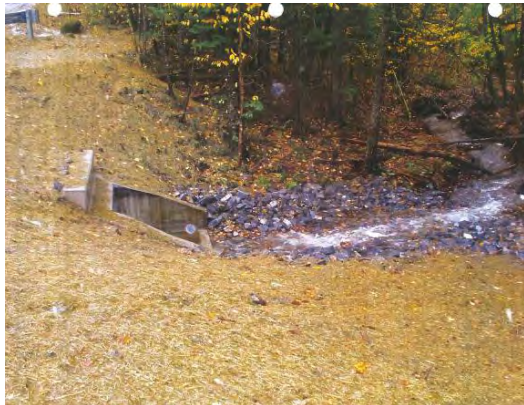
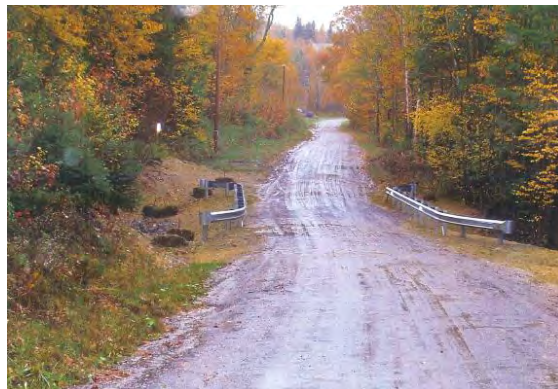
Work Description: Undersized pipe causes major roadway washouts.

1. Were BMP's identified in the BBR manual proposed for the repair and were they properly applied?
BMP's were used properly on this site and stream alteration and hydraulic engineers were consulted.
2. Effectiveness of BMP
BMP's have been effective at this site. The only recommendation would be to fill the baffles inside the box culvert to allow for aquatic passage.
3. Could additional funds be utilized at this site?
Yes, a project like this would be ideal to provide additional grant funds for as it is a quality and lasting fix to a severe erosion problem.

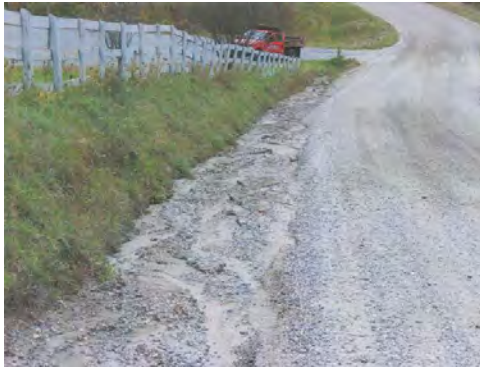
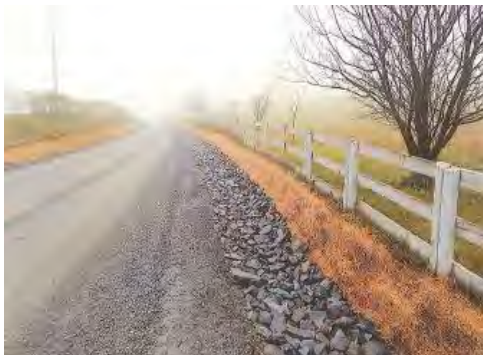
Work Description: Steep grades cause ditch erosion and loss of roadway gravel.

1. Were BMP's identified in the BBR manual proposed for the repair and were they properly applied?
BMP's were implemented well at this site, but road width and ROW constraints should be taken into consideration, as the project limited road width which could lead to safety issues for road users.
2. Effectiveness of BMP
The work done on this site was effective and all BMP's used have held up well.
3. Could additional funds be utilized at this site?
Yes, if ROW expenses were an eligible cost. If this were allowed in the future the town would be able to purchase ROW to increase road and ditch widths to enhance the safety of this roadway for all users.

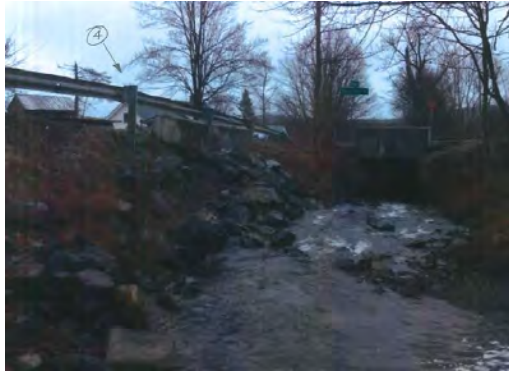
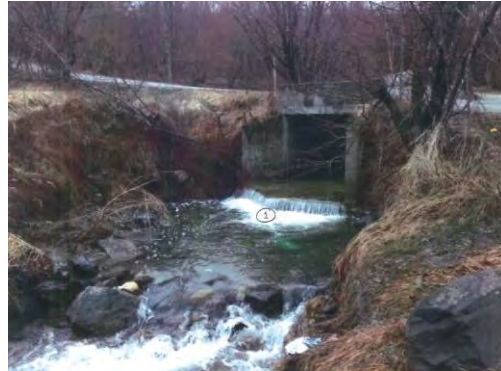
Work Description: Sweeney Pond outlet has failed causing roadway erosion.

1. Were BMP's identified in the BBR manual proposed for the repair and were they properly applied?
BMP's will not be used as they were not applicable to this project. It is suggested that projects like these have continued coordination with river management engineers.
2. Effectiveness of BMP
N/A. Project has not been constructed yet and BMP's are not applicable to this sort of project.
3. Could additional funds be utilized at this site?
Yes, the limiting factor at this site is an undersized box culvert, and additional funds could have been used to replace this undersized structure.

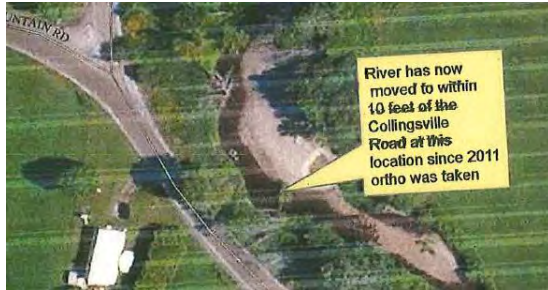
1. Were BMP's identified in the BBR manual proposed for the repair and were they properly applied?
BMP's were not used at this site as there were not applicable to this type of project. It is suggested that there is continued coordination with river management engineers.
2. Effectiveness of BMP
N/A. It is suggested that the town consider the project's impacts on downstream structures that are severely undersized and keep in working contact with river management engineers.
3. Could additional funds be utilized at this site?
Yes, this project requires significant funding for a proper fix though as there are so many undersized structures downstream and the river is currently in motion and incising.

Work Completed: Armor bank with stone (100'x6') making sure all rocks are keyed into slope.

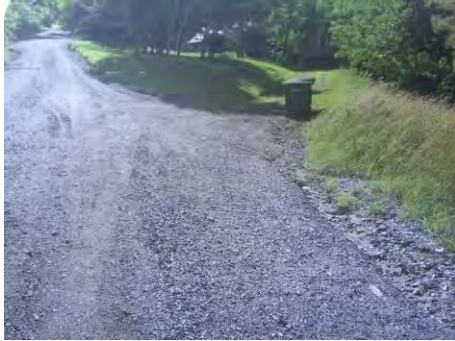
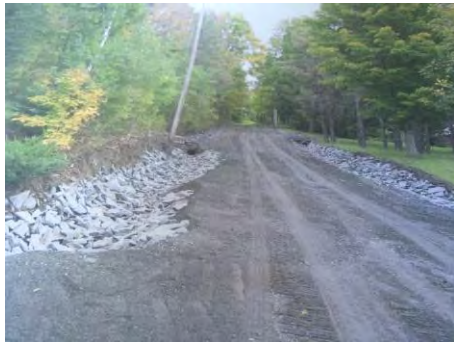
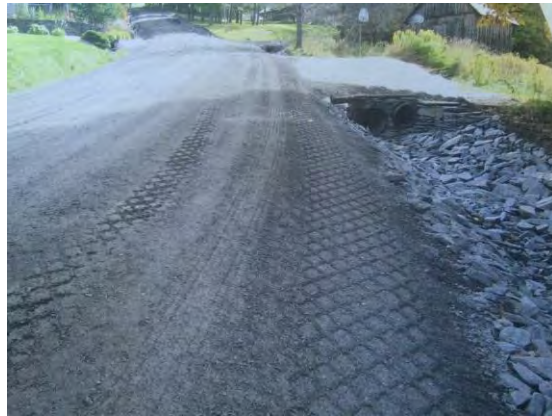
Work Description: Improper ditches and undersized culverts are causing road and ditch erosion.

1. Were BMP's identified in the BBR manual proposed for the repair and were they properly applied?
BMP's were used properly given the slope of the backside of the ditch. The grader operator did an excellent job cleaning up berms on this site and stone headwall work was done very well.
2. Effectiveness of BMP
BMP's were effective, and while the ditches were having issues, this was due to a property owner dumping debris into the ditches. It is suggested that the town work with the property owner to remedy this situation.
3. Could additional funds be utilized at this site?
Yes, additional funds would have allowed the town to spend less of their own funds and more grant funds on this project as well as complete a lower segment of the project.

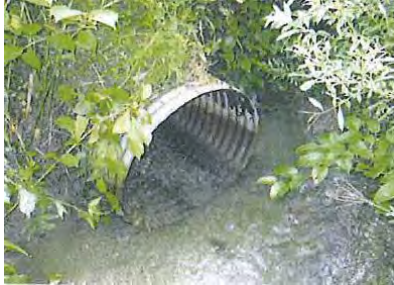
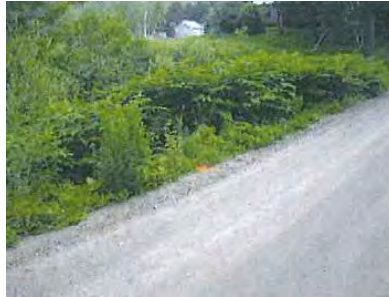
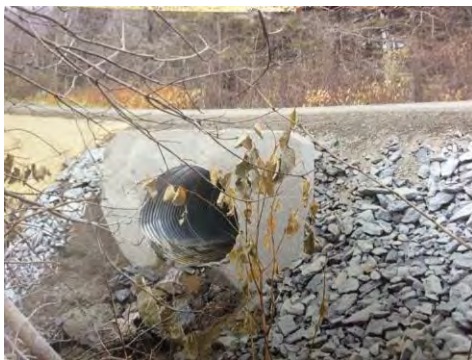
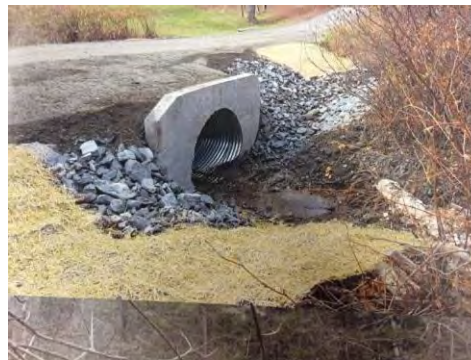
Work Description: Undersized 24" culvert causes erosion and sedimentation issues.

1. Were BMP's identified in the BBR manual proposed for the repair and were they properly applied?
BMP's were used properly on this site. Stream alignment and aquatic passage should have been considered as there was a drop on the outlet end which doesn't allow for aquatic passage. The culvert also wasn't aligned well with the stream, causing it to make a turn to enter, which can cause erosion and flow issues during high flow events. It also could have benefitted the project to place wingwalls on the culvert header.
2. Effectiveness of BMP
BMP's were effective, but alignment and passage should have been considered and the project may have benefitted from consultation with a river management engineer.
3. Could additional funds be utilized at this site?
Yes, additional funds may have allowed for stream alteration.

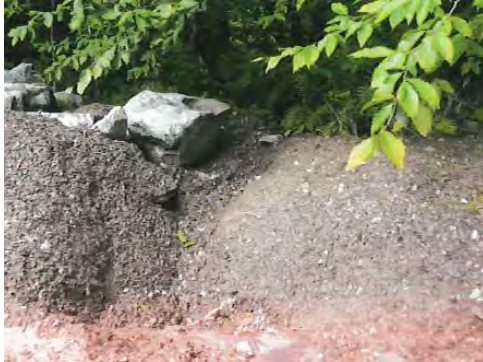
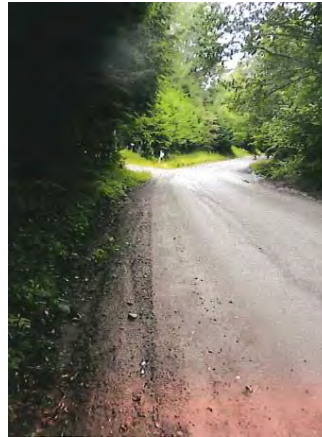
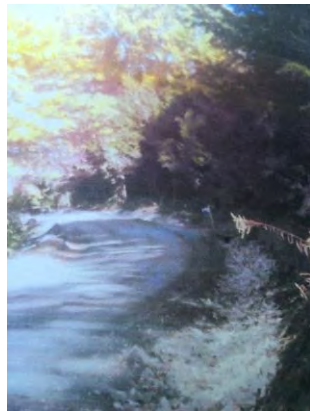
1. Were BMP's identified in the BBR manual proposed for the repair and were they properly applied?
BMP's were used. General and winter maintenance has created berms which channelizes the flow of water and has unintentionally created erosion issues. Upon review, the longevity of the solution may have been enhanced by stabilizing the slope rather than ditching. Proper grading could have eliminated the berm issue, and slopes should have been stabilized instead of trying to place a ditch. While not in the Better Backroads manual, it would be recommended to grade the road to sheet flow off and stabilize the slope issue.
2. Effectiveness of BMP
BMP's used were effective, but a different fix to this project may have resulted in a better solution.
3. Could additional funds be utilized at this site?
Yes, a proper fix at this site would require a significantly larger amount of funding.

Work Completed: Install curtain drain under stone lined ditch to effectively drain roadway.

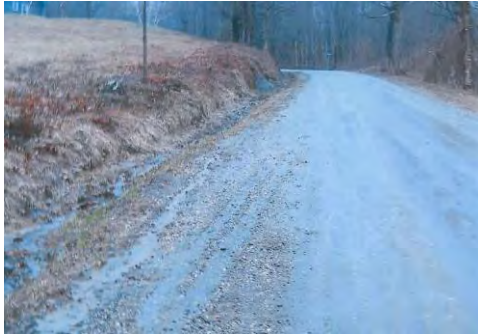
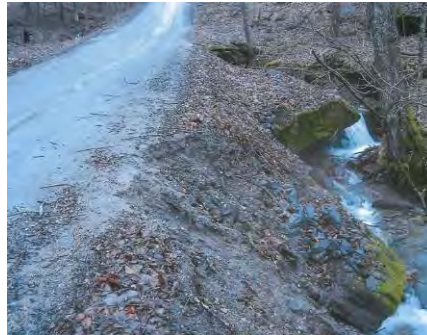
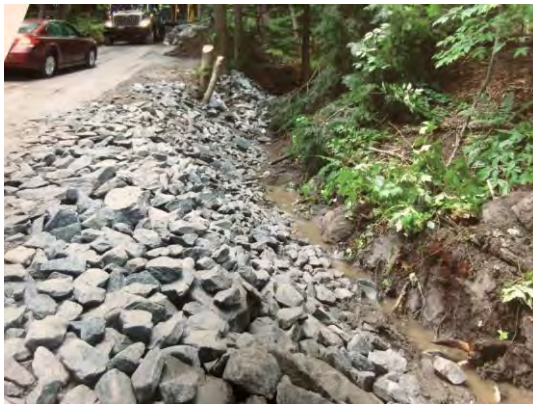
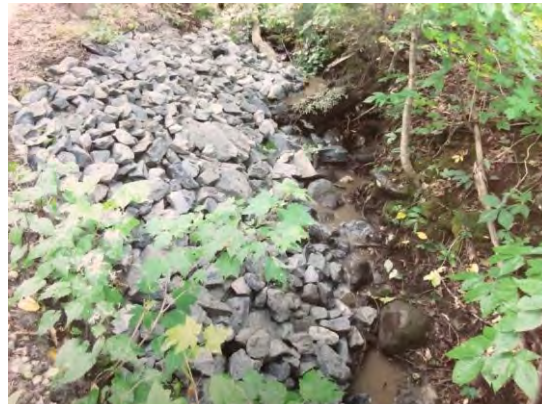
1. Were BMP's identified in the BBR manual proposed for the repair and were they properly applied?
BMP's were used properly, but we suggest consultation with a stream alterations engineer as the stream was constricted by stone and may cause flooding and road erosion during storm events.
2. Effectiveness of BMP
BMP's were effective, but constricted the stream.
3. Could additional funds be utilized at this site?
Yes, additional funds would allow for the project to be built without constricting the stream.

Work Completed: Shape and stone line ditch, place keyed in rip rap on eroding stream banks.

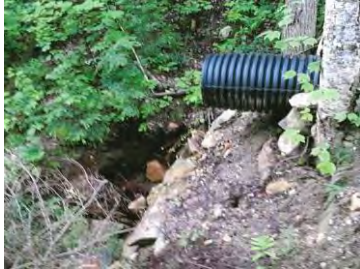
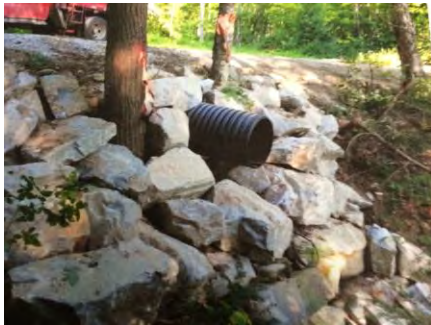
1. Were BMP's identified in the BBR manual proposed for the repair and were they properly applied?
BMP's were used, and properly for ditching techniques. It is suggested that the town look at downstream impacts, place a splash pad, and support the end of the culvert.
2. Effectiveness of BMP
The town had good intentions to use BMP's properly, and implemented several well with the knowledge they had, but with some guidance from VTTrans, could have done a better job implementing others. One BMP of particular concern was outlet protection, where the outlet was protected, but there was still a drop from the culvert outlet to the stone pad below.
3. Could additional funds be utilized at this site?
Yes, downstream impacts could have been mitigated with additional funding.

Work Completed: Stone line ditch and rip rap around culvert.

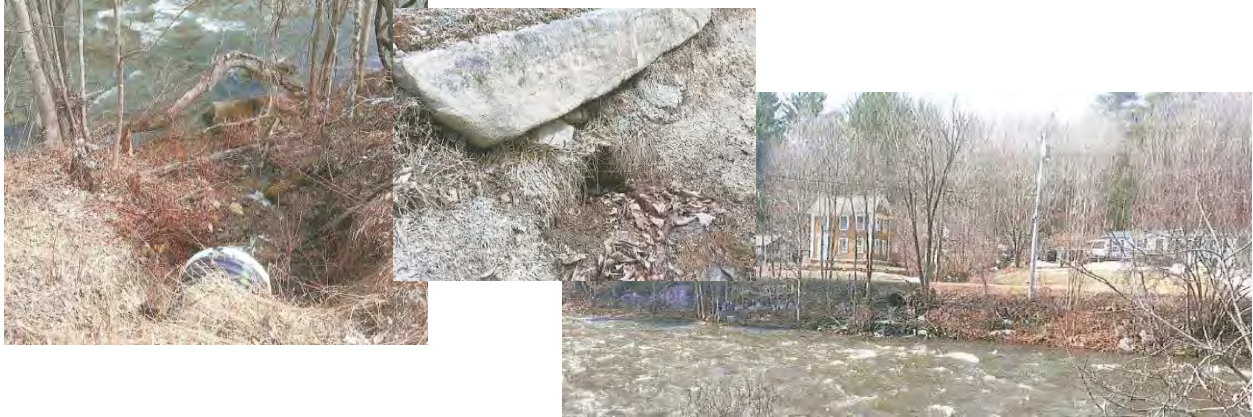
Work Description: 11 culverts are undersized for in poor condition and in need of erosion protection at inlets and outlets.

1. Were BMP's identified in the BBR manual proposed for the repair and were they properly applied?
BMP's will be used properly as culverts were properly sized and had splash pads, but it is suggested that culvert length be modified to better fit roadway widths.
2. Effectiveness of BMP
N/A. Project is under construction.
3. Could additional funds be utilized at this site?
Yes, this would allow the town to replace more culverts.
