**ASSESSMENT OF TECHCRETE A CONCRETE REPAIR
MATERIAL AND JOINT SEALANT**

Report 2013 – 11

December 2013

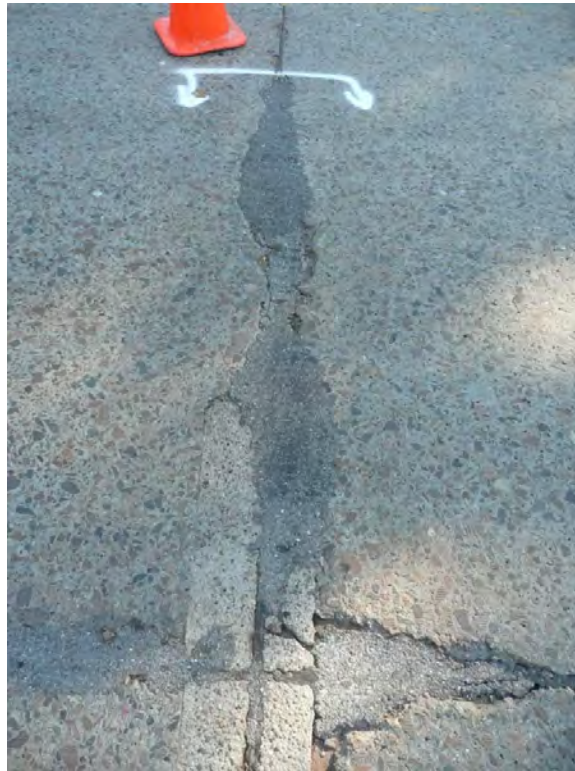
Figure 4 Typical concrete joint deterioration prior to repair

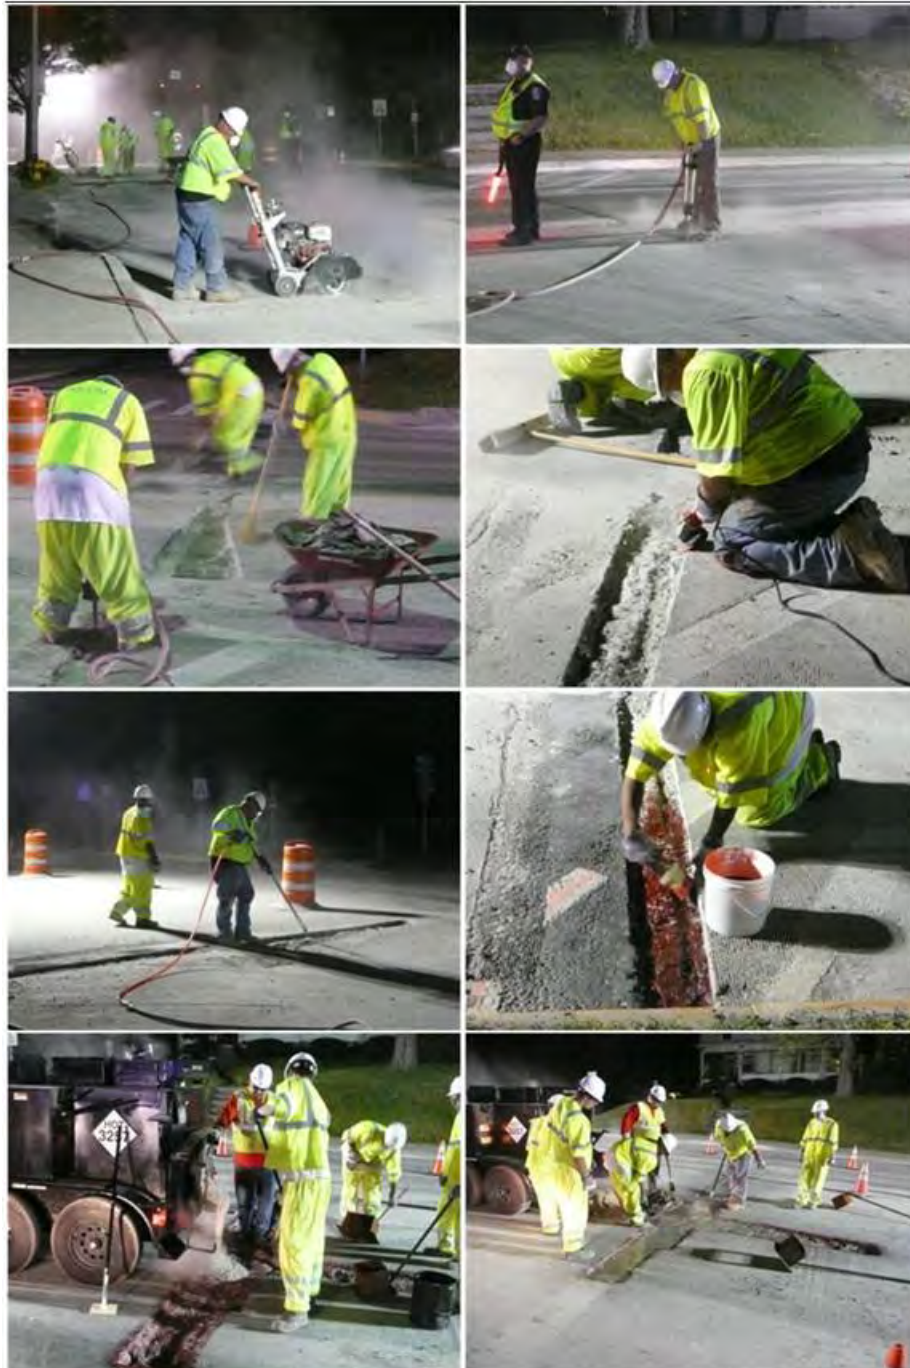
Once repair limits were identified, the damaged portions of concrete and joint filler from previous repairs were removed. This was accomplished by first cutting around the edges with a saw. This can be seen in Figure 5, along with the rest of the process.

Figure 5 Typical construction sequencing for concrete joint repair with TechCrete

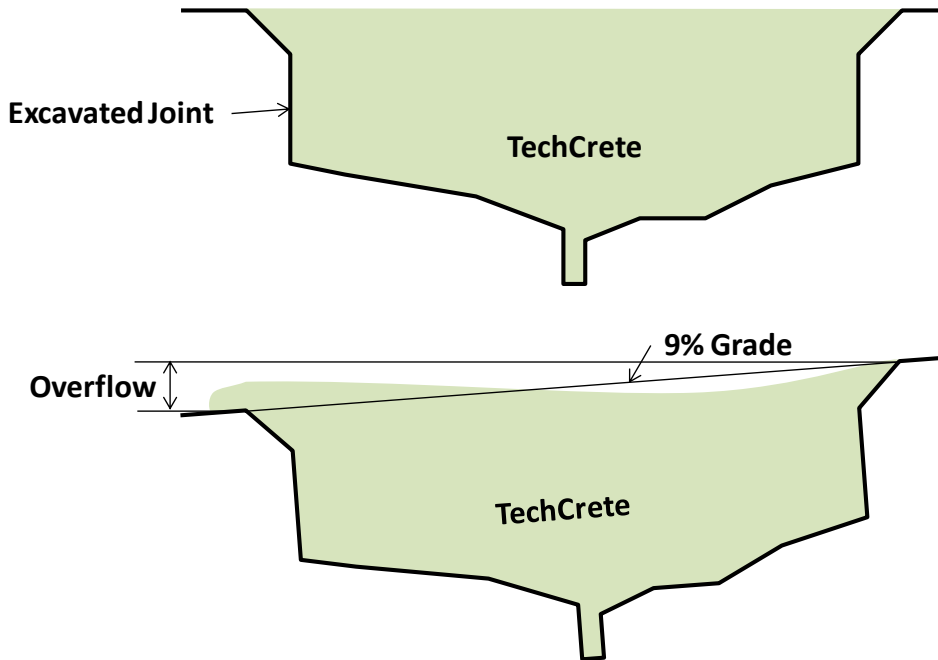
The Winooski portion on US 7 poses a large problem for the installation of a flowable material: the steep grade that encompasses a large portion of the PCC roadway. In conjunction with the chamfer on the upper edges of each joint, the repairs on the steepest section of road (approximately 9.0%) allowed the TechCrete to slowly ooze out of the joints and down the sloping concrete surface, giving an appearance of cooling lava. Additional material had to be placed into the upper elevations of each joint to ensure the higher part of the repair section was adequately filled, while at the same time allowing the material to cool enough to solidify at the lower part to keep the material overflow to a minimum. The chamfer further decreased the height of the 'berm' that would hold the TechCrete in place. The schematic shown in Figure 6 attempts to depict this phenomenon, while Figure 7 shows a picture of an overfilled joint after cooling.

Figure 6 Schematic of difficulty when placing TechCrete on a large grade

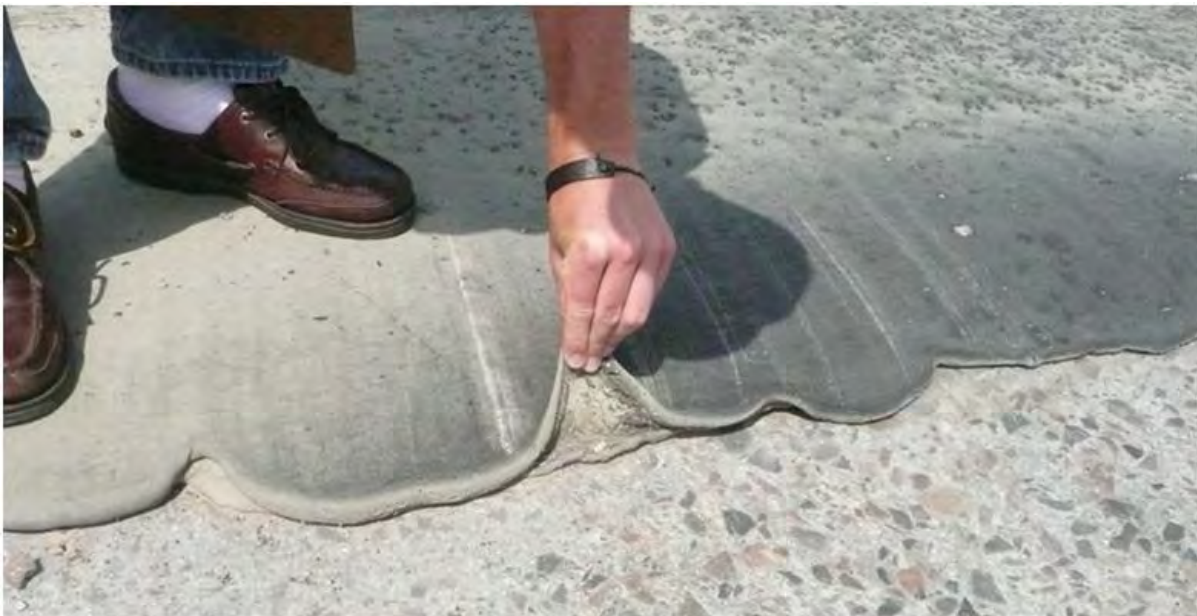
Figure 7 Excessive placement of TechCrete on an inclined joint

As can be seen in the figure, the TechCrete in this joint repair was overfilled and had begun to flow down the grade before cooling and solidifying. Once cooled, the excess material can easily be picked up as demonstrated. All joints that exhibited this overfilling had to be repaired afterward to prevent damage to the material itself and the concrete. A snowplow hitting the material could have damaged one or all of the repair material, the surrounding concrete, or the snow plow itself.

In an effort to repair the worst of the joint repairs on the steepest grade, Nicom, attempted three techniques. The first method was to cut the excess material away with a knife/blade. This method was quickly determined to be ineffective. The second method was to use a grader to plane the material away flush with the concrete pavement. This method was slightly more effective, however the TechCrete material proved to be too tough in most cases for the grader to plane the material effectively; it was a very uneven plane even when the grader was able to remove material. According to the daily work report:

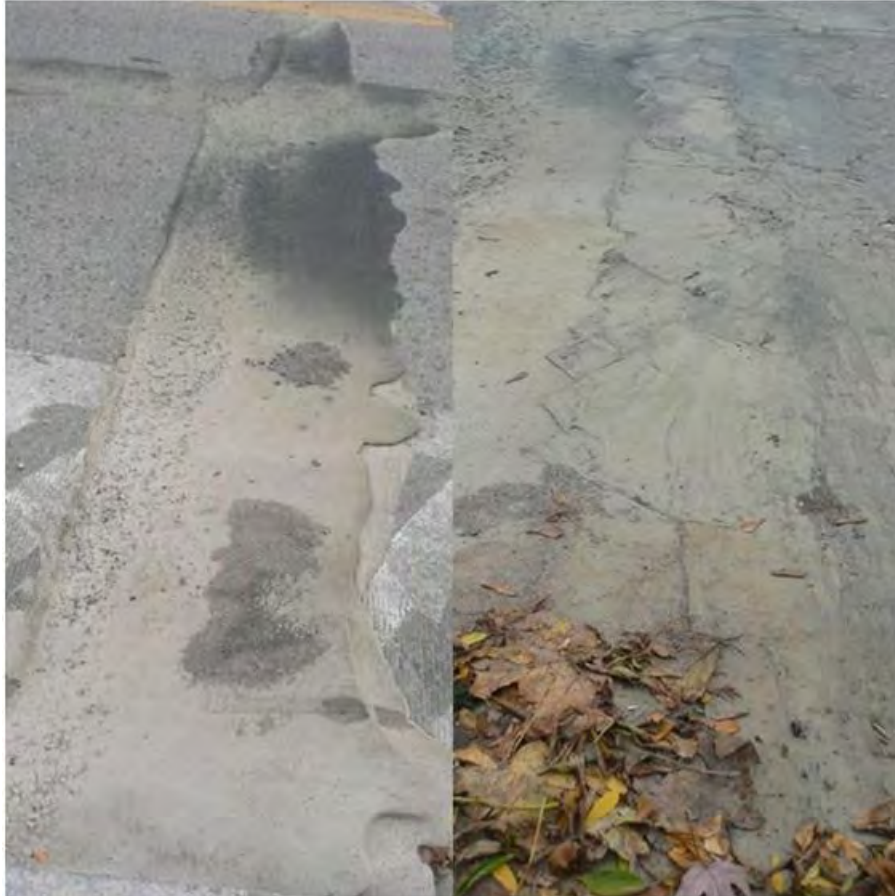
Figure 8 Side by side comparison of an overfilled joint (left) and the same joint after removal of material (right)

The image on the left of Figure 8 is a joint prior to repair, with a considerable amount of extra TechCrete having been placed into the joint. The right-hand side shows the same joint after a heated iron had been used to remove material and smooth out the remainder. The joint is virtually non-distinguishable as being the same one; its appearance is far different after repair. The extra material has been removed as well as possible and the markings from the iron are still visible. The joint is now much more effective, as it does not act as a speed bump as traffic moves across it, nor is it an obstacle for a snowplow.

smooth out the TechCrete. The actual use of a hot iron was the repair method suggested by Crafc. Once the three methods were attempted the third alternative was chosen as the preferred method, numerous joints were repaired once again, most of them being located adjacent and around the Key Bank area. Figure 8 shows a before and after comparison of one of the joints.

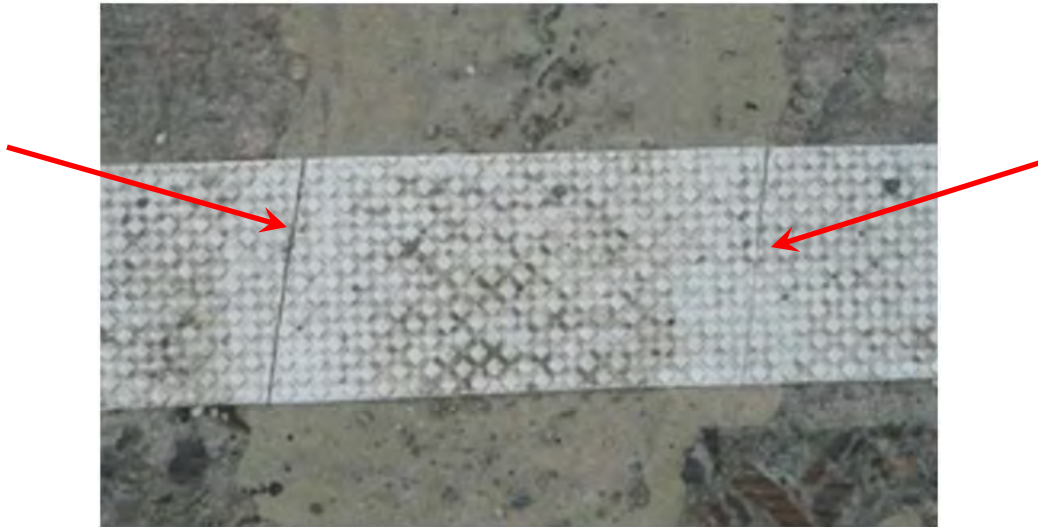
Figure 10: Durable pavement marking tape laid over both PCC and TechCrete. Please note the knife cuts on either side of the TechCrete

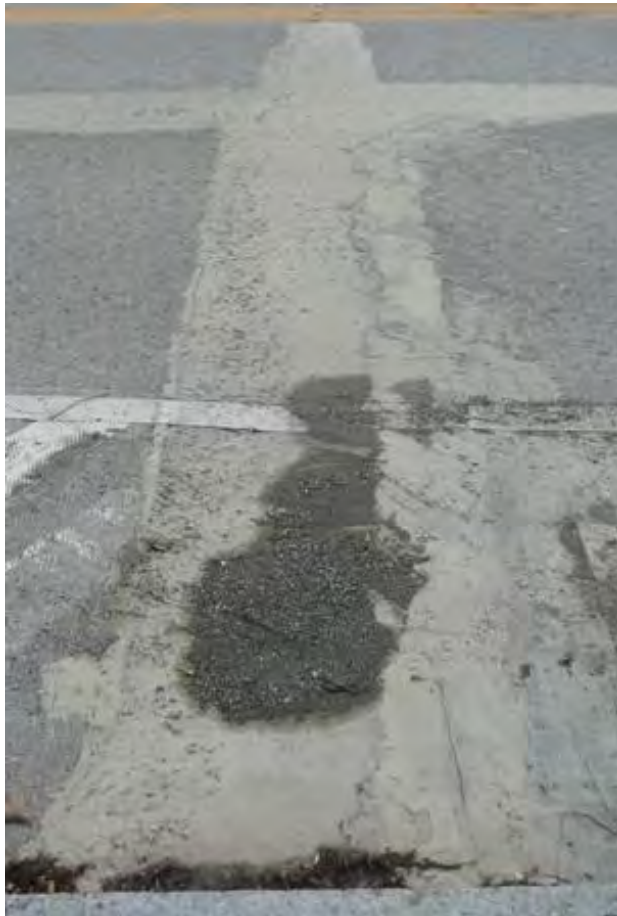
Prior to the 2008 pilot project with TechCrete, the concrete repair of 2002 had deteriorated significantly; with lengths of the concrete joint repair being fragmented. Figure 4 in this report gives an example of the state of that repair. Over the years since the repair, Winooski used asphalt patching material to seal the joints in places. In comparison, TechCrete has maintained a monolithic longitudinal integrity, and has maintained its position within the joint.

Figure 12: Condition of joint following first winter season

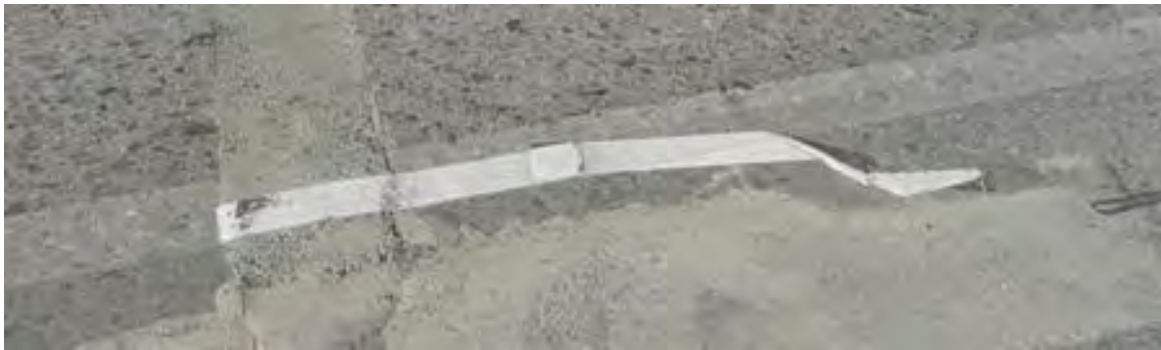
Figure 13: Tape markings adhered to TechCrete but not to the concrete

The tape markings on the TechCrete were slightly worn. In all locations where tape was placed on TechCrete, the tape remained in place; no tape has delaminated from TechCrete. What has happened is that the tape has worn down, especially on the highest spots, due to plow and traffic wear. Figure 14 below shows tape wear on the TechCrete, with the highest portion of the repair being at the bottom of the picture.

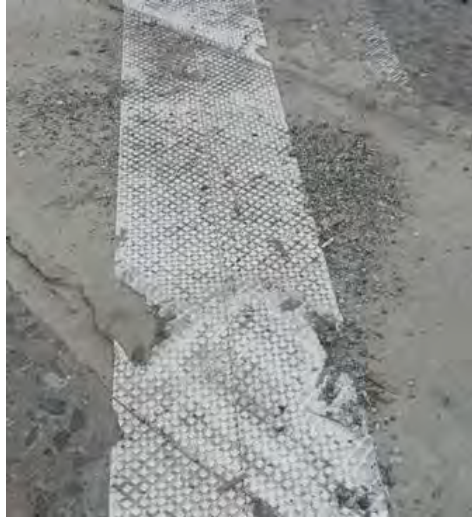
Figure 14: Tape wear over the higher points on the TechCrete repair

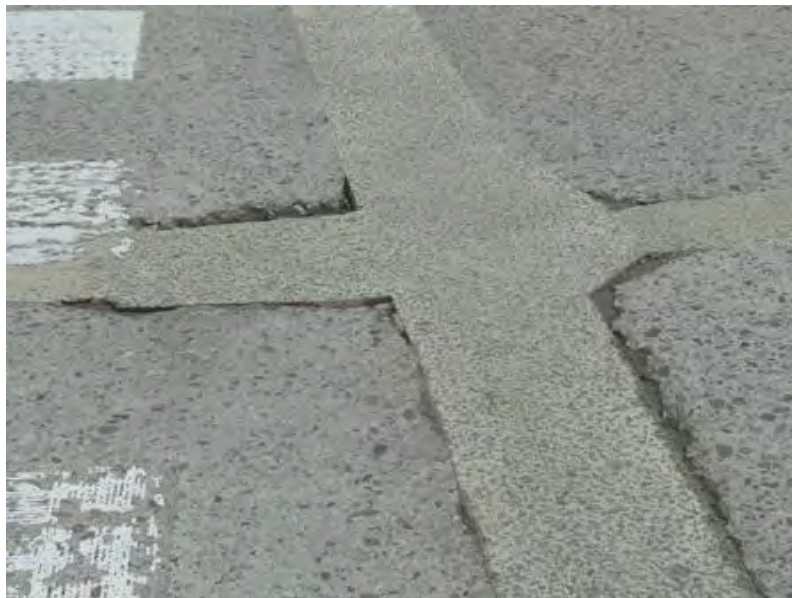
Site visits have been made following each passing winter. Each site visit showed that the TechCrete repair material was performing well and was intact in all locations as of early 2013. The quality of the concrete around the TechCrete repairs, however, has deteriorated drastically in some areas, as can be seen in Figure 15 below, from 2011, and Figure 16 from 2013. Some corner areas have spalled considerably around the TechCrete; the TechCrete shows no signs of damage or deterioration in these areas. The reason for such rapid deterioration of these corner areas of the concrete has not been determined.

Figure 15 Condition of some repair areas following the second winter of service life (2011).

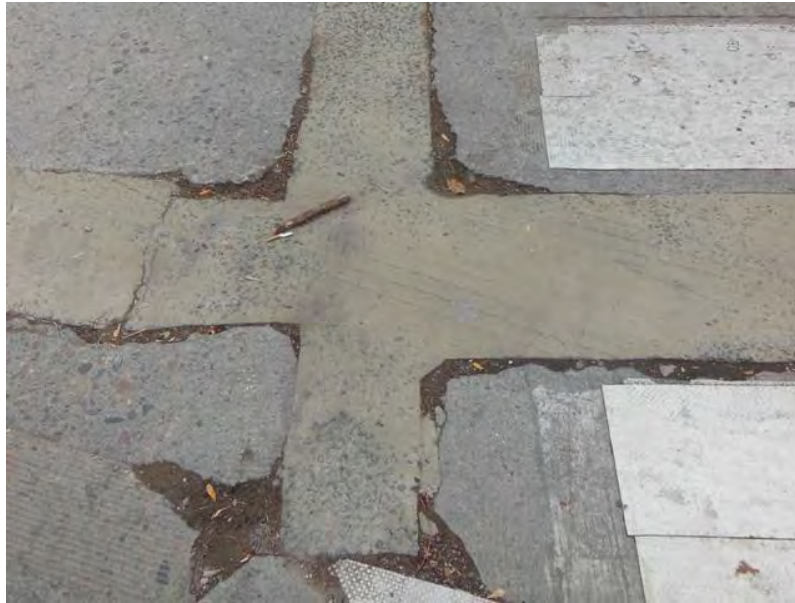
Figure 16 Condition of some repair areas following the fourth winter of service life (2013).
