**GlasGrid Pavement Reinforcement System  
Charleston and Barnet, Vermont  
Final Report**

**March 2008**

**Report 2008 - 1  
Reporting on Work Plan 95-R-11**

State of Vermont  
Agency of Transportation  
Materials and Research Section

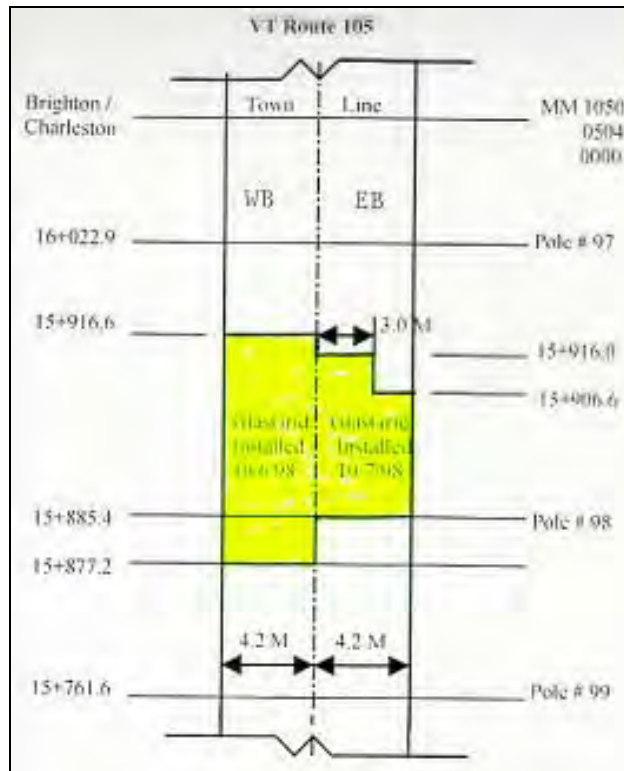
Figure 4 - GlasGrid® layout in Brighton

On October 6-7, 1998, GlasGrid® pavement reinforcement was placed on a portion of VT Route 105 in the town of Charleston near MM 9.87. The GlasGrid Complete Road System (8501) was installed on both travel lanes. On October 6, the product was applied to a 130 ft section of the westbound lane over the leveling course. Prior to the installation, the lane was swept clean of any dirt or debris. Following installation, the lane was then paved with a 1.375" wearing course, with no asphalt emulsion used between courses. A product representative, Alan Ward, of Nead Products, Lewiston, N.Y., was present for the installation. On October 7, the product was applied to the eastbound lane in an L-shaped section with a total length of 100 ft. The shorter length on the eastbound lane was done to allow for a side-by-side comparison with the product applied on the westbound lane. The layout of the GlasGrid installation is shown in Figure 4 below. The eastbound lane was also paved with a 1.375" wearing course, with no asphalt emulsion used between courses. The site was not swept prior to the installation of the product, as a considerable quantity of small aggregate was observed under the grid. It was also noted that the overlap of the GlasGrid at the centerline was less than the minimum required.

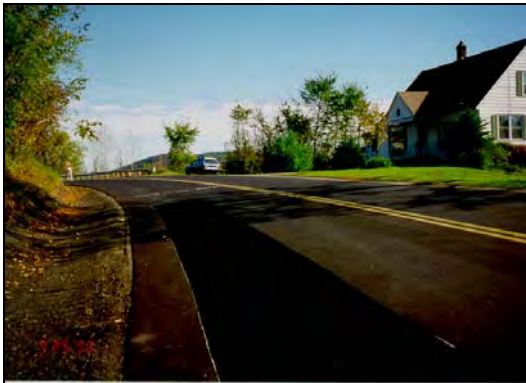
Figure 5 - GlasGrid Placement in Barnet

On September 25, 1998, GlasGrid<sup>®</sup> pavement reinforcement was placed on a portion of US Route 5 in the town of Barnet. The GlasGrid Detail Repair System (8502) was installed on the outside wheel path of the southbound lane. A preliminary crack survey of the test site clearly defined the location of the underlying concrete road base, with longitudinal and full-length transverse cracking. Severe fatigue cracking in the outside wheel paths was also evident, a distress possibly associated with the gravel subbase structure beneath the asphalt overlay, adjacent to the concrete slabs. This was probably created by the widening of the original concrete roadway. The test product was applied to a 100 ft x 5 ft section of the southbound lane as depicted in Figure 5. The material was installed by hand from a roll attached to the back of a pickup truck shown in Figure 6. The product was placed with the tacky side down on the leveling course and the material was coated with asphalt emulsion. The lane was then paved with a 1.5" wearing course. There was no manufacturer's representative present during the installation.

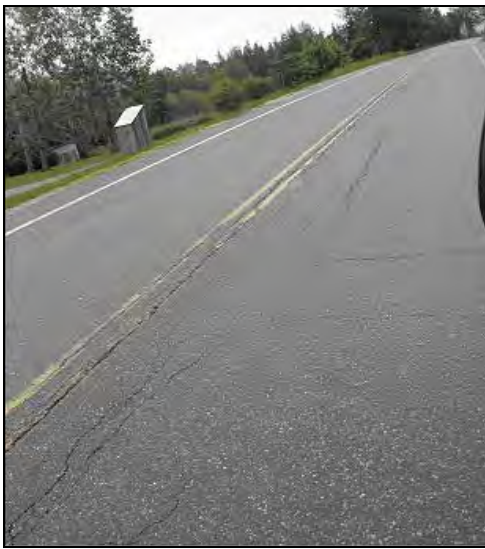
Figure 7 – Eastbound view, 2007

The cracking in the westbound lane continued to expand over the next two years, but not as severe as in the area outside of the test section. In July 2002, minor cracking was noticed in the inner wheel path of the eastbound travel lane. Again, this cracking appeared worse in the area outside of the test section, indicating that the GlasGrid may be aiding in retarding reflective thermal cracking. In August 2003, the cracking appeared to have increased in both travel lanes, although it appeared worse in the westbound lane. The pavement was observed to be in generally good condition at that time. A site visit in June 2007 revealed that fatigue cracking in the eastbound lane had increased significantly since the previous site visit and appeared to have more cracking than the westbound lane. Figures 7 and 8 display the cracking observed in the 2007 site visit. The westbound lane had developed minor fatigue cracking in the outer wheelpath as well as a few short transverse cracks in the middle of the lane. In general, less longitudinal cracking was observed in the test section than in the adjacent areas.

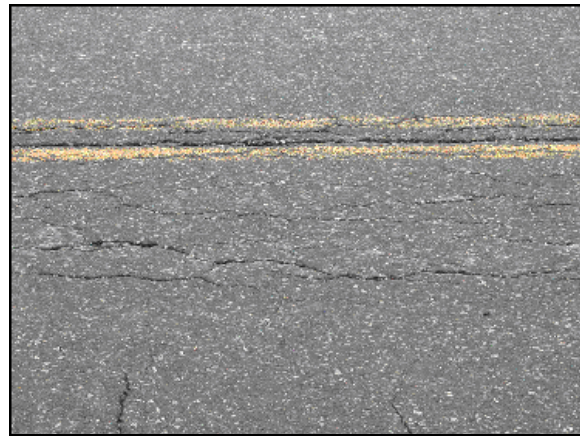
Figure 8 – Eastbound Lane cracking, 2007

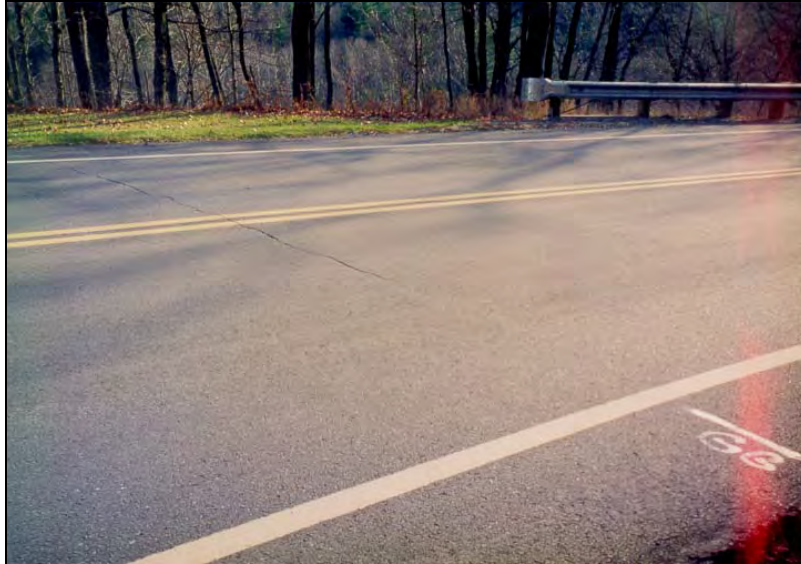
At the initial site visit in November 1999, only one year following installation, minor transverse cracking was observed. Two transverse cracks began in the northbound lane and spread slightly into the GlasGrid section of the southbound lane, as displayed in Figure 9. No evidence of longitudinal cracking, the primary type prior to the installation, was found. In July 2000, one of the previously noted transverse cracks had extended across the full width of the roadway and the other had extended all but one foot of the full width. Similar cracks, predominantly full width, were found both north and south of the test site. The first signs of longitudinal cracking were observed in June 2001 near the edge of the material in the southbound lane. The amount and length of transverse cracks also continued to increase, with some cracks up to 3 cm wide. No major new cracking was noted in July 2002, although the previously observed longitudinal cracks continued to increase in length. In August 2003, the site was found to be in relatively good condition with little deterioration in the GlasGrid test area.

Figure 9 – Barnett in 1999, 1 year after placement

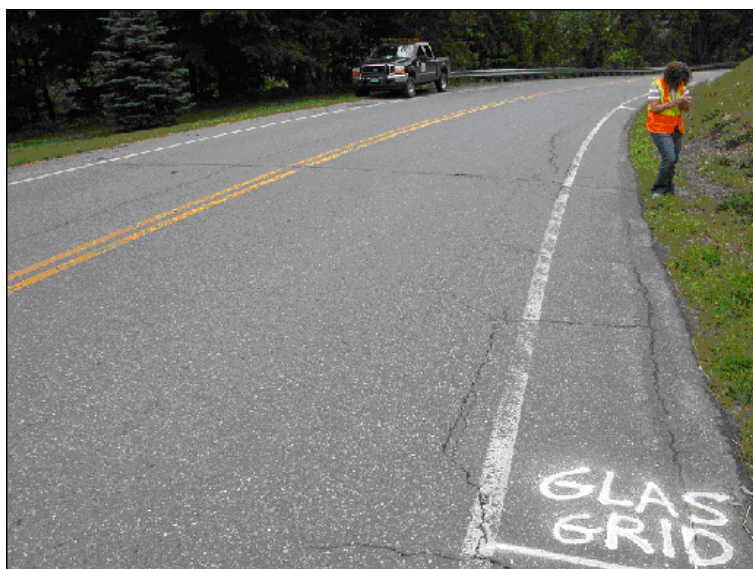
A site visit in June, 2007, shown in Figure 10, found that although there were only two transverse cracks in the GlasGrid area, both were rather severe and had developed into alligator cracking in the GlasGrid area, as shown in Figures 11 and 12. The northernmost transverse crack, shown in Figure 13, had expanded to about 4” wide exposing the underlying GlasGrid. A piece of the material was removed for inspection and appeared rotten looking and weak, as it could easily be pulled apart by hand. This transverse cracking pattern was typical outside of the test area as well, although generally not as severe in terms of crack width. It is believed that this cracking is caused by movement of the concrete subbase, which is reflecting through into the overlay. In addition to the transverse cracking, severe fatigue cracking had developed in the outer southbound wheel path of the GlasGrid test area. Outside of the test area, a single fatigue crack was found that spanned the test site in the inner northbound wheel path.

Figure 10 – Southbound view of Barnett test site in 2007

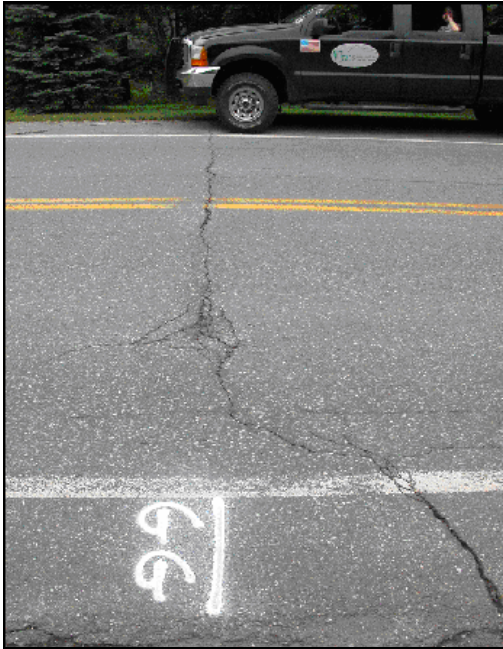
Figure 11–Crack 24m south of edge, 2007

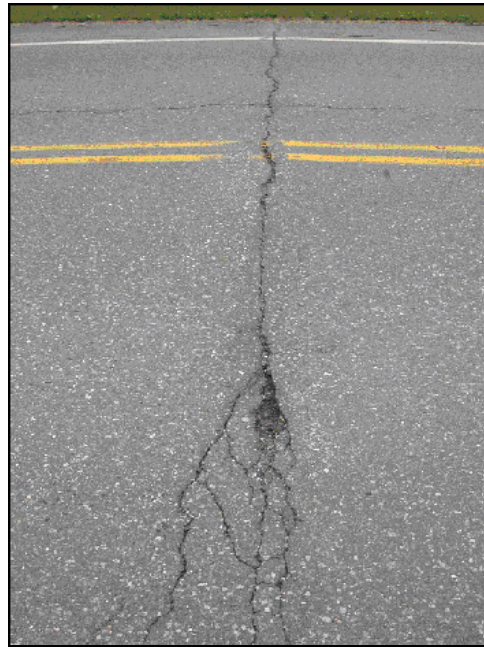
Figure 12–Crack 9m south of edge, 2007

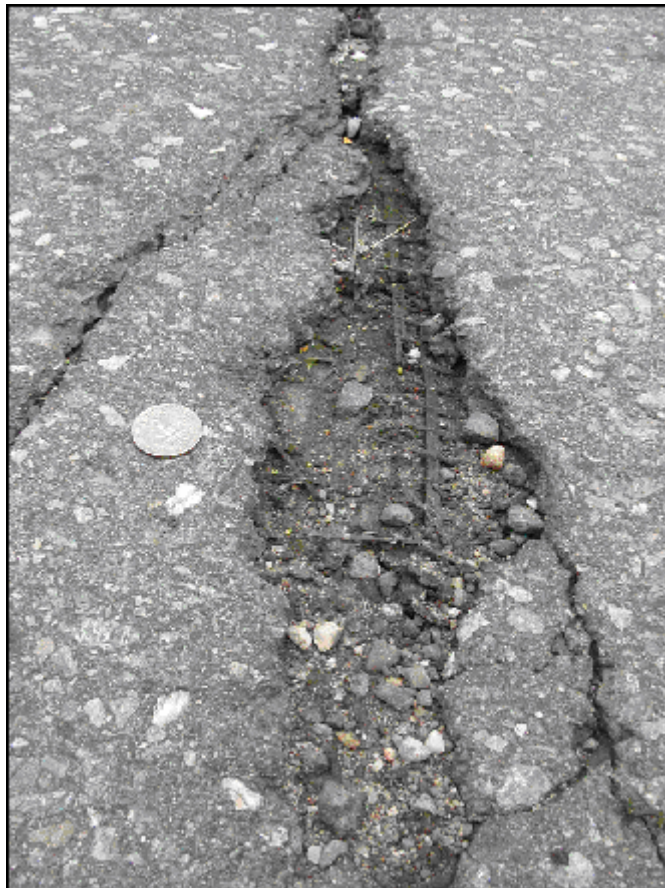
Figure 13 - Exposed GlasGrid material, 2007
