INVESTIGATION OF ALKALI- SILICA-REACTIVITY IN PORTLAND CEMENT CONCRETE

PHASE II – SELECT VERMONT STRUCTURES

**Vermont Agency of
Transportation
Research, Development and
Technology Transfer Project**

DECEMBER 2008

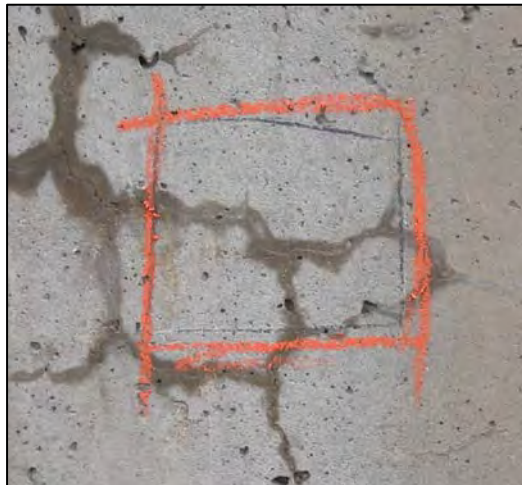
Figure 1 Crack with white precipitate.

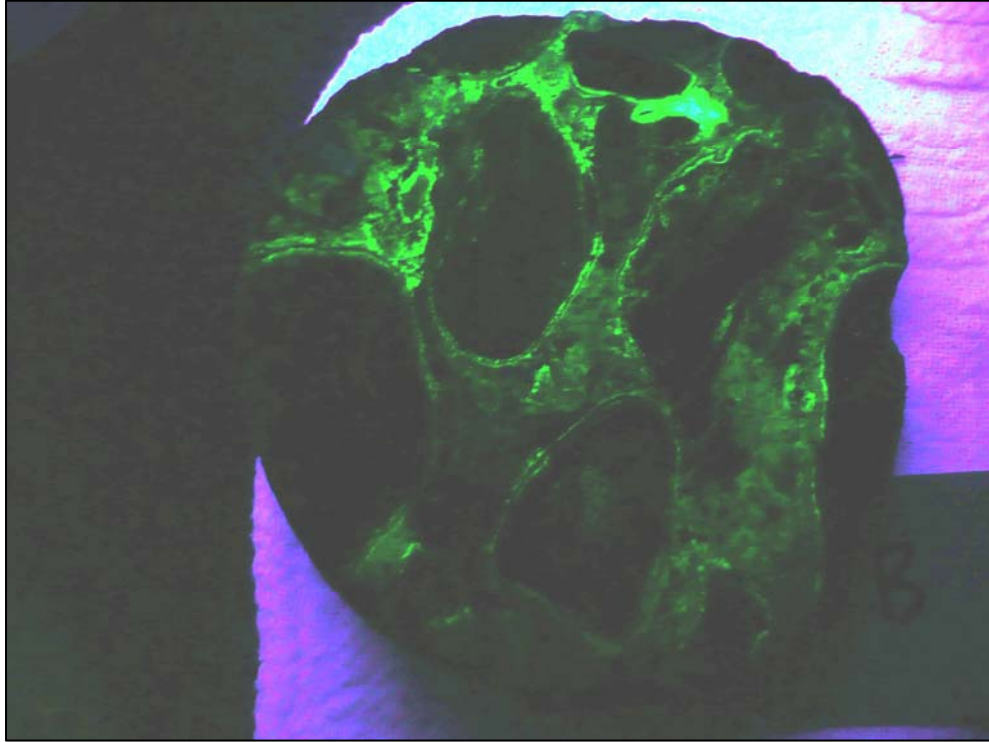
Figure 5 Photograph of core sample under Ultra Violet light showing ASR development.

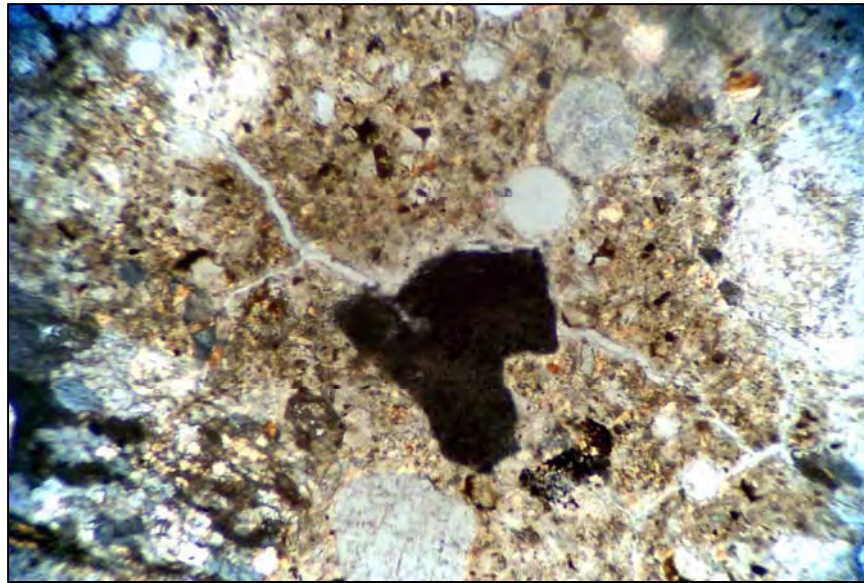
Figure 6 Photomicrograph showing ASR distress in the form of micro cracking.

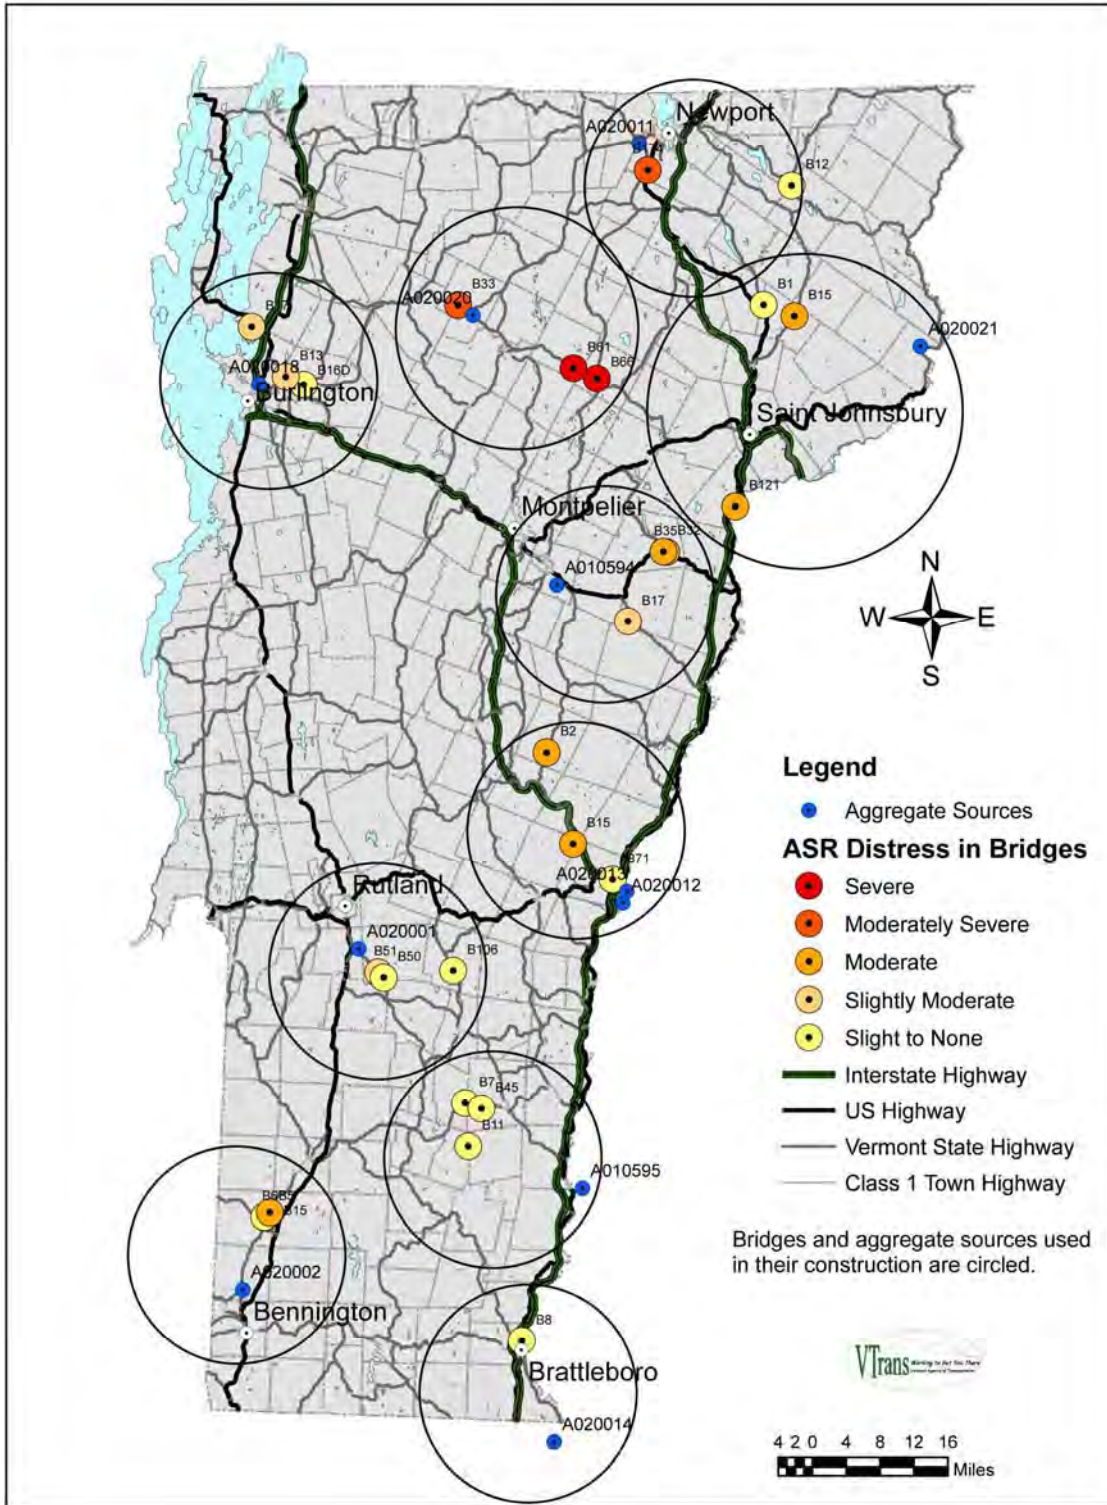
MAP SHOWING SEVERITY OF ASR DISTRESS

moderately severe ASR distress centered in the north-central portion of the state. Moderate ASR distress of bridges was noted in the upper Connecticut River Valley while slightly moderate to no ASR distress were observed in bridges in the Champlain Valley, Vermont Valley and southern portions of the state.

Figure 7 Map showing ASR distress in the bridges investigated during this study.
