**FIELD REPORT**

**U2017-1**

**Site Visit for RAS Surface Aggregate Blend  
Brookfield – VT Route 65**

**EA:** Experimental Features - SPR 352

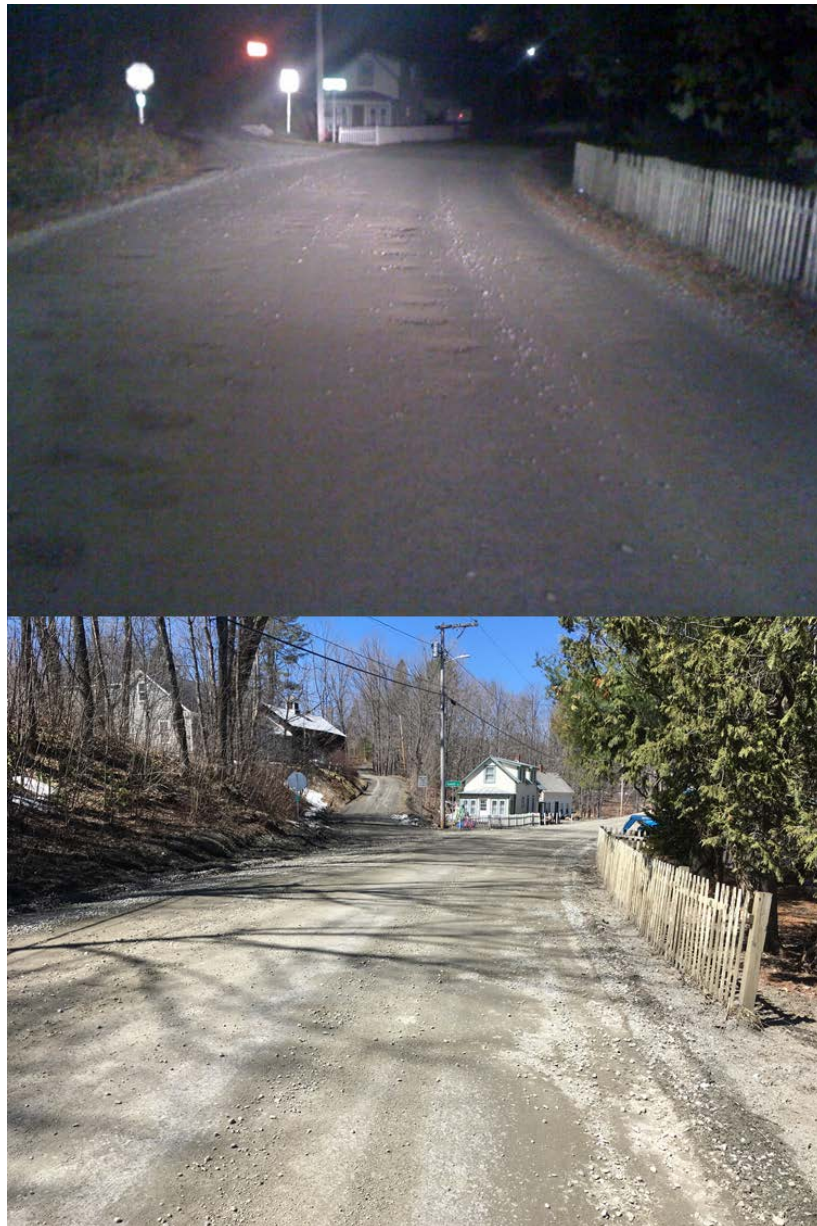
**Figure 1: Brookfield Village East of Floating Bridge (Non-RAS Section) at VT 65 Mile Marker 3.2. Photo Comparison between 10/26/16 Site Visit (Top) and 4/14/17 Site Visit (Bottom)**

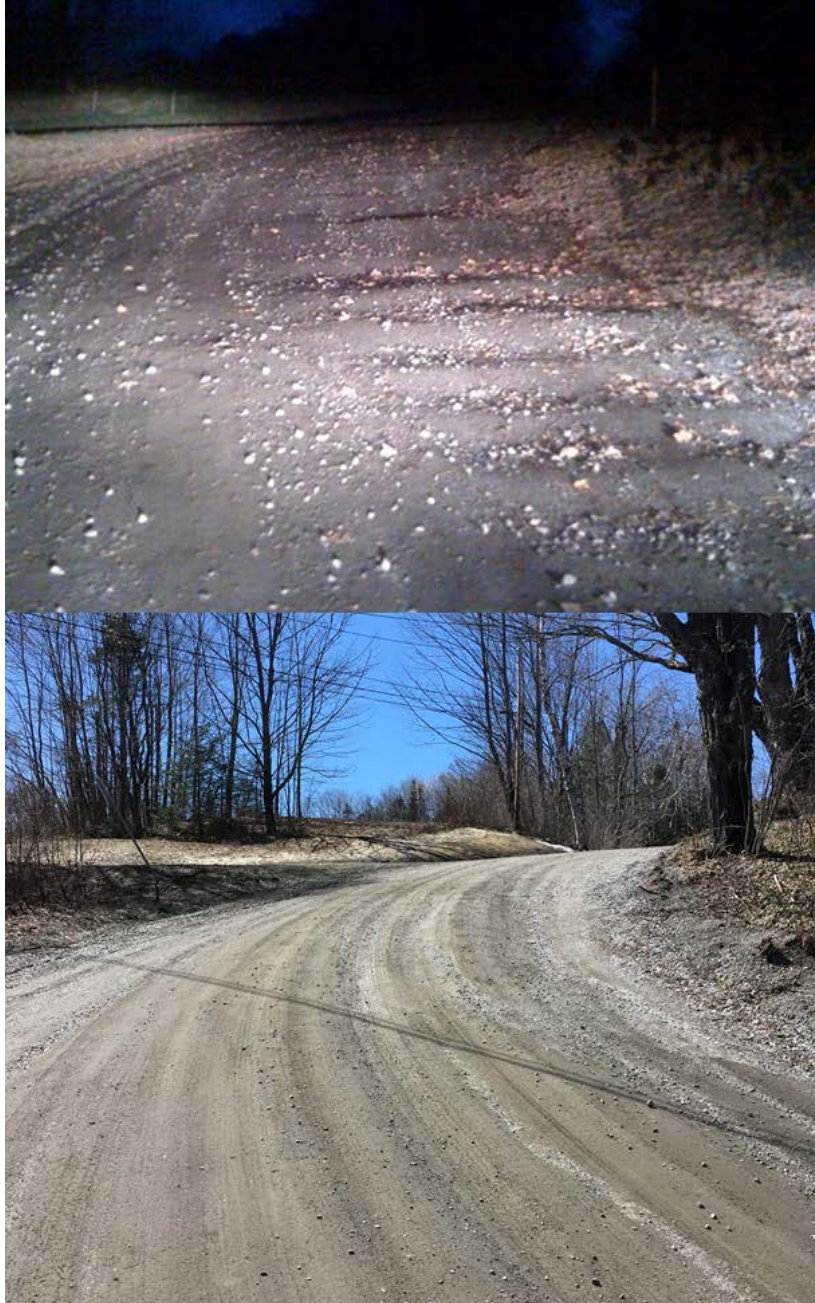
State Park. The decrease in traffic coupled with the last scheduled roadway grading before the winter months (November) were major contributing factors in improving the roadway conditions after the winter, compared to the conditions observed during the fall site visits. There are a few farms along VT 65 and it was brought to our attention that large farm equipment traveled on the road during harvesting activities during the fall months after construction. The driving of the farm equipment on the road along with the dry 2016 fall season most likely contributed to the roadway deterioration that was observed during the 9/9/16 and 10/26/16 VT 65 site visits. This includes the wash boarding that is evident in the top photos of Figures (2 - 4), around the inclined sections near the intersections with West Street and Bear Hill Road.

**Figure 2: Intersection with West Street at VT 65 Mile Marker 2.5. Photo Comparison between 10/26/16 Site Visit (Top) and 4/14/17 Site Visit (Bottom)**

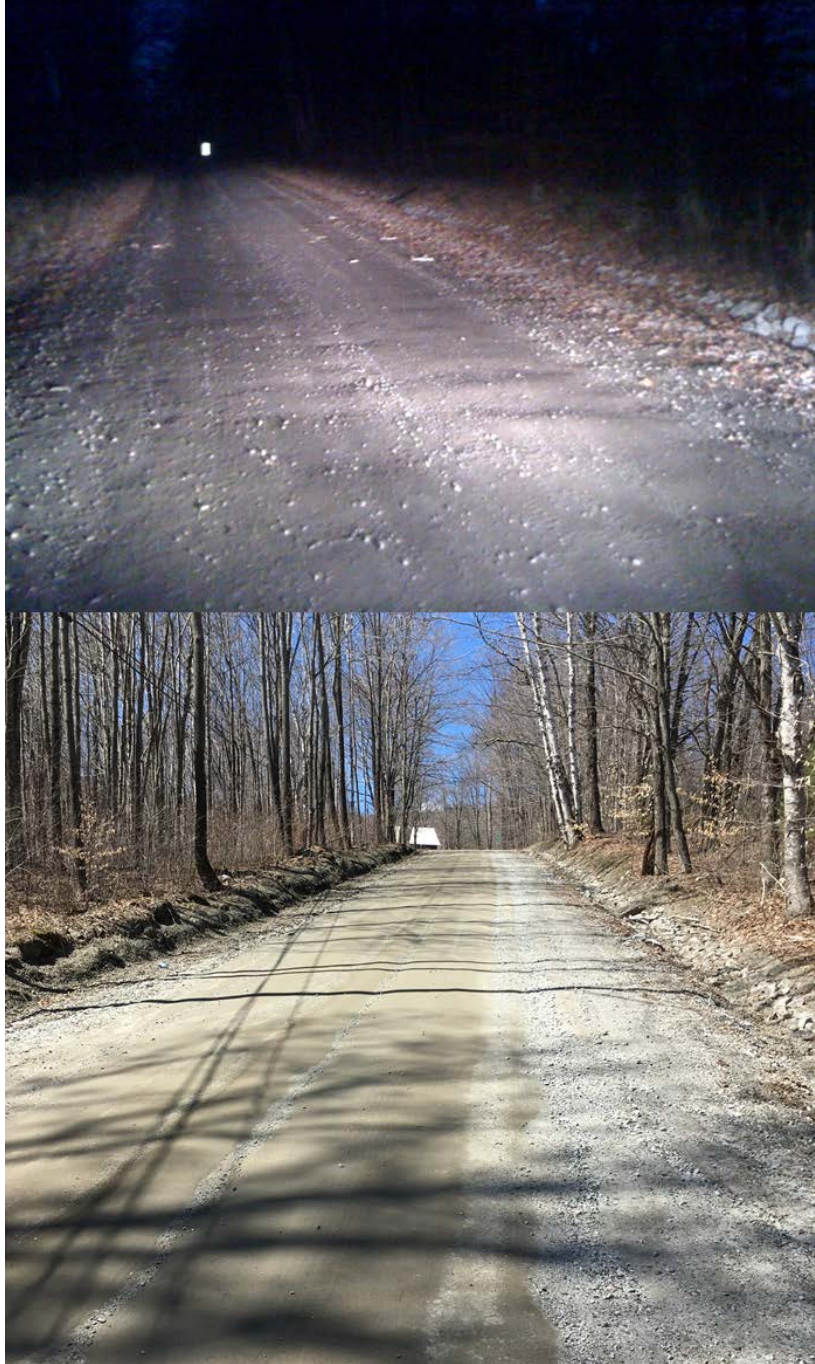
**Figure 3: East of Intersection with Bear Hill Road at VT 65 Mile Marker 2. Photo Comparison between 10/26/16 Site Visit (Top) and 4/14/17 Site Visit (Bottom)**

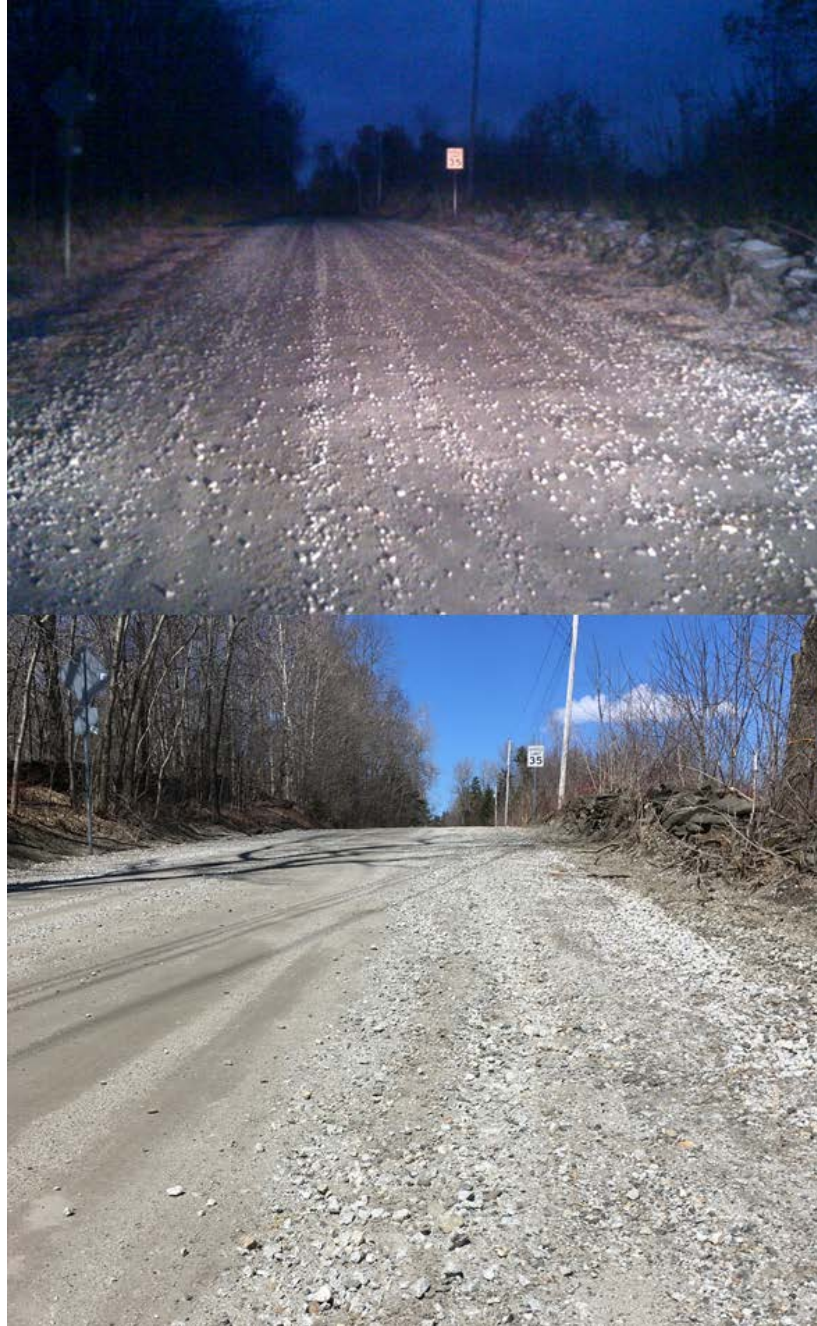
**Figure 4: North of Intersection with Bear Hill Road at VT 65 Mile Marker 1.7. Photo Comparison between 10/26/16 Site Visit (Top) and 4/14/17 Site Visit (Bottom)**

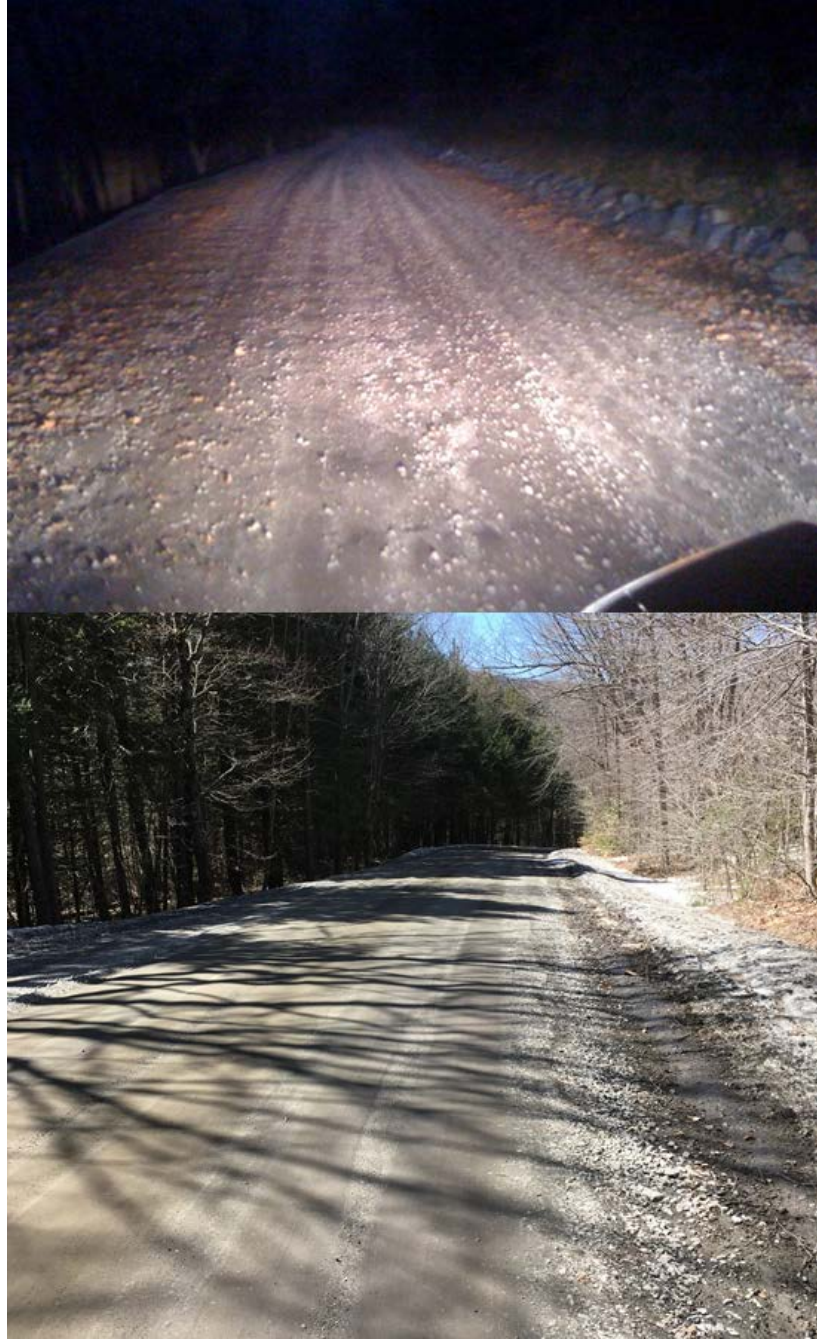
**Figure 5: VT 65 Looking Down Decline Towards VT 12 Mile Marker 0.8. Photo Comparison between 10/26/16 Site Visit (Top) and 4/14/17 Site Visit (Bottom). Minor ruts formed on the left side of the road and can be seen in more detail in Figure (11)**

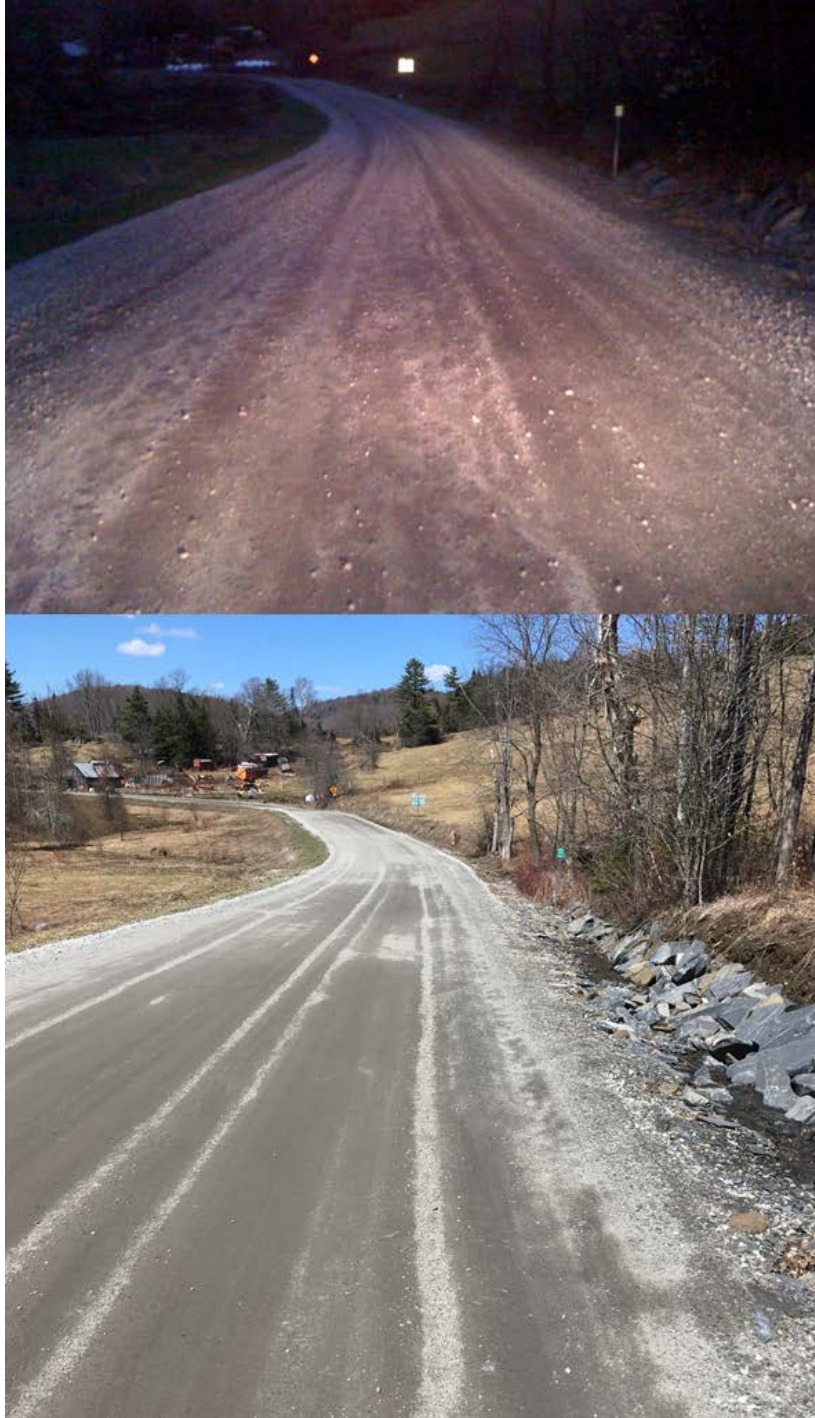
**Figure 6: VT 65 Looking Towards VT 12 Mile Marker 0.3. Photo Comparison between 10/26/16 Site Visit (Top) and 4/14/17 Site Visit (Bottom)**

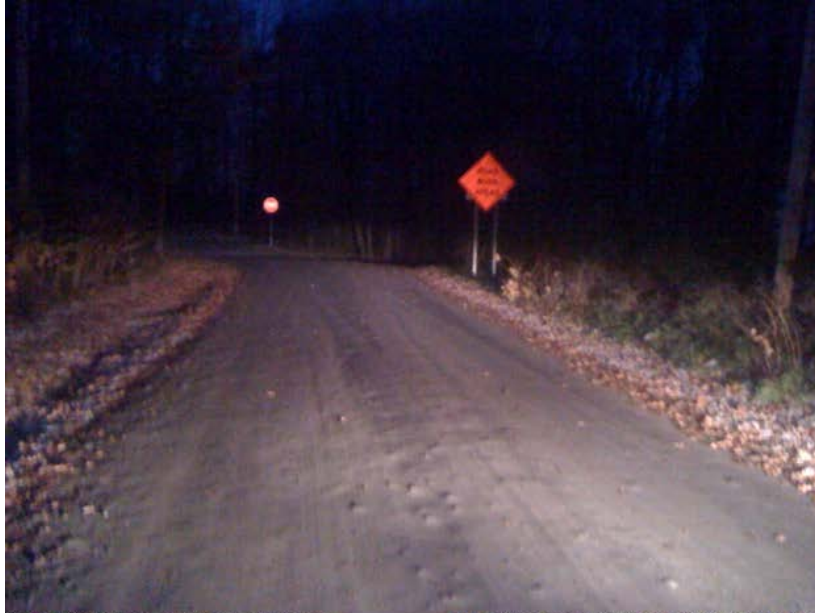
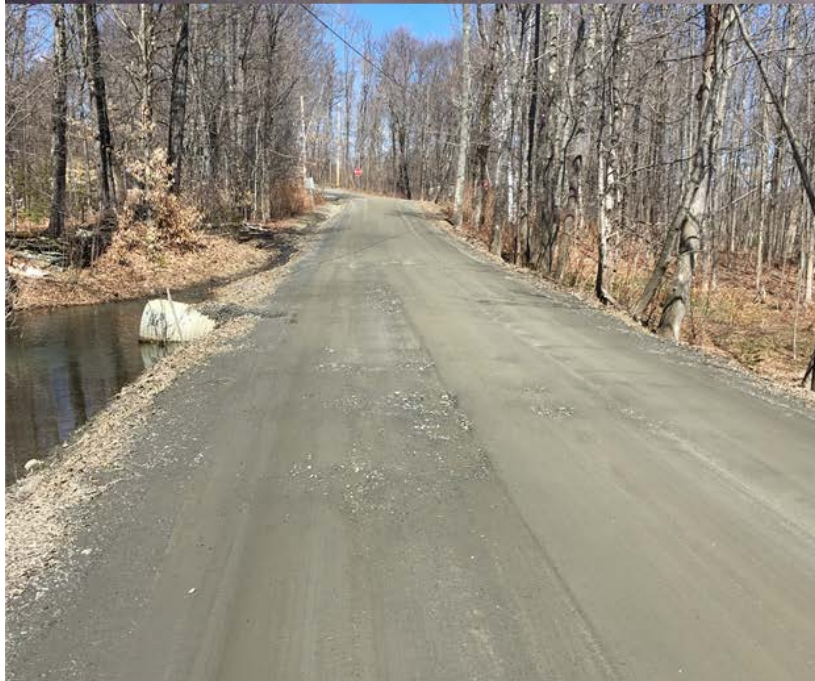
**Figure 7: Bear Hill Road Looking Towards Intersection with VT 65 (Non- RAS Section). Photo Comparison between 10/26/16 Site Visit (Top) and 4/14/17 Site Visit (Bottom)**

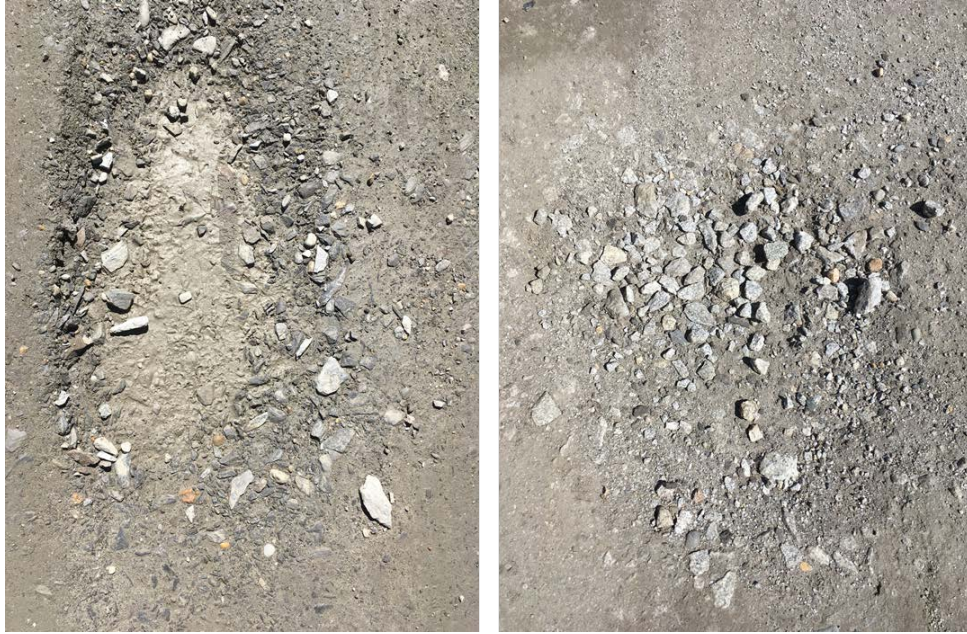
It is also evident in Figures (1 – 6) that the amount of aggregate on the roadway surface had decreased after the winter season. This is most likely due to the grading done in September and November 2016 before the first snowfall, which mixed the aggregate more homogeneously throughout the depth of the surface course and pushed the larger aggregate off the roadway surface and onto the shoulder. Snow plowing during the winter months could also have contributed to movement of the aggregate to the shoulders. It was also theorized that the size, shape and amount of aggregate on the roadway surface along with the low percentage of fines caused the vehicles tires to lose grip and spin, contributing to the wash boarding depicted in the figures (Denardo & Ewald, 2017). The differences in the aggregate size and shape can be seen in Figure (8). Two potholes of similar size were selected, one on VT 65 east of Bear Hill Road near mile maker 2.1 (with RAS, photo on the right) and the other on Bear Hill Road near the intersection with VT 65 (no RAS, photo on the left). A visual analysis of the aggregates within the potholes clearly shows that the aggregate used on the Brookfield project is more rounded and cubic as opposed to the more elongated and irregular aggregate used on surrounding roadways.

**Figure 8: Bear Hill Rd Pothole Near Intersection with VT 65. Road has no RAS, aggregate is more irregular (Left). Pothole on VT 65 East of Bear Hill Rd near Mile Marker 2.1. Road has RAS, aggregate is more cubic (Right). Photos taken during 4/14/17 Site Visit.**

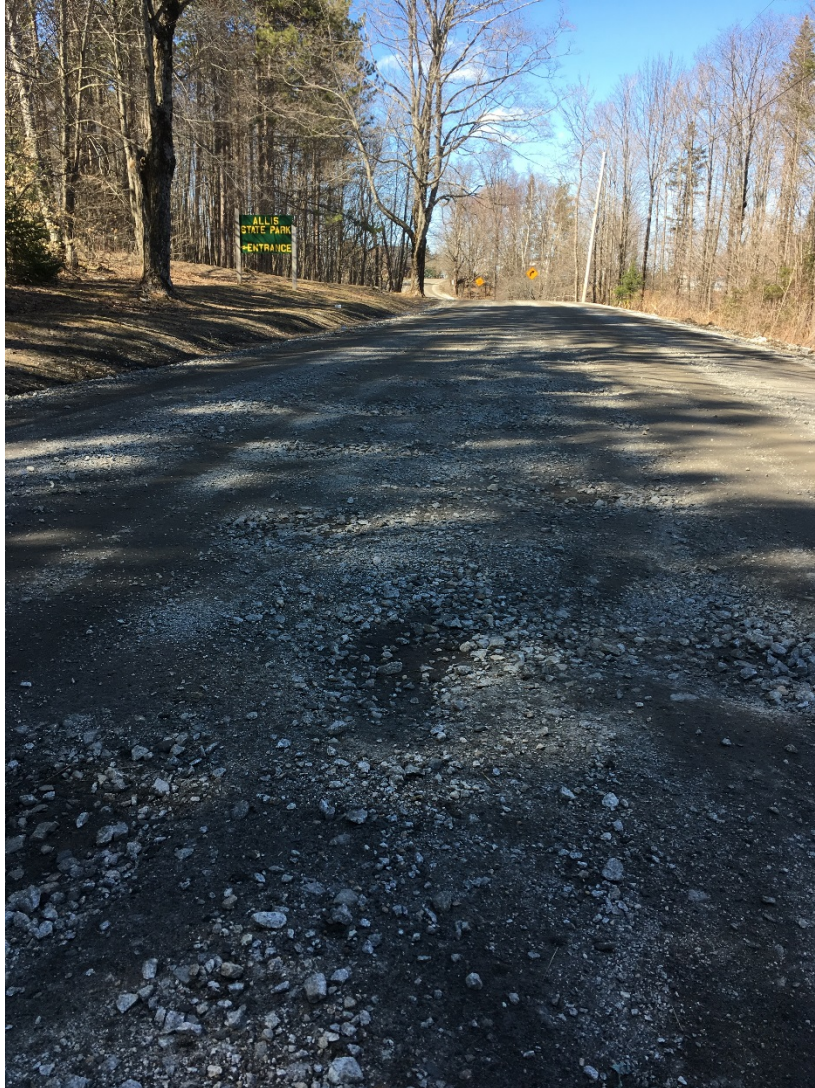
Assessing the performance throughout the length of the VT 65 project after the 2016/2017 winter season, deterioration of the roadway surface was limited to some localized potholing and rutting. Areas near the Allis State Park (Figure (9)), west of the I-89 overpass (Figure (10)), and east of Bear Hill Road (Figure (8)), exhibit the greatest concentration of the potholing after the winter season. It should also be noted that the aggregate within the potholes on VT 65 was more visible or exposed, most likely due to the lack of fines and mixing of the aggregate during construction. Rutting was prevalent, but not extensive, east of the intersection with Bear Hill Road near mile marker 2 (Figure (3)), north of the intersection with Bear Hill Road near mile marker 1.7 (Figure (4)), on the steep decline near the intersection with VT 12 at mile marker 0.8, (Figures (5 & 11)), and near the intersection with VT 12 at mile marker 0.3 (Figure (6)). The thawing of the roadway surface contributed to the rutting depth due to excessive moisture conditions in the roadway materials, which are expected on a gravel road during spring. Road conditions can be seen in Figure (11).

Figure 9: Potholes Near the Entrance to the Allis State Park, VT 65 Mile Marker 1.4. Photo taken during 4/14/17 Site Visit.

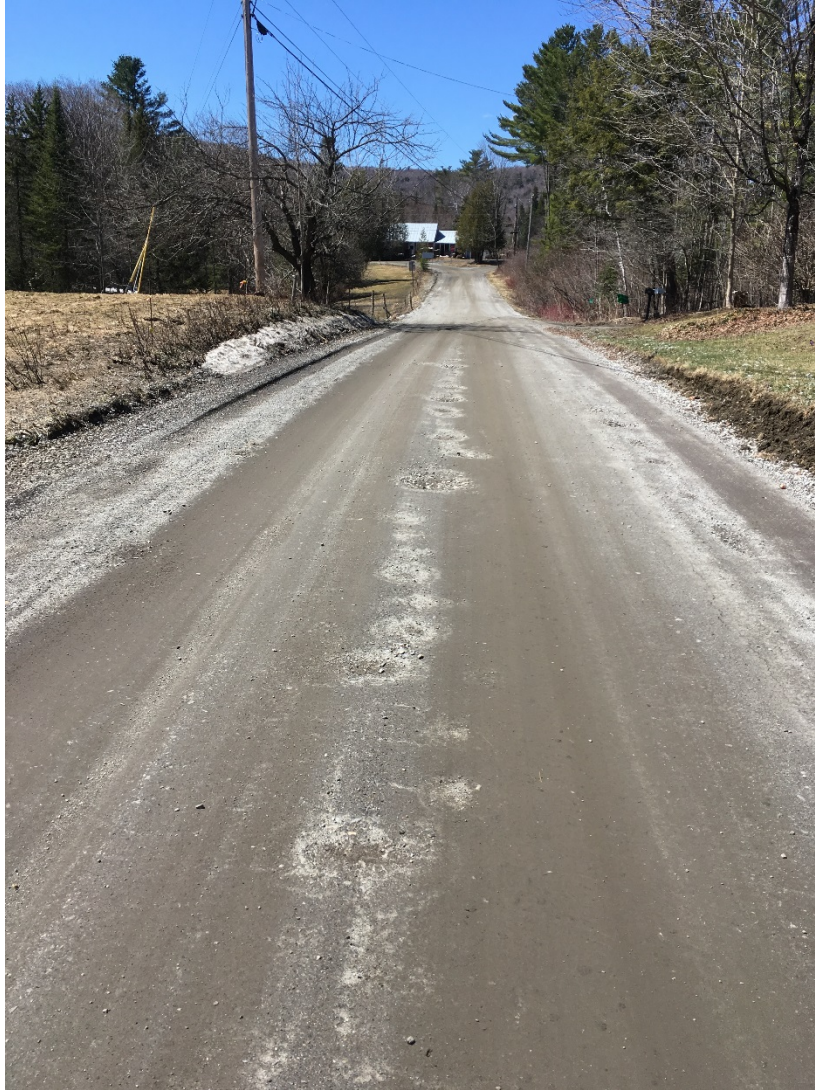
Figure 10: VT 65 just West of I-89 Overpass, Mile Marker 2.7. Photo taken during 4/14/17 Site Visit.

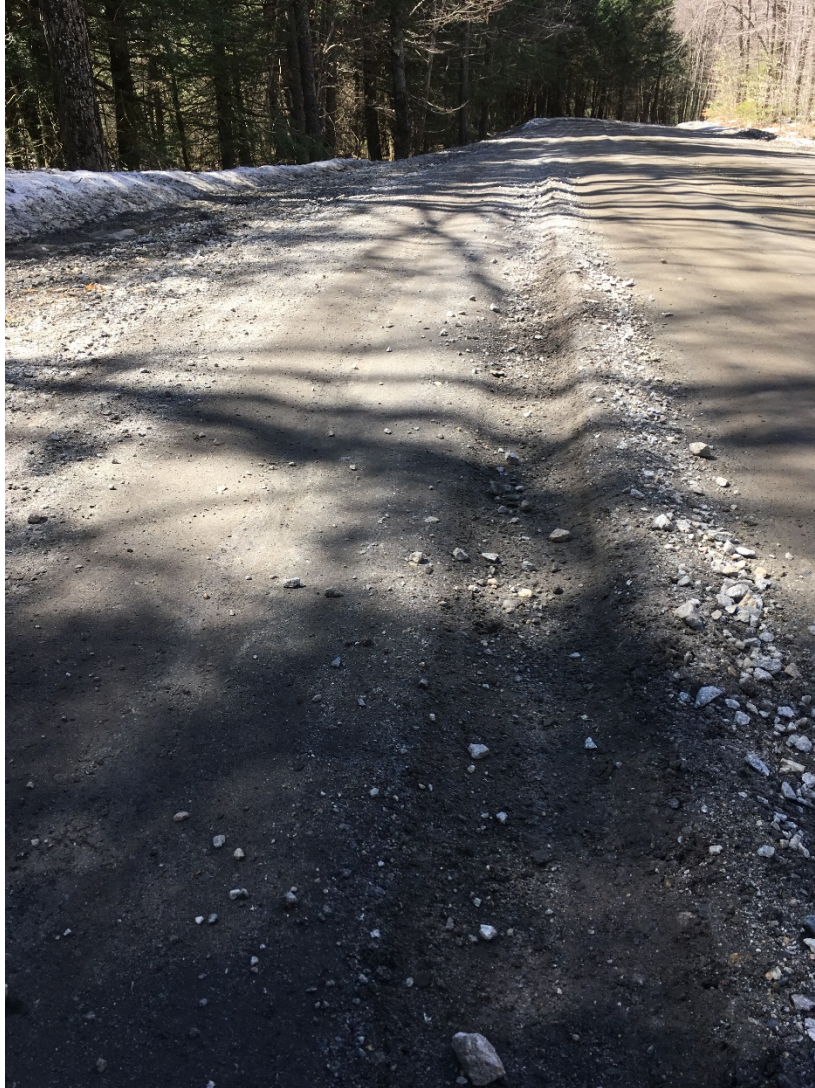
**Figure 11: VT 65 Looking Down Decline Towards VT 12 Mile Marker 0.8. Some Rutting is occurring on the left side of the road.  
Photo taken during 4/14/17 Site Visit.**

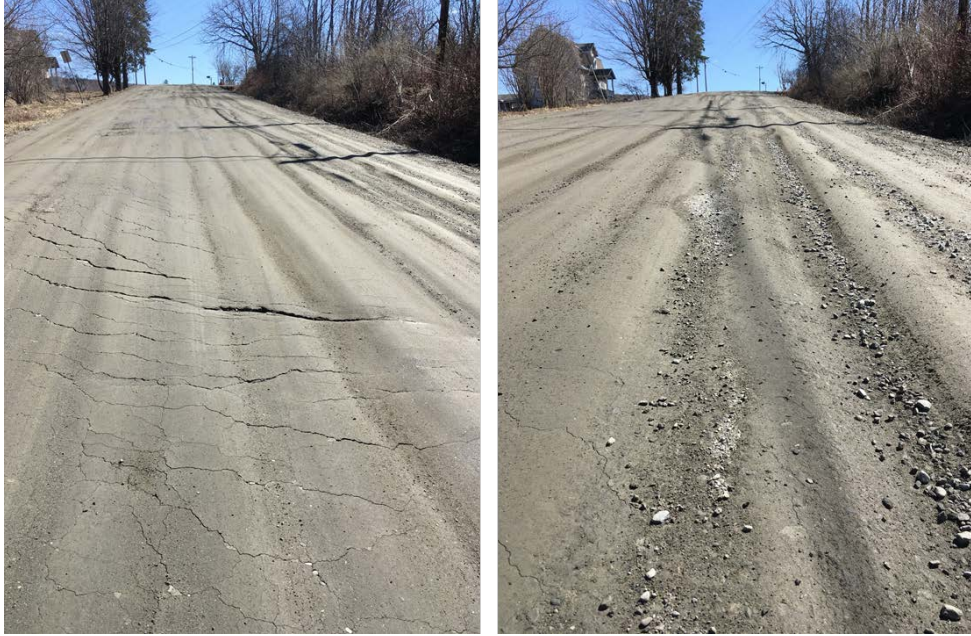
**Figure 12: Stone Road Near Intersection with VT 64 on a Hill (Town Road with no RAS). Road cracking, rutting, depressions and potholes were widespread. Photos taken during 4/14/17 Site Visit. See also [Stone Road video](#).**
