**October 20, 2017**

**FINAL FIELD REPORT**

**U2017 - 04**

**Poly-Carb Mark-163 Flexogrid Site Visit  
Bridge 8 on Concord Ave. (TH 4), Waterford VT**

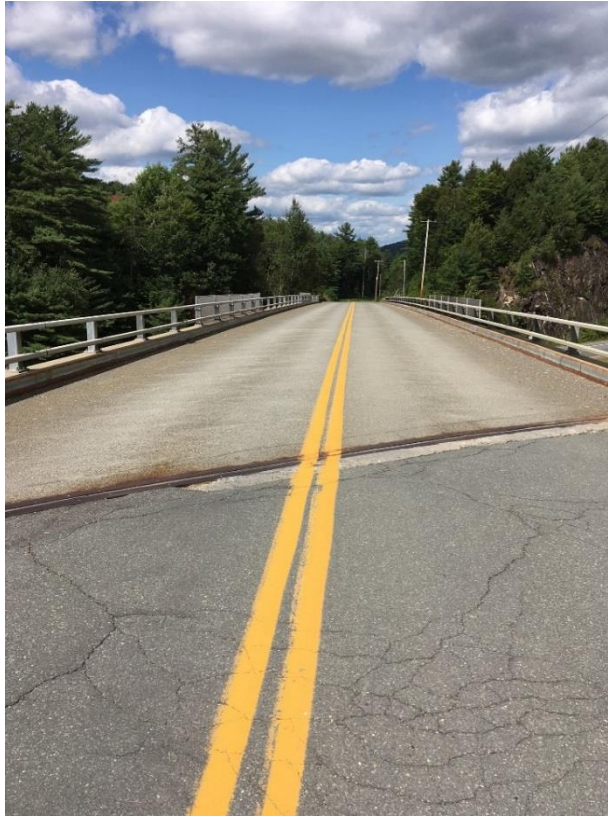
**Figure 1: Overall View of Bridge 8 on Concord Ave. (TH 4), Waterford VT.  
Facing north over I-93.**

Figures 1 & 2 show the overall view of Bridge 8 from both the north and south, while Figure 3 shows a close-up view of the overlay surface. The excellent condition of the bridge deck surface and evidence of no new surface deterioration, except for some minimal wear in the wheelpaths, can be seen in the above figures. The wheelpaths showed minimal signs of raveling and smoother, less textured aggregate. Small amounts of loose aggregate, from the Flexogrid System surface, was found around the wheelpaths and alongside the bridge curb. The slight wearing to the wheelpaths can be seen in Figures 1 & 2 and the loose aggregate can also be seen in Figure 6. The amount of wear to the wheelpaths should not be viewed as a major blemish to the performance of the Flexogrid System considering that the system was installed during the spring of 2013 and endured 5 winter seasons of plowing. The adhesive adhering the aggregate to the bridge deck has performed well given the small amount of loose aggregate found during the site visit.

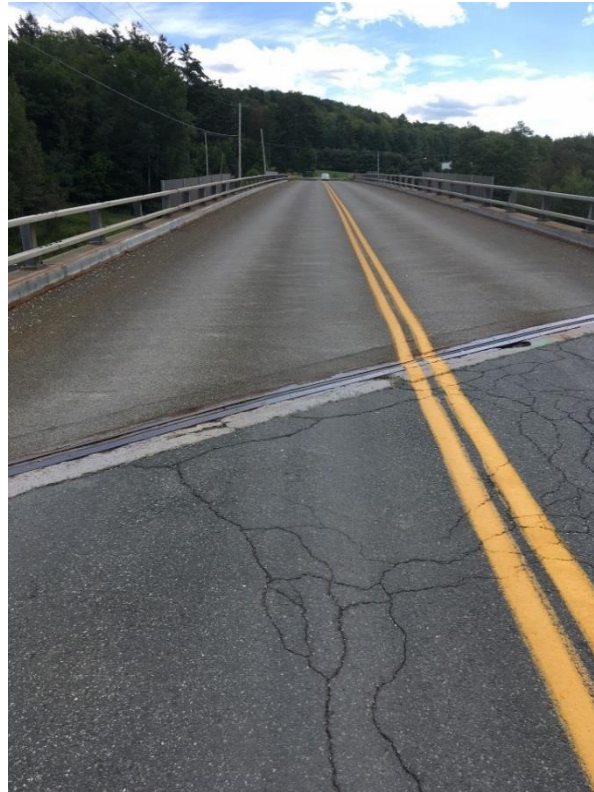
**Figure 2: Overall View of Bridge 8 on Concord Ave. (TH 4), Waterford VT.  
Facing south over I-93.**

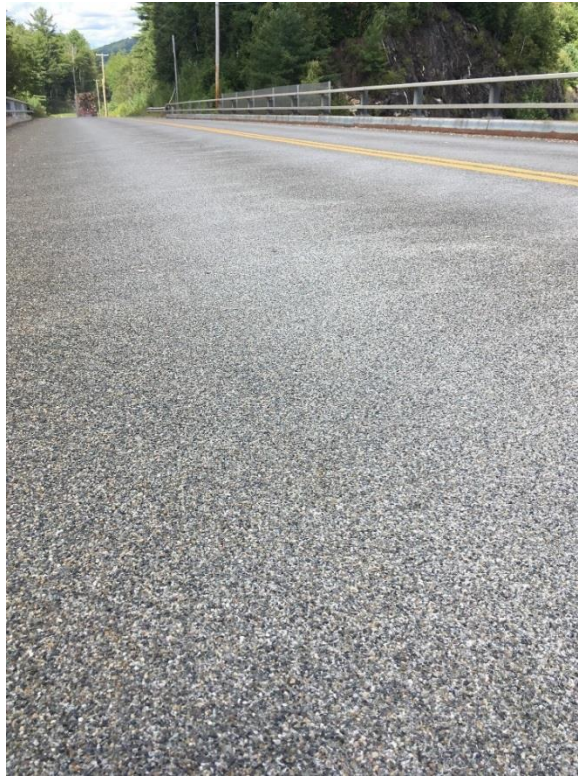
**Figure 3: Close-up of bridge deck surface.**

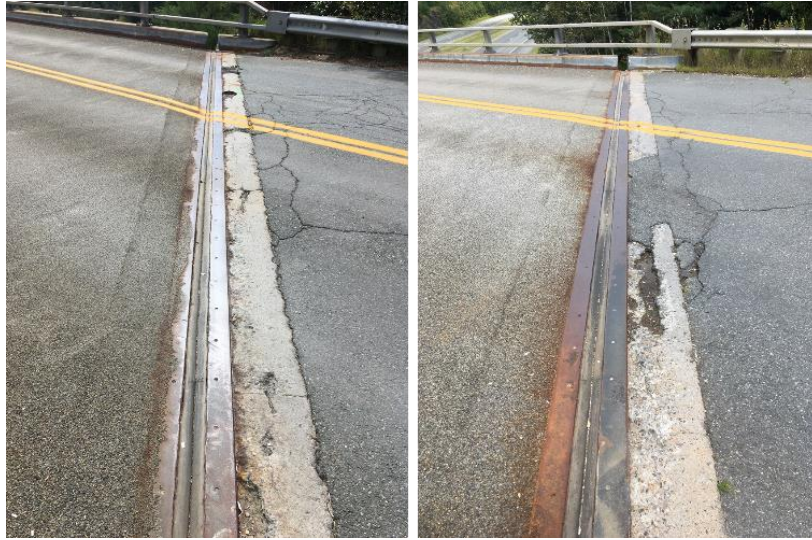
**Figure 4: Bridge joints. Photo on left shows the bridge joint on the north end of the bridge, while the photo on the right shows the bridge joint on the south end of the bridge.**

Significant cracking was evident around the bridge joints, Figure 4 and the approaches to the bridge, Figure 5. The cracking around the bridge joints were also noticed during the prior year's inspection by the Research Section and by the Bridge Management and Inspection Unit. Observations from the field show that the approaches to the bridge, from the north and the south, are experiencing significant transverse and longitudinal cracking. In certain areas, which are evident in Figure 5, alligator cracking has begun occurring. The patching near the bridge joints that was noticed during last year's research inspection seems to be performing well, accomplishing the task of extending the life of the bridge joint. At this point it is unclear why this cracking is occurring, but it is most likely attributed to the deterioration of the concrete bridge joint underneath the Flexogrid Membrane. Further discussions with the Structures Unit and The Bridge Management and Inspection Unit would have to be had to accurately determine the cause of the deterioration around the bridge joints and the approaches.

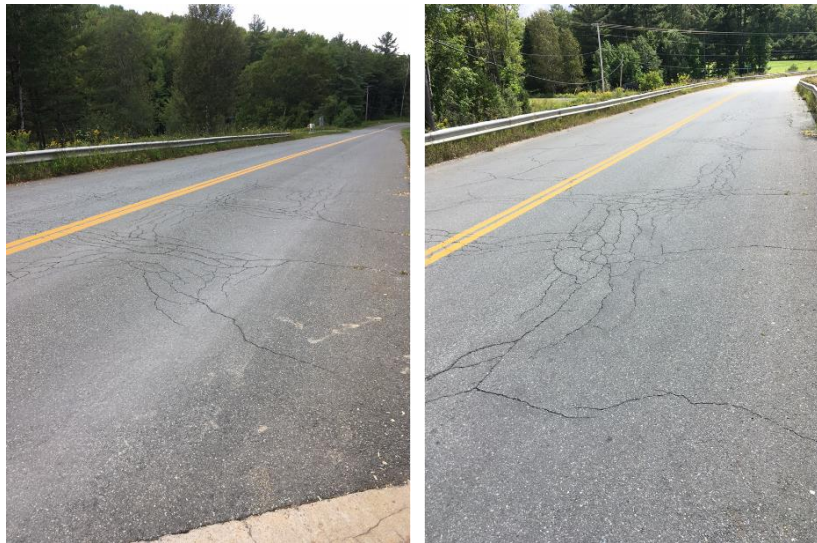
**Figure 5: Pavement deterioration. Photo on left shows the pavement deterioration approaching the north end of the bridge, while the photo on the right shows the pavement deterioration approaching the south end of the bridge.**

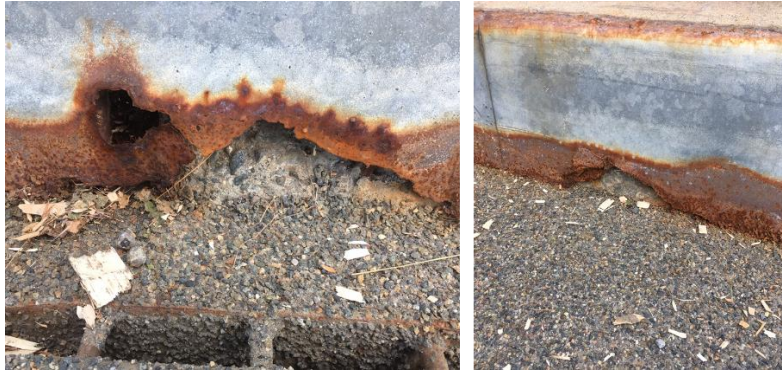
**Figure 6: Deterioration of metal curb protector.**

Figure 6 shows the deterioration on the metal protection of the curb. Aggressive agents from run-off and winter maintenance has most likely attributed to the metal curb protector deterioration around the concrete curb. The extent of deterioration and corrosion seems minor and has been slow to progress. The rust and some of the holes were evident during the 2013 installation of the Flexogrid System. Photos from the installation of the overlay system can be found by reviewing the [Installation Report](#).

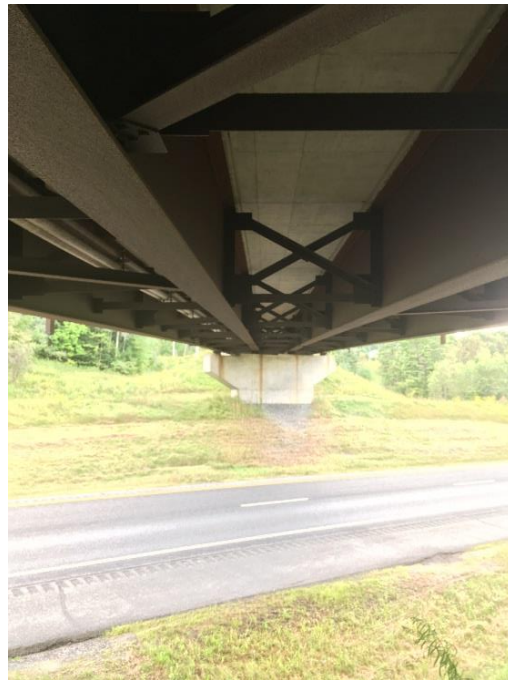
**Figure 7: Full view of the underneath of the bridge.**

No cracking, deterioration, or leaking was visible on the underside of the bridge, which can be seen in Figure 7.

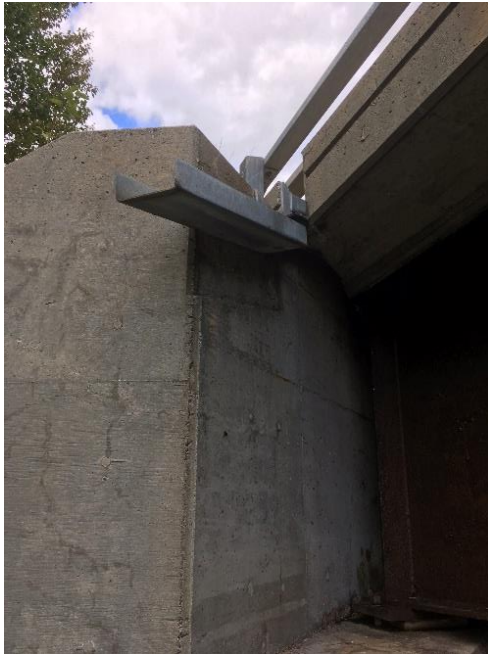
**Figure 8: Bridge 8 abutment and extended gutter.**

No new cracking to the bridge abutments was found near the bridge joints. This is most likely attributed to the extended gutter, seen in Figure 8, which carries run-off from the bridge joints away from the abutments.
