## MATERIALS & RESEARCH SECTION

## RESEARCH UPDATE

U2013-05

### Assessment of 40" Wide Paving Skid Box

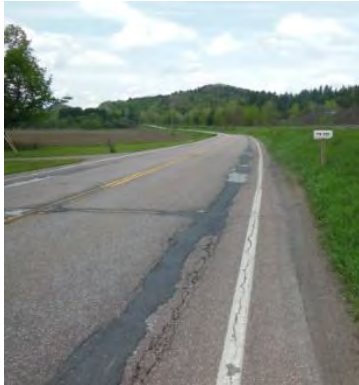
Sections of US Route 2 have a concrete base underneath the pavement layers. To accurately evaluate the repair process, four two hundred foot test sections were chosen along US Route 2 to quantify existing distresses including cracking and rutting. Preexisting site conditions are shown in Figures 2 and 3 below.

**Figure 2: Test Site 2  
looking WB.**

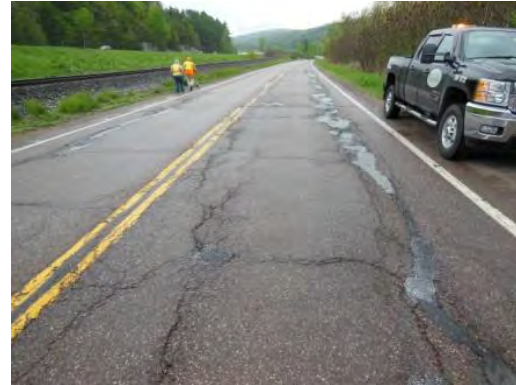
**Figure 3: Test Site 3, looking EB.**

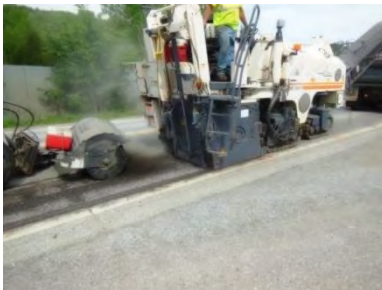
**Figure 4: Cold planing and  
sweeping.**

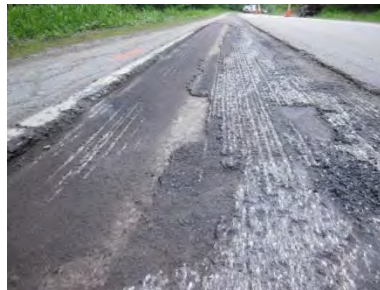
**Figure 5: After cold  
planing.**

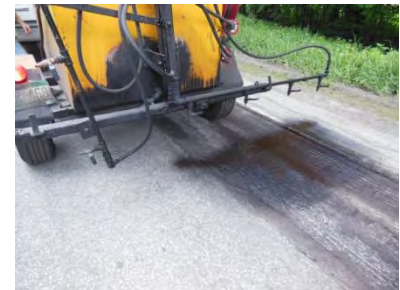
**Figure 6: Spraying  
emulsion tack coat.**

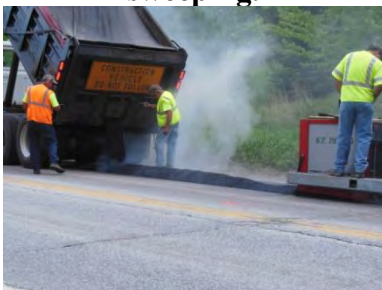
**Figure 7: Paving.**

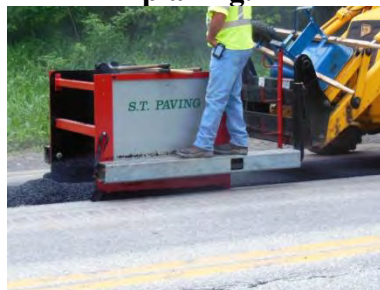
**Figure 8: Paving Skid Box.**

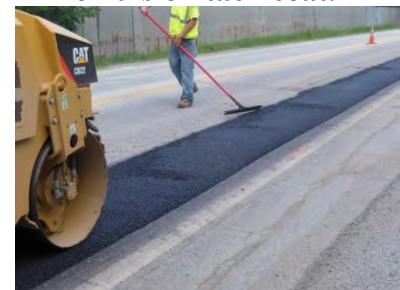
**Figure 9: Squeegee and  
Compaction.**

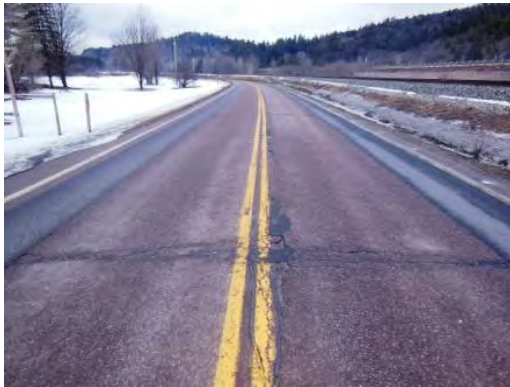
**Figure 12: Test Site 2, looking WB.**

The site was visited in March 2013 and July 2013 to evaluate the repair and measure rutting in each test site. Photographs and general observations were made at each visit. Test sites 2 and 3 are shown in Figures 12-15 below. Figures 12 and 13 depict each test site in March 2013 and Figures 14 and 15 show each in July 2013.
