VERMONT AGENCY OF TRANSPORTATION

**Research and Development Section
Research Report**

**COLD IN-PLACE RECYCLED BITUMINOUS PAVEMENT
DORSET-DANBY, VT**

Report 2015 – 04

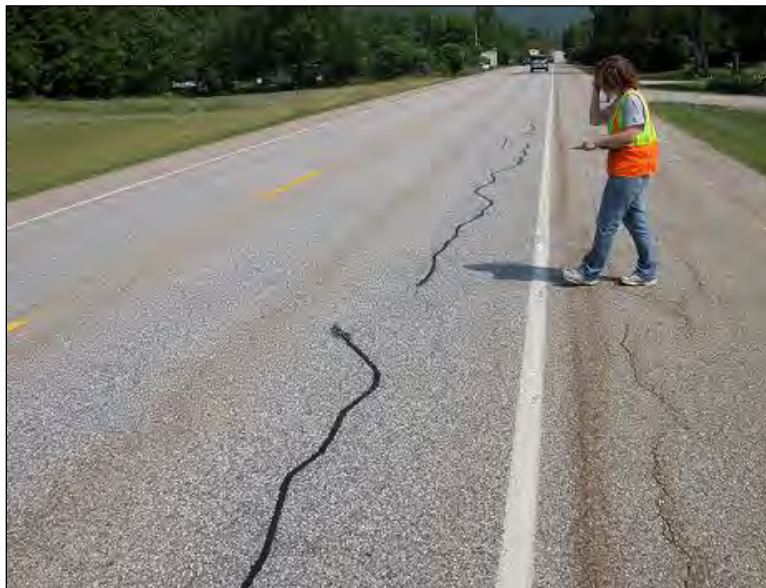
As indicated by the Distress Identification Manual, fatigue cracking occurs in areas subjected to repeated traffic loading, most notably the wheelpaths, and may be a series of interconnected cracks in early stages of development that progresses into a series of chicken wire/alligator cracks in the later stages. For this investigation, the wheelpaths were determined to be 3 feet in width with the center of the left wheel path 3 feet from the centerline and the right wheel path 8 feet from the centerline for both sides of the roadway. An example of fatigue cracking within test site 2 is provided in Figure 6.

Figure 6 Fatigue cracking (Test Site 2, year 10)

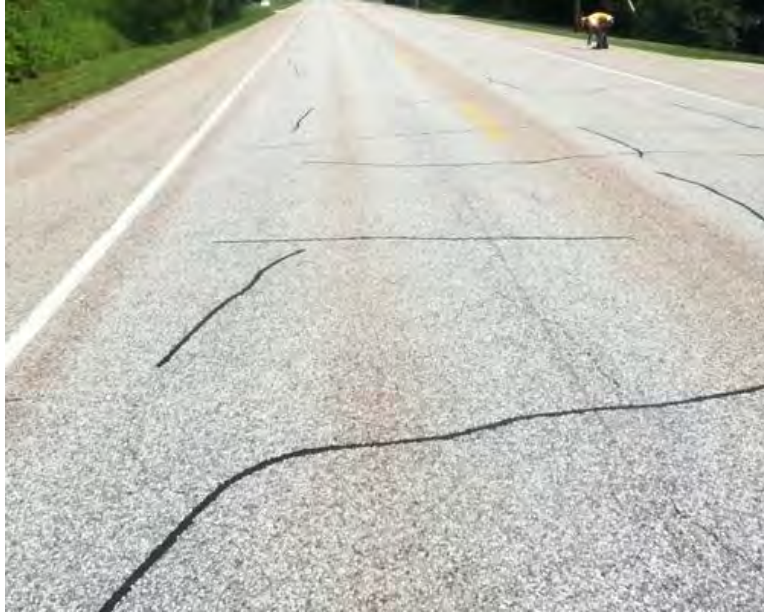
Figure 8 Example of transverse cracking (among others), within test site 1.
