ASSESSMENT OF THE BDM WATERPROOFING MEMBRANE SYSTEM

Experimental Feature
Reporting on Work Plan 2011-R-06

Final Report 2019-07

The BDM system was used on one bridge replacement project, Warren ER-STP 013-4(36), bridge number 165 on VT 100 in the town of Warren, 50 feet north of the Warren and Granville town line (Figure 1). The bridge was produced under rapid construction techniques. The bridge is 21 feet long by 34 feet wide and has a reported average annual daily traffic (AADT) of 980.

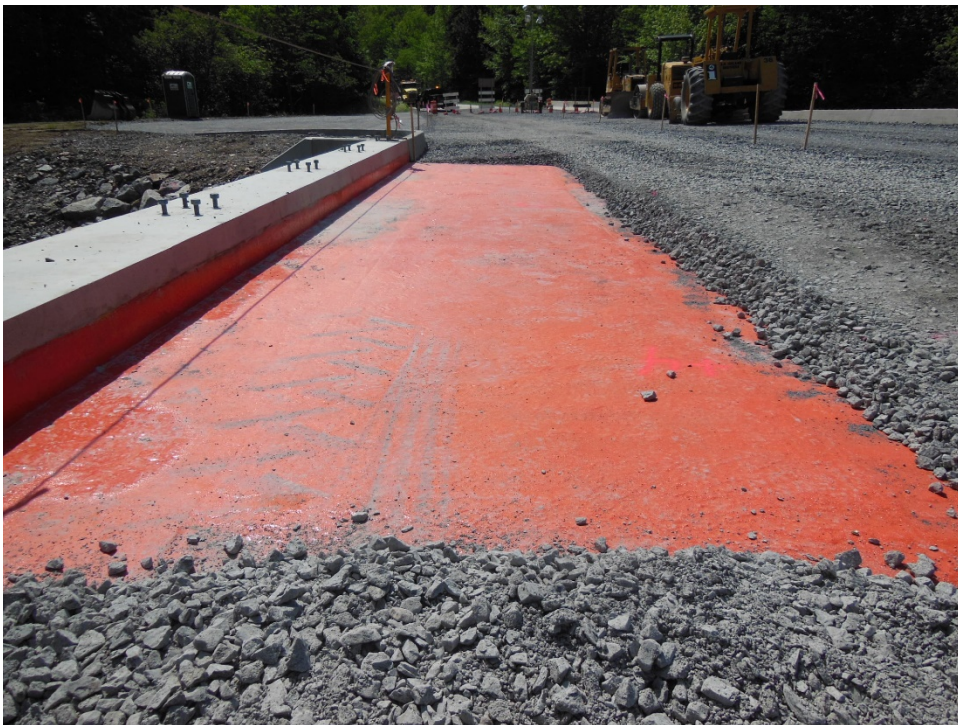
the onset of warmer weather in May, the bridge was again closed to traffic to begin paving activities. Once the gravel was removed from the bridge deck, GS Bolton performed an inspection of the membrane on May 23 to ensure the gravel did not puncture or cause any weak spots. The membrane was deemed to be in good shape, with no damage from the gravel evident (Figure 4). Binder and base courses of asphalt were placed on the bridge and approaches on June 6, and the top course on June 18, 2012.

Figure 4: BDM with gravel cover (June 1, 2012)

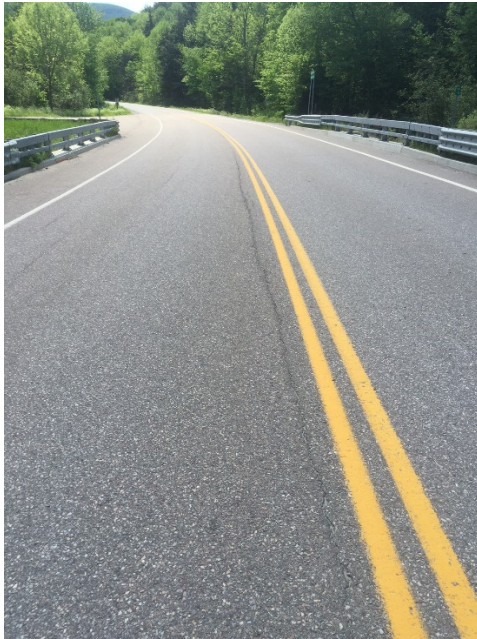
Figure 7: Centerline crack throughout bridge (June 2, 2016)

From the visual inspection and photographic evidence, the BDM has been working properly. The only signs of deterioration are several longitudinal cracks on the pavement surface. As previously stated from the 2016 field visit, it was observed and monitored that the longitudinal cracking occurring in the surrounding asphalt overlay, again emphasizing the fact that the cracking could be attributed to the material properties of the asphalt overlay and not the bridge deck membrane. The site visit showed the single longitudinal crack on the southbound lane and eight longitudinal cracks on the northbound lane. The crack on the southbound side was located on the south end of the bridge, in the center of the wheel path, and was approximately 12ft long. The northbound lane had two cracks in the wheel path and one between the wheel paths, three cracks near the mid-span of the bridge within the wheel path that were approximately 9, 12 and 15ft long, and two cracks on the north end of the bridge in the center of the wheel path that were 6 and 12ft long. The centerline crack that runs the whole length of the bridge was again evident.

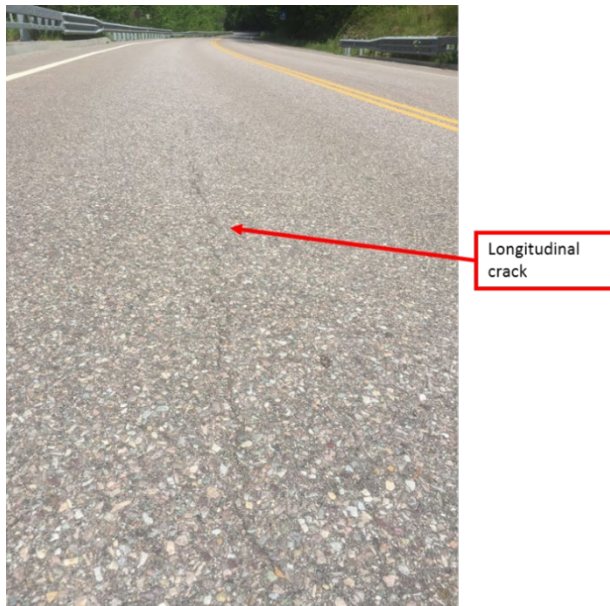
Figure 8: Longitudinal crack on southbound lane (June 2, 2016)

From the visual inspection and photographic evidence, it can be said that the BDM is working and at this point it is inconclusive if the membrane is contributing to the longitudinal cracking on the bridge deck. During the inspection it was noticed that the longitudinal cracking was also occurring in the surrounding asphalt overlay, which means that the cracking could be attributed to the material properties of the asphalt overlay. While on the site visit it was noted that there was one longitudinal crack in the southbound lane and seven cracks on the northbound lane. The cracks ranged from approximately 3ft to 12ft. Figure 8 shows a centerline crack that runs the whole length of the bridge. Figure 11, which shows the underside of bridge 165, depicts some sort of white material seeping through bridge deck joints and cracks and depositing on the underside of the bridge. The depositing material is most likely chloride or salt from de-icing the roads during the winter season. The condition of the bridge deck is good in general, and further studies of the bridge deck would have to be conducted to determine if the BDM is contributing to the bridge deck cracking.

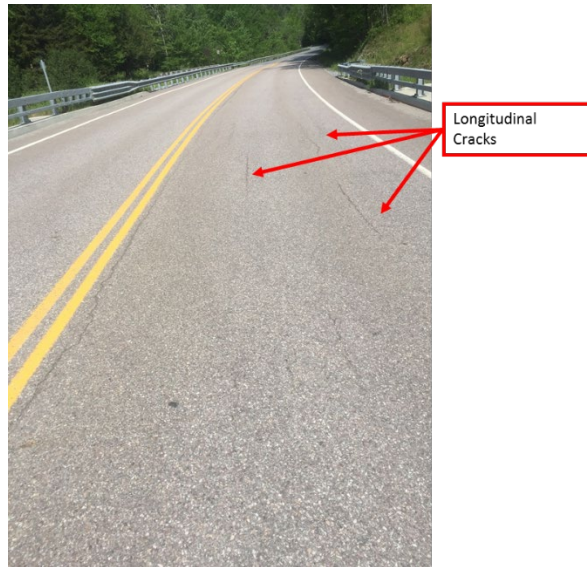
Figure 9: Longitudinal crack on northbound lane (June 2, 2016)

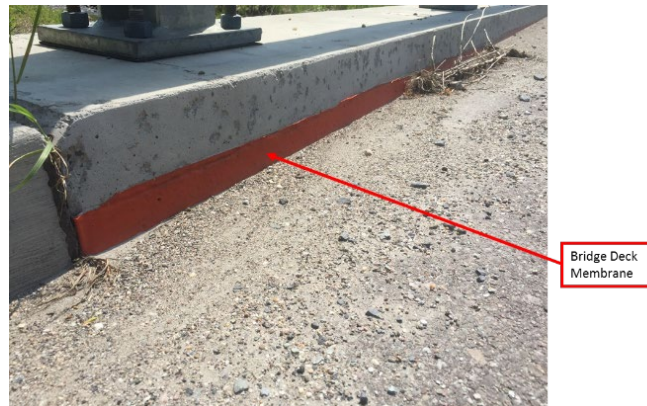
Figure 10: Bridge deck membrane (June 2, 2016)

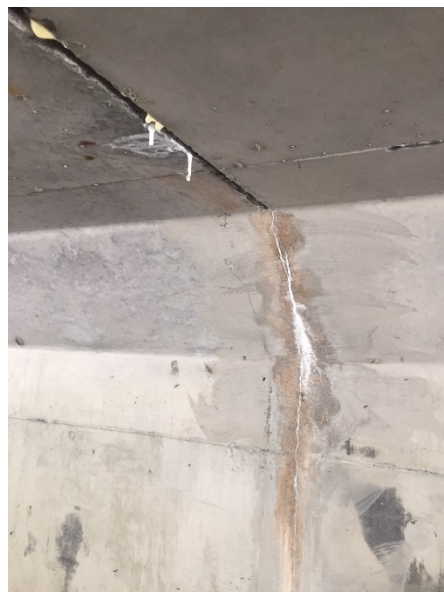
Figure 11: Bridge underside deposits (June 2, 2016)

During the 2016 site visit, an inspection of the underside of the bridge was done. A white material was found to be seeping through the bridge joints and depositing on the underside of the bridge. This is most likely caused by salts and chlorides collecting during the deicing process. During the 2017 site visit, a follow up inspection of the underside of the bridge was performed. No further evidence of the white material was observed and no new cracks or leaks on the underside of the bridge were found. Overall, the bridge deck membrane has performed as specified and has shown few signs of wear.

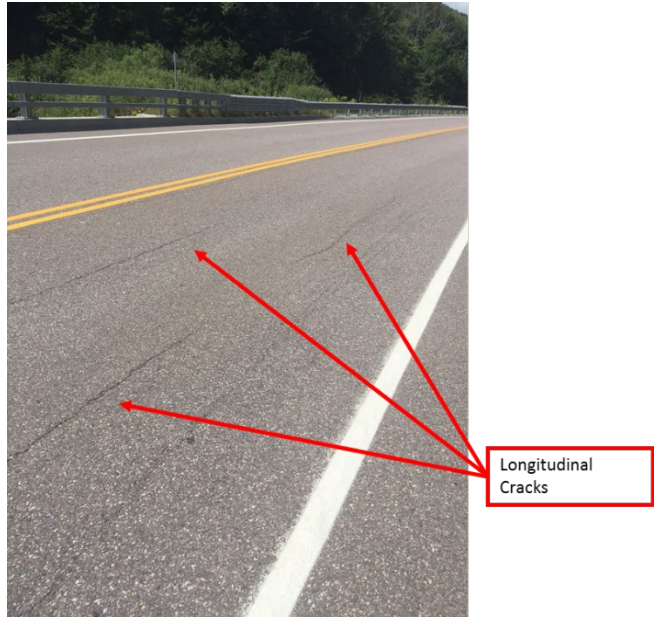
Figure 17: Longitudinal crack on northbound lane (August 15 ,2017)

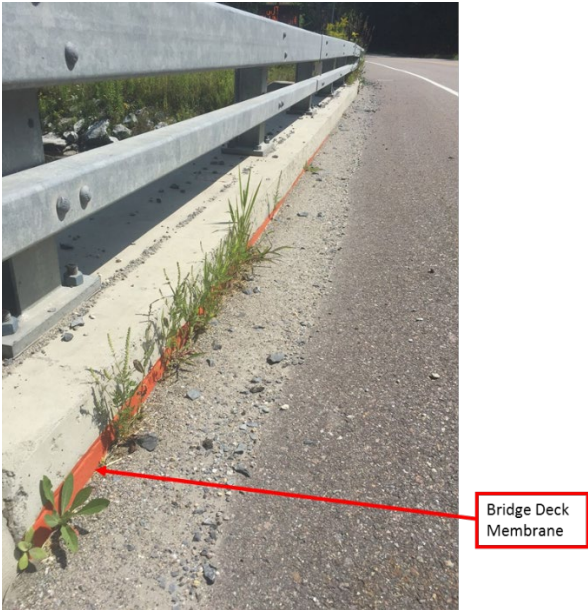
Figure 18: Bridge deck membrane (August 15 ,2017)

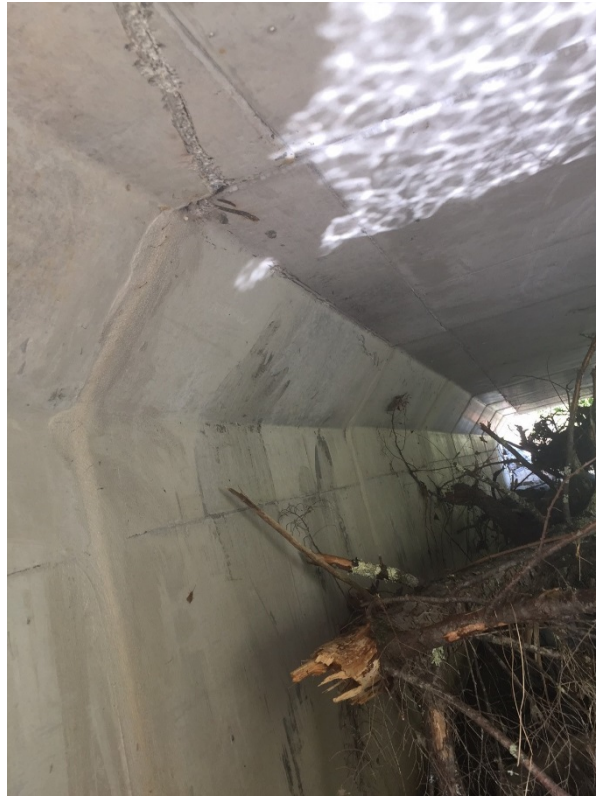
Figure 19: Underside with debris (August 15 ,2017)

After the initial inspection of the surface pavement on bridge 165, a subsequent inspection of the underside of bridge was done. There was no evidence of the white material seeping through the bridge deck joints and cracks that was observed and noted during the [2016 site visit](#). The current inspection revealed no new cracks or leaking of the underside of the concrete bridge. The inspection did yield evidence of wood debris on the north side of the bridge, which can be seen in Figures 13 & 20.
