**To:** Paul Libby, Project Manager, Highway Safety and Design  
MLM CEE

**From:** Marcy Meyers, Geotechnical Engineer, via Callie Ewald, P. E., Senior Geotechnical Engineer

**Date:** March 10<sup>th</sup>, 2014

**Subject:** Mount Holly STP 0133(8) – Revised Stationing

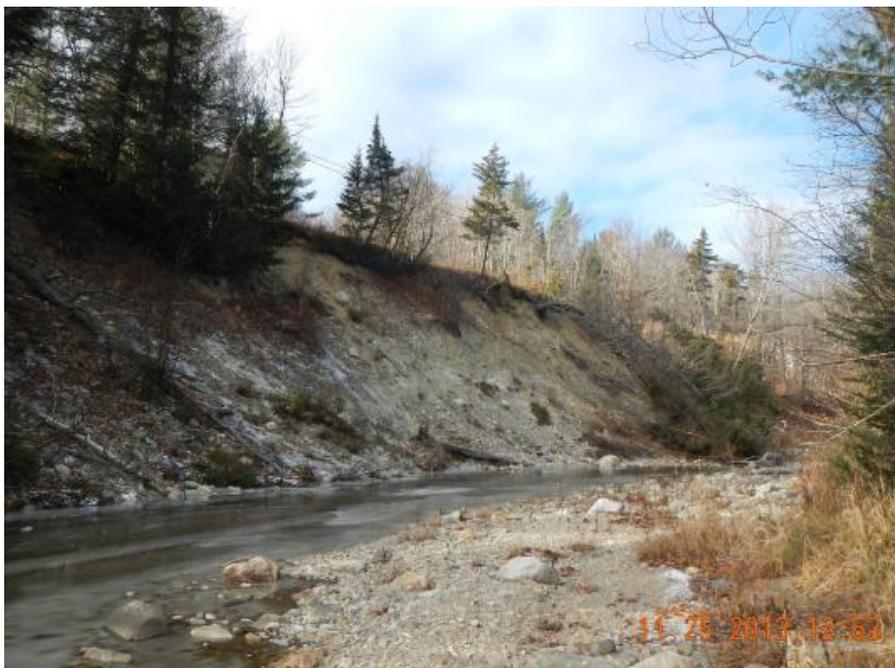
We have completed our geotechnical investigation for the Mount Holly STP 0133(8) project, located along Vermont Route 155 near MM 5.57 in the Town of Mount Holly, Vermont. This project involves addressing a slope instability issue along the eastern slope adjacent to the Mill River. The high rain event that occurred during Tropical Storm Irene caused the river waters to rise and become more turbulent, as well as large amounts of water to run off VT 155 down the face of the slope. A combination of saturated surficial soils and raging river forces caused a significant amount of vegetation and soil to wash away down the river. As a result, an unvegetated and unstable slope now exists, threatening the stability of the roadway directly adjacent, as shown in Figure 1.1. Evidence of the threatened roadway stability is seen in the shoulder of the roadway where stone fill has been dumped over the side to prevent the raveling of roadbed material down the slope, as shown in Figure 1.2.

**Figure 1.1.** Unvegetated Slope from Across Mill River

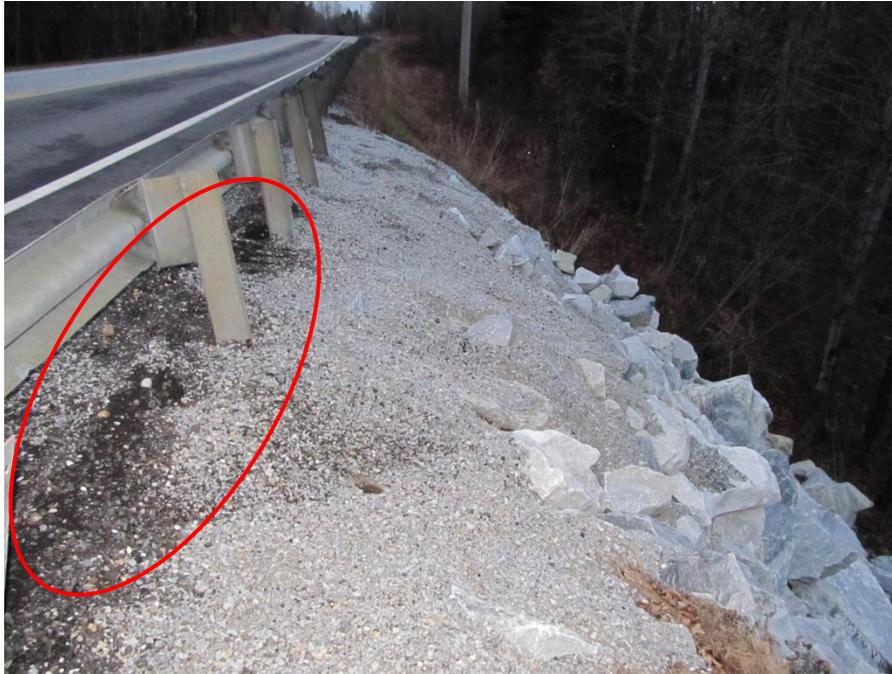
**Figure 1.2.** Threatened Shoulder and Roadway Instability

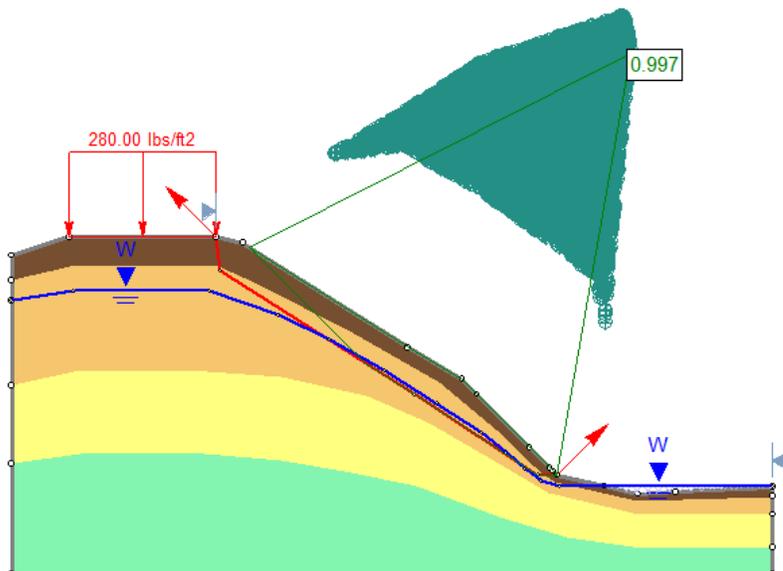
Based on the site visit and information gathered off of the boring logs, it was determined that a translational surficial failure in the slope is occurring as shown in Figure 4.1.

**Figure 4.1. Translational Failure with a Factor of Safety = 0.997**

The entire length of slope evaluated had a couple different geometries throughout. In addition, a large portion of the slope was very steep with almost no vegetation. This section of slope is anticipated to slowly creep toward the road until the material becomes stable at its internal angle of repose. This portion of slope is evident in Figure 1.1. Two sections of the slope exist where stone fill has been dumped to stabilize the shoulder and top of the slope (one of these being evident in Figure 1.2). Based on the current geometry of the slope, it appears excessive surface water has caused sloughing just off of the roadway pavement and a natural berm has been scoured away at the toe of slope. It is evident that the roadway shoulder material will continue to ravel down the slope creating an unstable shoulder and distress in the pavement if the slope is not stabilized surficially from the toe up the slope.

In order to remediate the surficial stability of the slope, as well as to provide adequate armoring of the toe to prevent future material loss, several options were considered. Re-grading the slope to a 1V:1.5H and armoring the toe proved to be the best alternative to mitigate the continuing material sloughing on the slope. As a result, two typical sections were designed to help better accommodate the varying geometries of the slope. These sections incorporate a combination of Type II and Type IV stone fill as well as granular borrow to act as a filter medium. Both typical sections are attached to this report.
