To: Paul Libby, Highway Safety & Design Project Manager
 MLM
From: Marcy Meyers, Geotechnical Engineer, via Callie Ewald, P.E., Senior Geotechnical Engineer
 CEE
Date: July 23rd, 2014
Subject: Mt. Holly STP 0133(8) – Slope Recommendations Addendum

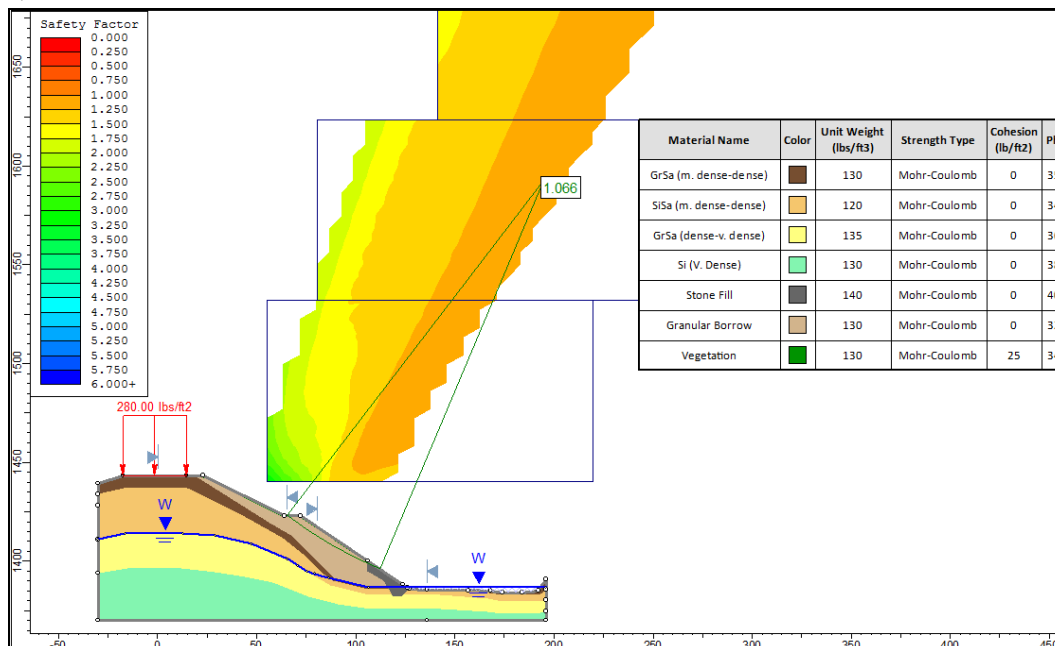
After review of the proposed vegetated slope for Sta. 609+55 (the critical section as determined in the first geotechnical report), the 1V:1.5H vegetated slope below the bench and above the stone fill raised concern of the potential for surficial slope failure. A computer model was generated using the software program, Slide, version 6.0, developed by Rocscience for Sta. 609+55 using the Bishop Simplified Method, and our initial concerns were confirmed. Results from this model indicated a failure surface occurring in the 1V:1.5H slope below the bench and above the stone fill as seen in Figure 1.

Figure 1: Proposed Vegetated Slope at Sta. 609+55 with Failure below Bench

In order to address the instability while still maintaining the vegetated slope alternative, removing the bench and regrading the slope to a 1V:2H was evaluated. The stone fill remained in place at the same offset as specified in the sections provided by Green. A 1 foot thick layer of vegetation was input in Slide to model the surficial stability that the actual in place vegetation will provide for the surficial soils on the slope. A Slide model using the Bishop Simplified Method was evaluated and results can be found in Figure 2.

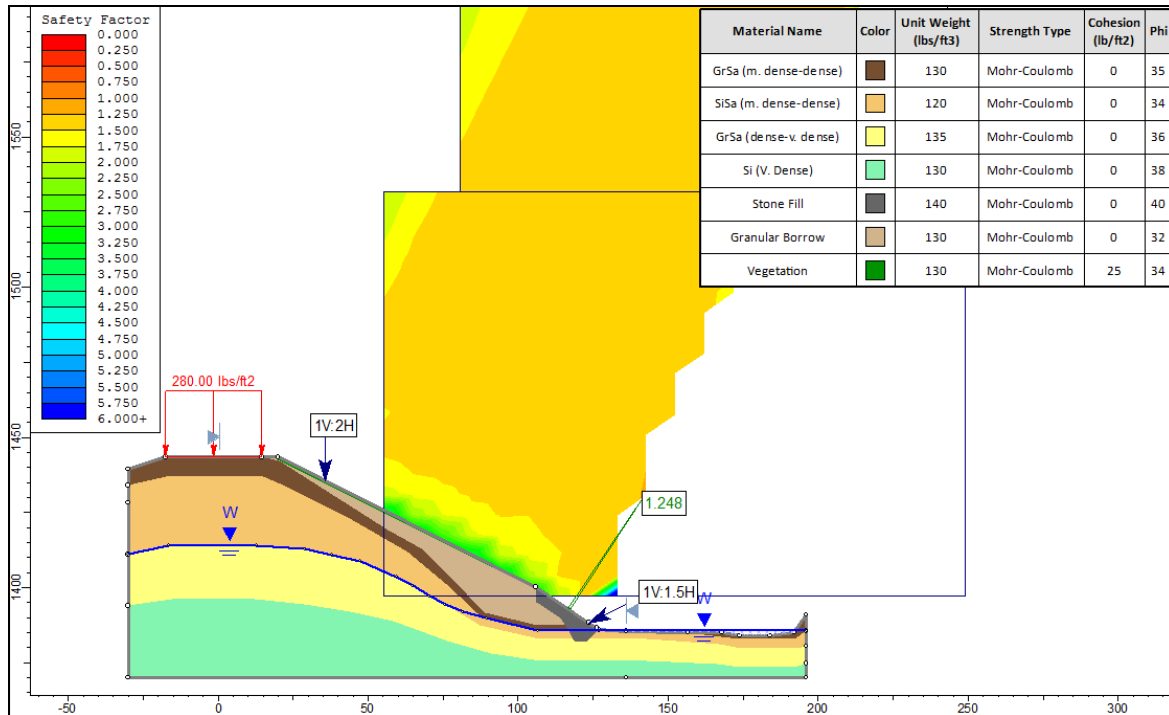
Figure 2: Revised Vegetated Slope at Sta. 609+55 with Failure in Stone

Although this minimum factor of safety of 1.25 is below AASHTO’s recommended value of 1.3, we are comfortable with this value as the failure surface is occurring in the stable Type IV stone fill section.

We recommend using a revised grade for the slope being vegetated as seen in Figure 2 (and also attached) for the unstable slope present at this site. The toe armoring of Type IV stone fill should be kept the same as detailed in the sections provided by Green, however we recommend beginning the 1V:2H grade from the top of stone and continuing it to the shoulder of the roadway. This does narrow the bench at the top of the slope, but still leaves approximately 5.5 feet of a bench from the guard rail to the top of slope. As mentioned in Section 2.0 above, a 1 foot thick layer of vegetation was used in the Slide models. It is our understanding that the vegetation for the slope will be designed by others and that surficial stability will be taken into account when developing details for the proposed 1V:2H vegetated slope.

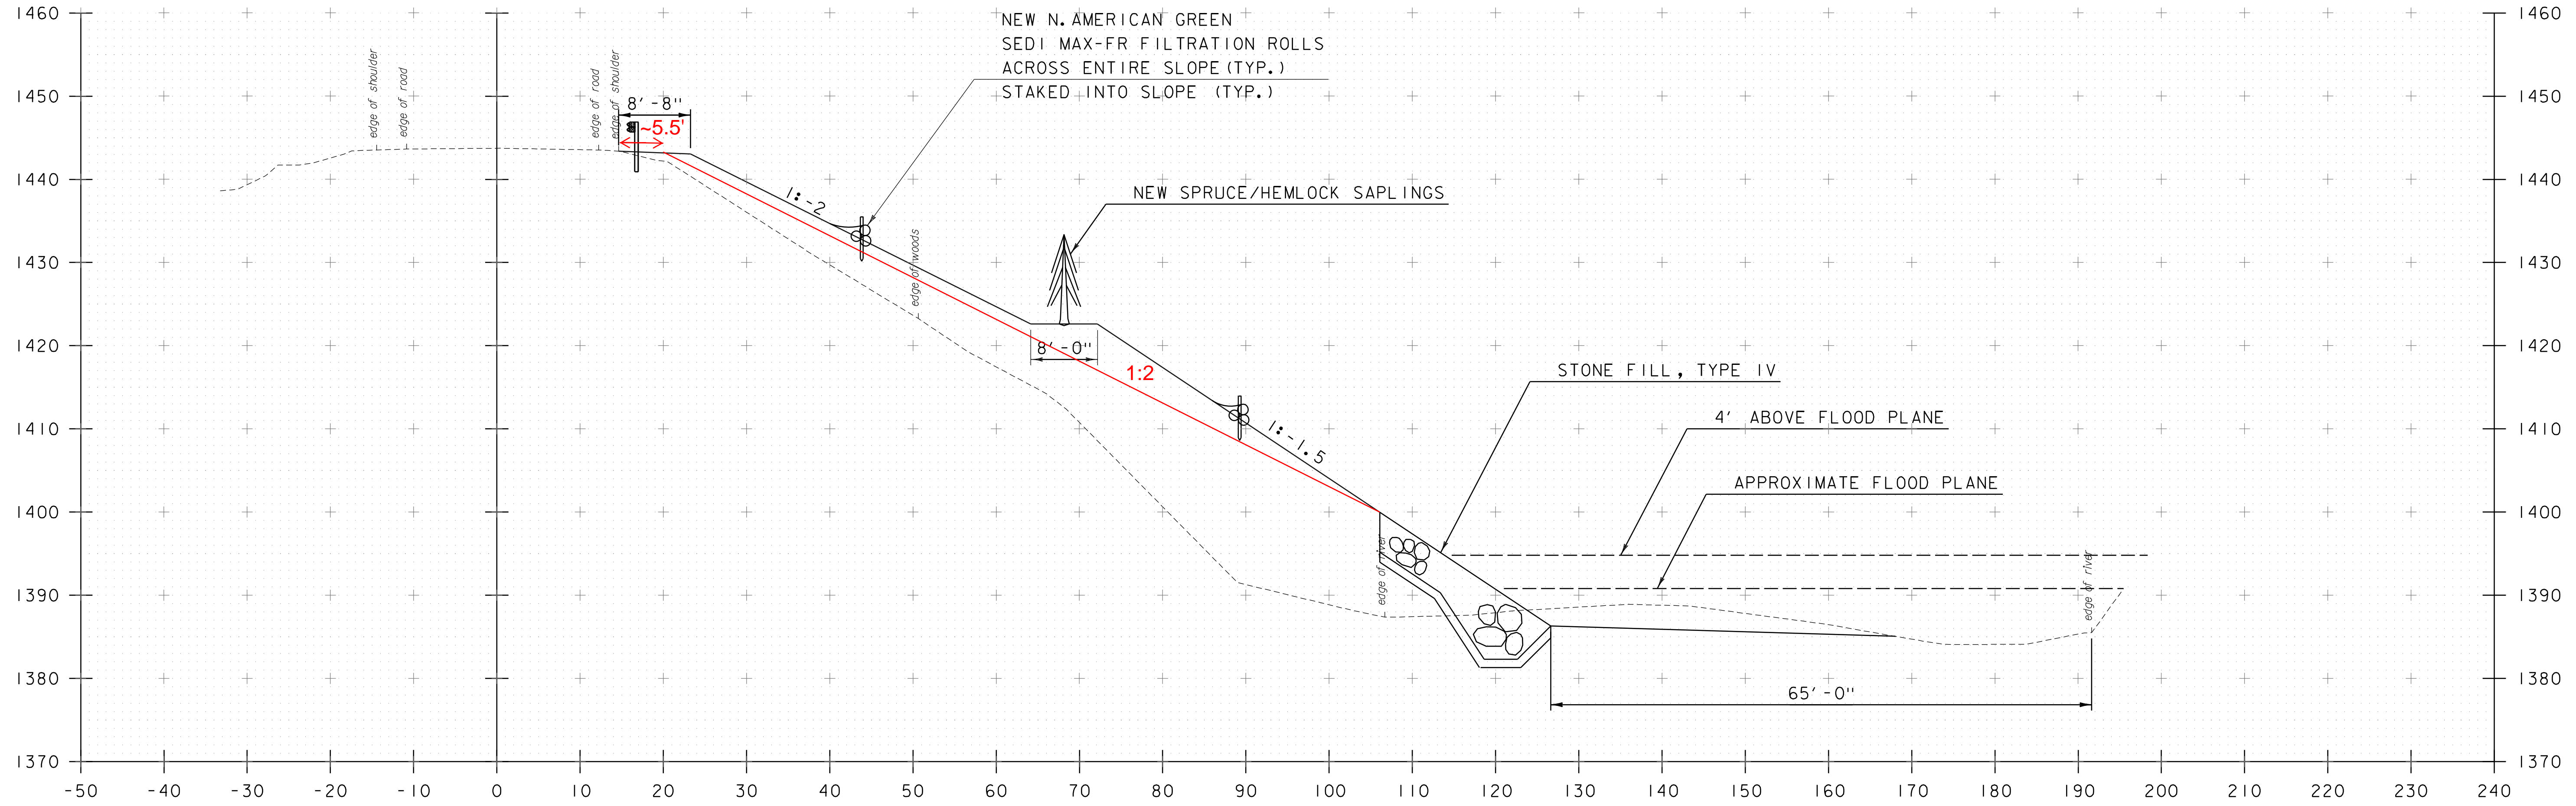
VEGETATED SLOPE

STA. 609+55 TO STA. 609+55
