An Evaluation of TYFO S Fibrwrap

Final Report

Report 2013 – 05

Reporting on Work Plan 1994-R-7

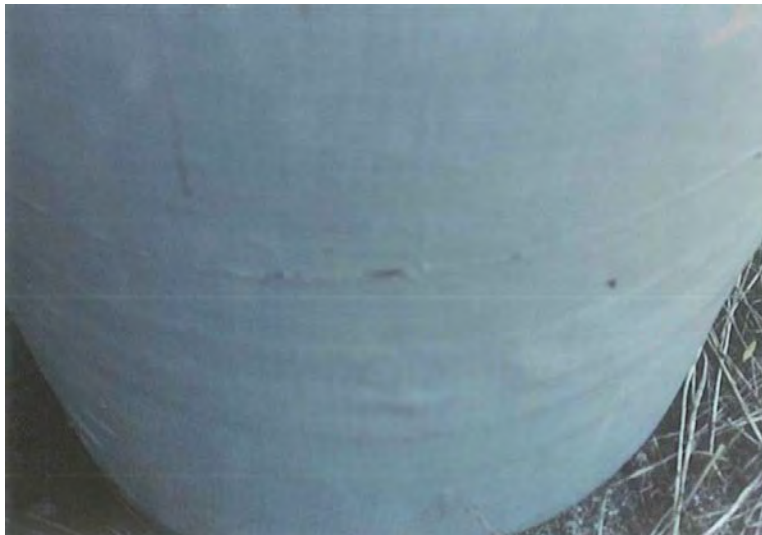
During an inspection in August 1997, apparent bubbles or small bulges in the FRP wrap were discovered, ranging from approximately one to three inches in diameter. A July 1998 inspection showed no change in the size or shape of the air pockets, indicating that they are a result of air being trapped between the Fibrwrap and the concrete at the time of installation and not a result of subsurface activity in the concrete. The status of the bulges was unchanged in the final May 2013 site visit. In June 1999, a separation, approximately one inch wide appeared along a horizontal seam of the bottom wrap of column #1 (Figure 6). This separation had no substantial depth and since the installation of this material involves overlap, there is little concern for salt intrusion. In the final 2013 inspection, the separation did not exhibit any advancement, and appeared to be more of a fray in the FRP fabric that was not smoothed out during installation.

Figure 6 Slight Separation, not substantial in length or depth (1999).

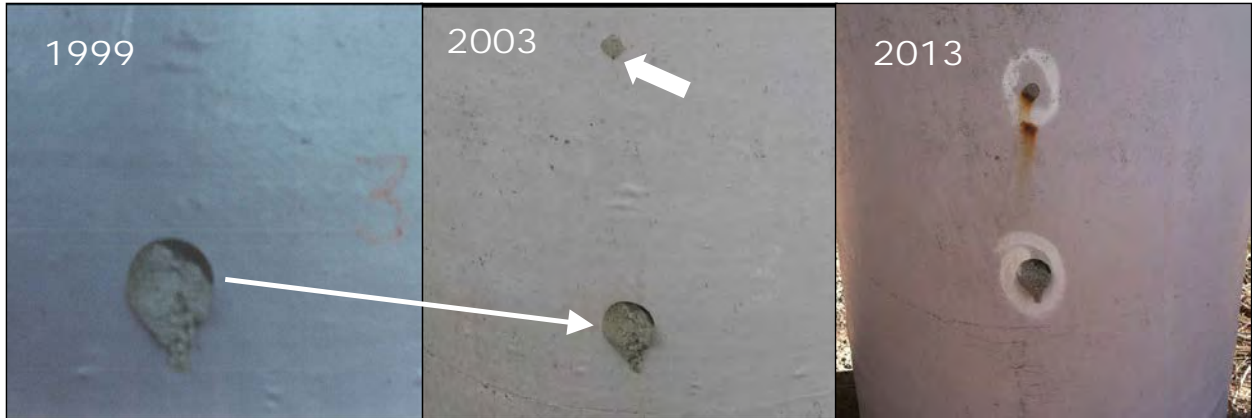
In 1997, core samples turned up no signs of distress in the concrete. During the June 1999 inspection, it was discovered that one of the cored holes in column #2 was inadequately filled resulting in a small void in the top section of the hole. By 2013, no distress has resulted from the void. However, as shown in Figure 7, the core hole above is exhibiting leaching rust, which was originally detected in the 2003 inspection. This leaching has advanced by 2013. A core hole location in column #1 showed some signs of rust leaching out around the perimeter of the former hole in 1999. There may have been some moisture trapped within the hole when it was filled, shown in Figure 8.

Figure 7 Core hole in Column #2 under pier #1 over 14 years.

The leaching rust is likely originating from reinforcing in the column the core cut through, and is slowly bleeding between the in situ concrete and the core filler concrete. As it makes its way out the column, it exits the core hole, but also seems to be seeping between the column concrete and the TYFO wrap in an outward spreading pattern. As shown in the previous figures, the core hole in Column #1 shows a lateral leaching pattern, where the Column #2 core

hole exhibits a downward leaching pattern. The leaching pattern seems to be confined within a three to four inch radius of the core hole.

Future installations of an FRP wrap should be inspected using non-destructive evaluation processes such as Infrared Thermography to check for areas of unbonded or debonded FRP wrap and areas of delaminating concrete. From observations made from the repairs made after taking core samples, it is clear that destructive testing methods put the structure at risk of advanced deterioration.

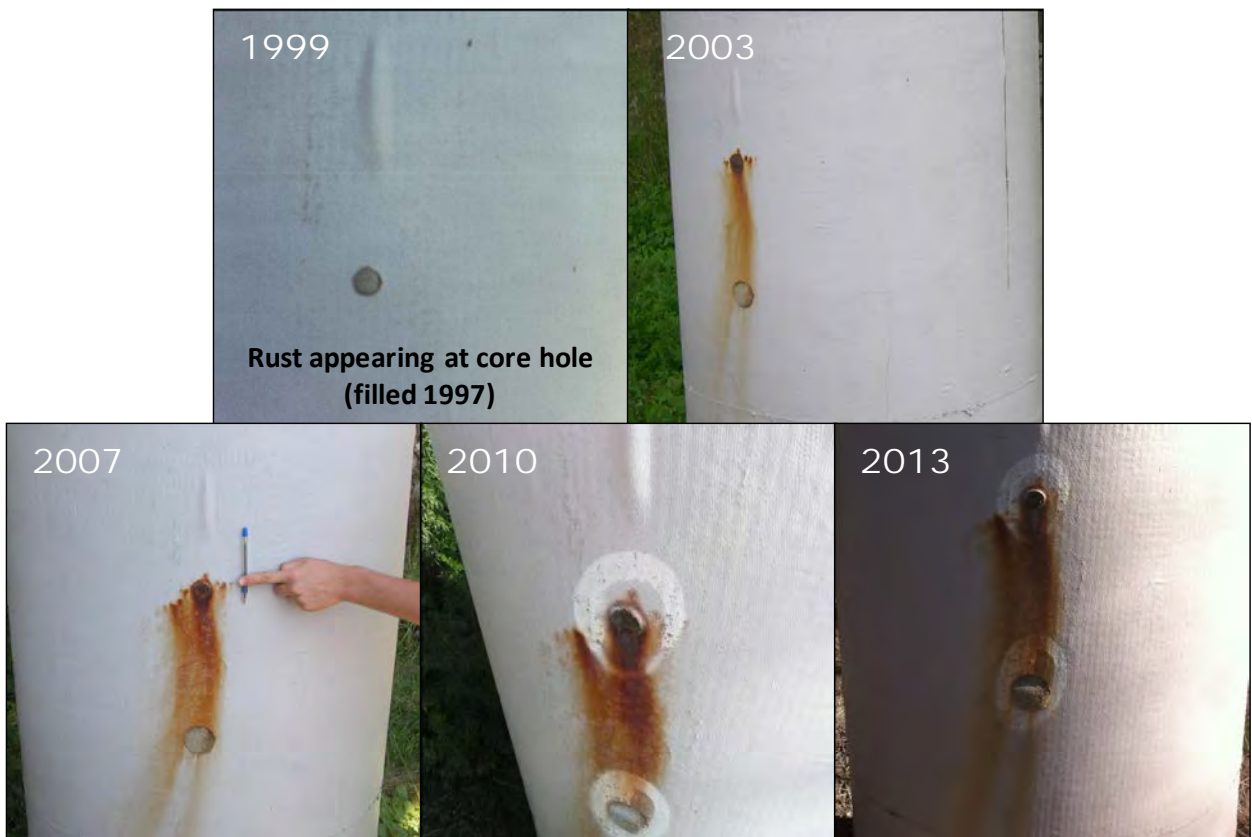
Figure 8 Core hole (filled in 1997) in Column #1 under pier #1, over time.

By 2013, no other rust spots were detected on the column. Only these two core holes out of ten have exhibited any deterioration. This should not be viewed as a failure of the system, but rather the evaluation process. This suggests that the method of evaluating a CFRP Wrap should be limited to non-destructive methods. J. Levar and H. Hamilton, concluded in a University of Florida study, that “Infrared Thermography can be used effectively for non-destructively evaluating CFRP strengthening systems for concrete.” (4)

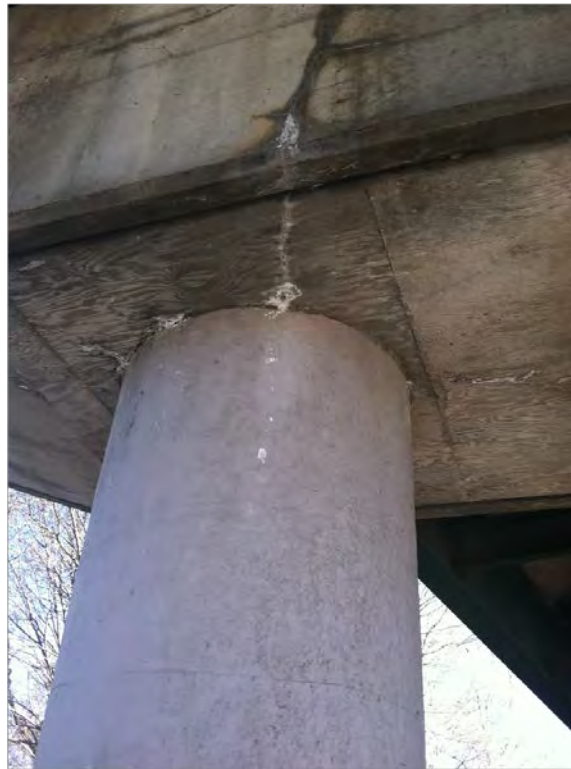
An observation made in 2013 was with chlorides that were leaching out of the pier cap adjacent to the top of Column #3. The chlorides seem to make the customary route to the column via cracks. Rather than remain and build up on the column as what typically happens with concrete, the chlorides seems to be washing, blowing or flaking off the column with typical environmental diffusion of rain, or air, shown in Figure 9.

Figure 9 Chlorides leaching onto column.

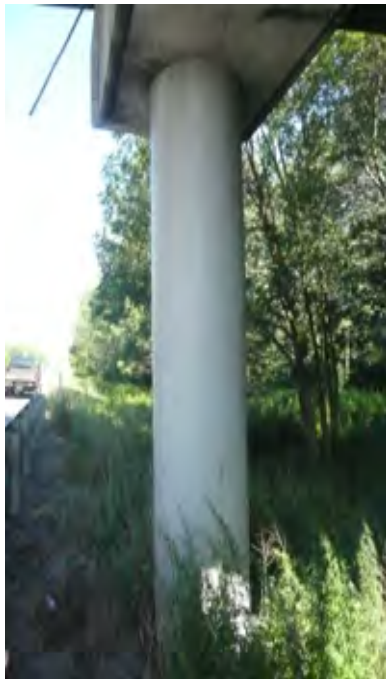
Upon the inspections in July of 2010 and in May of 2013, no further imperfections were noted. The Fibrwrap material seems to be performing at a very satisfying level. The concrete columns beneath the surface have shown no signs of distress or decay, and even though there is some surface rust leaching from the core holes, it is not considered to have any structural consequence. The untreated concrete columns under have exhibited further cracking and

Figure 10: Column #3 under pier #1, 2010 treated with TYFO S Fibrwrap

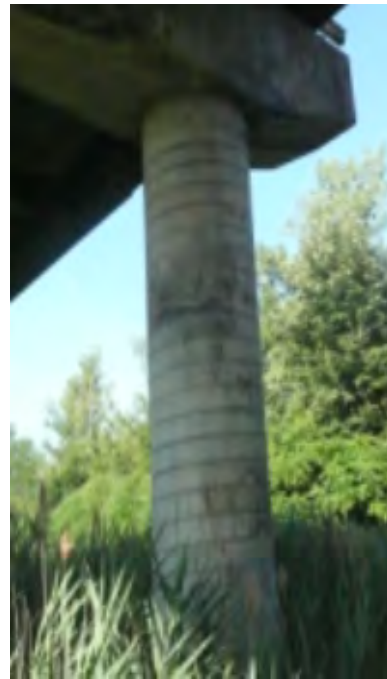
spalling. The control columns are overall in worse condition than the experimental columns. At this point, nearly nineteen years after installation, the TYFO S Fibrwrap material remains aesthetically pleasing as well as structurally sound. A comparison of a wrapped and unwrapped column is shown in Figure 10 and Figure 11.

Figure 11: Column #3 under pier #2, 2010 not treated with TYFO S Fibrwrap
