VERMONT AGENCY OF TRANSPORTATION

ALTERNATIVE PAVEMENT DESIGNS  
RANDOLPH PARK AND RIDE

Report 2013 – 04

**Final Report**

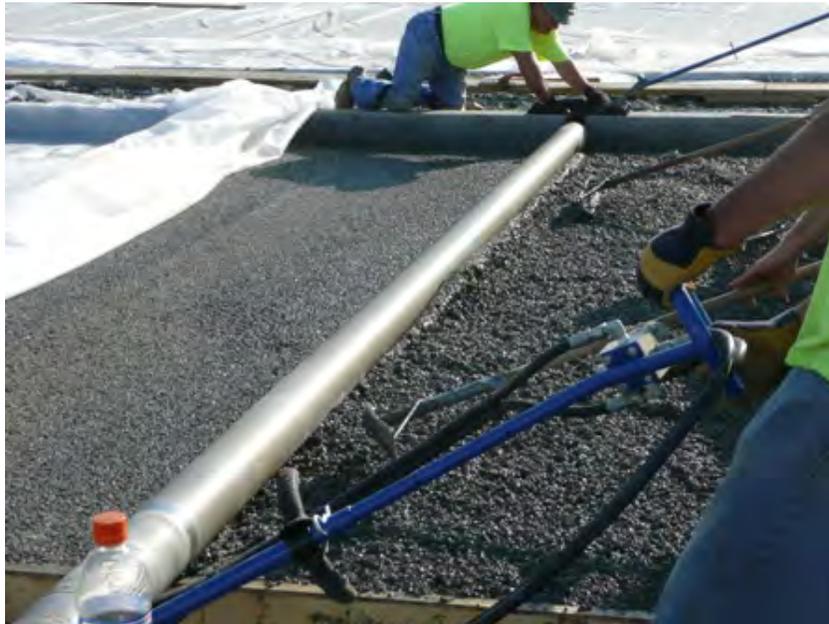
Prior to the end of placing the concrete, it was noted that an area in the northeast corner of the lot was showing signs of raveling. The raveled section was removed and placed once again on September 10. A typical installation at the park and ride is shown in Figure 3, with the

**Figure 3. Placement and rolling of porous concrete.**

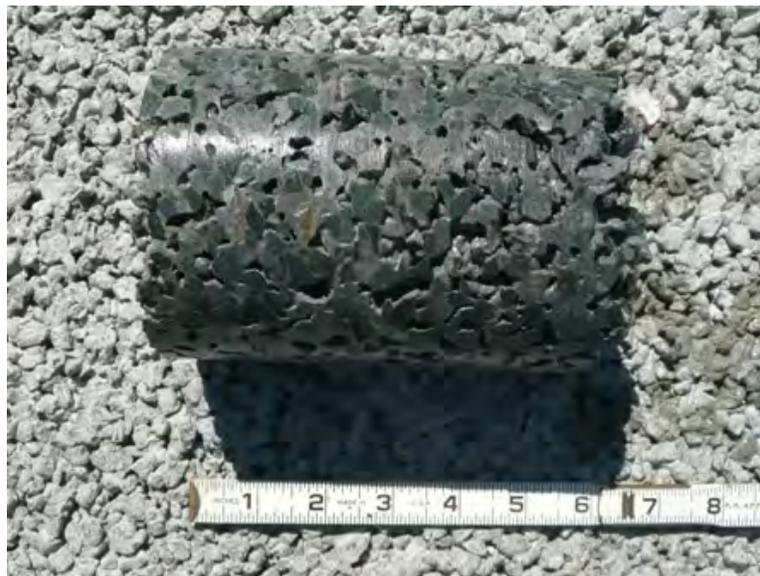
Core 1, was taken from a location east of the median, where winter maintenance activities are not performed. The location was selected in the eleventh parking space from the southern edge of the last row of spaces because the visual and audibly testing suggested the area was sound. As seen in Figure 5, the 6 in. core was extracted fully intact and represented the specified design depth.

**Figure 5. Core 1, taken from a visually and audibly sound portion of the lot.**

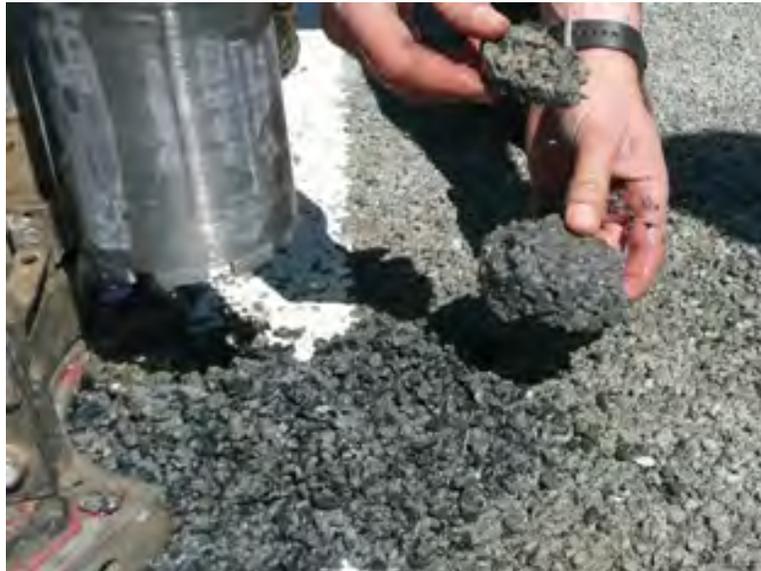
Core 2, as seen in Figure 6, was taken from a location that visibly looked good (virtually no raveling) but sounded delaminated during sounding tests. It was taken from the pavement marking gore area located at the northern end of the parking lot encompassing parking rows two and three. The core was extracted in three material regimes. The top of the core was a few solid pieces of concrete roughly 0.75 in. thick (top of picture). The bottom of the core was one solid piece roughly 1.5 in. thick (middle of picture). The middle approximately 3.75 in. came out as un-adhered concrete, or rather, gravel (on the ground in the picture), with very little cement present on the aggregates.

**Figure 6. Core 2, taken from a visually sound but audibly unsound location.**

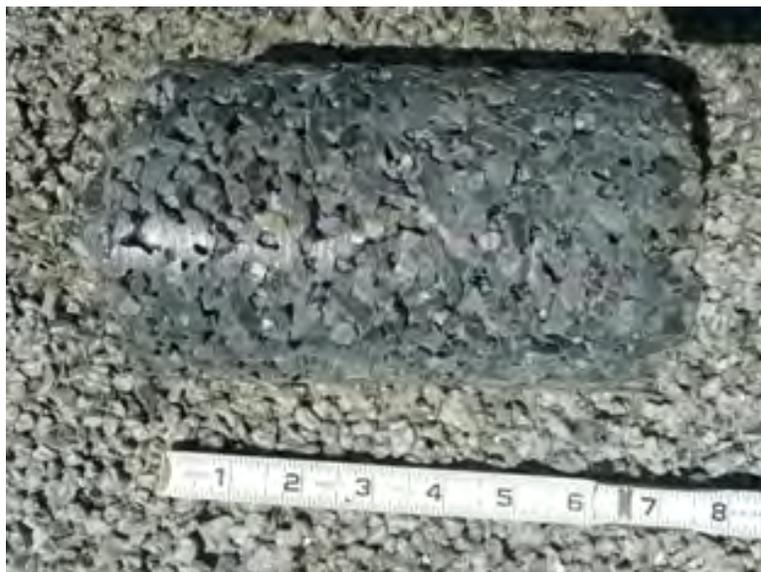
Core 3, as seen in Figure 7, was taken from a location 2 ft. away from Core 2, where sounding tests indicated a spot of good concrete, in addition to a good visual spot. The core was

also located in the gore area. When extracted the core was indeed in sound condition as it came out as a complete 6 in. core.

**Figure 7. Core 3, taken from a visually and audibly sound location, two feet from Core 2.**

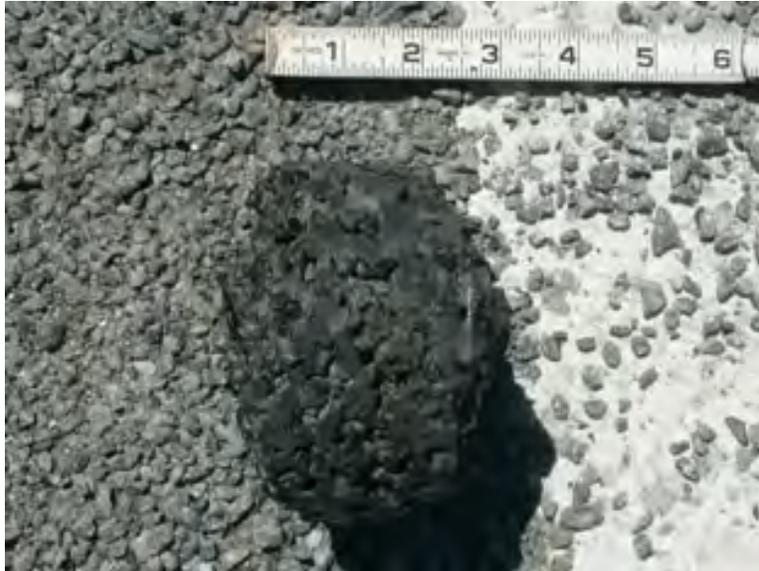
Core 4, as seen in Figure 8, was extracted from one of the most severely raveled areas, also in the same gore area, in which an approximately 1 in. deep hole had already raveled away. When extracted, the bottom roughly 2.5 in. of the core were intact (shown in the picture) while all concrete above this was gravel-like with little cement visible.

**Figure 8. Core 4, taken from a visually and audibly unsound location.**

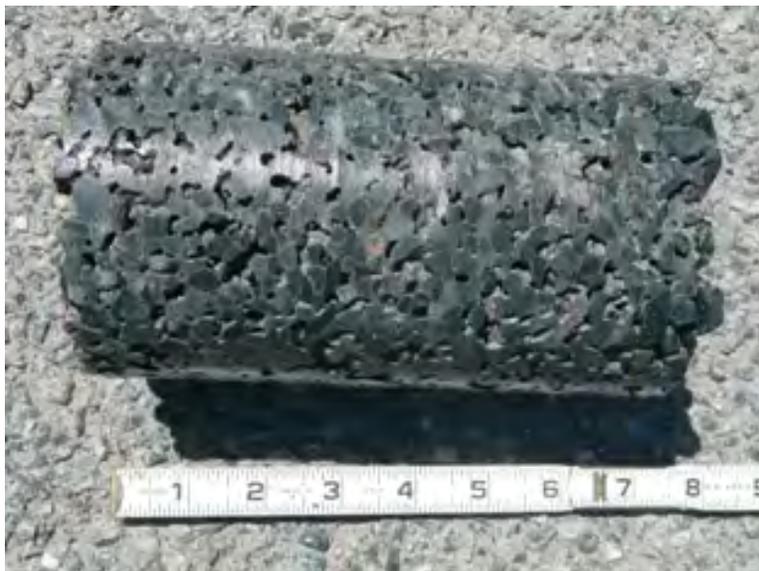
Core 5, as seen in Figure 9, was taken from the entrance lane onto the porous concrete, in the southern most concrete slab. Sounding tests on this area indicated good concrete. When extracted the core came out whole and measured 7 in., one inch thicker than the specified 6 in. thickness.

**Figure 9. Core 5, taken from a visually and audibly sound but clogged location at the entrance.**

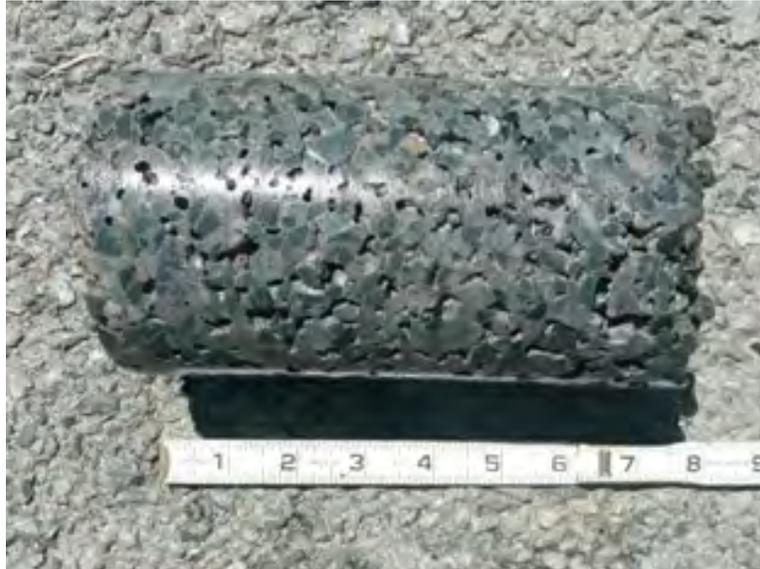
Core 6, as seen in Figure 10, was taken from the exit lane from the porous concrete, in the second slab from the south. As with Core 5, sounding tests in this area indicated good concrete. When extracted the core came out whole and measured 7 in., one inch thicker than the specified 6 in. thickness.

**Figure 10. Core 6, taken from a visually and audibly sound but clogged location at the exit.**

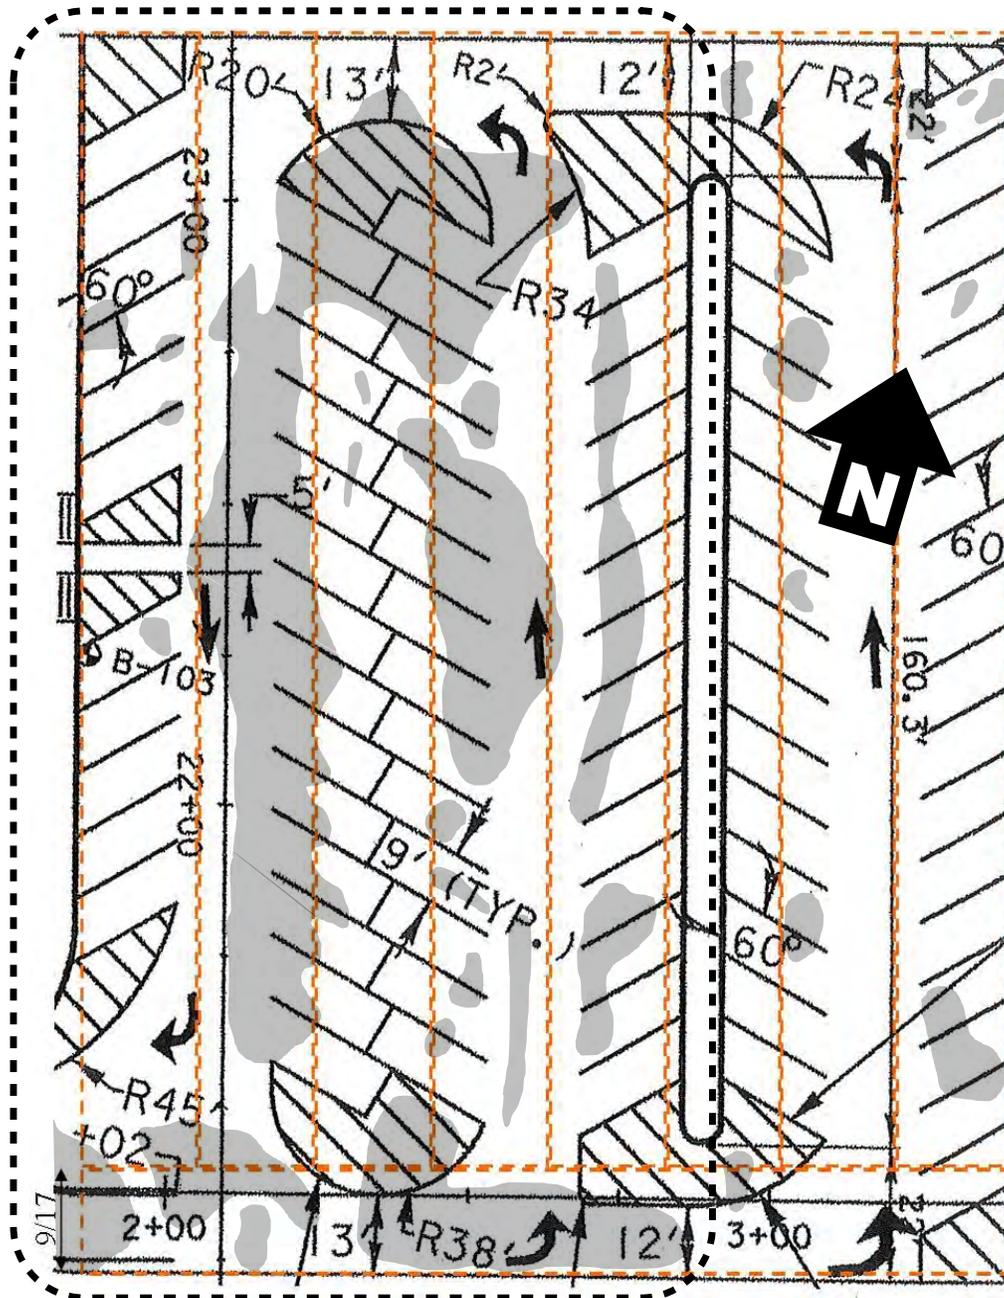
Since construction, the parking lot has been subjected to segregated plowing and salting maintenance activities during the winter. It was decided that no sand would be placed on the structure, as this is known to easily clog the pours in the concrete thus limiting its drainage capabilities; therefore only salt has been used. Maintenance personnel have maintained only the west side of the parking lot, with plowing and salting. During the winter, the lot is closed east of the median; however, some people will park their cars when the snow accumulations are low. It has been determined through freeze-thaw testing of cores removed from the parking lot during

construction that there is a high probability that the addition of de-icing salt onto the front part of the lot is the primary cause of the breakdown of the porous concrete structure.

During the summers of 2010 through 2012, chain drag sounding tests were performed to document the extent of potential delaminations and structural breakdowns within the porous concrete structure. The survey taken in 2012 is shown in Figure 11. Deteriorated areas identified by the chain drag test are drawn and shaded. As can be seen, the greatest extent of deficiencies is present in the front (left of the median) portion of the lot. The shaded areas represent approximately 15% of the entire lot and about 30% of the front portion. In addition to these findings, more of the surface of the concrete has shown signs of raveling and deterioration beyond these areas.

Figure 11. Deteriorated areas, as determined by chain drag sound testing, after four winter seasons.

At the current rate of deterioration, a considerable amount of the west portion of the porous concrete is rapidly deteriorating. Within a few more years could most likely be thought of as a gravel lot. Assuming this outcome is not desirable, remedial action would be required in the near future. The lot was originally designed and constructed so that if the concrete failed the lot could be paved over with bituminous asphalt; conventional drainage is already in place to deal with an impermeable lot. There are concerns that the partial deterioration of the concrete slab may lead to differential settlement of the asphalt and premature failure. It is generally believed that the science of porous concrete for northern climates is continually improving; therefore, it may be possible to replace existing concrete with a new porous concrete structure, one of improved mix design. The Agency is currently working with Norwich University and the University of Vermont to refine the porous concrete mix used on this project for strength and durability while maintaining porosity.

Another possible alternative would be to replace some (or all) of the deteriorated areas with removable/replaceable porous concrete panels that are available on the market. These are designed to have the same environmental properties of a monolithic porous concrete slab, but are able to be removed and replaced easily and cost effectively by Agency personnel if they become damaged or clogged with fines. The removed panels can be cleaned for reuse in future maintenance projects. Either of these two options would be viable and would represent opportunities for further research of the technologies for not only Vermont Agency of Transportation use and knowledge, but also other local communities that have a history of soliciting advice from the Agency for these types of products' use.

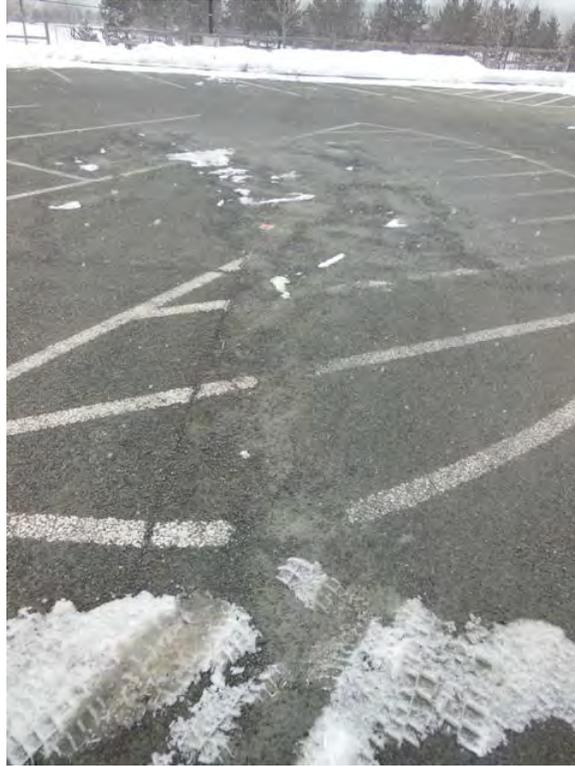
A site visit was conducted in March of 2013 to photograph the condition of the lot following the majority of its fifth winter season. The lot displayed readily noticeable deterioration since the previous fall. Two pictures of its state during this visit are shown in Figures 12 and 13.

**Figure 12. Deterioration in the gore area of the front portion of the lot after five winter seasons.**

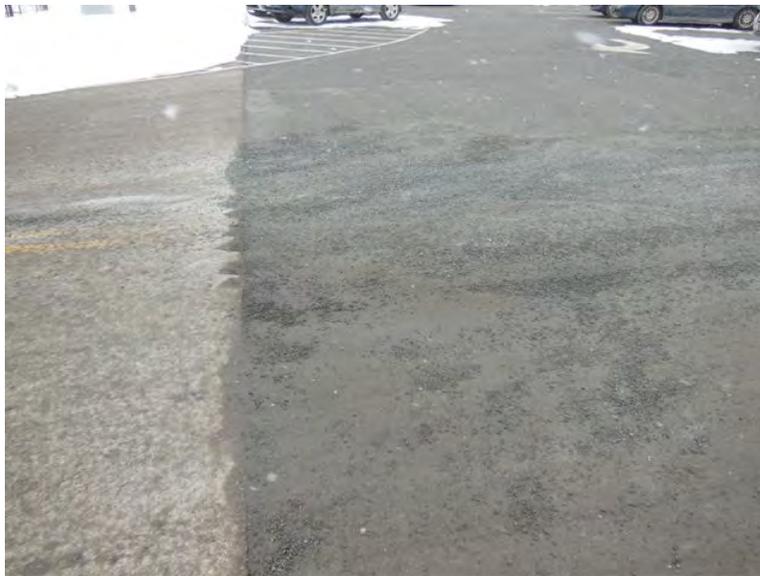
**Figure 13. Deterioration at the transition between the bituminous drive (left) and porous concrete lot (right) after five winter seasons.**
