**PavePrep Crack Reduction Interlayer
Lowell, Highgate and Hartford, Vermont
Final Report**

May 2008

**Report 2008 - 3
Reporting on Work Plan 94-R-19**

State of Vermont
Agency of Transportation
Materials and Research Section

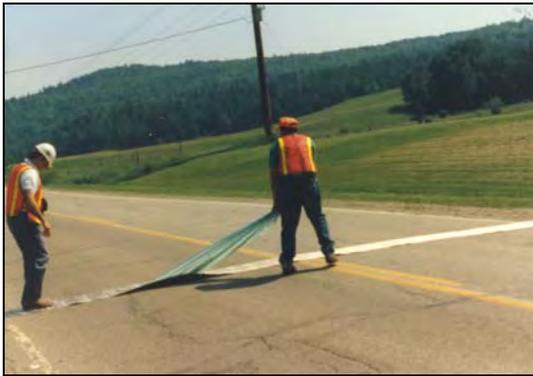
Figure 6 – Lowell MM 6.13 Installation

In the summer of 1994, PavPrep Crack Reduction Interlayer was installed in four locations in conjunction with three separate projects. The first installation occurred on June 15, 1994 on the Lowell-Westfield project. A 20" wide by 22' long section of PavPrep SA was applied to a transverse shoulder to shoulder crack in two locations, at MM 3.26 and MM 6.13 in the town of Lowell on VT Route 100. The installation is shown in Figures 6 and 7 below. The roadway was paved on June 21, 1994, 6 days following application, with a 1.5" wearing course of standard Type III Marshall overlay at MM 3.26 and a 1.5" ARHM overlay at MM 6.13. Emulsified asphalt was applied prior to placement of the overlay.

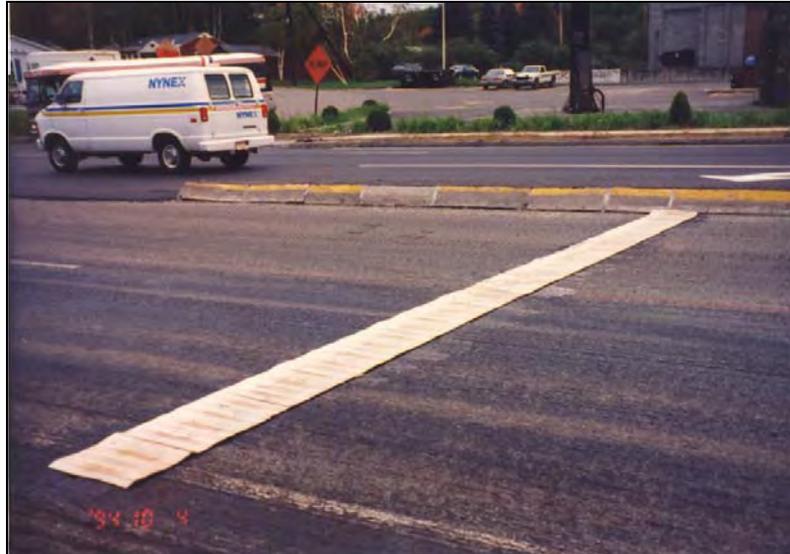
Figure 8 – Hartford PavePrep Installation

The final PavPrep installation began on September 28, 1994 on the Hartford project. A 20" wide by 24' long section of PavPrep SA was applied to a transverse shoulder to shoulder crack at the intersection of US Route 5 and Sykes Avenue on a milled surface. The following day, the material was found to have detached itself from the road surface, most likely caused by the rough textured pavement surface and further aggravated by rain

showers following installation. On October 4, 1994 a new 20” wide by 24’ long strip of PavePrep SA was placed at MM 3.13 on US Route 5, as shown in Figure 8. Emulsified asphalt was applied to the milled surface prior to the PavePrep SA installation, as recommended by the manufacturer. The first lane was then paved within ten minutes following installation. During paving operations, the PavePrep fabric was picked up by the shoes on the paver’s automatic grading and slope equipment. This problem was corrected by lifting up each pad as it passed over the PavePrep material, as shown in Figure 9. The roadway was paved with a 2.5” wearing course consisting of two 1.25” lifts of a standard Type III bituminous concrete overlay as shown in Figure 10.

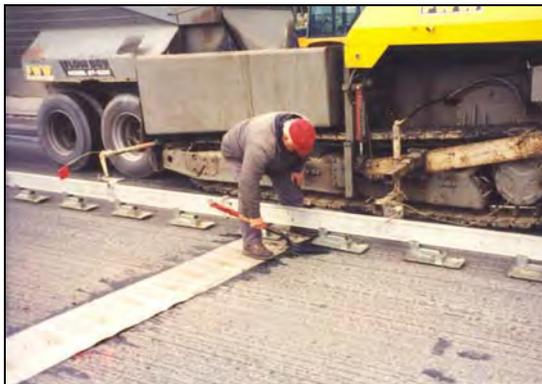
Figure 9 – Hartford Paving Problem

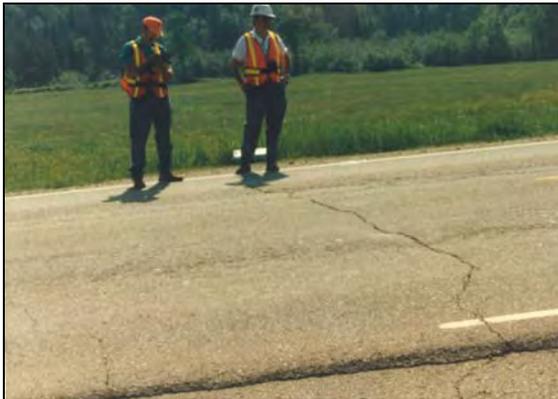
Figure 11 – Lowell MM 3.26 Preconstruction

At the initial site visit in 1995, one year following application, there were no signs of reflective cracking in either of the PavePrep test locations or the control sections. In general the pavement appeared to be performing well in the test section and adjacent areas. In the summer of 1996, three small reflective cracks totaling 10 feet developed at the test location at MM 3.26, with seven feet located in the northbound lane and three feet in the southbound lane. It was later determined that portions of the crack were located outside of the PavePrep area, as the crack diverges away from the interlayer towards a southerly direction beginning nine feet from the shoulder extending towards the centerline. Several reflective cracks were also found in the control section, with a maximum length of 11 feet. The test section at MM 6.13, within the experimental AHRM section, was still found to be free of cracking. In 1997, the previously noted reflective crack at MM 3.26 had increased in length from 10 feet to 14 feet, with 10 feet in the northbound lane and four feet in the southbound lane. Figures 11-14 show the test sites prior to the PavePrep installation in 1994, and again four years after installation in 1998.

The locations were again inspected in June 1998. Notes from the site visit indicate that no further cracking had developed at MM 3.26 and no reflective cracking was observed at MM 6.13. However, upon comparison of photos from preconstruction in 1995 and the 1998 site visit, it appears that the transverse crack had reflected at MM 6.13. A transverse crack that was noted as being three feet south of the PavePrep material was determined to actually be at the location of the PavePrep. This was verified by comparing the shape and characteristics of the reflected crack with the preconstruction crack. Upon further investigation, pavement life surveys for the test site indicated that the reflected crack was originally observed in 1996 along with several other transverse cracks in the area. In 1996 the crack extended within two feet of the entire roadway width and in 2005 the crack reflected the final two feet across the roadway. In the 1998 photographs, the reflected crack appeared to be much less severe than the preconstruction crack. This indicates that although the PavePrep had not prevented the crack from reflecting, it had minimized the severity of the crack.

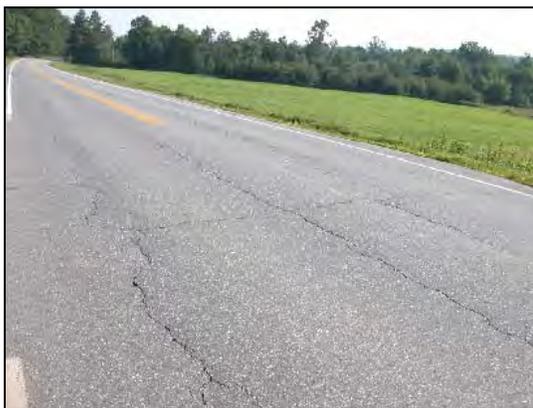
Figure 15 – Lowell MM 3.26 in 2007

In July 1999 it was found that the reflective crack at MM 3.26 had extended across the entire width of the northbound lane, to a length of 12 feet in the northbound lane and 4 feet in the southbound lane. This crack had increased to a length of 18 feet in October 2000, although still only nine feet of the crack length was located within the PavePrep test area. Also in 2000, hairline cracking was noticed at the test section at MM 6.13. These cracks were longitudinal in nature and not transverse or reflective, which indicates that they were caused either by fatigue or environmental factors. In July 2001, the hairline longitudinal cracks at MM 6.13 had expanded in width to nearly 1" in certain locations. The cracking at MM 3.26 remained unchanged from the previous inspection. At a final site visit in July 2007, the crack at MM 3.26, shown below in Figure 15, had extended across the entire roadway and was interconnected with other longitudinal cracks in the pavement, which had led to alligator cracking in one area. At MM 6.13, shown in Figure 16 below, the transverse reflective crack spanned the entire roadway and had a width of up to 2 cm. This crack was interconnected with several longitudinal cracks, but did not display the severity of alligator cracking.

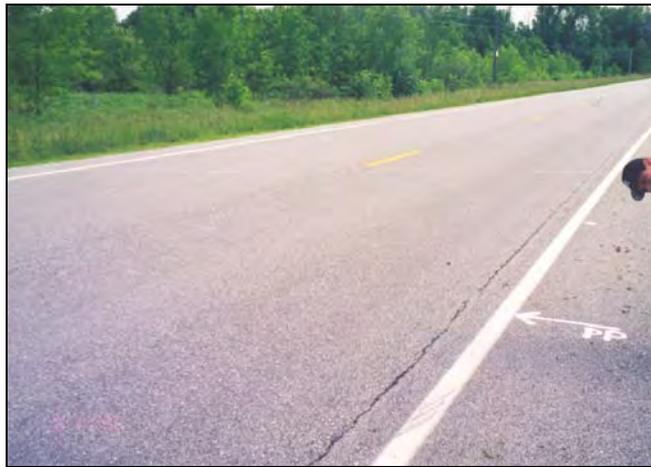
Figure 17 – Highgate in 1998

At the initial site visit in 1995, one year following application, there were no signs of reflective cracking in either the PavePrep test location or the control section. In general the pavement appeared to be performing well in the test section and adjacent areas. Figure 17 shows the condition of the pavement during the 1998 site visit. No cracking had developed in either the experimental or control sections until June 2000, when full length transverse cracking was observed both 15.5 feet and 36.5 feet south of the PavePrep material. Longitudinal cracking was noted 10" off the center of the white edge line in the northbound lane and 16" off the center of the white edge line in the southbound lane in both the experimental and control areas, as shown in Figure 18 below. These cracks were typical of the roadway in the immediate area and most likely are located at the paving joints. Signs of longitudinal cracking at the centerline were observed beginning slightly south of the PavePrep location and continuing southerly. No reflective cracking was observed in the experimental PavePrep area.

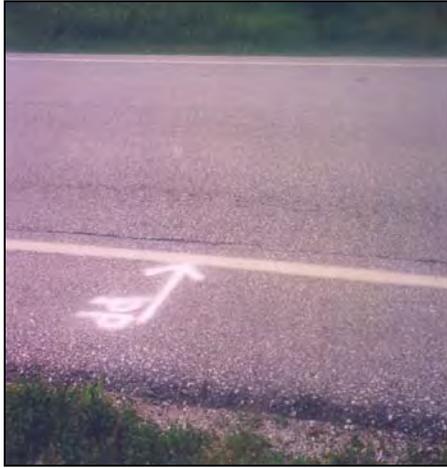
Figure 18 – Highgate in 2000

In July 2001, the longitudinal cracking had become more evident throughout the site. During this site visit a centerline longitudinal crack extending through the PavePrep test location with an average width of 0.5 cm was recorded. However field notes and photographs from the August 2002 site visit indicated that this is not the case. The paving joint was visible but there were no signs of reflective cracking in the PavePrep area, though there were some reflective centerline cracks in the control area. No reflective transverse cracking was noticed at the PavePrep location, but full length transverse cracks were observed at 40 foot intervals throughout the control section. These cracks are most likely caused by the joints of the underlying Portland cement concrete reflecting through the overlay, but could also be caused by construction practices during the installation of the new overlay, with each crack representing a new truck load of asphalt during application. At a final site visit in July 2007, shown in Figure 19 below, cracking had begun to develop on both the transverse and centerline PavePrep locations. The transverse crack spanned the entire roadway, but was only 5 mm wide. The centerline longitudinal crack was also only 5 mm wide and did not extend

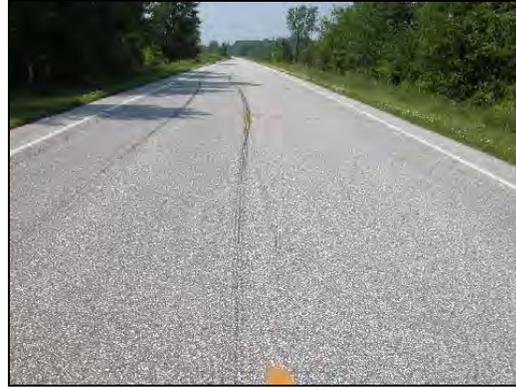
Figure 19 – Highgate in 2007

through the entire length of the test site. Longitudinal cracking had developed next to the centerline paving joint.

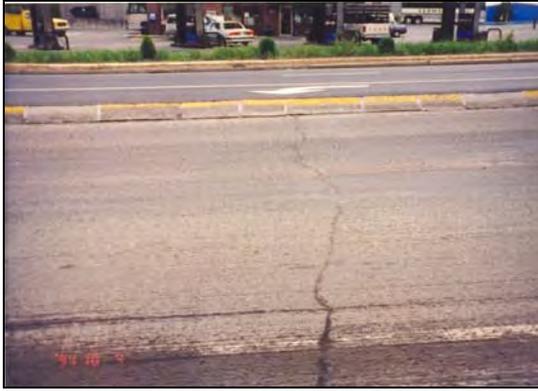
Figure 20 – Hartford in 1994

At the initial site visit in 1995, one year following application, there were no signs of reflective cracking in either the PavePrep test location or control section. In general the pavement appeared to be performing well in the test section and adjacent areas. No cracking was observed through 1997, and no site visit was conducted in 1998. In July 1999, two transverse reflective cracks were observed at the test site along the PavePrep location. One crack measured nine feet in length, spanning from the shoulder edge towards the centerline, while the other crack measured 23 feet in length and spanned from the island median towards the centerline. The cracks overlap slightly at the centerline, and combined they span the entire roadway width. The crack had been filled with crack sealer prior to the 1999 site visit. No additional cracking was observed until July 2001 when polygon cracks began to develop off both sides of the sealed cracks. This trend was also observed during an August 2002 site visit, and a centerline longitudinal crack had also developed and been filled with crack sealer. At the final site visit in July 2007, additional cracking had developed off of the original transverse cracks, as well as additional longitudinal cracking along the centerline and shoulder edge of the roadway. However, it is important to consider problems associated with construction as described previously making it difficult to draw any conclusions regarding performance at this particular test site. Figures 20-22 below show the condition of the PavePrep area prior to construction in 1994 and post construction in 2000 and 2007.
