MATERIALS & RESEARCH

RESEARCH UPDATE

U 2006-2

SNOWPLOWABLE RAISED PAVEMENT MARKINGS

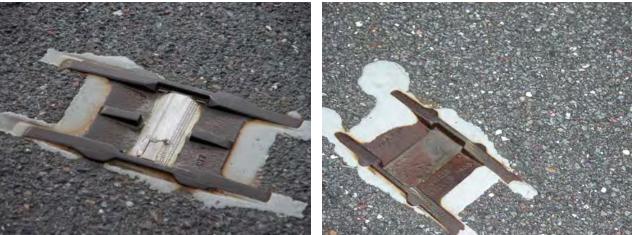
Further inspection revealed that 101 LPCR only had two damaged or cracked lenses, while the H100 (6) and SnowLite 150 (8) exhibited a similar number of damaged lenses. The SnowLite 200 had the most significant damage with one third of the lenses (17) affected, however it had only one lens completely missing from the

marker. This compared to the H100 markers which had seven lenses absent from their housings. Both the 101LPCR and the Snowlite 150 had no lenses missing from their housings at the time of inspection.

Figure 3 – Avery Dennison 101LPCR

Figure 4– Hallen H100

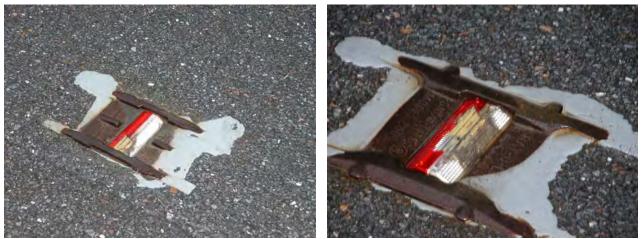
It was noted that one of the markers (in the Ray-O-Lite 150 area) appeared to be completely missing from the test site. However, upon closer inspection of that particular site, it became apparent that while the epoxy had been applied, no marker had been placed in the groove at the time of installation. All other housings appear to be in good condition with no significant distress at the time of this inspection.

Figure 5 - Ray-O-Lite SnowLite 150

Figure 6 - Ray-O-Lite SnowLite 200
