**ASSESSMENT OF JAHN PERMEABLE MORTAR SYSTEM IN A  
HISTORIC BRIDGE ABUTMENT APPLICATION**

**Report 2015 – 10**

**June 2015**

Reporting on Work Plan 2011-R-05

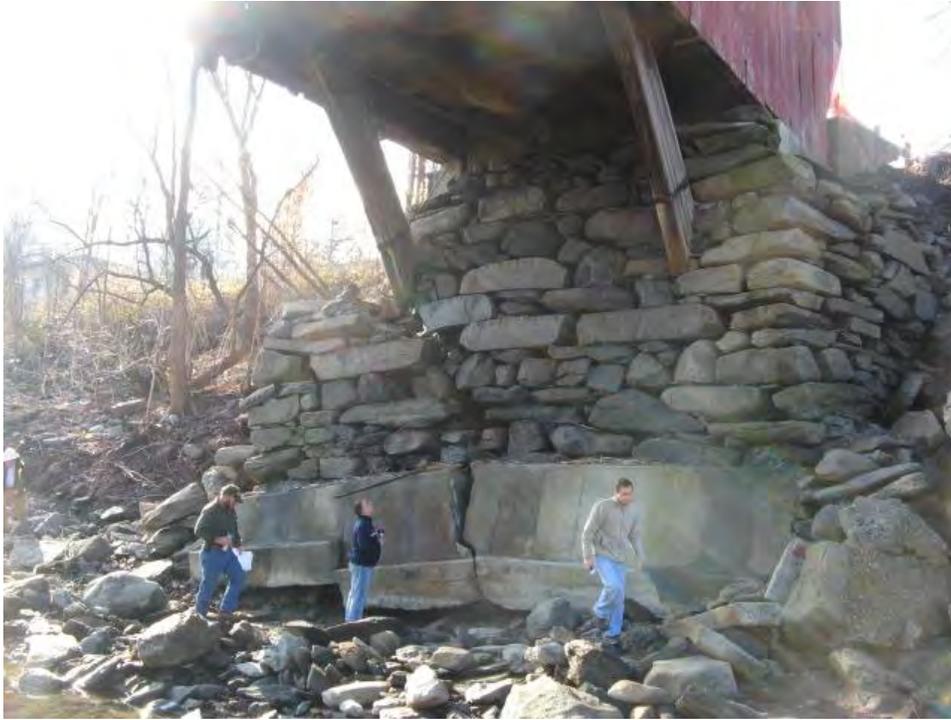
On August 28, 2011, the Tropical Storm Irene caused significant damage to the crossing. In particular, the westerly abutment was undermined and partially collapsed (Figure 8), causing damage to the timber structure of both spans of the bridge. Though the bridge remained standing, the westerly abutment continued to break apart in the months after the storm. That winter, the westerly span was removed except for the arches (Figure 9). The timber was carefully removed, labeled and stockpiled at the town garage for later use in the rehabilitation project. For nearly two years, the surviving components of the structure lay dormant. In late 2012, construction began on the bridge and on September 7, 2013 the bridge was reopened after extensive \$2.5 million reconstruction was completed. (Cassidy, 2013)

**Figure 8 Westerly abutment partially collapsed (VTrans 2011)**

The tropical storm eventually undermined the westerly abutment at the downstream end. The abutment fractured (Figure 8) resulting in the downstream westerly arch to pull out of the stone socket securing it in place. (Figure 10) In turn, the westerly span twisted, causing damage at connections throughout both spans. The covered bridge was scheduled for a nearly \$3 million National Covered Bridge rehabilitation project that was scheduled to begin in September 2012. Much of the work that was planned for that project was incorporated in the project resulting from the storm activities.

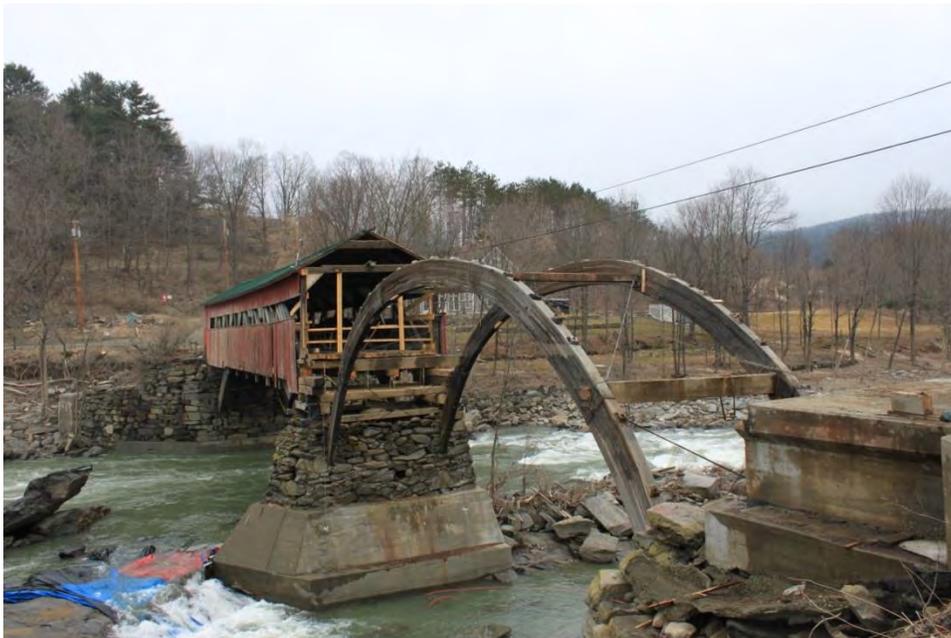
**Figure 9 Westerly span dismantled leaving only the arches (VTrans, 2011)**

According to McFarland Johnson, the engineering firm hired to design and specify the rehabilitation work for the covered bridge, the dry-laid stone abutments and pier have flaws and weaknesses. McFarland Johnson continued with this assessment by saying, “[The original builders] *just got the best stones that they could, field stones or whatever and tried to do the best they could to stack them up.*” (Power, 2011) The pier comprises of dry-laid stone down to the riverbed. The pier and abutments have a concrete skirt encasing the stone pier placed after the original construction, which can be seen in Figure 9. (Historic Covered Bridge Committee, 2008)

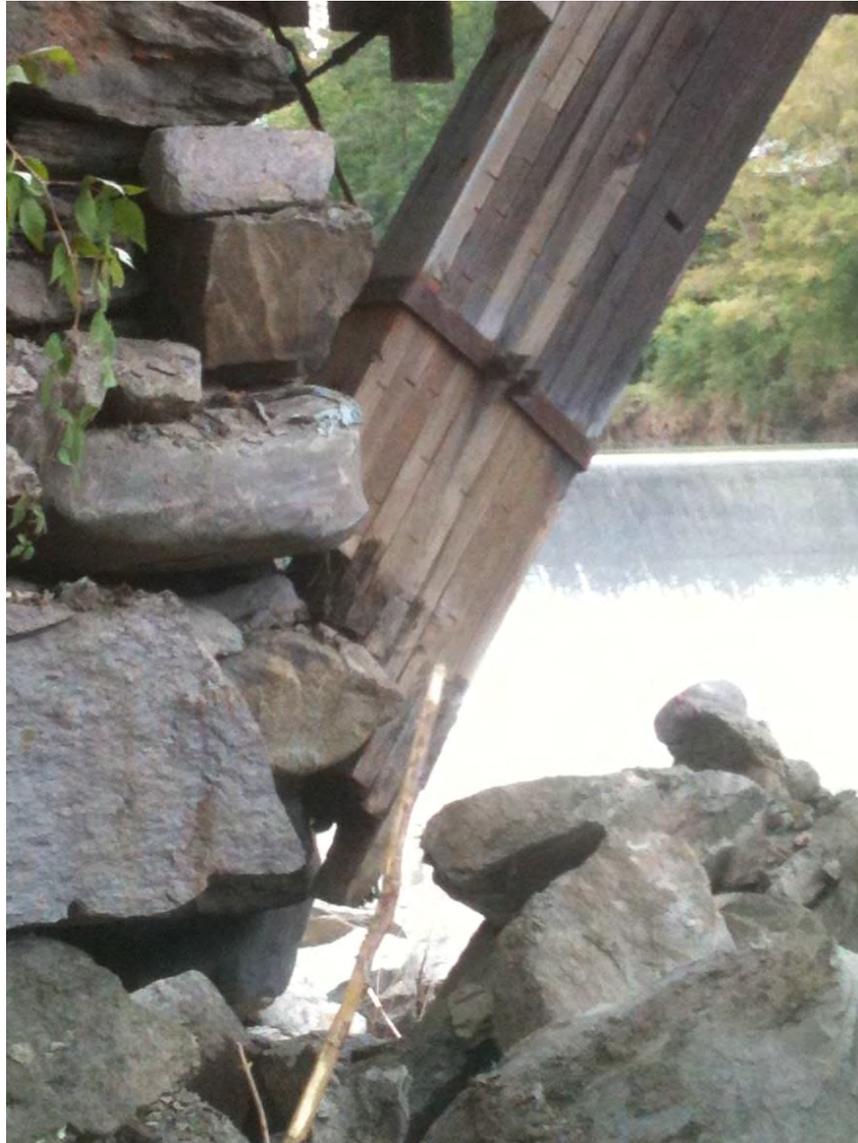
**Figure 10 Downstream westerly arch dislodged from abutment (VTrans 2011)**

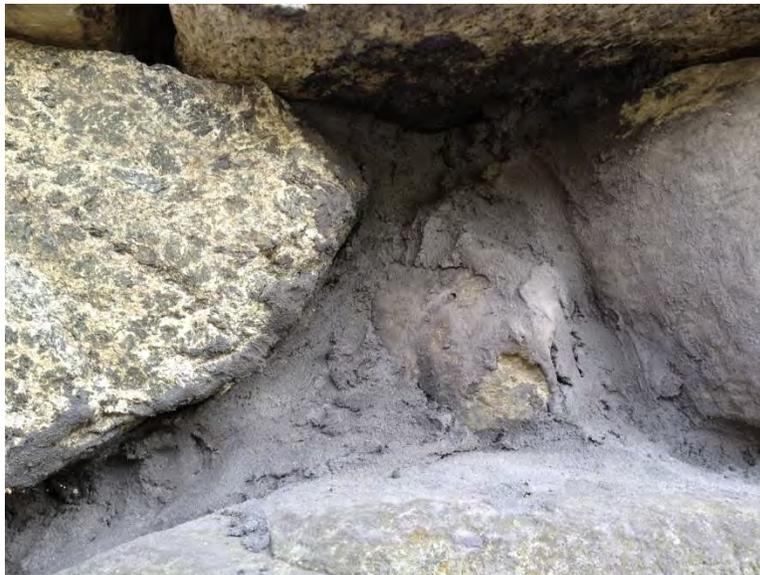
The stonemason used a narrow pointed mason's trowel to pry out small loose stones and debris from the dry-laid stone joints. Using a brush or their hands, the stonemason would remove dust and dirt from within the joints. The crew had access to an air compressor, which they used to clean fines out of the joints. It was determined that a power washer would be the best option to conduct the final cleaning of the stones. Where there were gaps, the stonemason would size up a stone provided on the rigging, and fit it into the opening, carefully matching the shape of the stone to the shape of the gap. In places, several stones were required. Smaller stones were worked deep into the larger gaps (Figure 14 and Figure 15). The stones for this work came from the collapsed westerly abutment that was being excavated. The larger stones were broken apart to make smaller stones for chinking.

**Figure 14 Up-close view of stone pointing and mortar work (VTrans 2013)**

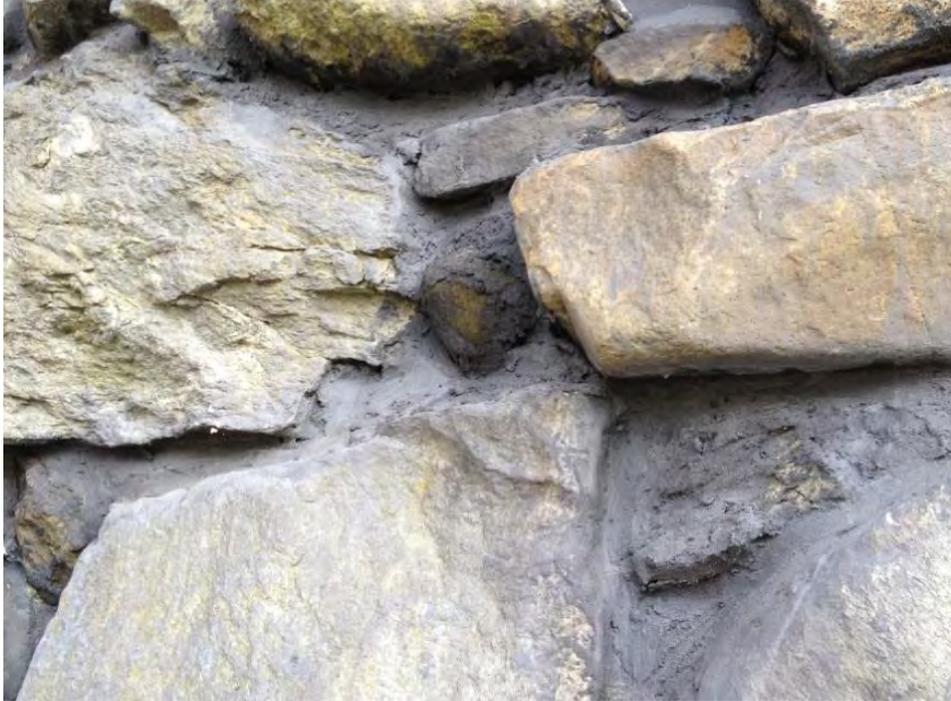
**Figure 15 Completed mortar work (VTrans 2013)**

Once the stone pointing and cleaning was complete, the stonemasons would mix a portion of the Jahn Pointing Mortar. The grout was given a blackish color to give the appearance of a void, to simulate the open joints of dry-laid stone. When cured, the color would become more of a dark gray. The stonemasons would work the mortar deep into the stone joints. Repeated application would continue until the mortar either could no longer be worked into the joint or the stonemason felt the joints were sealed. The mortar was then worked into a smooth concave surface using a joint filler tool allowing the original stones to protrude out to maintain their original appearance.

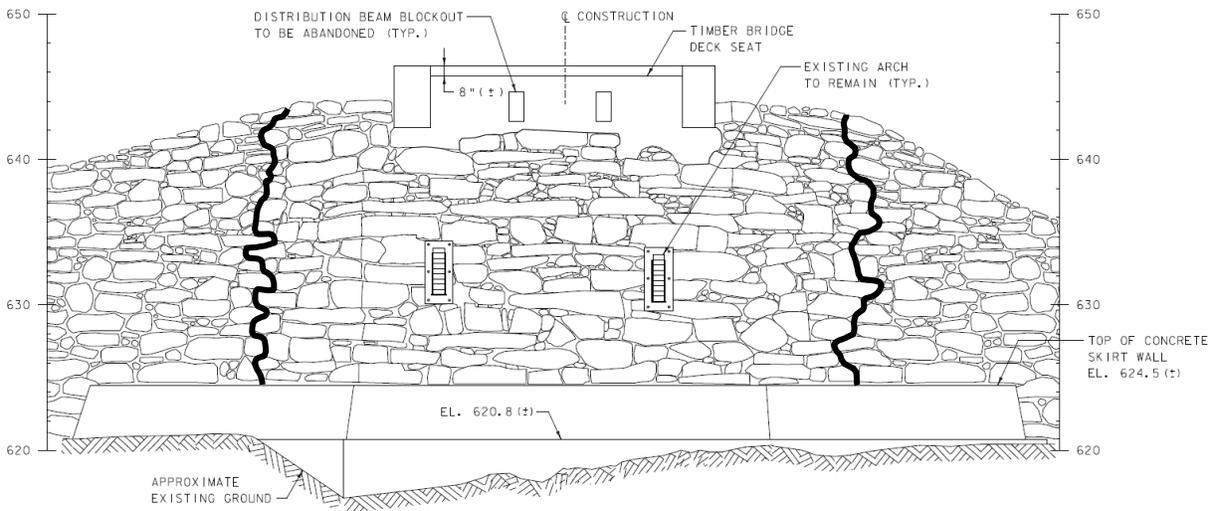
**Figure 16 Details of the Easterly Abutment (dark lines shows approximate extent of pointing – VTrans 2012.)**

With the experience level adequate for the job, the mortaring process continued on the pier on all faces. Since the work was being accomplished in February, the stones and surroundings in the enclosure needed to be warm enough to meet the specifications of a 50°F minimum. This was done by indirectly heated air blowing into the enclosure. By February 22, the stone pointing was complete. On February 26, the enclosures were made ready to begin pointing stones on the easterly abutment (Abutment #2, see Figure 16). This work was done directly below the superstructure. The stonemasons began pointing on February 28. By March 1, the pointing was complete with the exception of the bottom two feet, as that was outside the heated enclosure. This would be completed later in May. (Chase, 2013)

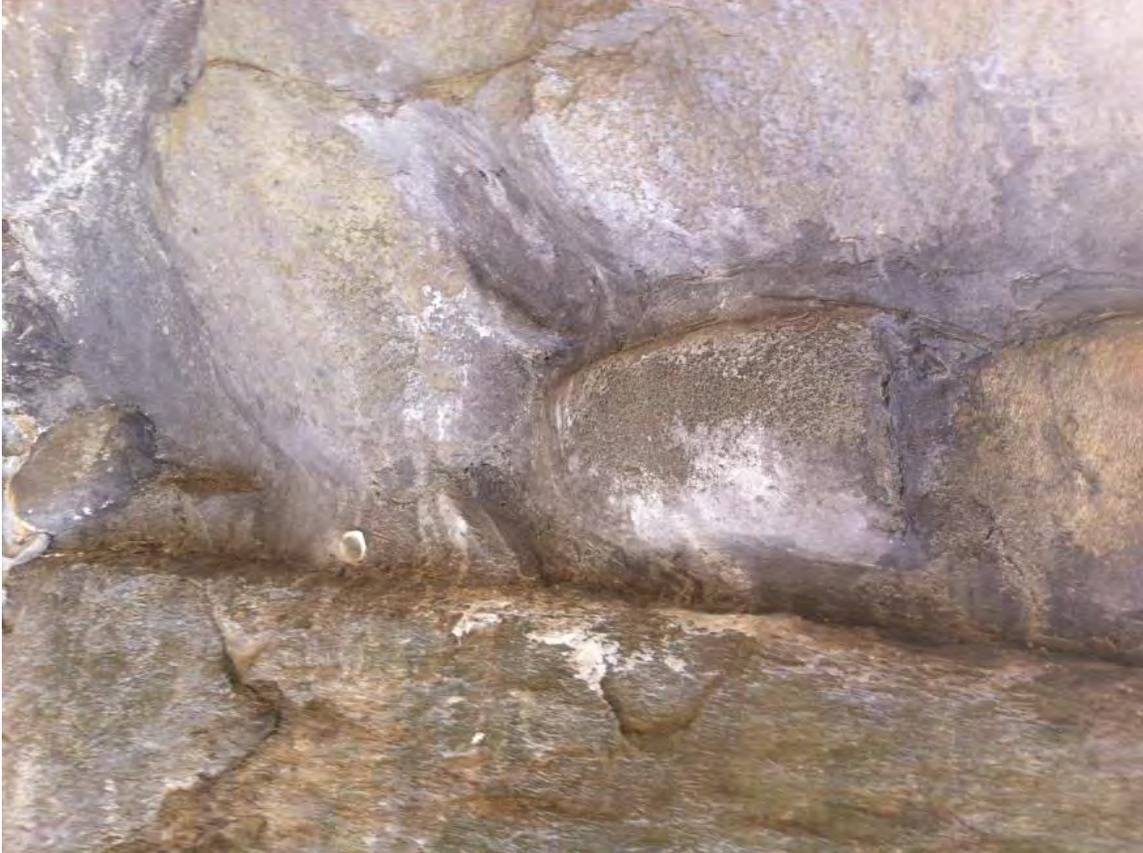
Research and Development has visited the project site once a year since the project has been completed. In a discussion with the CEO of Cathedral Stone Products, Denis Rude, he said that as the salts leach out of the interior of the pier and abutment, a white powder like substance would appear on the surface of the grout. This powder would eventually blow off the surface with wind or be washed off by rain. There were concerns that the repairs to the pier and abutment would cause an efflorescence to form in places. The use of the Jahn products was intended to prevent such efflorescence from forming. In the last two years, the white powdery substance has

been observed forming; however, it is not accumulating (Figure 18). There seems to be a consistent light dusting in places. Overall, the grout appears to be functioning as expected.

**Figure 18 Up-close view of white powdery residue on mortar (VTrans 2013)**

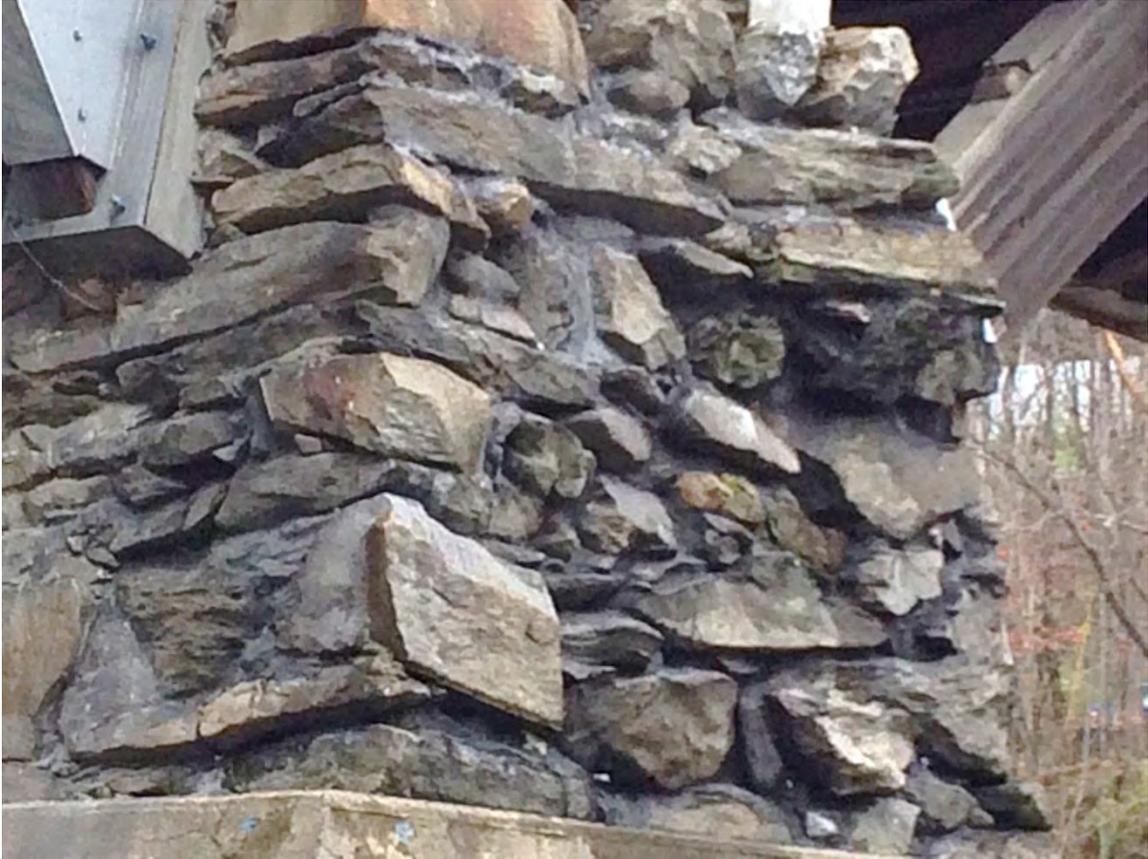
Another purpose of using the Jahn products was to strengthen the dry-laid stone pier and abutment to preserve the overall historic appearance of the bridge. Concerns were that the mortar would be obvious from a distance. Observations at various distances from the substructure units gave an appearance of dark joints between stone (Figure 19 and Figure 20). The mortar and pointed stones were virtually invisible to the eye from afar. Even up close, the dark grey color of the mortar has aged in a way that it is not obvious in most places on each substructure unit. Places where the mortar is visible are where there were large gaps in the dry-laid stone (Figure 21).

**Figure 21 Downstream face of pier showing final construction (VTrans 2014)**
