May 10, 2019

Project No. 19120896

**RE: PRELIMINARY ROCKFALL MITIGATION DESIGN, FAIRLEE ESCARPMENT SOUTHBOUND  
INTERSTATE 91, MILEPOST 92.7, FAIRLEE, VERMONT**

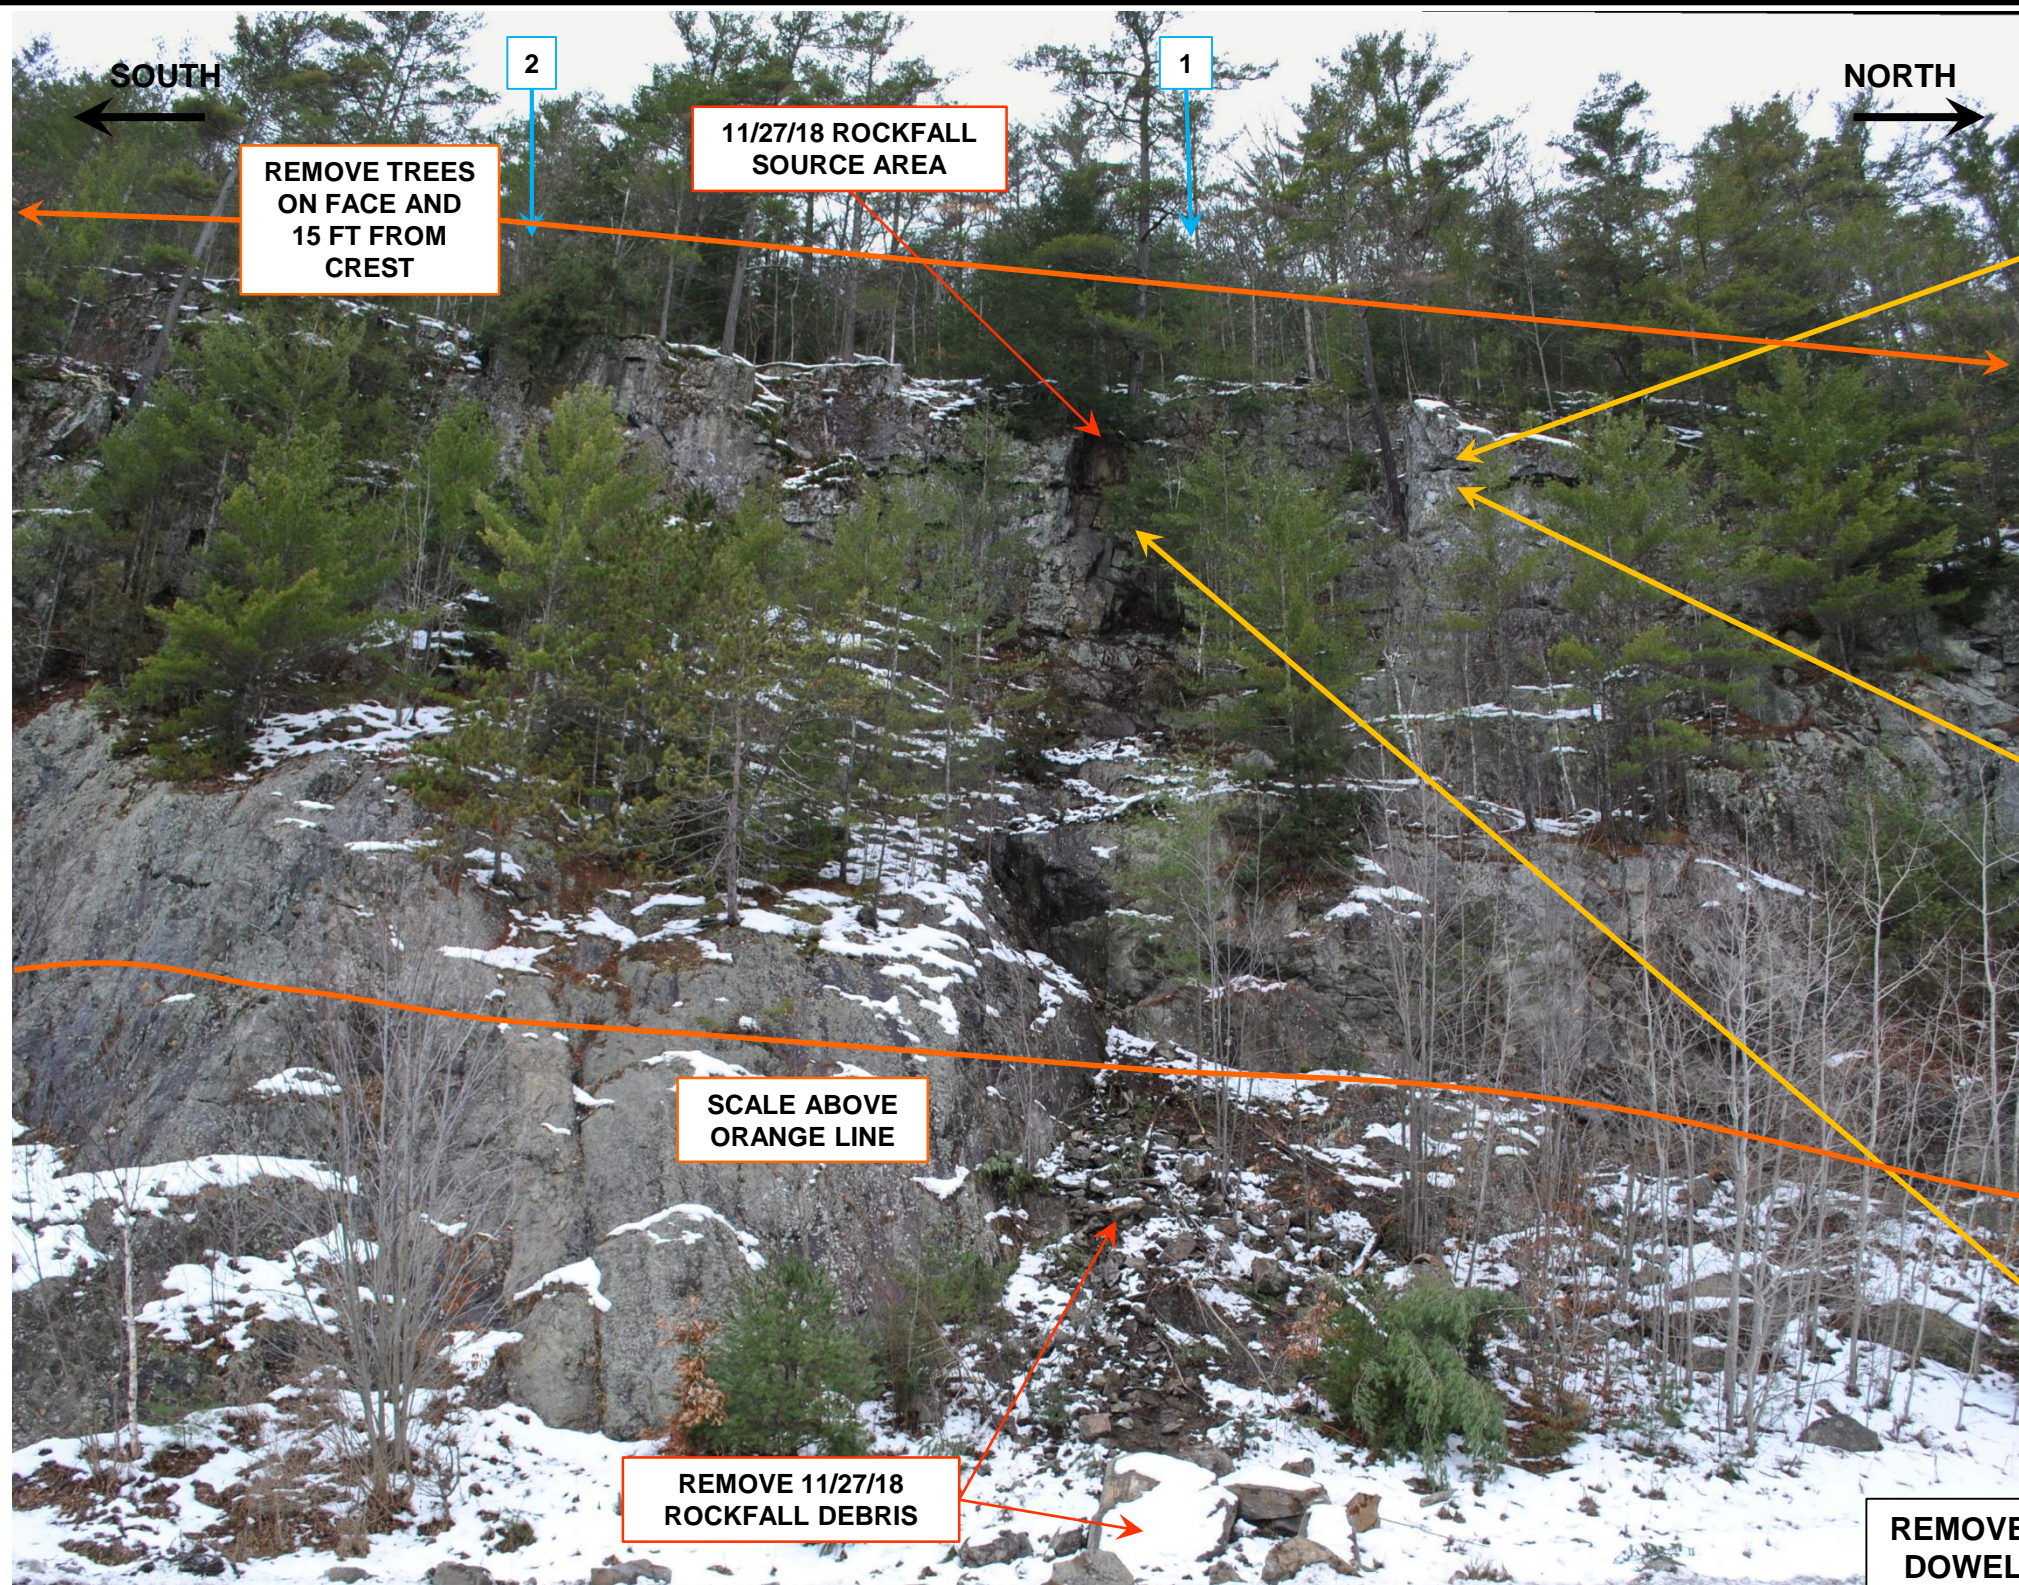
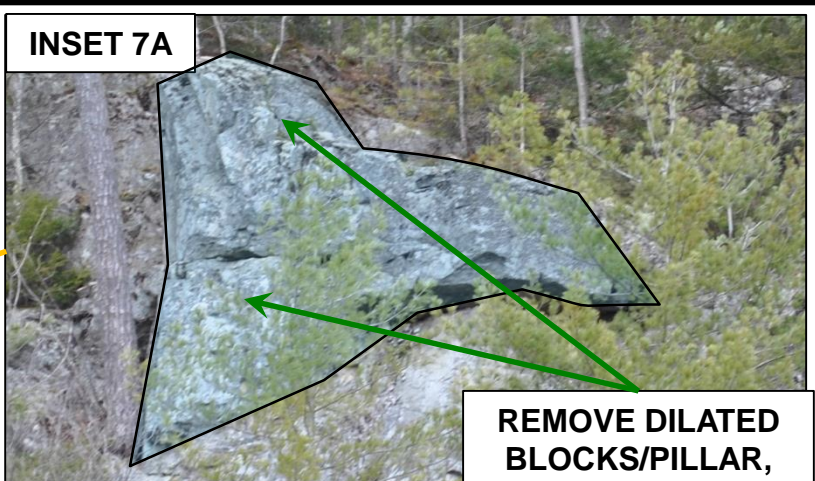
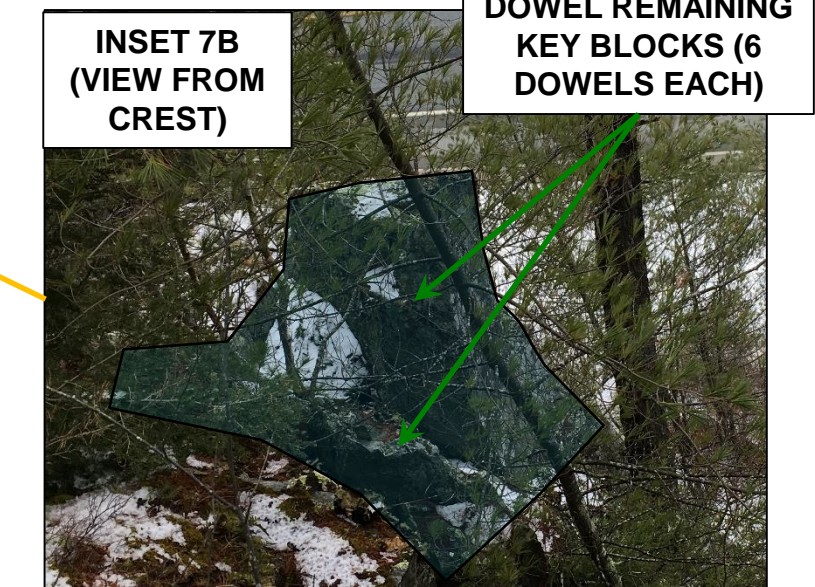
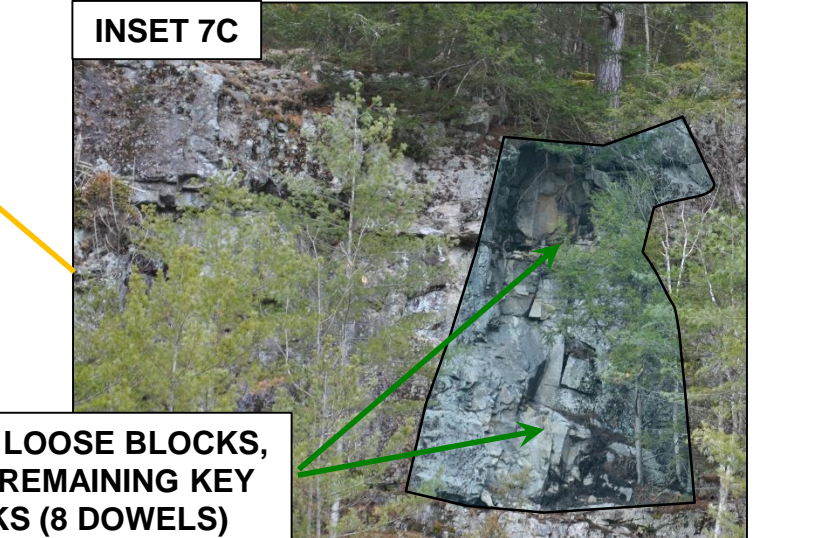
11/27/18 ROCKFALL SOURCE AREA

REMOVE TREES ON FACE AND 15 FT FROM CREST

SCALE ABOVE ORANGE LINE

REMOVE 11/27/18 ROCKFALL DEBRIS

REMOVE DILATED BLOCKS/PILLAR, DOWEL REMAINING KEY BLOCKS (6 DOWELS EACH)

REMOVE LOOSE BLOCKS, DOWEL REMAINING KEY BLOCKS (8 DOWELS)

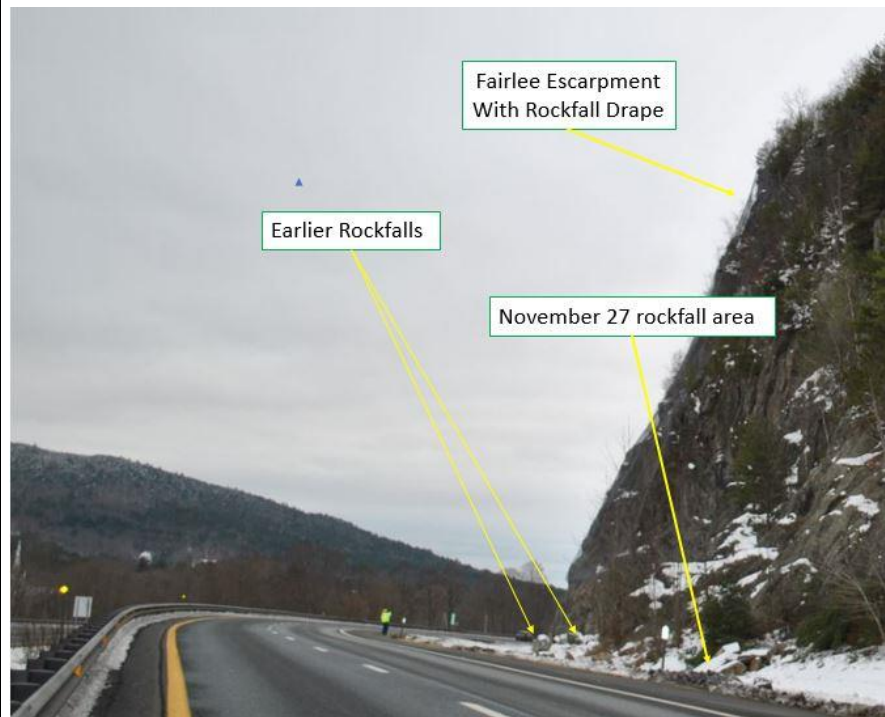
**PHOTO 2**

Two large blocks that reportedly fell three weeks before the November 27 rockfall event were observed south of the November 27 rockfall location during our November 30 site visit (Photo 2). Both blocks rolled out in the ditch and did not reach the roadway or shoulder. At the time of our November 30 site tour Golder concluded that the slope is in need of maintenance scaling in the near term (Photo 5). Observation of the November 27 rockfall source area did not reveal apparent evidence of imminent rockfall conditions, and weather and surface (snow and ice) conditions did not allow close observation of the entire crest and toe from the draped mesh to the rockfall source (roughly 400+ feet of crest). Despite the two rockfall events over three weeks' time, Golder did not believe the observed conditions warranted an immediate emergency response during Winter conditions and recommended that the slope be addressed in the Spring of 2019. Additional maintenance patrols and signage were recommended, together with marking existing rockfall blocks with spray paint so that any new rockfalls could be readily recognized and appropriate actions taken as needed. VTrans subsequently implemented these recommendations.

North end of rockfall drape showing recent rockfall event locations. View to south from SB LT shoulder. Photo date 11/30/18.

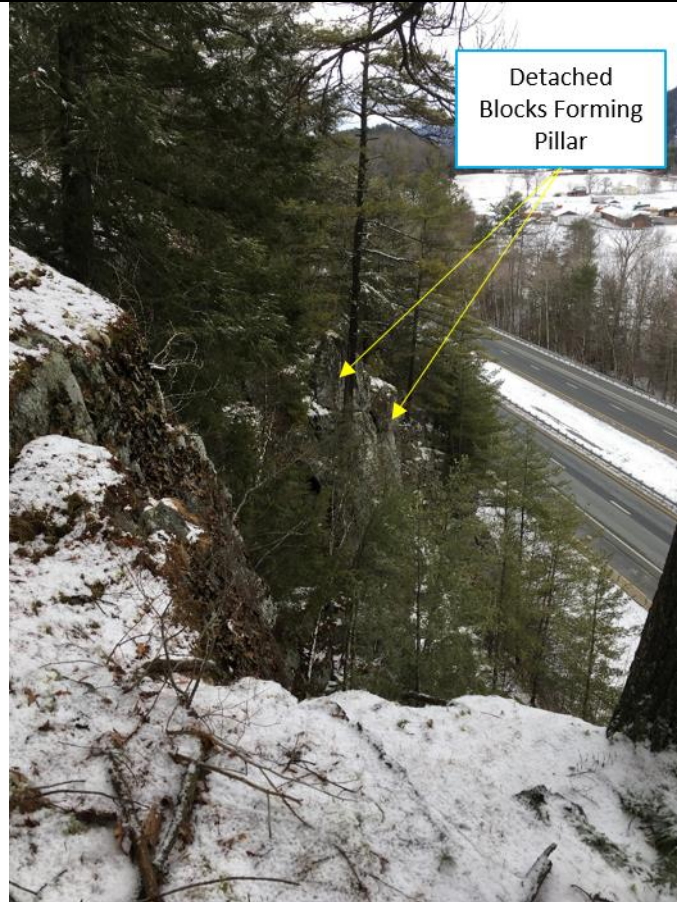
**PHOTO 3**

Rappel 1, view to north from crest showing detached blocks forming pillar as shown in Insets 7A and 7B of Figure 7. Photo date 04/10/19 (IMG\_7142.jpg).

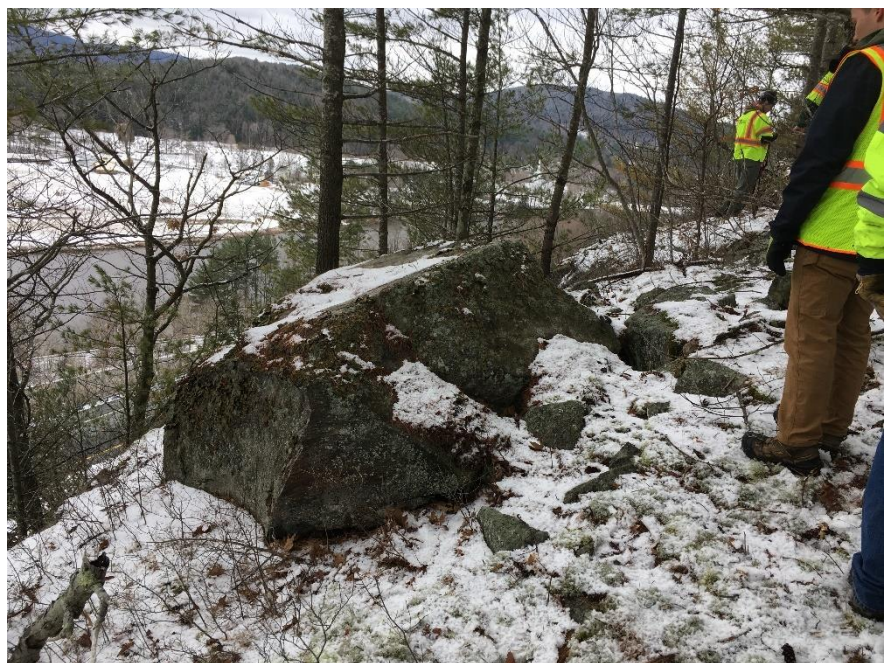
**PHOTO 4**

50 to 100 feet and has a gentler slope. The backslope is strewn with quartz monzonite boulders (Photo 4), ranging from a few feet to over ten feet in nominal size that were deposited during glaciation where the Palisades were a leeward or pluck-slope.

Rock block sitting on near horizontal surface about 5 ft from crest at Rappel 3 location. Photo date 04/10/19 (IMG\_7143.jpg).

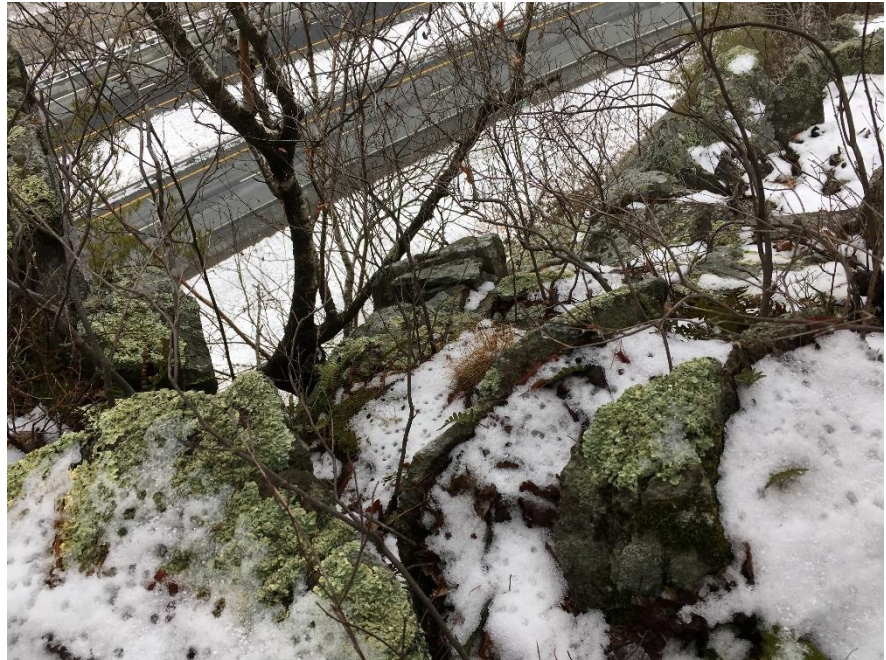
**PHOTO 5**

Typical loose rock block conditions at crest between Rappel 3 & 4 locations. Photo date 04/10/19 (IMG\_7152.jpg).

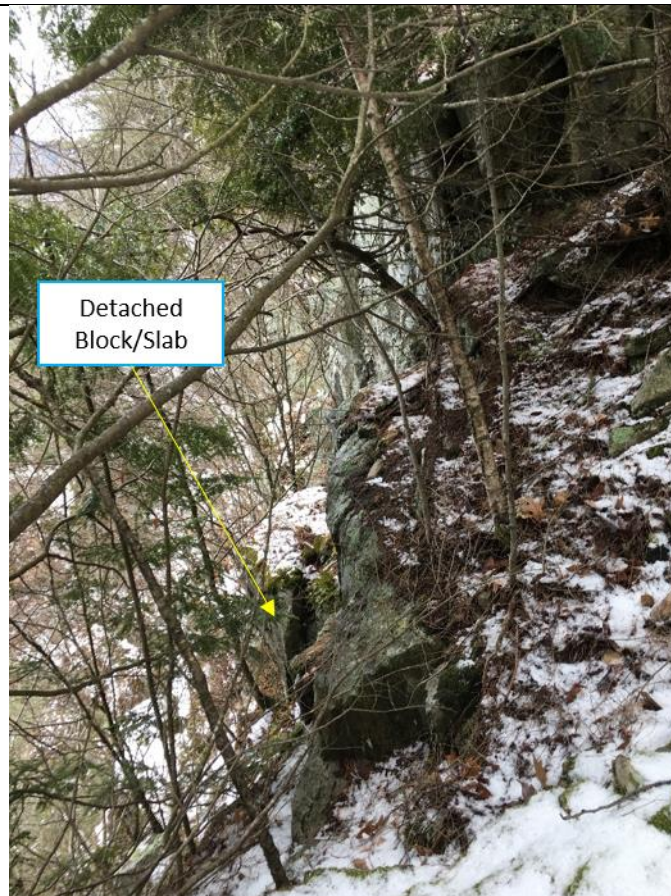
**PHOTO 6**

Typical detached block/slab conditions just below crest, between Rappel 4 and 5 locations. Photo date 04/10/19 (IMG\_7155.jpg).

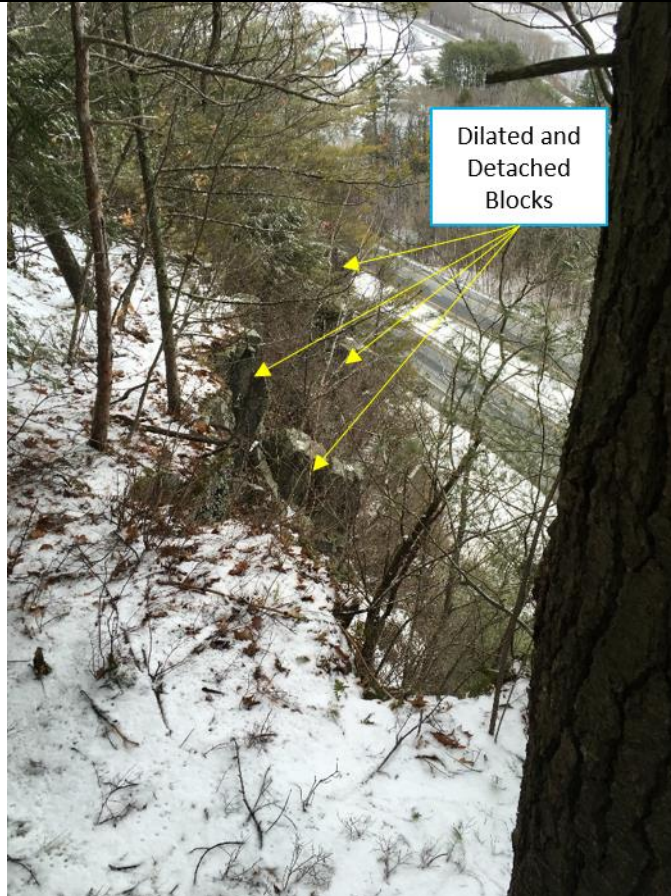
**PHOTO 7**

Typical dilated and detached rock blocks and slabs just below crest at Rappel 7 location, as shown in Inset 3A of Figure 3. View to north. Photo date 04/10/19 (IMG\_7158.jpg).

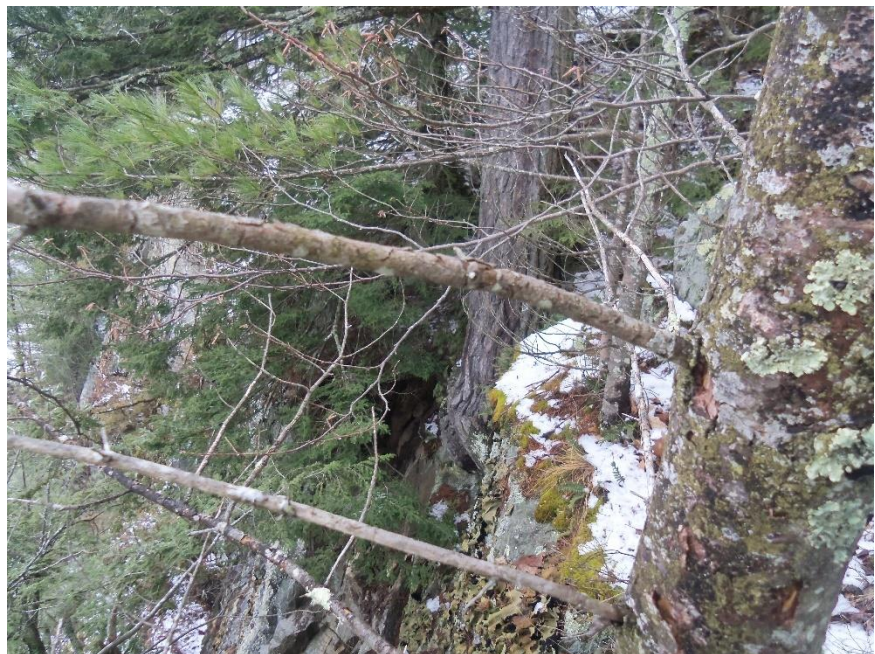
**PHOTO 8**

Rappel 1 at crest, view to south showing source area of November 27, 2018 rockfall event, and shown in Inset 7C of Figure 7. Note large white pine sending roots into open joints leading to root jacking and ongoing joint dilation. Photo date 04/10/19 (100\_3368.jpg).

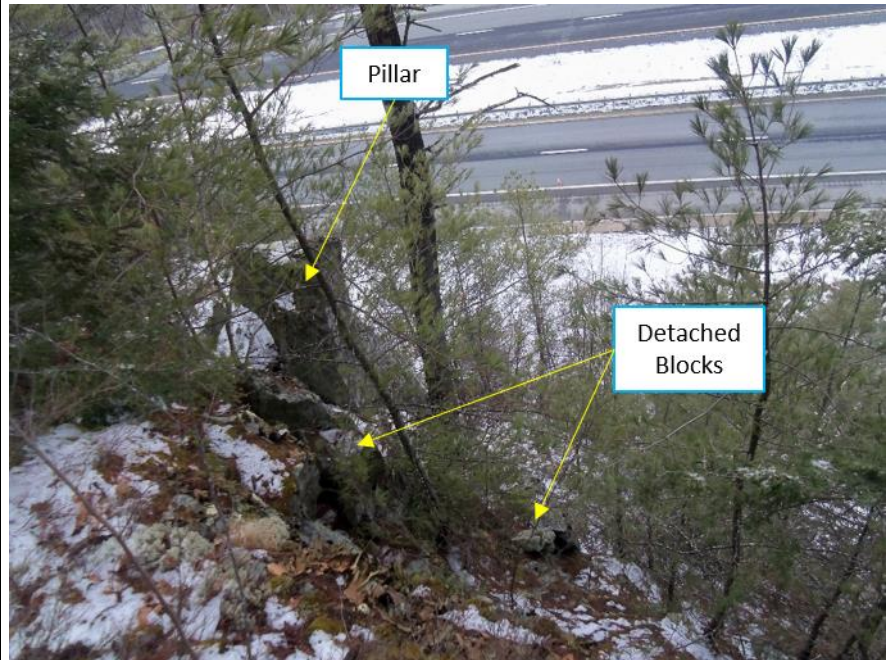
**PHOTO 9**

Rappel 1, at crest, view to north of detached rock blocks forming pillar, as shown in Insets 7A and 7B of Figure 7. Photo date 04/10/19 (100\_3370.jpg).

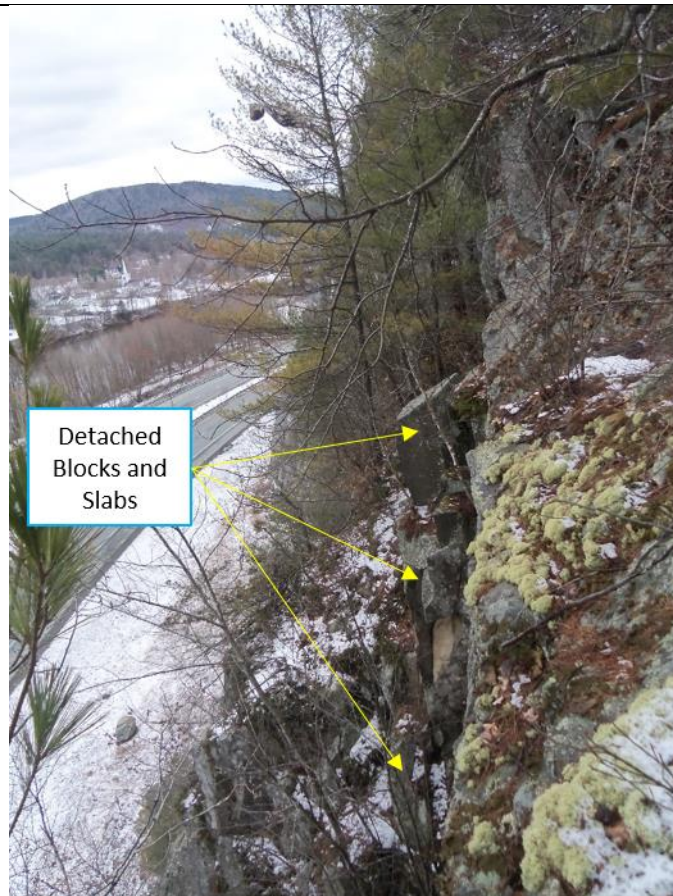
**PHOTO 10**

Rappel 4 at crest, view to south showing detached rock blocks and slabs, as shown in Inset 5A of Figure 5. Photo date 04/10/19 (100\_3388.jpg).

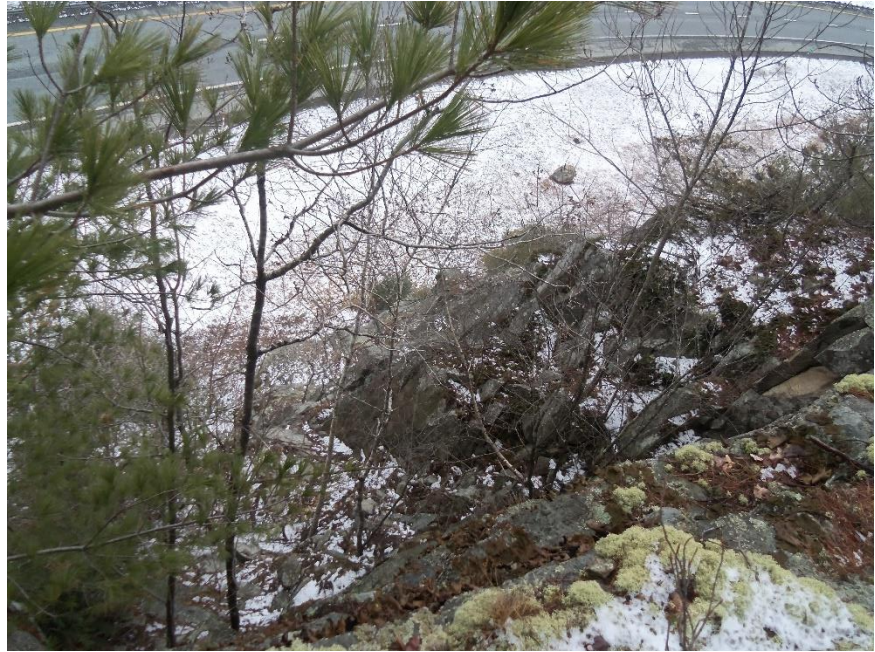
**PHOTO 11**

Rappel 4 at crest, view of upper slope area showing detached slabs in Photo 10 above (right), and loose rock blocks on steeply dipping slope. Photo date 04/10/19 (100\_3389.jpg).

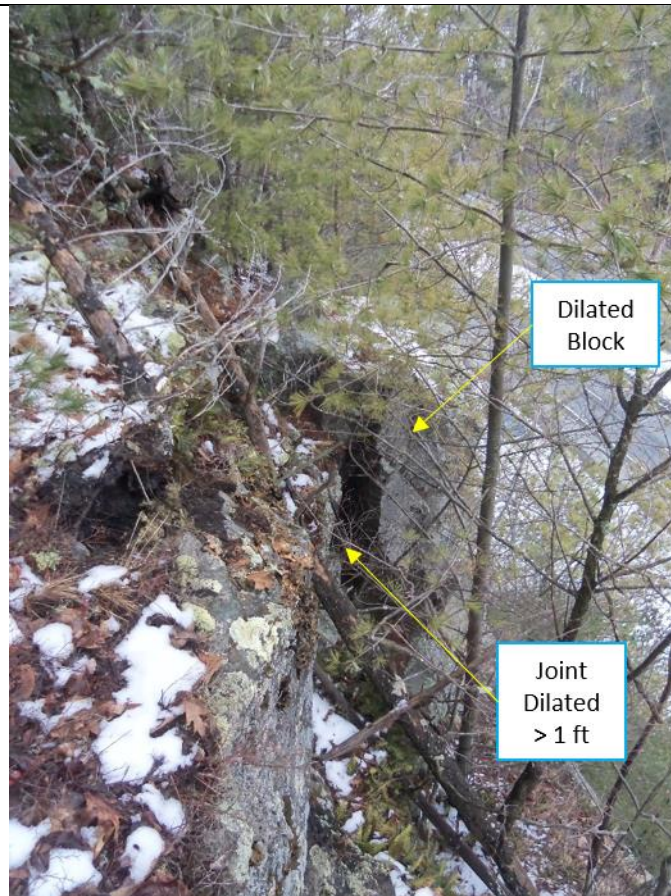
**PHOTO 12**

Rappel 5 at crest, view to north showing dilated block. Dilation at least 1 ft wide. Photo date 04/10/19 (100\_3393.jpg).

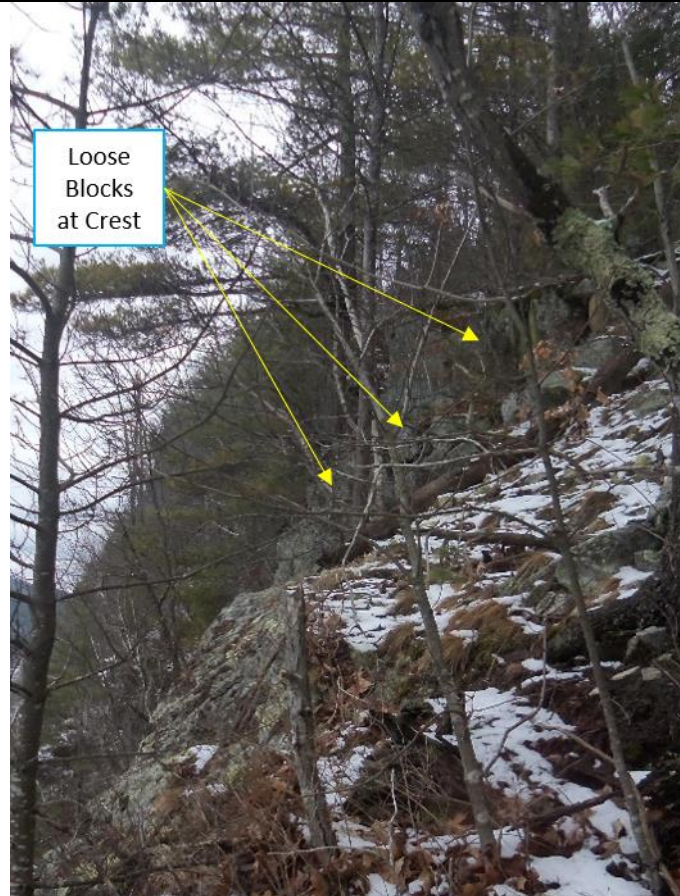
**PHOTO 13**

Rappel 5 at crest, view showing general loose rock block conditions as slope crest rises to south. Photo date 04/10/19 (100\_3399.jpg).

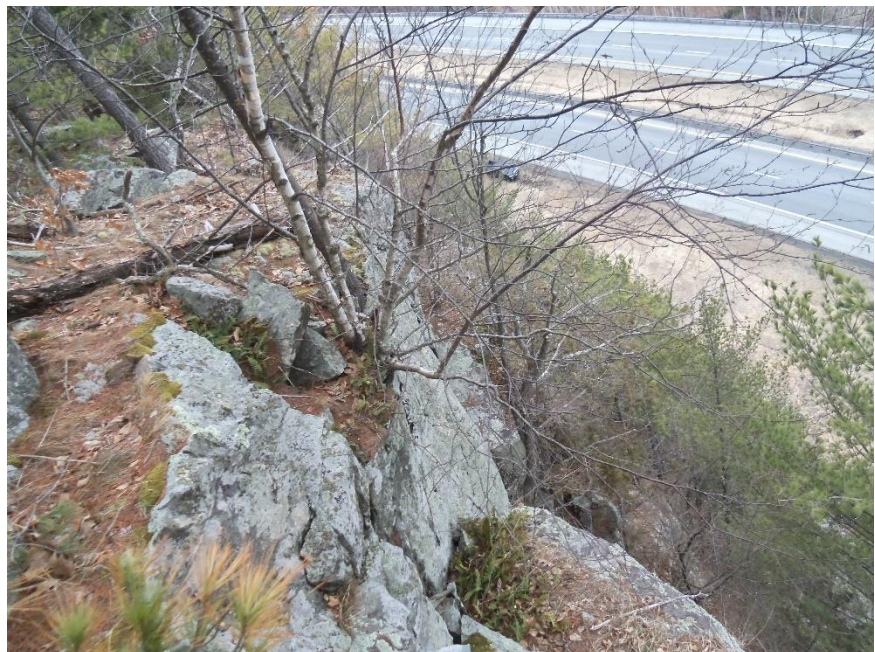
**PHOTO 14**

Rappel 6 at crest, view to north showing general loose rock block conditions. Photo date 04/12/19 (100\_3403.jpg).

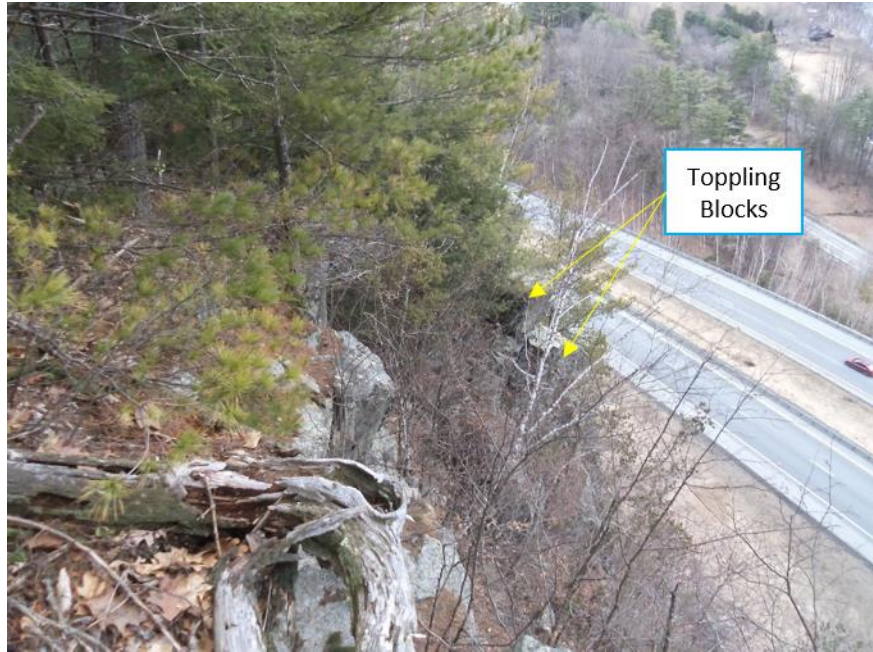
**PHOTO 15**

Rappel 7 at crest, view to north showing general loose rock block conditions. Note dilations >1" wide, with shallow dipping basal joints to east, and more closely spaced subvertical joints dipping steeply to the northwest, favoring a toppling failure mode. Photo date 04/12/19 (100\_3417.jpg).

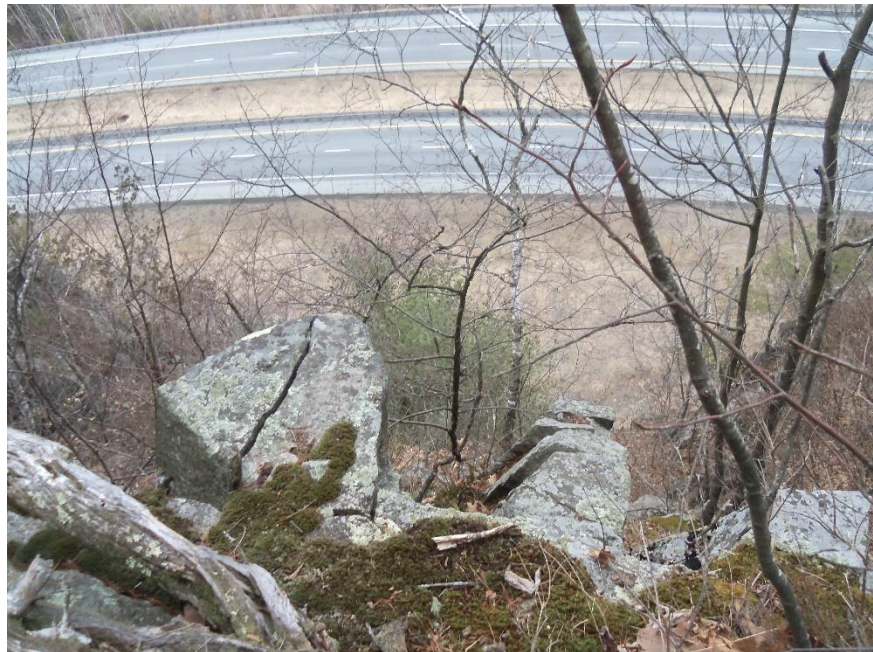
**PHOTO 16**

Rappel 7, view downward below crest showing loose, detached rock blocks and slabs. Photo date 04/12/19 (100\_3421.jpg).

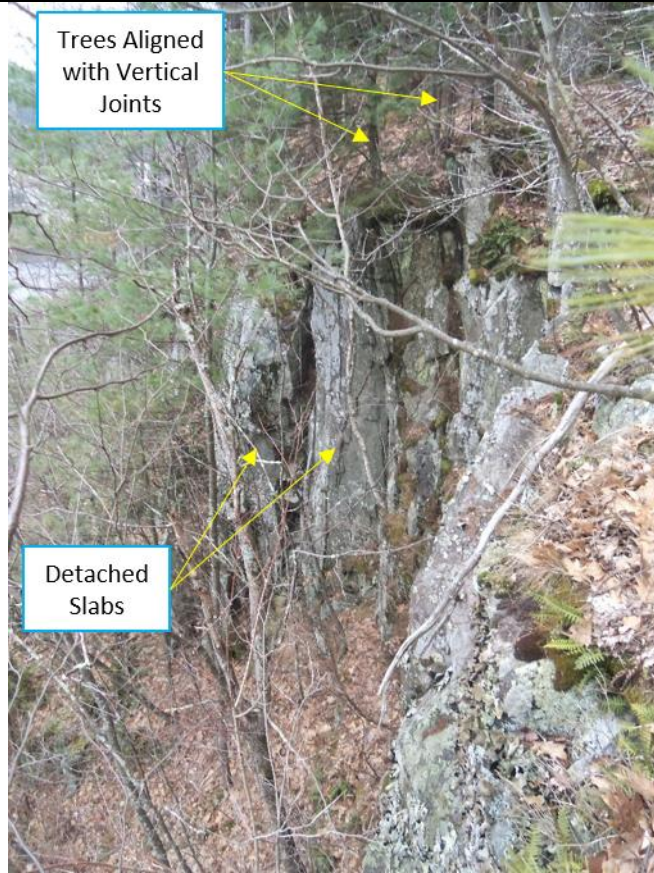
**PHOTO 17**

Rappel 7, view to south showing typical detached slabs developed along closely spaced near vertical joint sets. Note trees aligned with vertical joint sets. Photo date 04/12/19 (100\_3423.jpg).

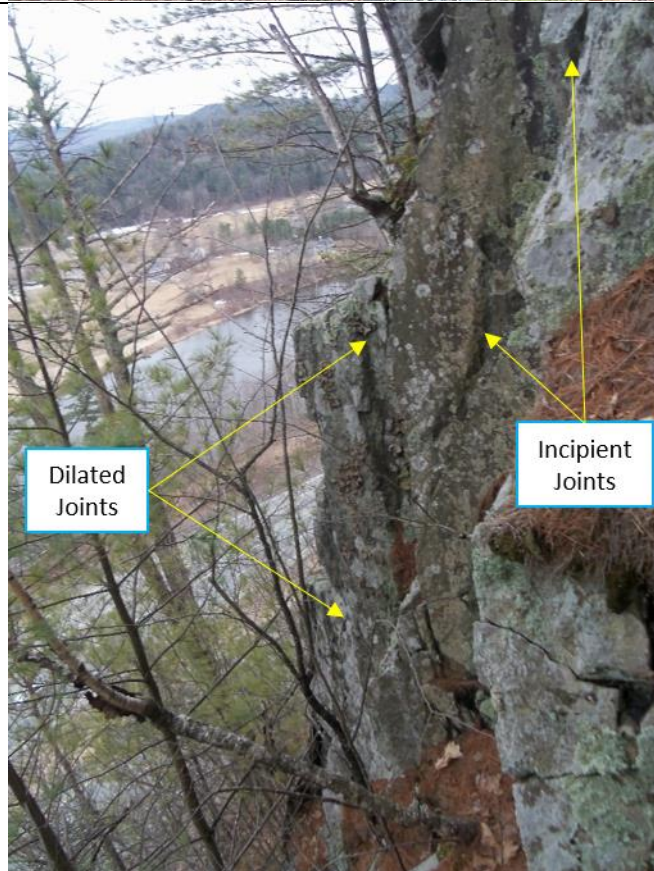
**PHOTO 18**

Rappel 9, view to south showing typical detached slabs developed along closely spaced near vertical joint sets. Photo date 04/12/19 (100\_3423.jpg).

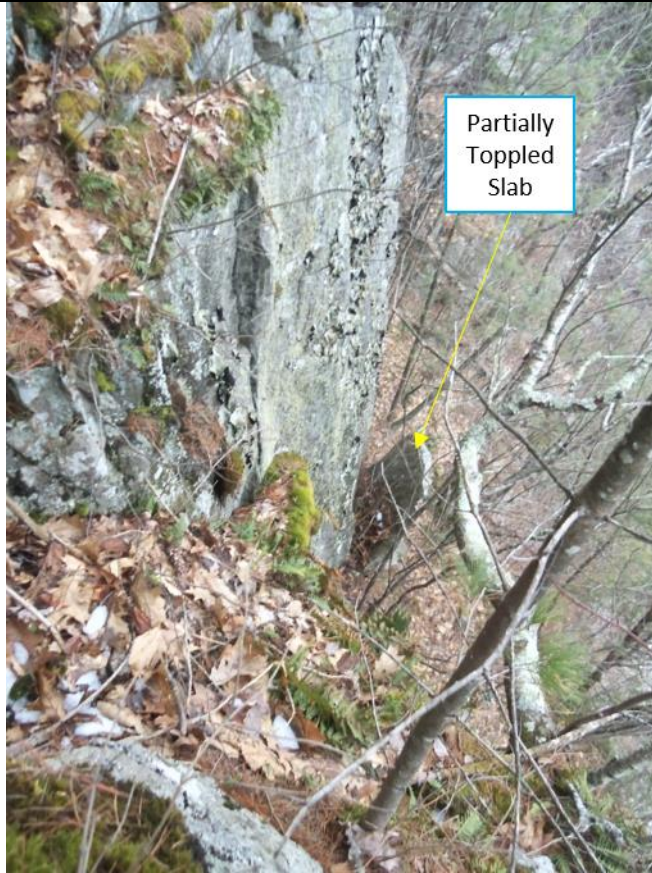
**PHOTO 19**

Rappel 9, view to north showing partially toppled rock slab at base of larger rock slab with incipient dilated vertical joint. Photo date 04/12/19 (100\_3430.jpg).

Partially  
Topped  
Slab

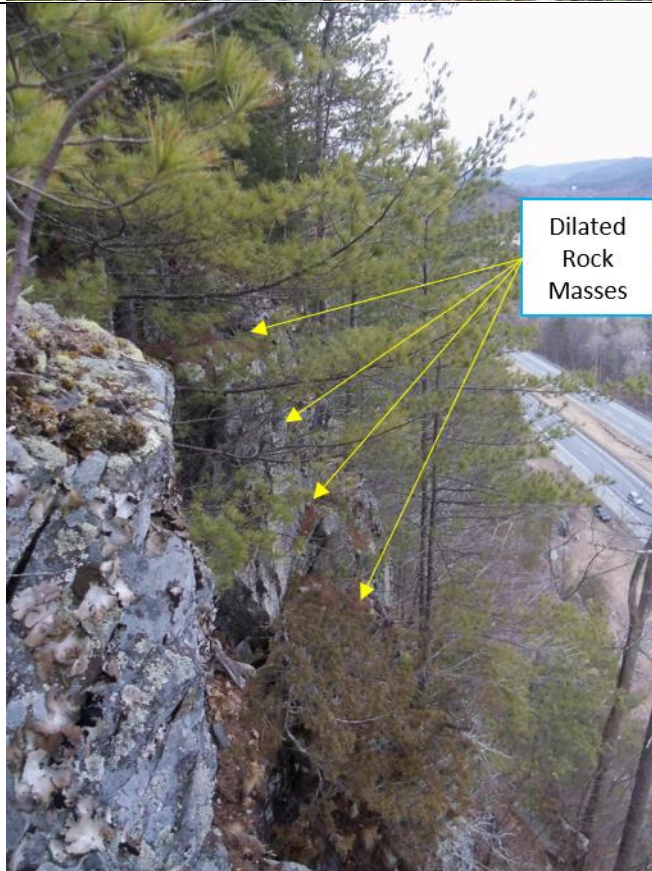
**PHOTO 20**

Rappel 10, view to north showing dilated rock masses at crest. Photo date 04/12/19 (100\_3439.jpg).

Dilated  
Rock  
Masses

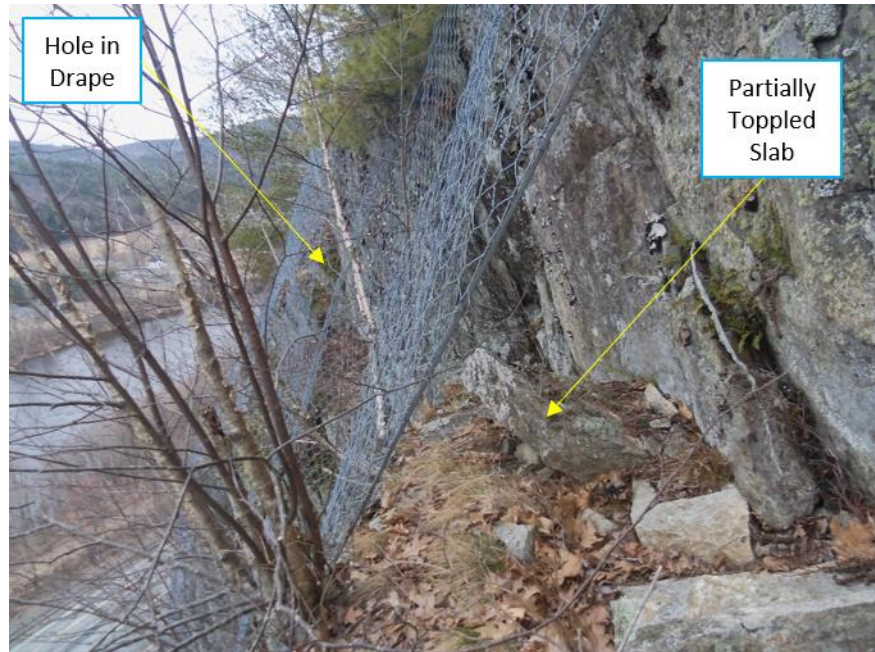
**PHOTO 21**

Rappel 10, view to south of rockfall drape below crest. Note open hole at drape mesh seam, and small, detached, partially toppled rock block. Photo date 04/12/19 (100\_3444.jpg).

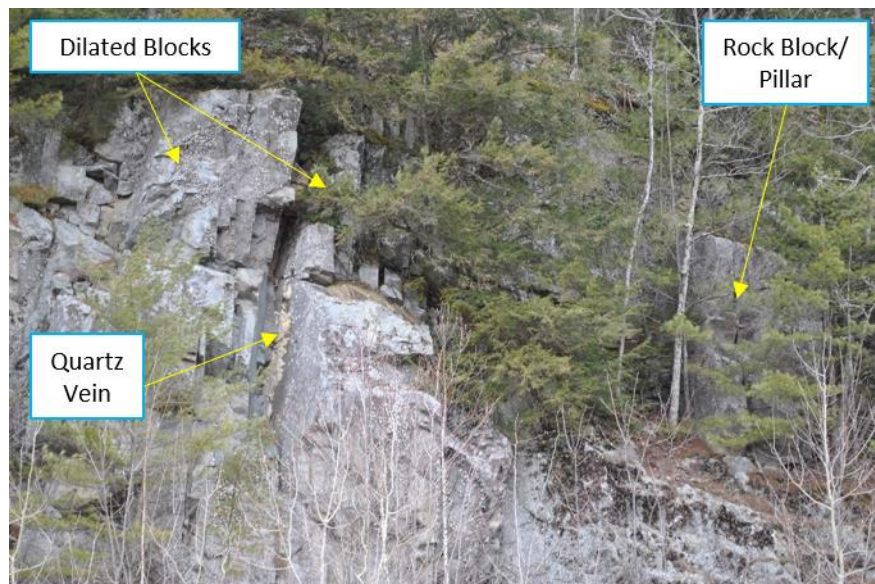
**PHOTO 22**

Dilated blocks at north end of slope bisected by near vertical quartz vein of Insets 8A and 8B of Figure 8 (left), and Rock block/pillar shown in Inset 9A of Figure 9 (right). Photo date 04/12/19 (DSC\_2892.jpg).

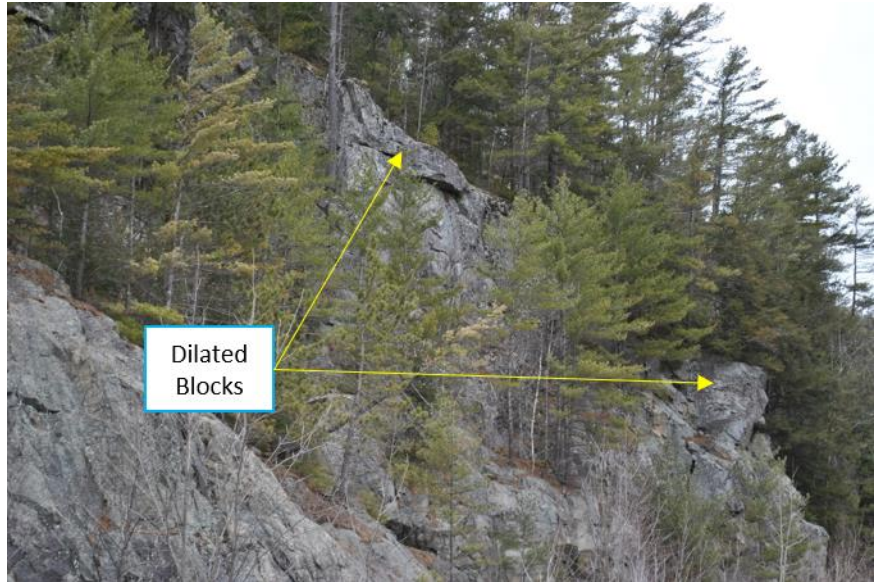
**PHOTO 23**

Dilated blocks shown in Insets 7A and 7B of Figure 7 (left), and Insets 8A and 8B of Figure 8 (right). Photo date 04/12/19 (DSC\_2908.jpg).

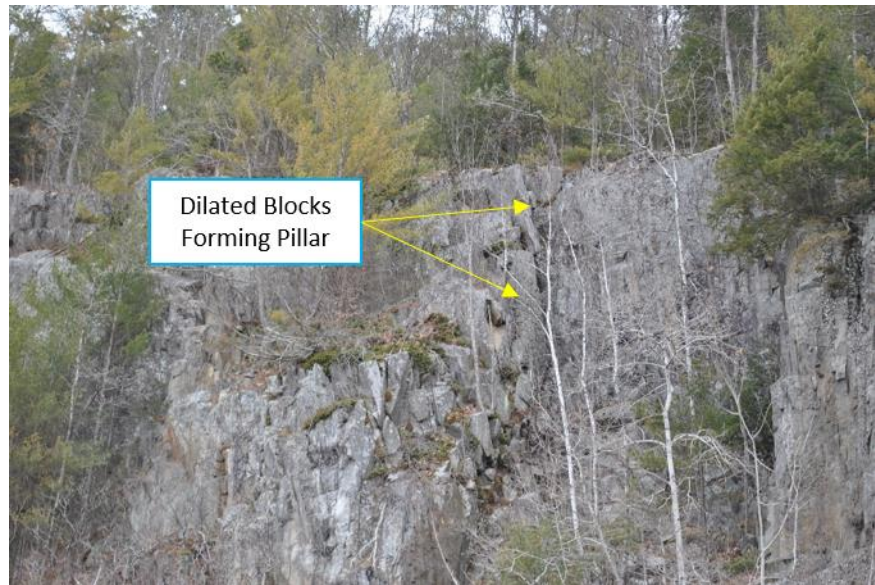
**PHOTO 25**

Dilated rock blocks forming pillar near crest of slope, as shown in Inset 5A of Figure 5. Photo date 04/12/19 (DSC\_2902.jpg).

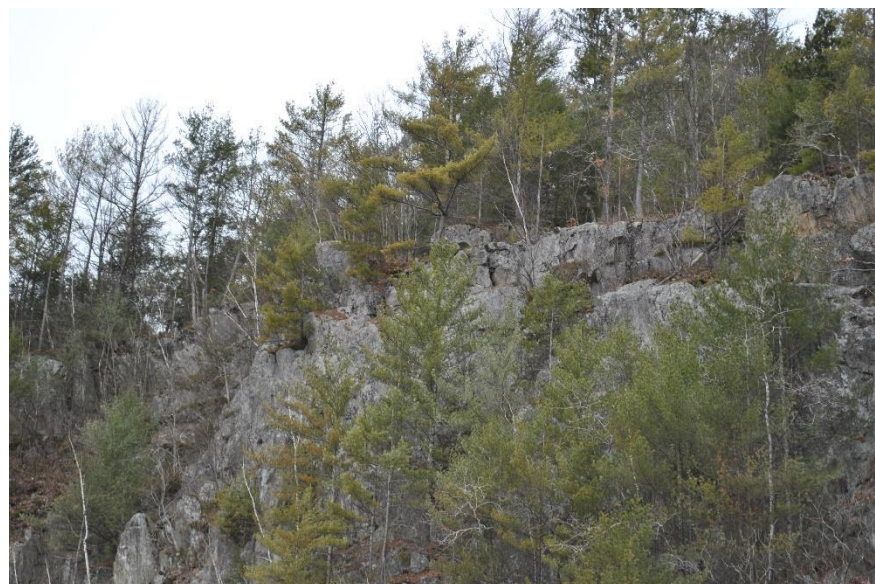
**PHOTO 26**

Dilated rock blocks at crest, as shown in Figures 3, 4 and 5. Note trees at crest on face causing root jacking of rock blocks. Photo date 04/12/19 (DSC\_2907.jpg).

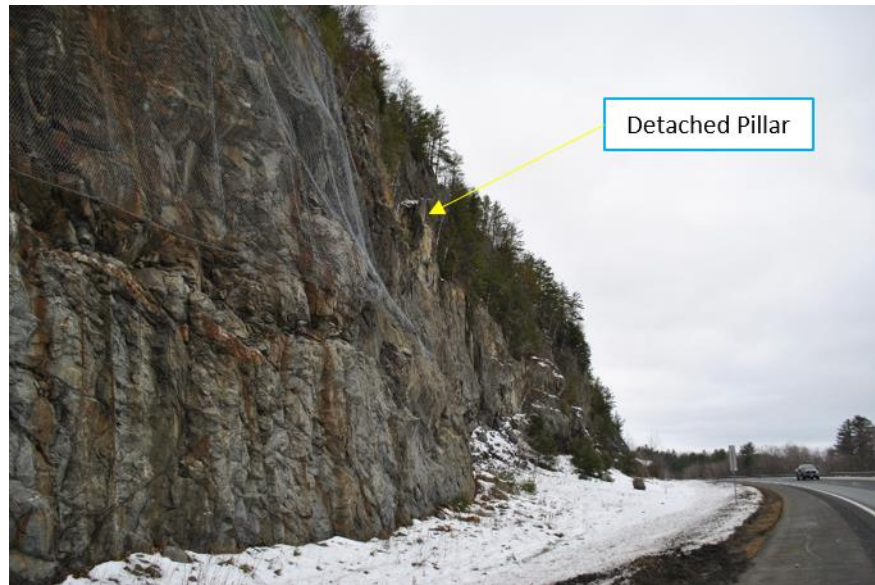
**PHOTO 27**

View to north of detached pillar and rock blocks shown in Inset 2D of Figure 2. Photo date 11/30/18 (DSC\_2373.jpg).

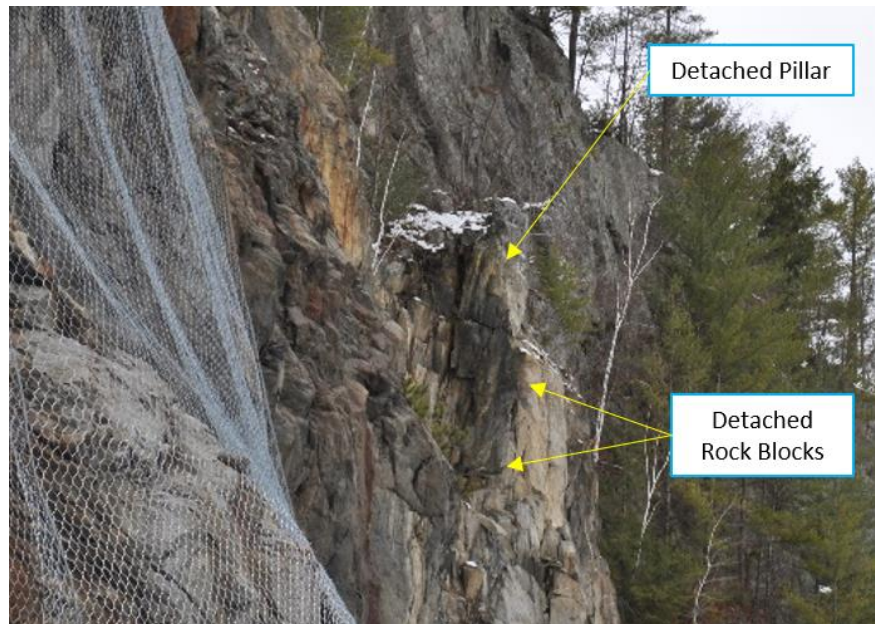
**PHOTO 28**

The heavily weathered condition of many of the slabs and blocks on the face suggest that stabilization, at least of the features with open joints greater than 1-inch, may be more complicated than scaling the rocks down (Photo 28). For some slabs, the first two joints are too dilated for rock dowels (Photo 17) and once scaled, the remaining rock may need to be secured with untensioned rock dowels.

Zoomed-in view to north of detached pillar and rock blocks shown in Photo 27 above and Figure 2. Photo date 11/30/18 (DSC\_2374.jpg).

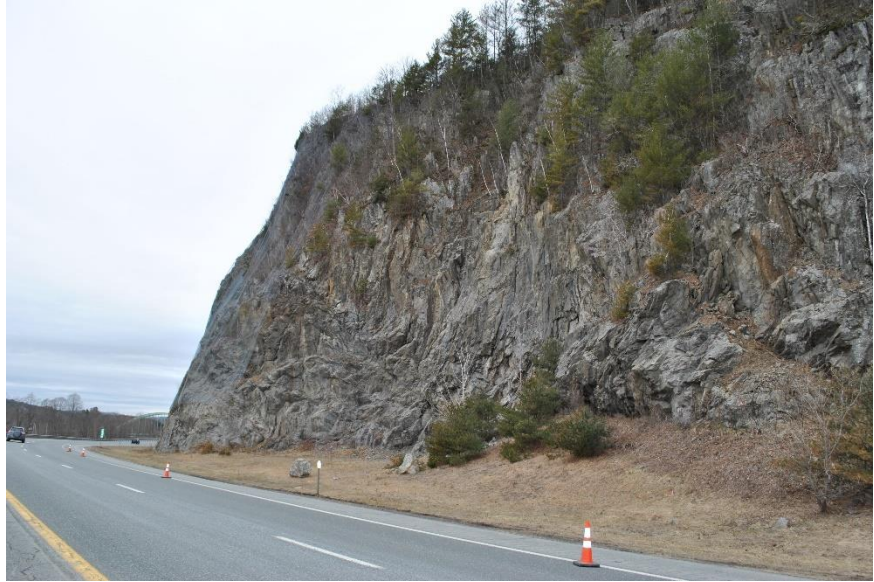
**PHOTO 29**

View to south of southern end of rock slope, showing northern extent of rockfall drape, and rockfall debris in ditch from November 2018 rockfall event. Photo date 04/12/19 (DSC\_2905.jpg).
