- **Project: Hardwick BF 037-3(8)** State Bridge Program
- Route: VT 16  $\bullet$
- Bridge: Br. 1
- **Built: 1950**  $\bullet$
- Span: 82 ft.  $\bullet$
- 6 36WF280 Rolled Beams
- 15 MC 18 x42.7 Channel Diaphragms
- Total Weight of Structural Steel: 142,000 lbs. (71 Tons)
- Total Surface Area Coated: 5300 Sq. ft.

# Field Metalizing of a Steel Beam Bridge

J. B. McCarthy, PE **Vermont Agency of Transportation – Structures Design Section**

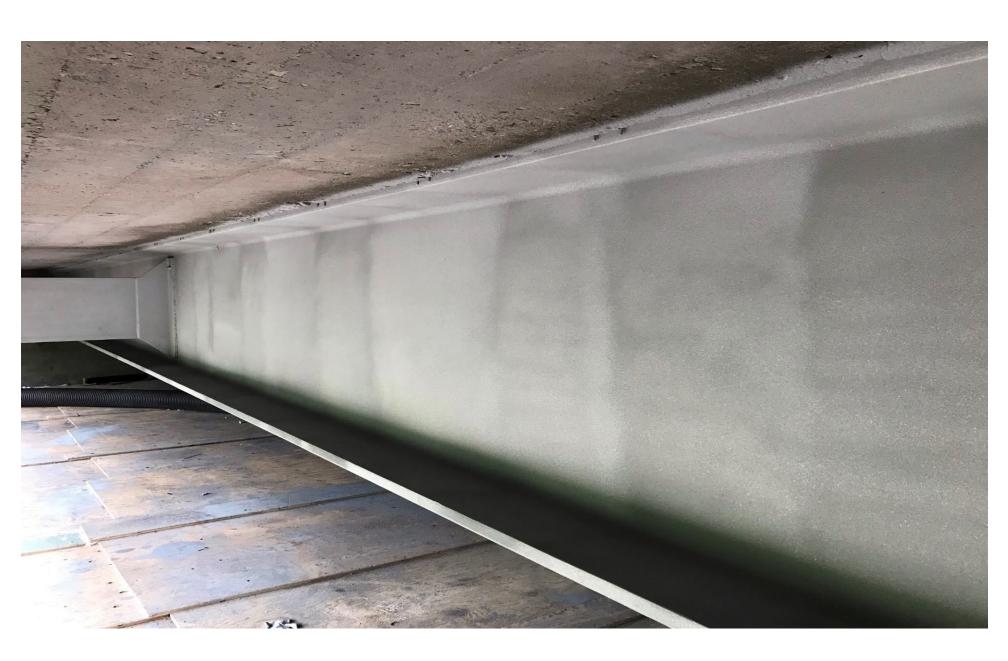
- Using a larger zinc wire 3/16" vs 1/8" would increase production.
- Humidity is a major factor during metalizing and can be difficult to control in the field.
- **Clear sealer coating over metalizing left** streaks in final appearance.
- All adhesion tests, bend tests and coating thicknesses met specifications.

# **Streaks in Metalized Coating**
