Residual Strength Assessment of a Fire-Damaged Steel I-girder from a VT-14 Bridge

Introduction

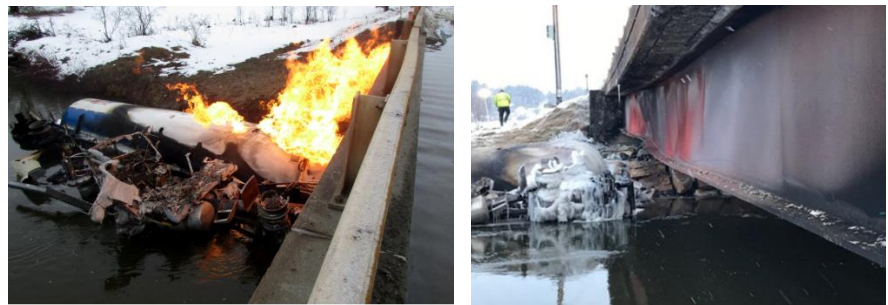
10,000-gallon liquid propane tanker off-gassing (left), subsequent damage in the steel fascia girder (right). Photos courtesy of vermontpublic.org and VTrans.

The Vermont Agency of Transportation (VTrans) decided to replace the entire bridge and abutments due to distortion of the steel, spalling of the concrete deck and integral abutments, and approximately 9 inches of deck sag near midspan of the bridge. Though the degree of damage and the difficulty to shore the bridge over a waterway to remove the camber precluded utilization of traditional repair methodologies, understanding the residual integrity of steel superstructures can inform repairs on other bridges bounded within this damage state. Also of interest is the metallurgical phase composition of the weathering steel itself, and its patina development, as the distance and relatively low combustion temperature of propane may not have dramatically affected the steel's crystalline properties.

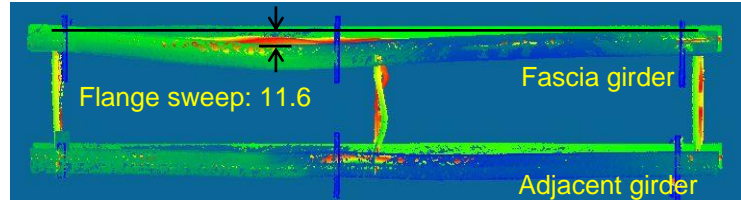
Geometric scanning revealed up to 11.6 inches of flange sweep and severe web distortion in the retained girder lines. The retention of two girder lines connected with the cross-frames was chosen to maintain representative lateral bending and warping fixity at the locations of largest damage, such that the geometry can be reasonable correlated back to an in-situ repair situation after the deck had been removed.

Rapid lidar scan of the retained 42-ft girder lines.

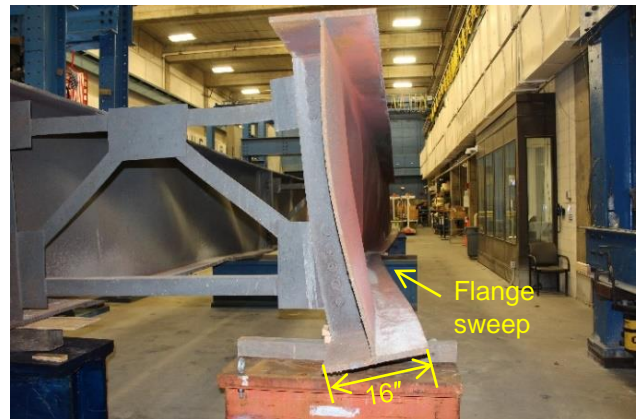
Sighting down the retained section.
