Hizb Ullah Sajid, Ph.D. and Ryan Slein, Ph.D.
Structures Laboratory, Turner-Fairbank Highway Research Center, McLean, VA.

Irasburg Bridge Fire Accident – December 2023

Residual Strength Assessment of the Bridge Steel Girder

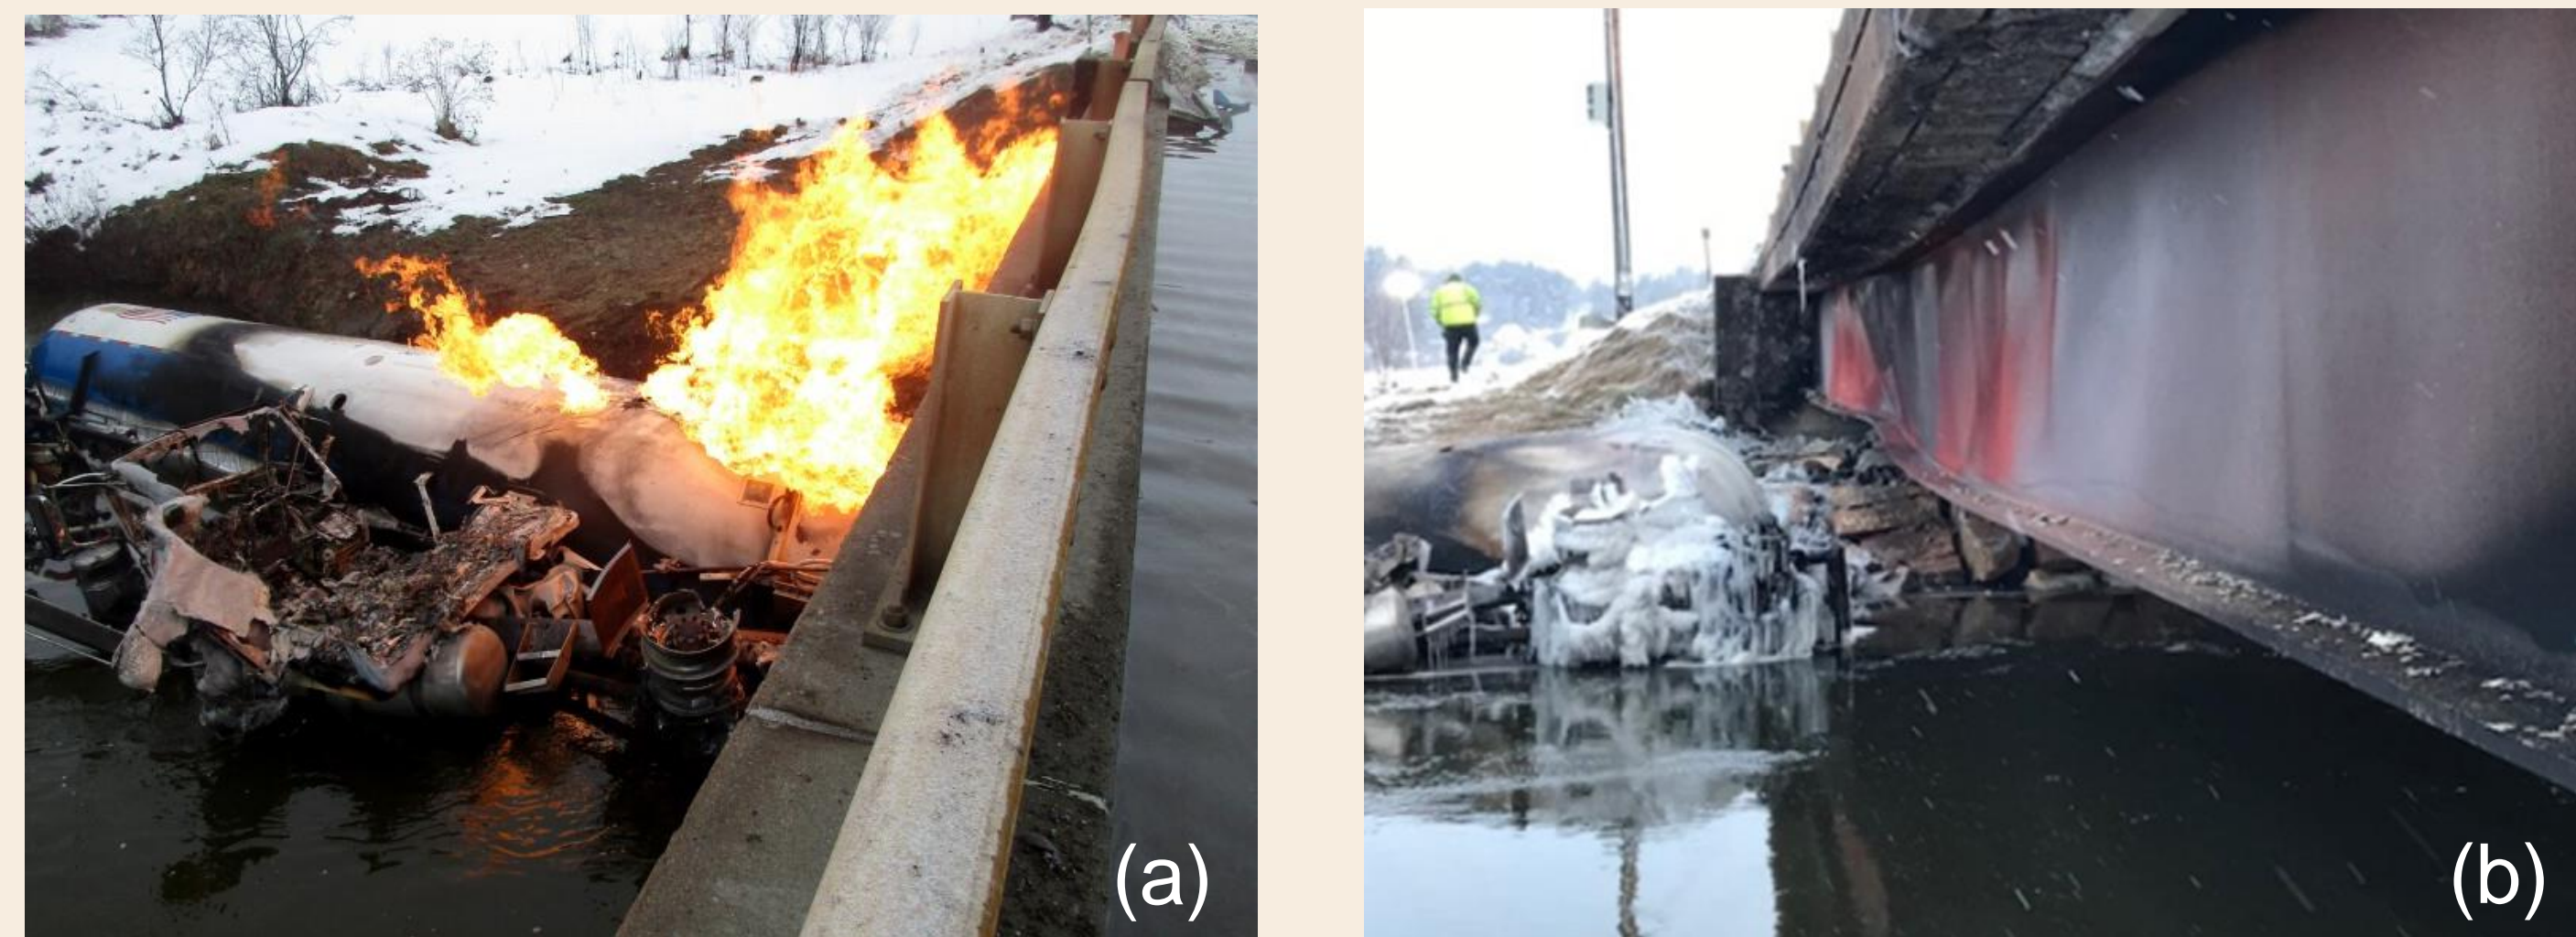
- On December 4, 2023, a propane tanker crashed in Irasburg, VT, resulting in a fireball that burned for 36-hrs several feet from a VT-14 bridge.
- The fire caused extensive damage in the exterior bridge girders and VTrans determined to replace the bridge after evaluating the postfire condition.

Figure 1. Photos of (a) Bridge VT 129 during fire, and (b) after fire extinguishing.

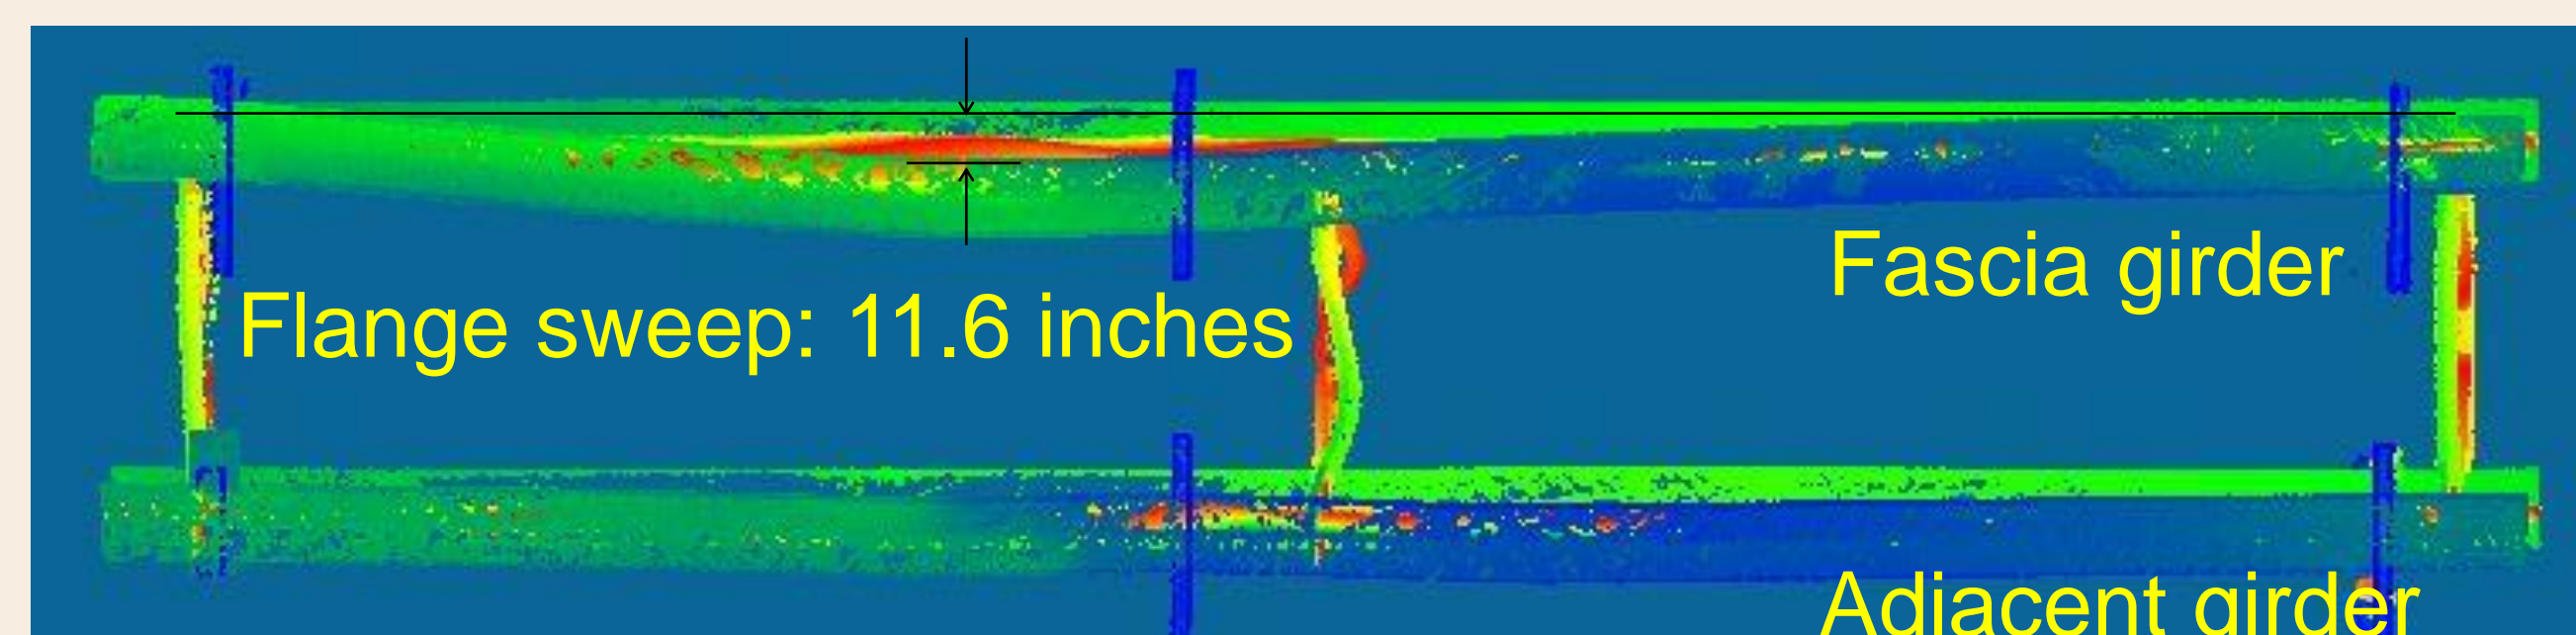
Geometric laser scan: Rapid lidar scan revealed 11.6 inches flange sweep in fire-exposed girder.

Figure 3. Rapid lidar scan of the 42-ft girder line depicting distortions.

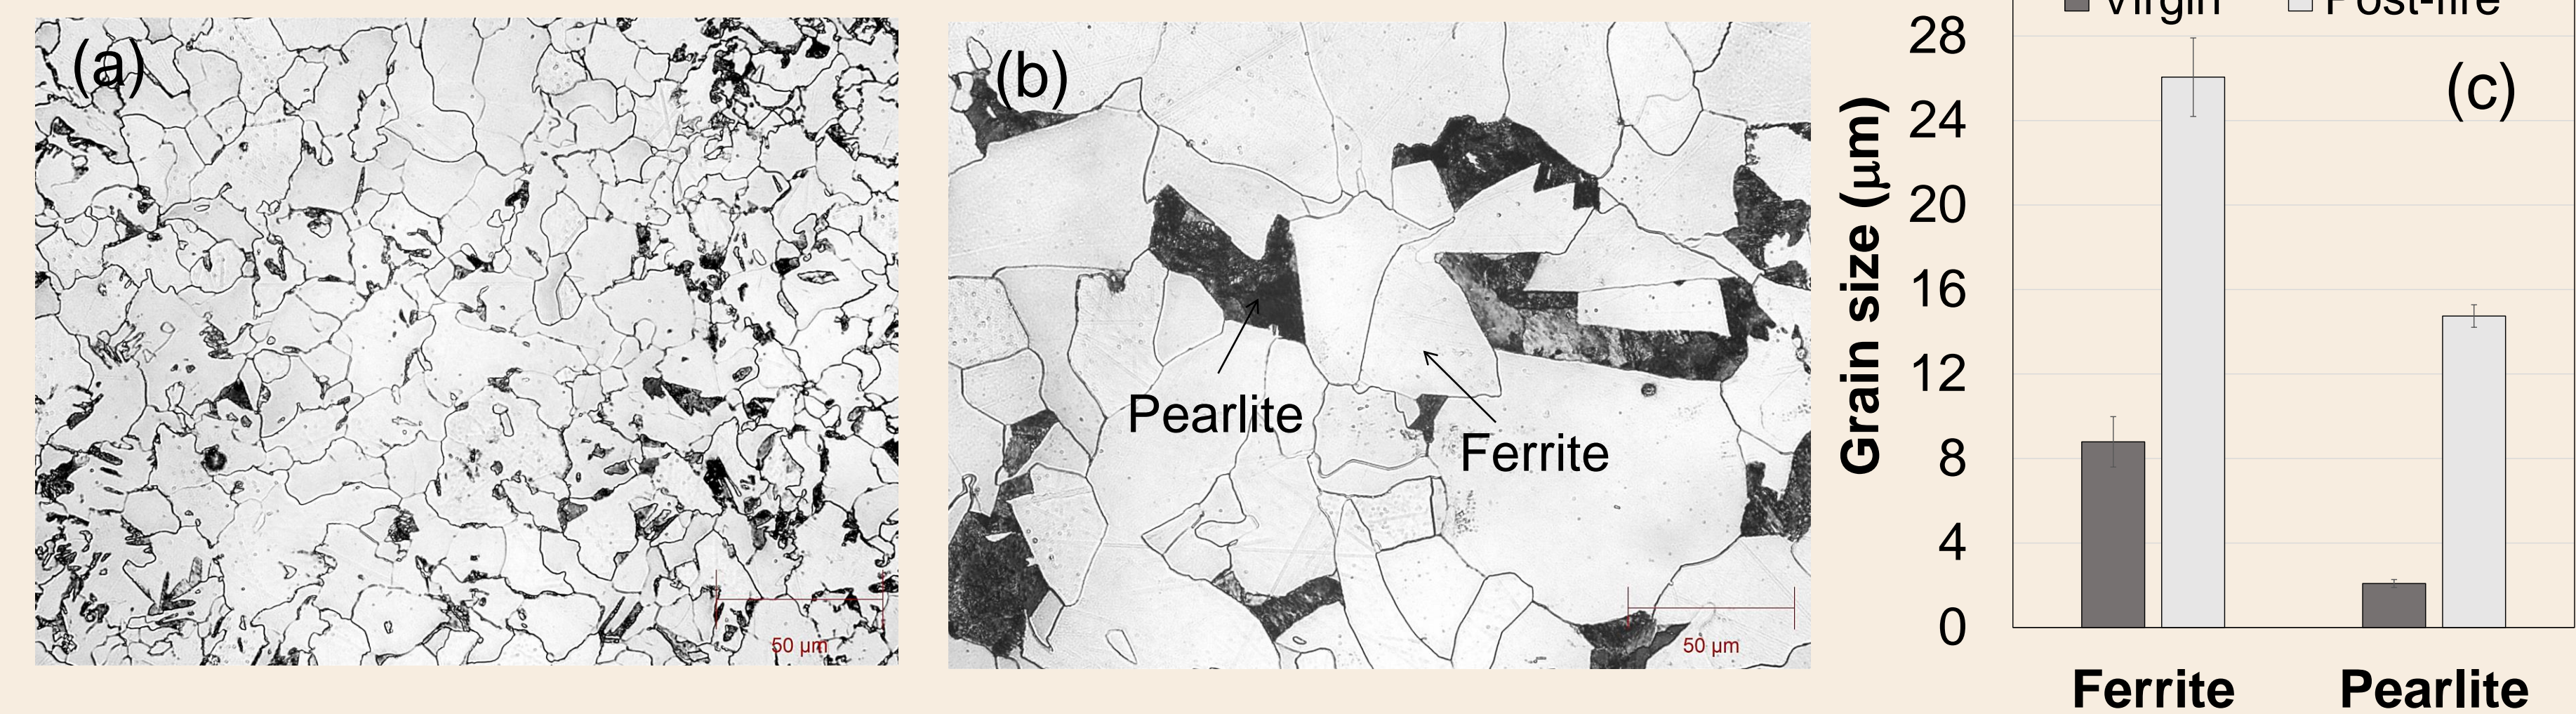
Metallographic analysis: Prolonged fire exposure caused significant grain recrystallization, though the crystalline structure remained ferrite and pearlite dominant post-fire.

Figure 4. Microstructure of (a) virgin steel and (b) post-fire steel, and (c) grain sizes.

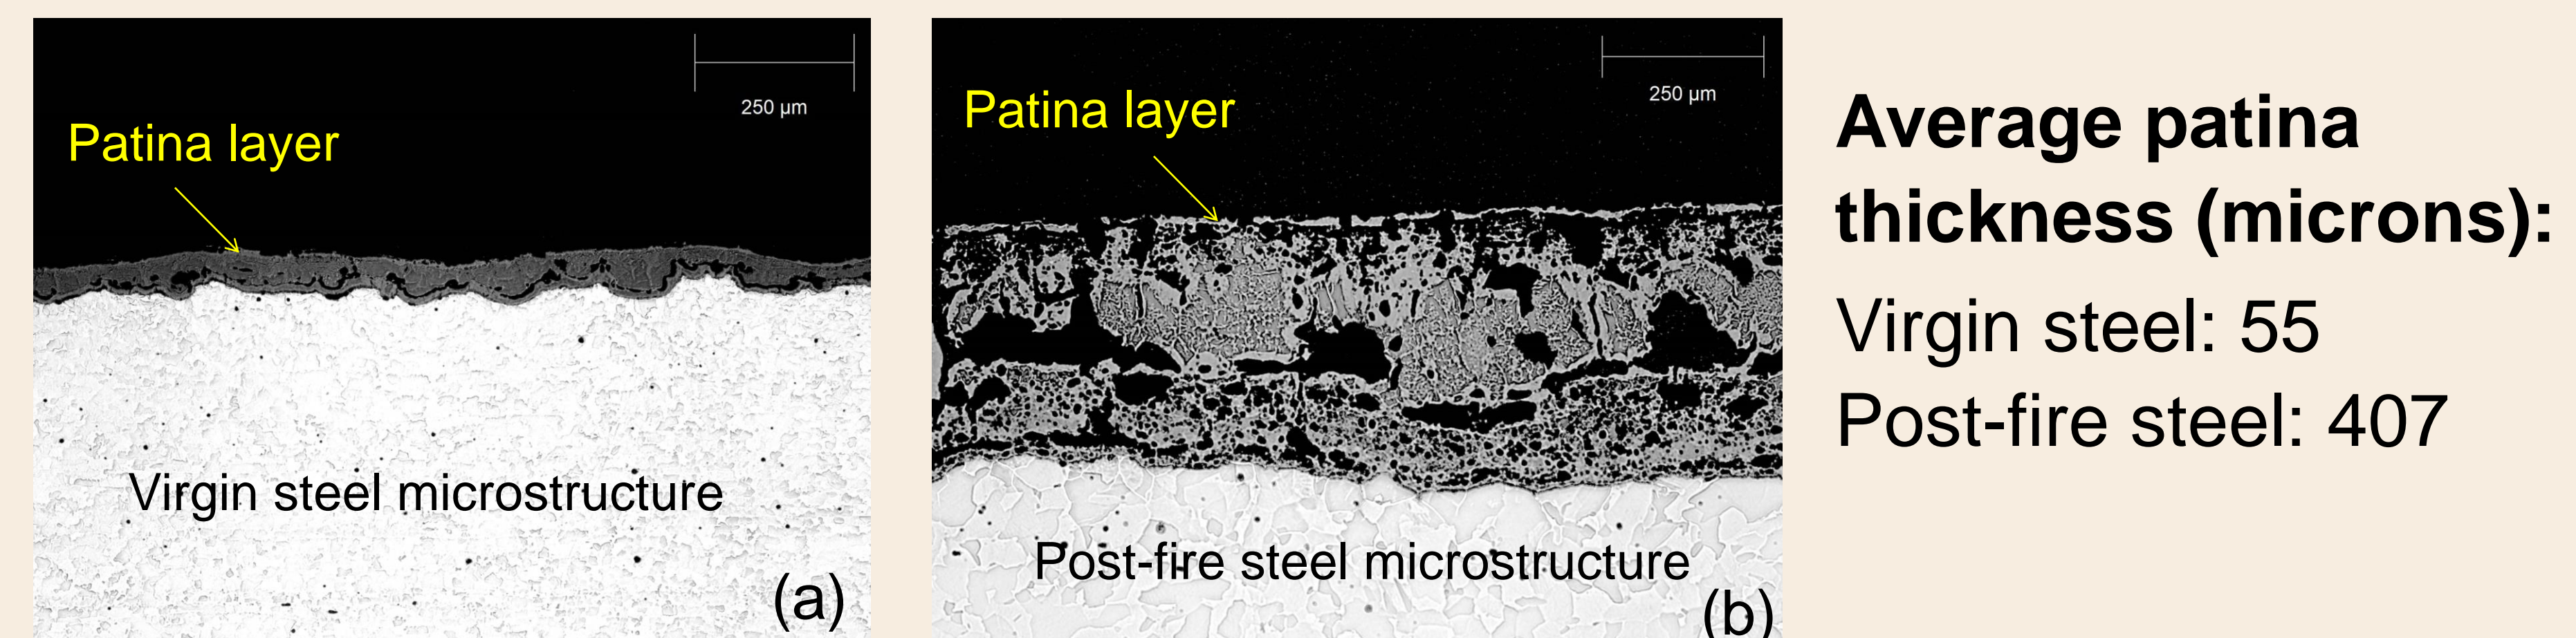
Patina characterization: Formation of significantly thicker oxide layer (almost 8 times the thickness of virgin steel patina) on the fire-exposed surface.

Figure 5. Patina layer in (a) virgin steel, and (b) post-fire steel.

Average patina thickness (microns):
Virgin steel: 55
Post-fire steel: 407
