U.S. Department of Transportation
Federal Highway Administration

Turner-Fairbank
Highway Research Center

Residual Strength Assessment of a Fire-Damaged Steel I-girder from VT-14

Vermont Research and Innovation Symposium, September 25, 2024

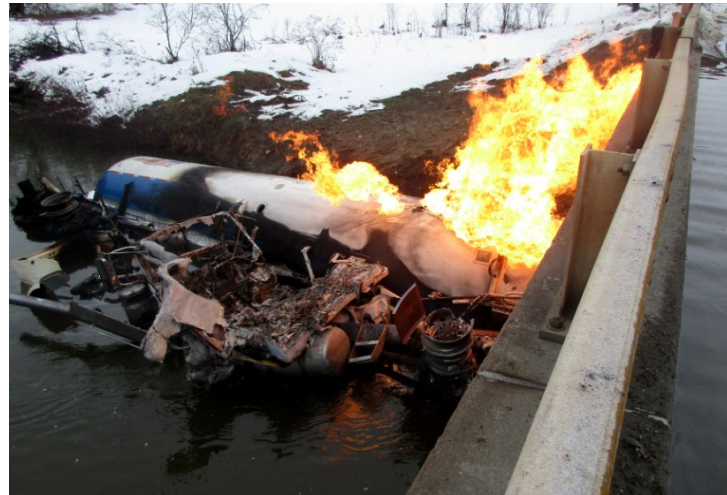
Fig. Bridge-129 during fire.

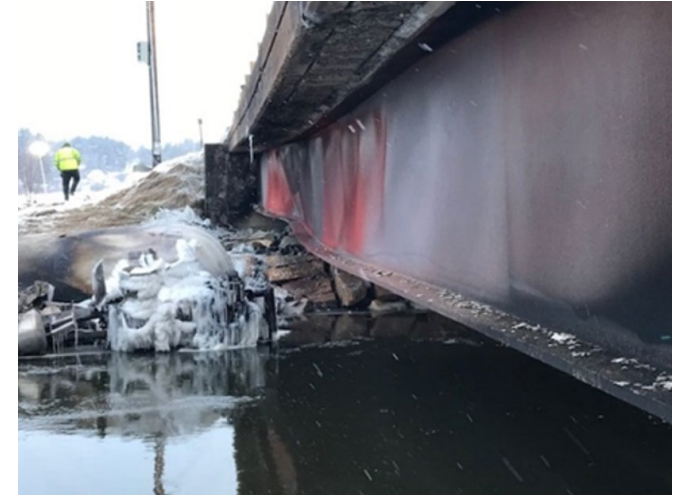
- On December 4, 2023, a **propane tanker** crashed in Irasburg, VT, resulting in a fireball that burned for 36-hrs several feet from a VT-14 bridge.
- The fire caused **significant distortions** in the exterior steel girder, and deck sag.
- VTrans decided to **replace** the bridge abutments due to **extensive damage**.

Fig. Bridge-129 after fire.

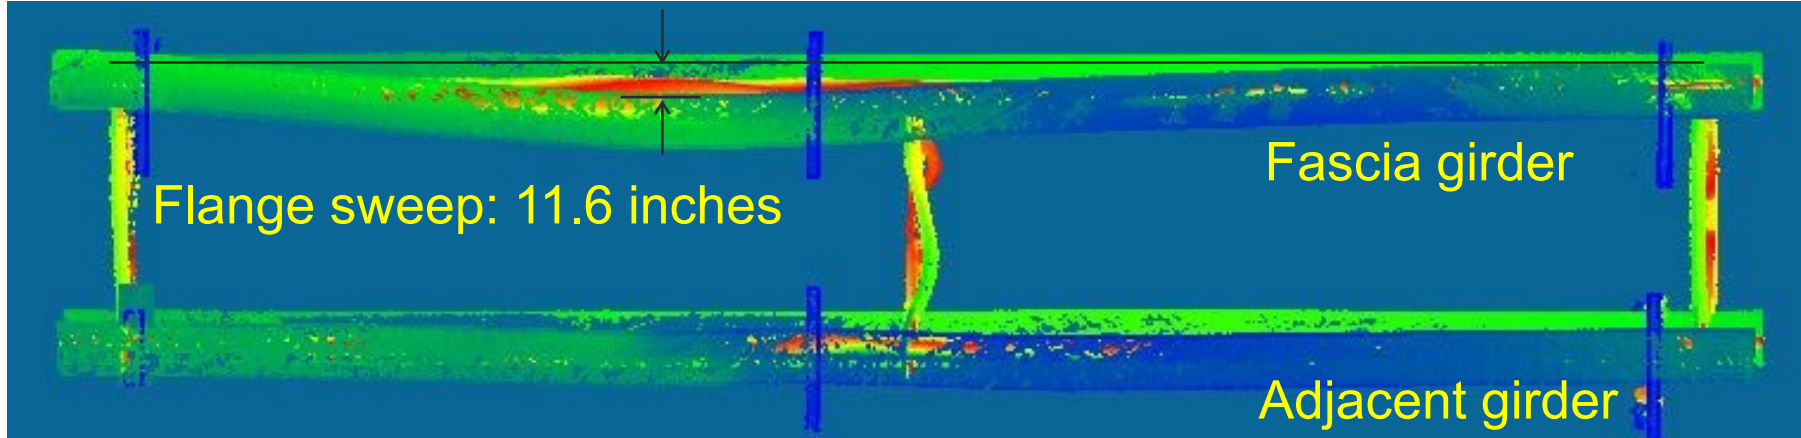
Fig. Rapid lidar scan of the 42-ft girder line depicting distortions.

- Prolonged fire exposure caused approximately 11.6 inches flange sweep.
- Fire exposure resulted in nearly a 3 times increase in the steel ferrite and pearlite grain size. However, no metallurgical phase change occurred.
- The uncoated weathering steel's protective patina layer increased in thickness up to 8 times its normal thickness during the fire.

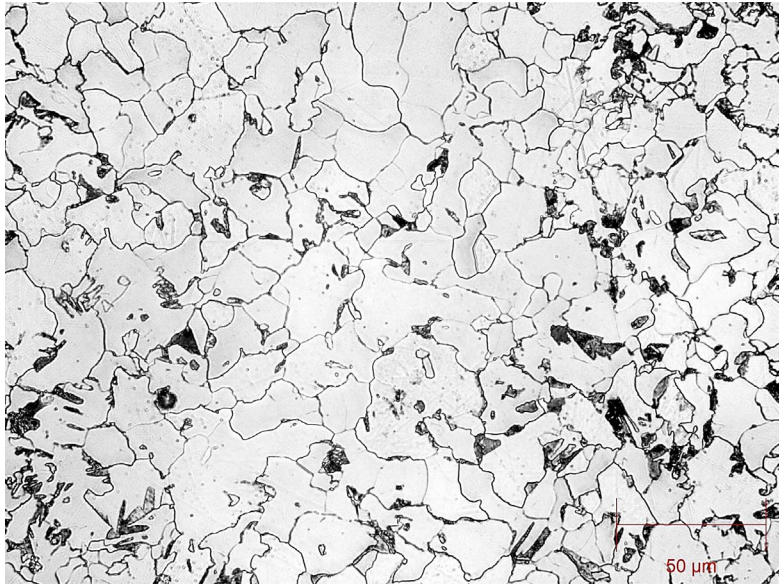
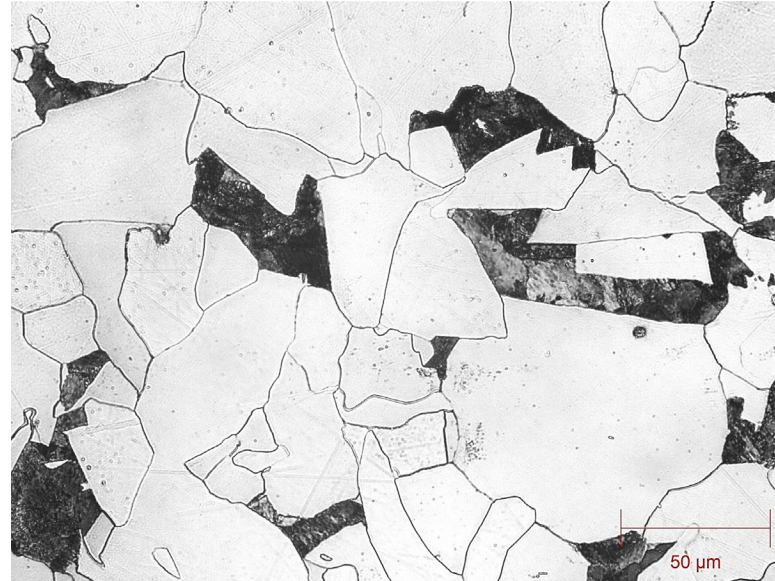
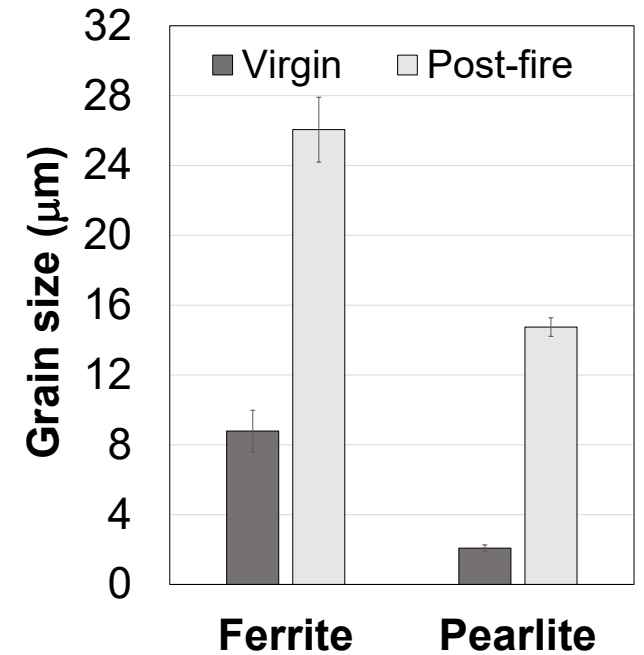
Fig. Microstructure of virgin and post-fire girder steel.

Fig. Grain sizes in virgin and post-fire girder steel.

- Significant grain enlargement in fire-affected steel.
- The fire exposure did not cause any metallurgical phases changes in steel.

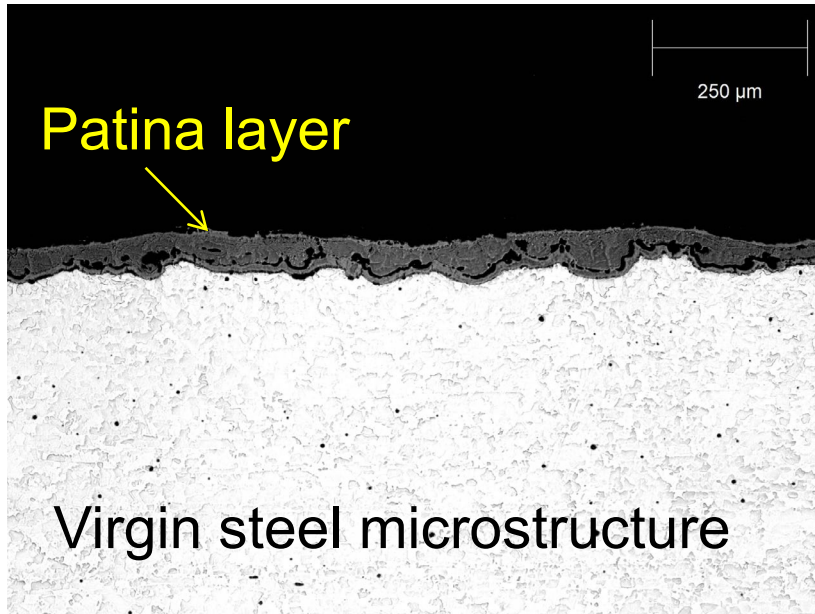
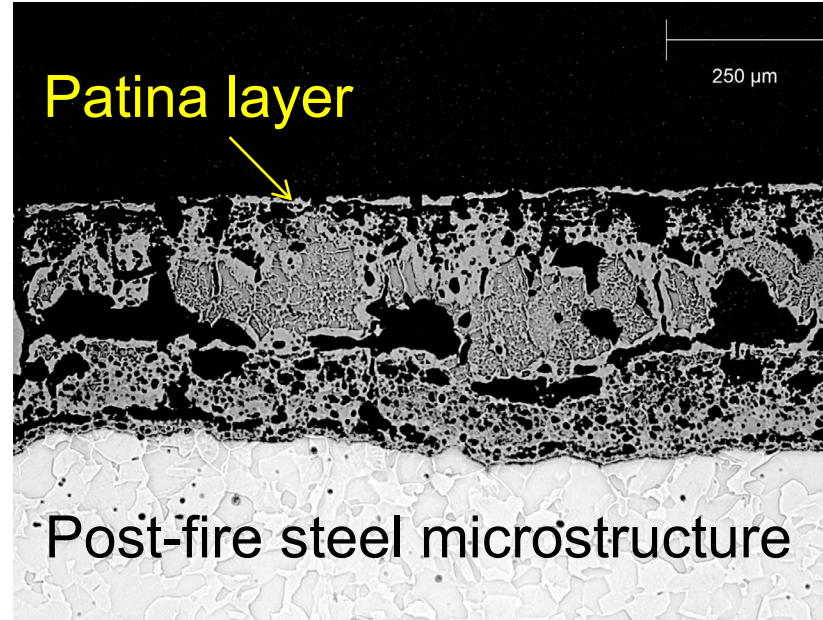
Average patina thickness (microns):

Virgin steel: 55

Post-fire steel: 407

Fig. Cross-section of patina layer in virgin and fire-affected steel.

- Fire caused significant increase in the patina layer thickness.
- Patina layer chemistry is being currently being evaluated.
