Contractor	Hartigan Company
Responsible:	Michael Melanson
Department:	
Street:	31 Welch Park Dr.
City:	Middlesex
Telephone:	800-696-0761
Fax:	hartigancompany.com
Mobile:	802-585-9916
E-Mail:	hartigancompany.com

Pipe Segment Refere...	City VILLAGE OF WATERBUR...	Street ELM ST	Material POLYVINYL CHLORIDE	Location C...	Pipe Use SANITARY S...
Upstream MH 55	Total Length	Year Constructed	Shape CIRCULAR	Location Details	
Downstream MH 54	Length surveyed 230	Year Renewed	Height 15	Width 15	Pipe Joint...
SPR 2	MPR 8	PO Number		Customer	
SPRI 2	MPRI 2	Work Order Number		Purpose	
QSR 2100	QMR 2400			ROUTINE ASSESSMENT	
OPR 10	Surveyed By EEM	Direction UPSTREAM	Date 20170517	Media label	
OPRI 2	Certificate Number U-1016-07005746	Pre-Cleaning LIGHT CLEANING	Time 08:11	Weather DRY - NO P...	
Date Cleaned			End Time 08:30	Additional Info

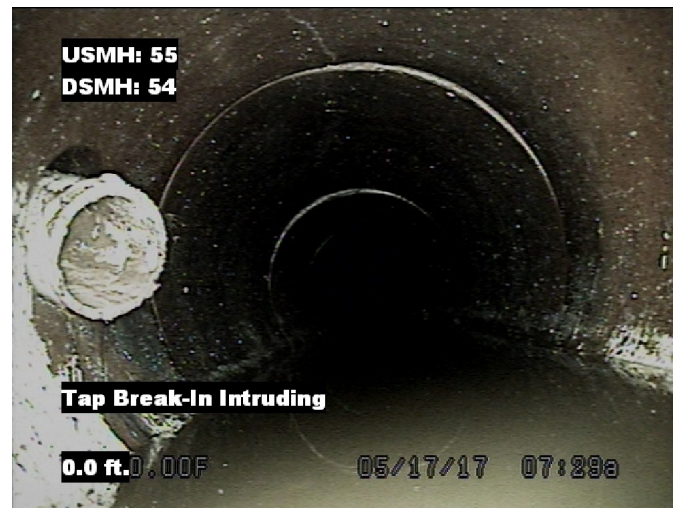
Distance: 2.0 ft. Grade: 2
 Condition: Tap Break-In Intruding
 Remarks: N/A

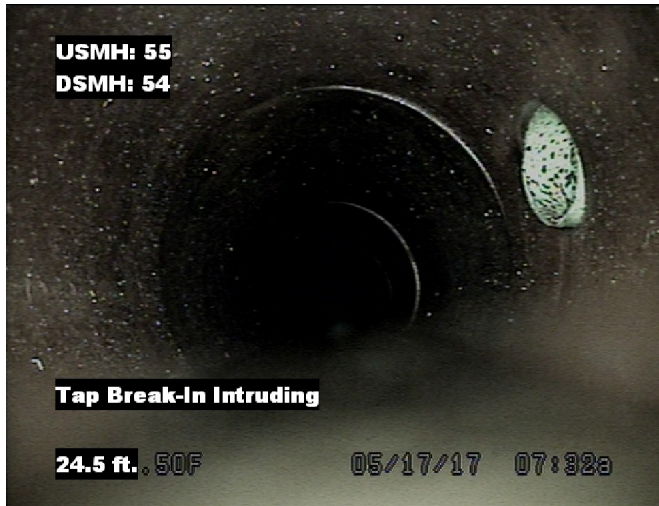
Distance: 26.0 ft. Grade: 2
 Condition: Tap Break-In Intruding
 Remarks: N/A

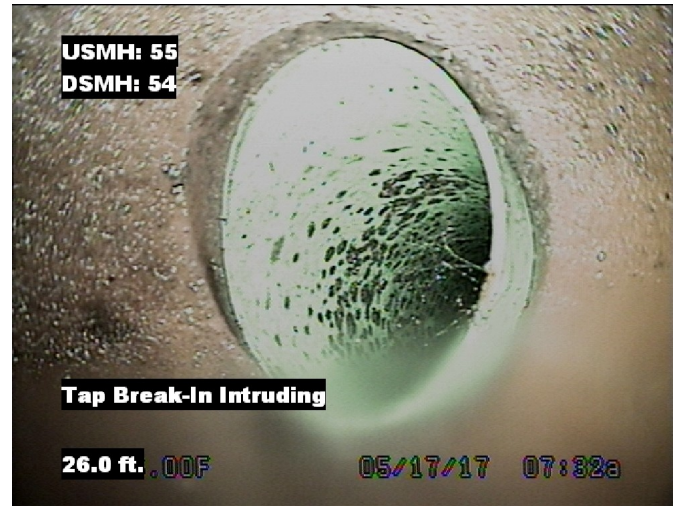
Distance: 26.0 ft. Grade: 2
 Condition: Tap Break-In Intruding
 Remarks: N/A

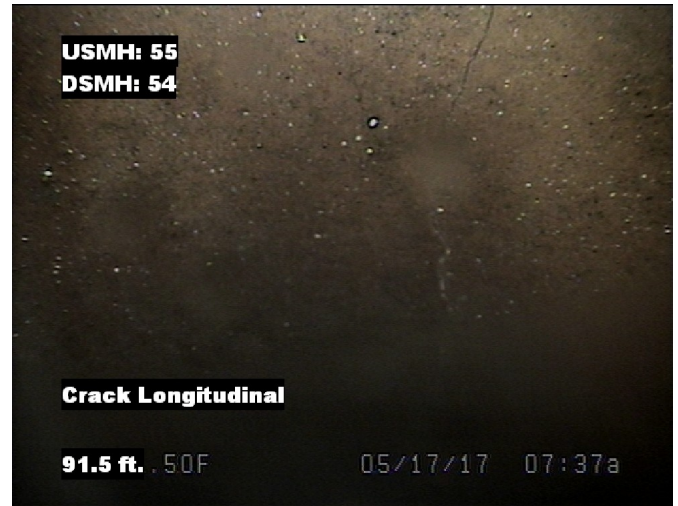
Distance: 91.5 ft. Grade: 2
 Condition: Crack Longitudinal
 Remarks: N/A

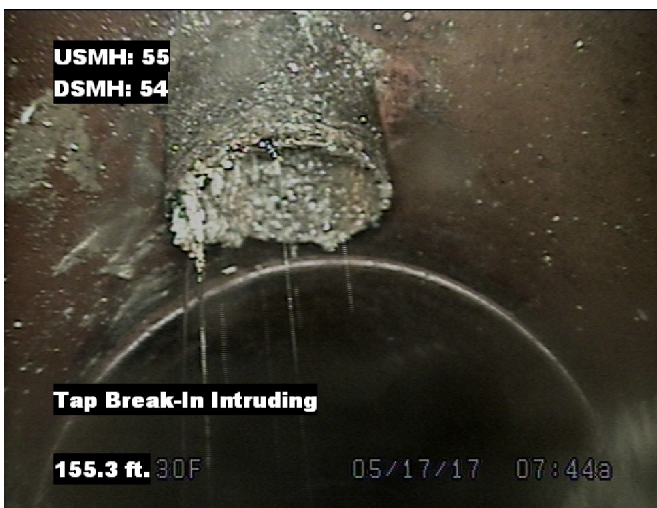
Distance: 155.3 ft. Grade: 2
 Condition: Tap Break-In Intruding
 Remarks: N/A

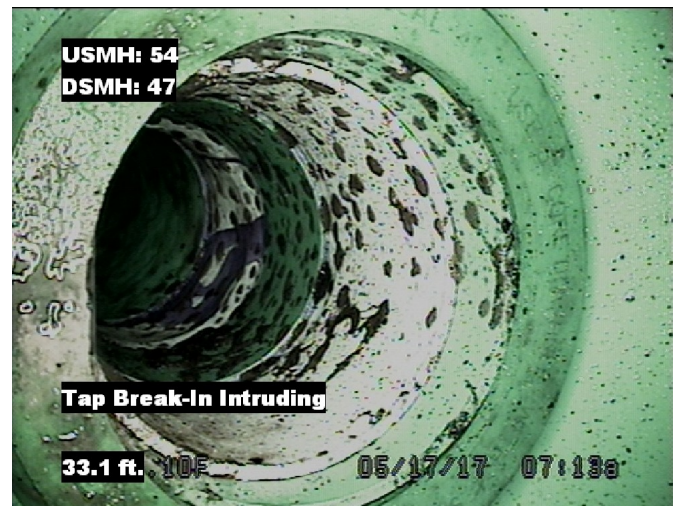
Distance: 33.1 ft. Grade: 2
 Condition: Tap Break-In Intruding
 Remarks: N/A

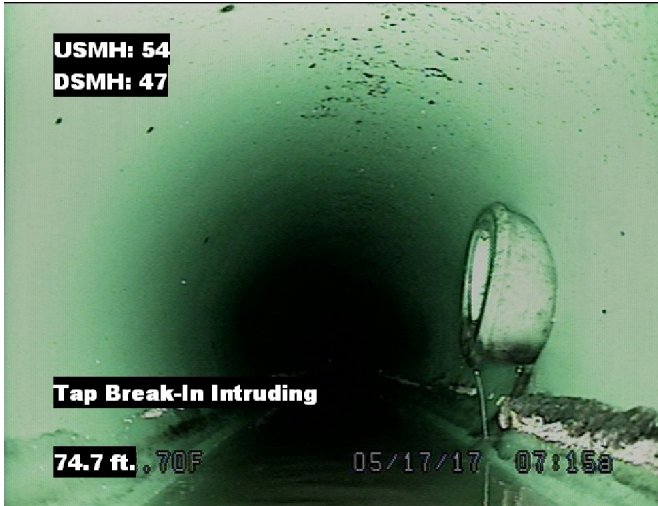
Distance: 76.2 ft. Grade: 2
 Condition: Tap Break-In Intruding
 Remarks: N/A

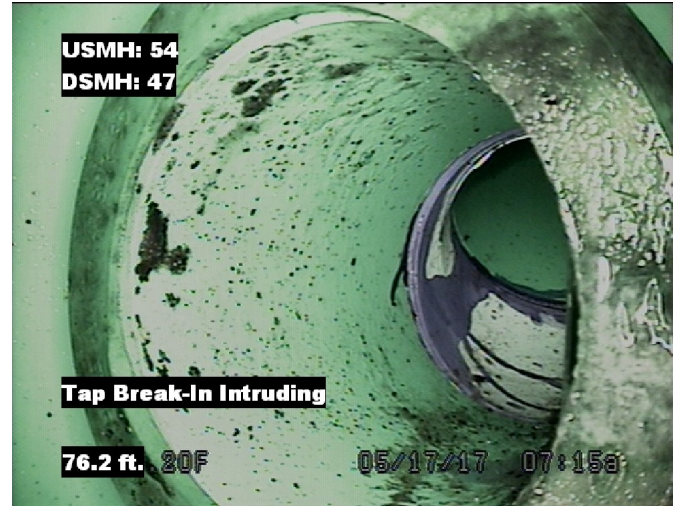
Distance: 76.2 ft. Grade: 2
 Condition: Tap Break-In Intruding
 Remarks: N/A

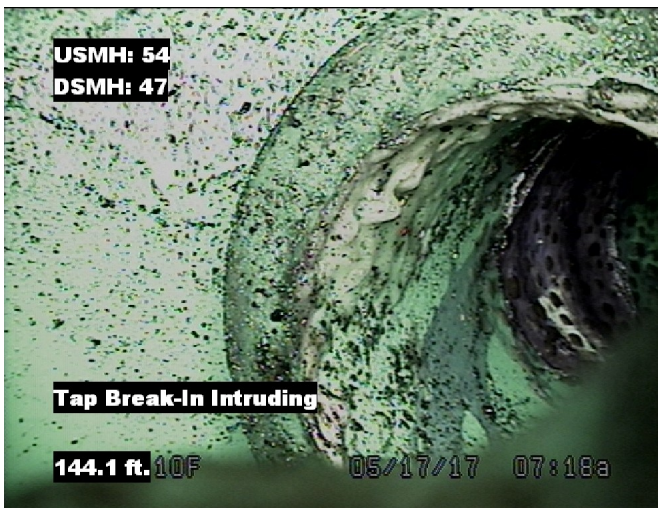
Distance: 144.1 ft. Grade: 2
 Condition: Tap Break-In Intruding
 Remarks: N/A

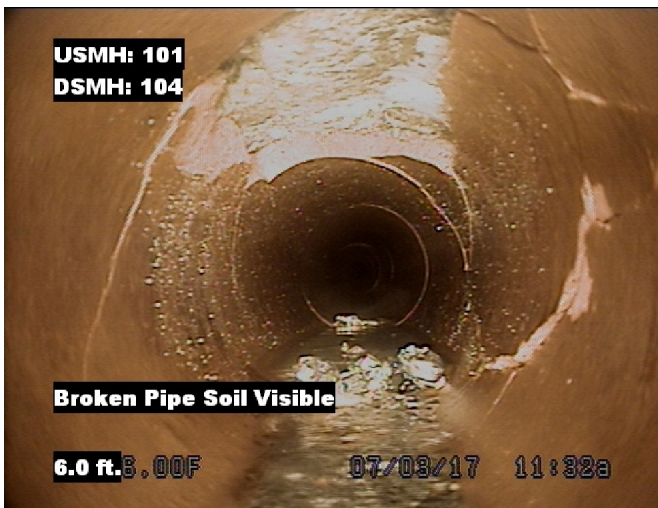
Distance: 6.0 ft. Grade: 5
 Condition: Broken Pipe Soil Visible
 Remarks: N/A

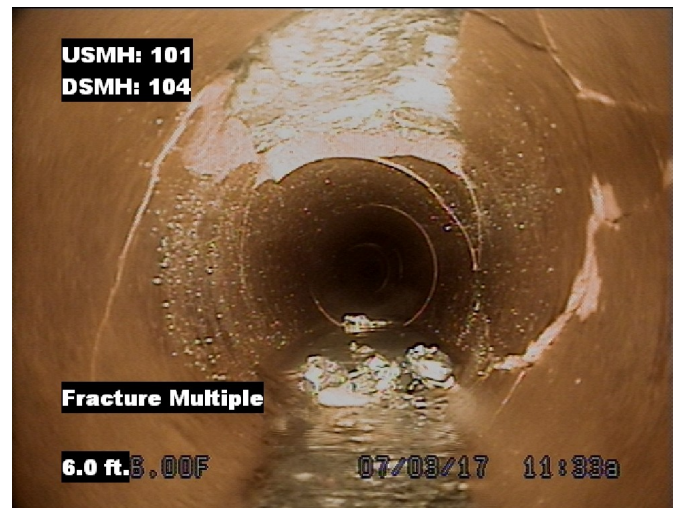
Distance: 6.0 ft. Grade: 4
 Condition: Fracture Multiple
 Remarks: N/A

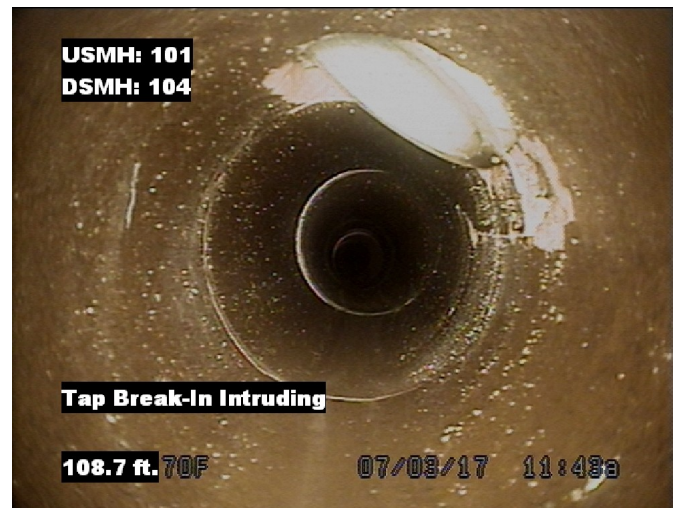
Distance: 109.8 ft. Grade: 2
 Condition: Tap Break-In Intruding
 Remarks: N/A

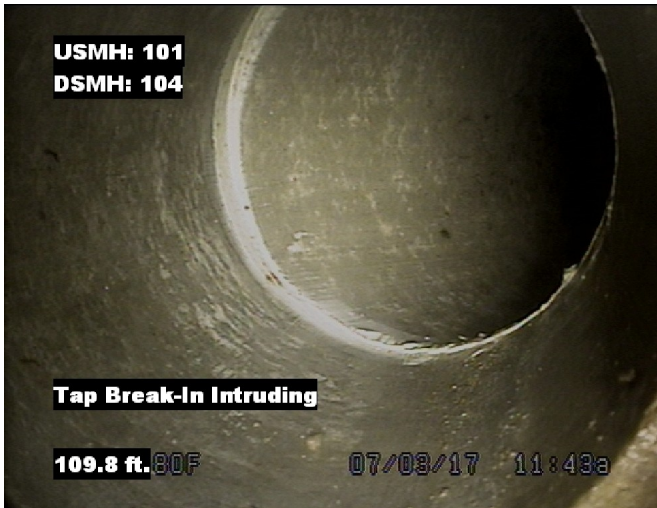
Distance: 109.8 ft. Grade: 2
 Condition: Tap Break-In Intruding
 Remarks: N/A

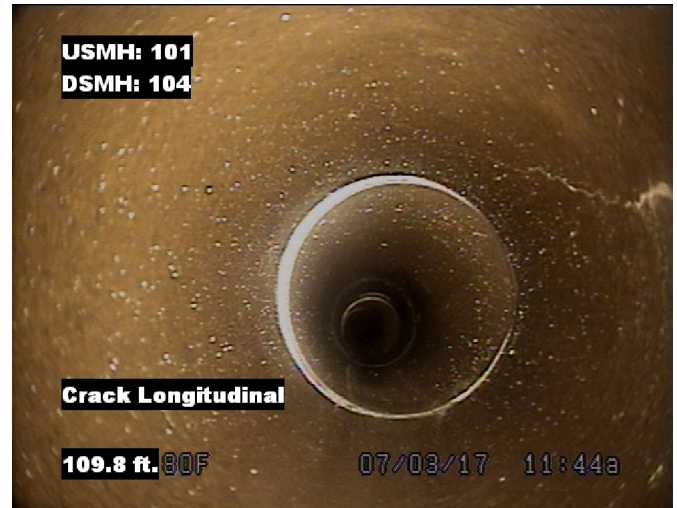
Distance: 109.8 ft. Grade: 2
 Condition: Crack Longitudinal
 Remarks: N/A
