**AN EVALUATION OF BRIFEN WIRE ROPE
SAFETY FENCE**

Report 2013 – 06

Final Report

Follow Up to Initial Report U2006-4

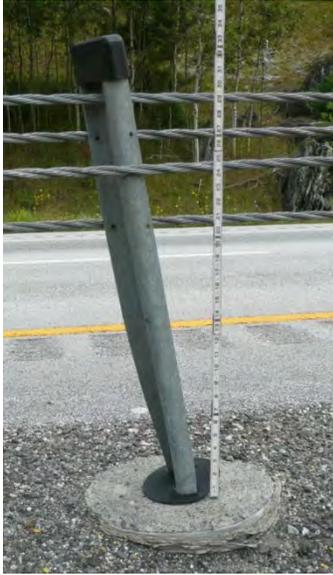
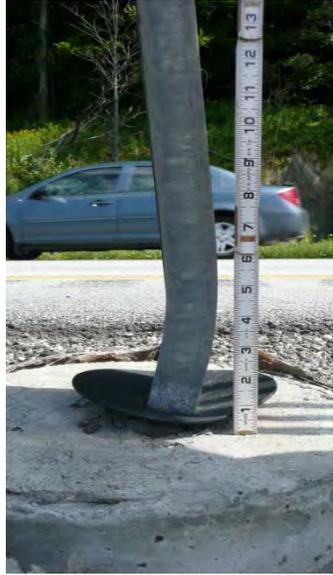
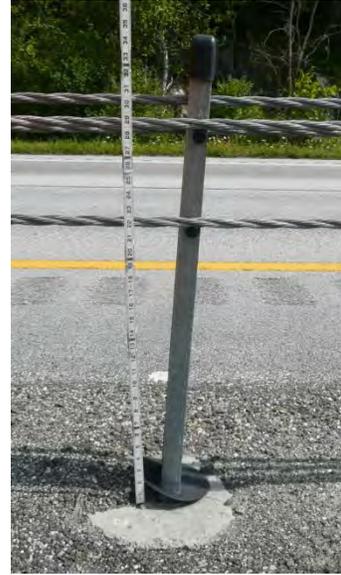
Figure 4

During an inspection on August 25, 2008, it was noted that eight of the posts were leaning, twisted, or bent. It appeared that an impact or some kind of torque and tension caused the force/damage to the posts. Some of the wires appeared to be not as tight as other sections on the fence. This might have been caused from the previously mentioned posts that are under torque and are twisting and bending from the force. These defects are illustrated in Figure 4, Figure 5 and Figure 6, which are all examples of posts in tension.

Through site observations it appears that the safety fence is faring considerably well, however the posts under torque is causing concern of how well the fence will continue to work when vehicles make contact with it. The excluder caps, post caps, and locator pegs should be replaced with a more durable material due to excessive cracking and breaking. This fence might not be an ideal choice for Vermont due to the inclement weather and the involved tasks of repairing the fence after accidents. Operations have stated that the repair process is quite extensive, especially in winter months. (4) Shown in Table 2 above, although half as many posts needed replacement over the course of the evaluation the labor costs in the winter months were far more expensive due to the increased effort of extracting the damaged post and replacing and setting the new posts, and tensioning the fence due to cold, inclement temperatures. Labor costs during the winter months, totaled \$2394.34 and during the summer months, totaled \$2099.54. It was reported that 24 posts were replaced during winter months at \$99.76 per post. The cost per post during the summer months was \$42.85. The post replacement costs in the summer months proved less than half of what post replacement costs were during wintertime.

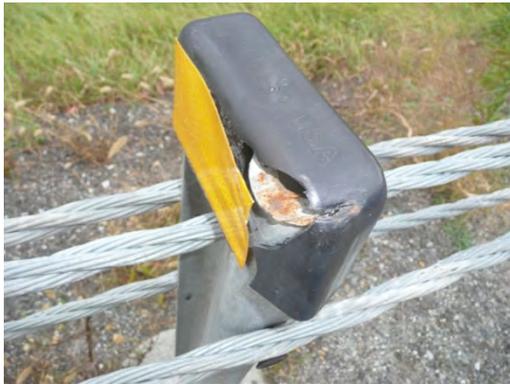
During an inspection on September 30, 2009, it was noted that the post caps and excluders did not appear to be very durable. Many of the caps were cracked, broken, or missing (Figure 7). Many of the excluders were broken. The damage was assumed to be caused by snowplow damage. Almost all excluders were allowing debris and water to build up inside the base (Figure 8). This is a cause of concern due to freeze/thaw and repairing the posts in the winter months. (2)

Figure 7: Cracked post cap

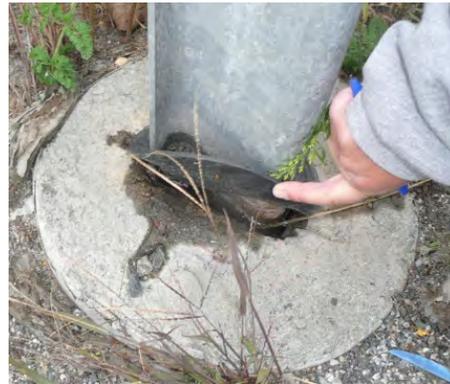
Figure 8: Debris and water build-up in and around the posts

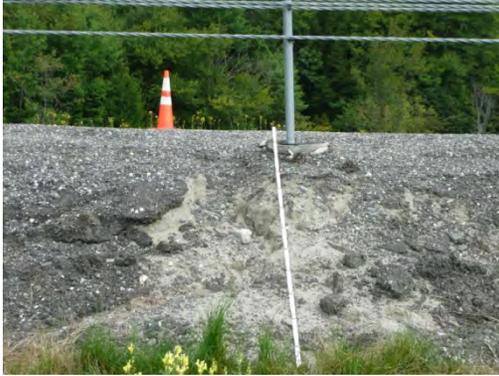
Upon inspection of the Brifen Wire Rope Safety Fence on Monday, August 25, 2008, a considerable amount of erosion was noted. Erosion was evident along the bank of the northbound passing lane, and around the concrete anchors for fence posts, shown in Figure 9 and Figure 10. (4)

Figure 9: Erosion of the bank - median side

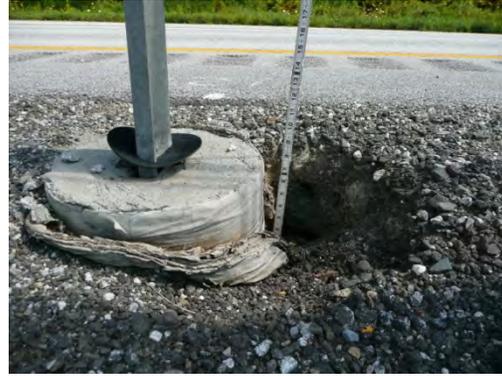
Figure 10: Erosion around the post foundation
