VERMONT AGENCY OF TRANSPORTATION

**Materials & Research Section
Research Report**

**ENNIS PAINT, INC. TYREGRIP HIGH FRICTION
SURFACE SYSTEM**

Report 2014 – 02

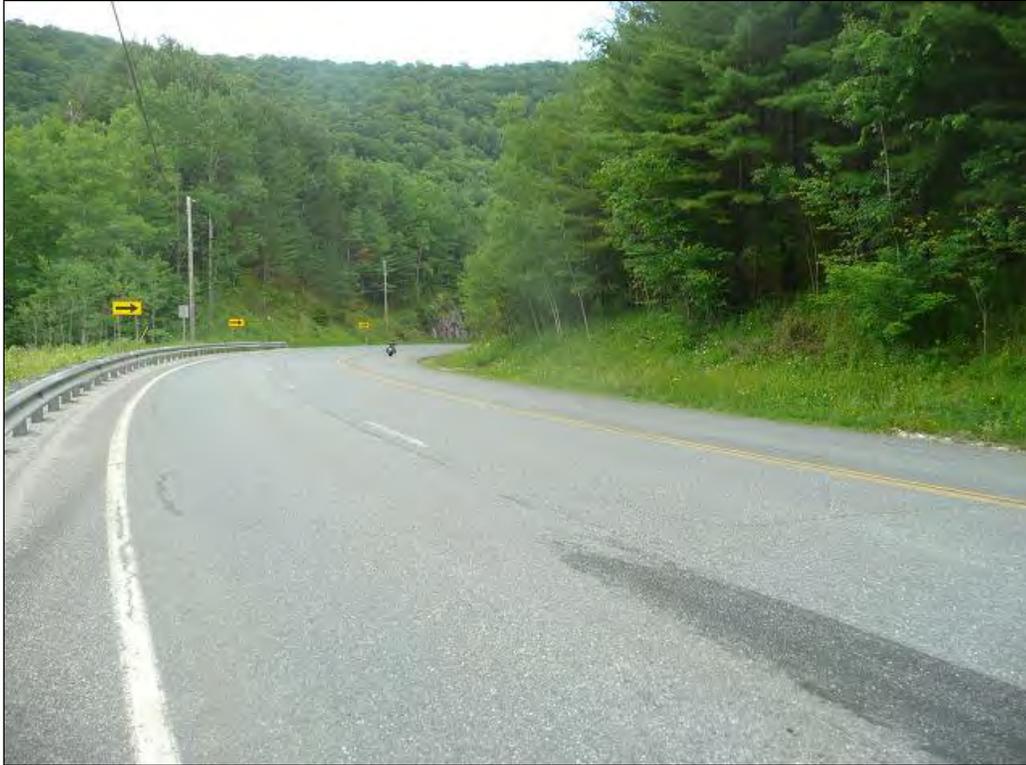
Figure 1 Overview of the site pre-construction

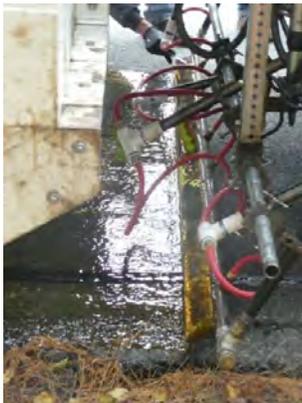
The application process shown in Figure 2 and Figure 3 began at 10:49 am at which time, the pavement temperature was 51°F and the air temperature was 52°F. The operation was halted by the contractor after laying 60 feet down. The epoxy did not appear to be curing correctly and the truck did not appear to be moving smoothly and at the necessary slow speed required for the application, presumably due to the steep grade of the hill. At this time, the contractor cleaned and changed several distribution hoses to meet proper application requirements. After several attempts, the contractor told Research personnel that they would not be able to correct the problems and decided to apply the overlay by hand.

Figure 2: Epoxy truck application

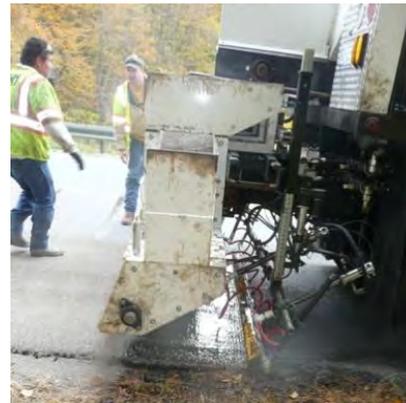
Figure 3: Truck application

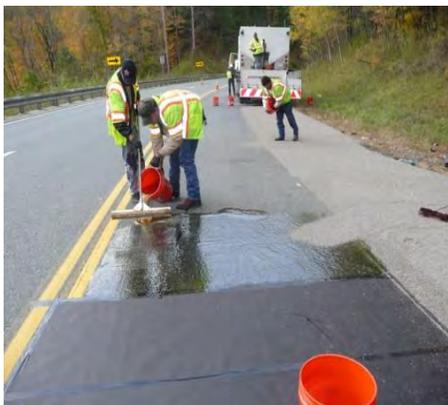
Hand application commenced at 12:58 PM, at which time the pavement temperature was 65°F and the air temperature was 54°F. District forces offered to assist the contractor as many of them were quite familiar with the procedure since they had installed a similar overlay called Cargill SafeLane Overlay two years ago in a similar manner shown in Figure 4. This process went rather quickly. Epoxy was ejected from the guns on the truck into 5 gallon pails and then poured onto the pavement surface and spread using the serrated squeegees. The aggregate was shoveled into buckets, applied onto the epoxy binder and spread with push brooms to achieve a uniform thickness. It should be noted: though the contractor generally uses the truck for applications, they also use hand application methods and has done so for several years. The operation was completed at 3:00 PM shown in Figure 5. After the overlay cured at the surface, THM drove their vacuum truck over the surface to recover any loose aggregate.

Figure 4: Hand application

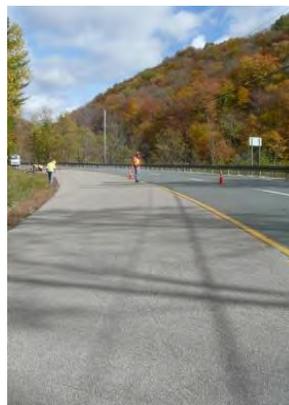
Figure 5: Completed application

At the conclusion of the day, the contractor decided that the 60 feet of mechanical applied material previously placed was not curing properly due to improper mixing ratios of the two-part epoxy and needed to be removed and replaced. They proceeded to scrape the material off the roadway. Some of the material remained on the roadway surface. To rectify the issue, the contractor returned on Monday, October 12 to repair this section.

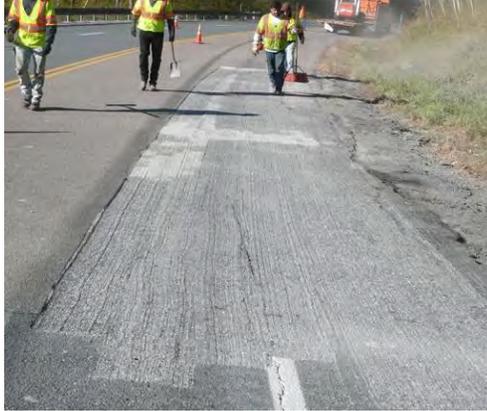
On October 12, 2009, THM, District 1, and Research personnel were once again, onsite to complete the removal of the improperly placed overlay and the subsequent replacement of new overlay within the 60-foot by 8.5-foot section. The operation began at approximately 9:20 AM at which time the pavement temperature was 31°F and the air temperature was 43°F. The errant material was removed by grinding the existing surface and a minor portion of the underlying bituminous pavement. Loose materials remaining on the surface were removed with a sweeper shown in Figure 6.

Figure 6: Repair area, after grinding and sweeping

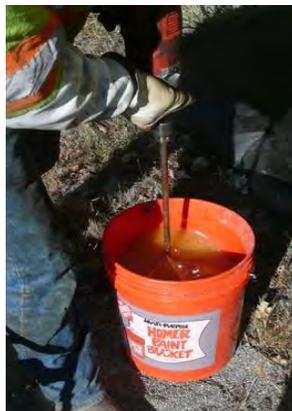
Figure 7: Mixing the epoxy

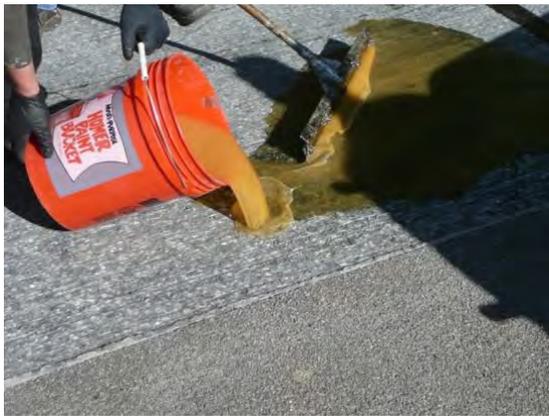
Figure 8: Pouring the epoxy

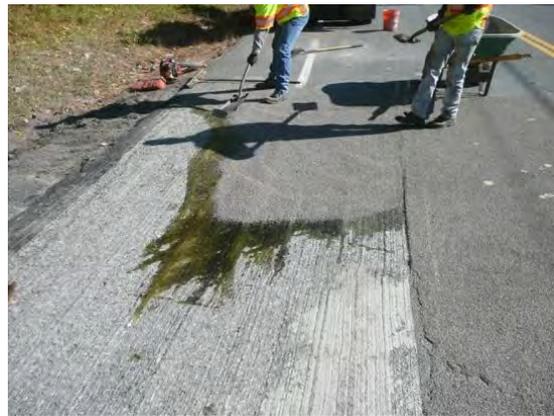
Figure 9: Spreading the aggregate

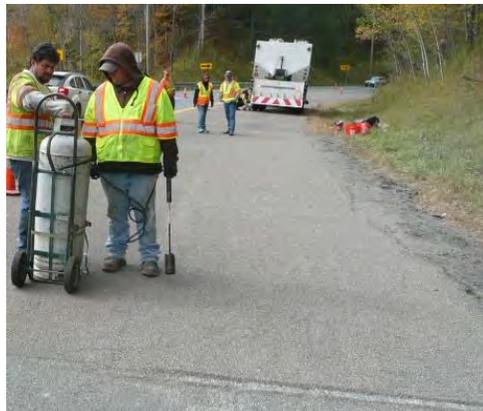
Figure 10: Completed repair

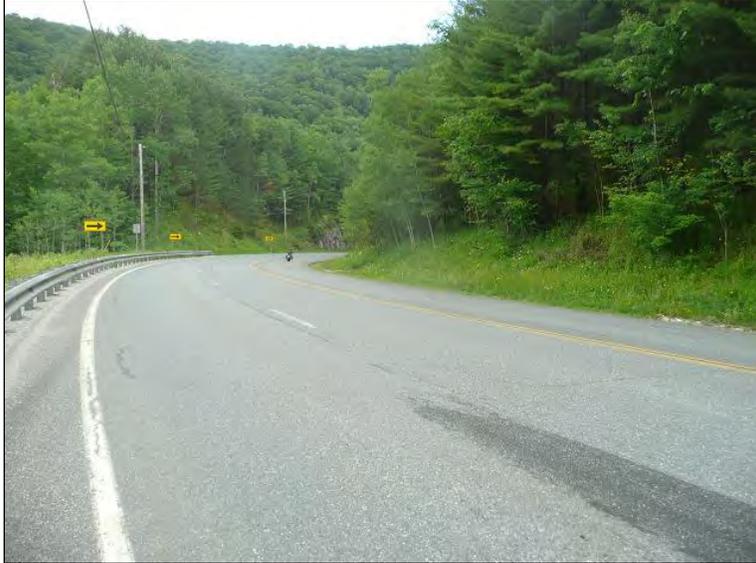
Figure 11: Overview of site
