**Westfall Fiberglass Bridge Drain Pipe System
South Burlington, Vermont
Initial Report**

June 2007

**Report 2007 - 7
Reporting on Work Plan 2000-R-2**

State of Vermont
Agency of Transportation
Materials and Research Section

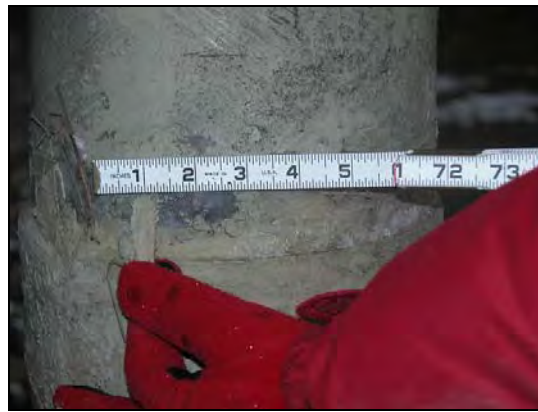
Figure 3 – Flaking of Adhesive

Pipe fittings were also examined. While found to be in good condition, external flaking of the resin adhesive, used to bond and seal the elbow pieces to the straight pipe section, was observed as shown in Figure 3. This raised concerns regarding the potential for water infiltration between the connections potentially resulting in freeze thaw damage during winter months. Immediately following the site inspection, the Westfall Company

was contacted to discuss this phenomenon. They explained that the resin adhesive will not adhere to the glazed finish on the exterior of the pipe. Furthermore, the resin is only needed for the bond between fittings and is not intended to be applied beyond the joint.

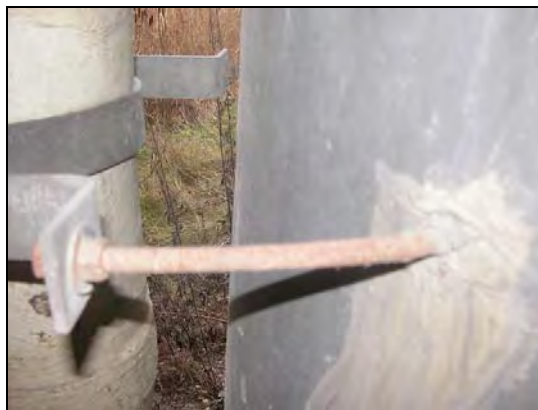
Figure 4 – Bolt Deformation

All lower supports were examined during the site visit and found to display signs of distress. As shown in Figure 4, the bolts that secure the drainage system to the pier were slightly deformed. This is most likely caused by shear forces generated from wind currents and bridge vibration. Section loss resulting from rust was also observed. Both will likely contribute to some form of stem or shear failure. When assessed by Peter Bergerson, he stated that the bolts were too small in diameter to withstand shear and vibratory forces.

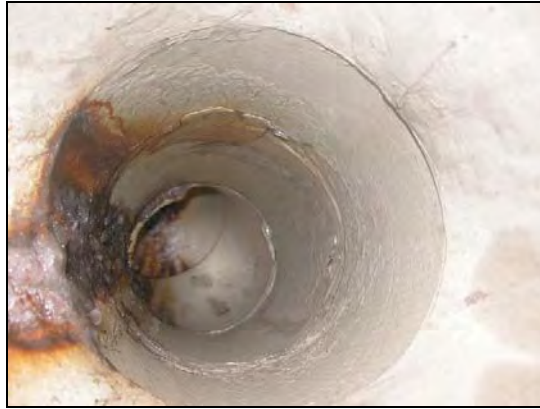
Figure 5 – Iron-Oxide Discoloration

Following an exterior examination, the interior of each catch basin and associated trough was assessed. Some iron-oxide discoloration, shown in Figure 5, was noted on the inside of the catch basin and drainage pipe most likely resulting from a discharge of runoff containing rust subsequently washed from the bridge deck into the trough and drain pipe. This may also indicate that there was some plugging and the water pooled in the catch-basin causing the orange colored ring around the top. Peter also noticed what he referred to as “fissure cracking” within some of the fiberglass structure, a term referring to the miniscule cracks in the fiberglass caused by fatigue, movement and expansion stressing.

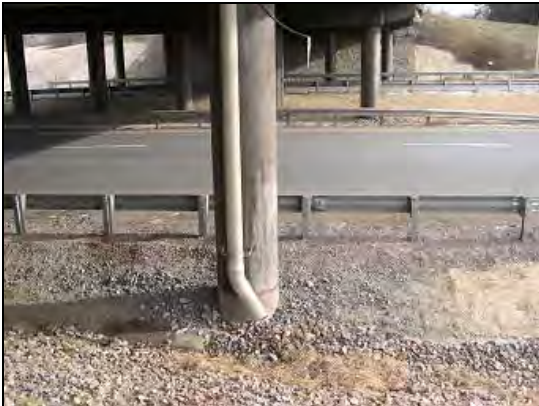
Figure 6 – Drainage on Dec. 2, 2003

During the inspection, runoff from the downspout was pooling around the bottom of the pier columns rather than draining away. This indicates that the stone fill drainage has failed. Figure 6 and 7 provide a comparison between the condition of the drainage system at the base of the piers at the time of installation and during the site visit conducted in December 2006. According to the Portland Cement Association, concrete absorbs water, which expands when it undergoes a freeze-thaw cycle and builds pressure. This internal pressure can cause damage to the concrete such as scaling and spalling. The infiltration of water also provides a mechanism for the penetration of destructive materials such as chloride and sulfate ions increasing the likelihood for concrete delamination and corrosion of reinforcing steel. Maintenance of the drainage system on at least an annual basis is recommended at this time.

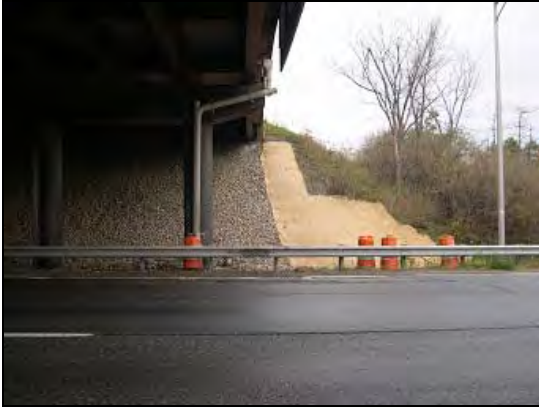
Figure 8 – After Installation

The intent of this investigation was to assess the durability of a material that is reportedly inert to oil, gas and deicing salts known as fiberglass. Installed in 2003, the six fiberglass drainage systems were found to be performing well four years following installation. Minor fisher cracking typically caused by fatigue, movement and expansion stressing was observed inside a few catch basins located at the outlet of the trough. Iron-oxide staining was also visible inside the catch basin most likely resulting from runoff containing rust. Although there were concerns raised regarding flaking of the resin adhesive found at joint connections, the Westfall Company assured that this is common when adhered to the glaze finish of the fiberglass. The bolts connecting the supporting system for the drainage pipe to the pier column were deformed as a result of wind and vibratory forces. This along with apparent section loss will most likely result in some type of shear or stem failure in the future. As a final aside, inadequate drainage was noted below the fiberglass drainage system indicating that the stone fill basin has failed generating a ponding effect around the adjacent concrete piers. This will cause premature concrete spalling and corrosion of reinforcing steel if left unaddressed. Maintenance is recommended at this time. This could be accomplished by cleaning the stone fill or by extending the discharge drainage pipe away from the column. With regards to cost, fiberglass is certainly cost effective when compared to other typically utilized materials. Overall, preliminary results are favorable. Figure 8 and 9 display the drainage system immediately following installation and three years following installation.
