A Masonry Wall and Slide Repair Using Soil Nails and Rock Dowels

Drew Gelfenbein, Christopher Benda, PE and Peter Ingraham, PE

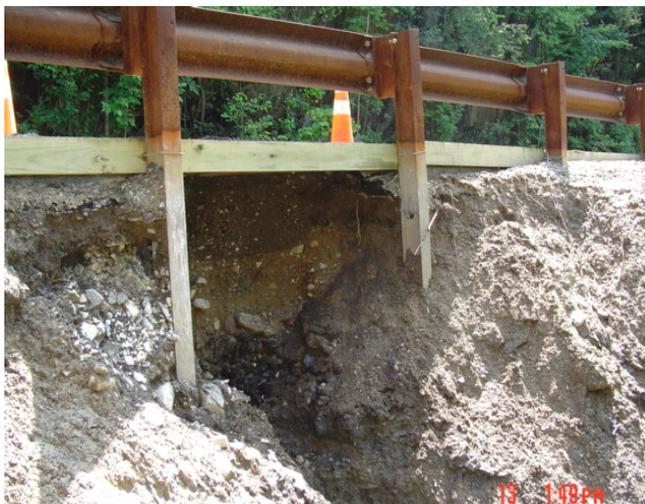
In the middle of August 2003, Vermont experienced several days of very heavy rains which precipitated a slide failure on Vermont Route 73 in Forest Dale at approximately mile marker 6.36. A blocked culvert on the south side of VT 73 caused an overflow of water across the road surface and over an asphalt and wood curb down an embankment. This resulted in a significant amount of erosion, undermining of the road surface (Figure 1) and a washout of a timber cribbing retaining structure located on the top of a mortared masonry wall (Figure 2).

Figure 1: Undermining of north side of VT 73 in Forest Dale.

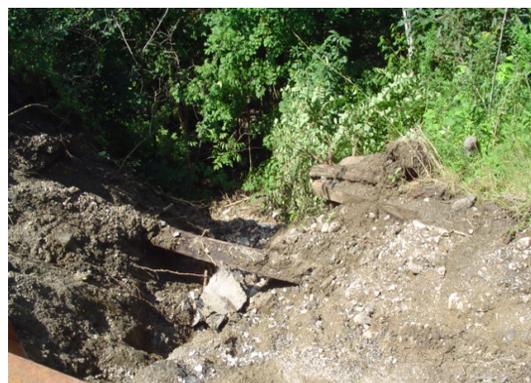
Figure 2: Washout of timber cribbing above mortared masonry wall. (View from road level)

gabion basket retaining wall would then be built on the top of the mortared masonry wall in the wash out area to provide a stable slope back up to the road surface. A Gabion basket structure was selected to minimize the need for specialty construction, and allow participation of VTrans maintenance personnel in the construction to expedite the project. To support design of the structures, VTrans completed 6 standard penetration borings in the roadway behind the two walls.

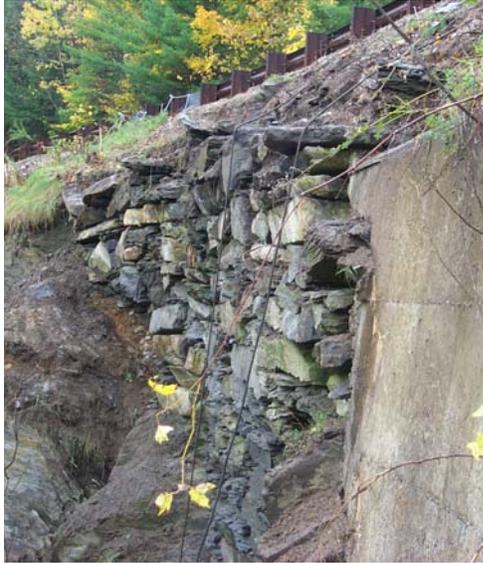
After site visits by Vermont Agency of Transportation (VTrans) staff, it was decided that the laid up masonry wall immediately west of the slide area was also in desperate need of repair. The laid up masonry wall (Figure 3) was observed to have broken and missing blocks. Also the top of the wall was leaning out past the bottom of the wall an estimated 12-18 inches. During the 1970's the west end of the laid up masonry wall was replaced with a cast in place concrete wall. As both walls could be remediated by the same contractor, it was decided to repair both locations at the same time.

Figure 3: Laid up masonry wall, immediately west of slide area.

Design of soil nail reinforcement of the masonry wall west of the washout assumed a 16-foot wall height with no batter and a surcharge load of 640 psf consistent with HS20-44 loading. The service load design followed the procedures outlined in the Federal Highway Administration (FHWA) “Manual for Design and Construction Monitoring of Soil Nail Walls” revised October 1998 (FHWA-SA-96-069R). Soil internal friction was assumed at 34 degrees and the soils assumed to be cohesionless (conservative). Global stability of the nailed soil block was checked using the program SLIDE. To account for variations in rock surface elevation, the soil nails were extended a minimum of 8 feet into sound bedrock at each nail location (Figure 4b).

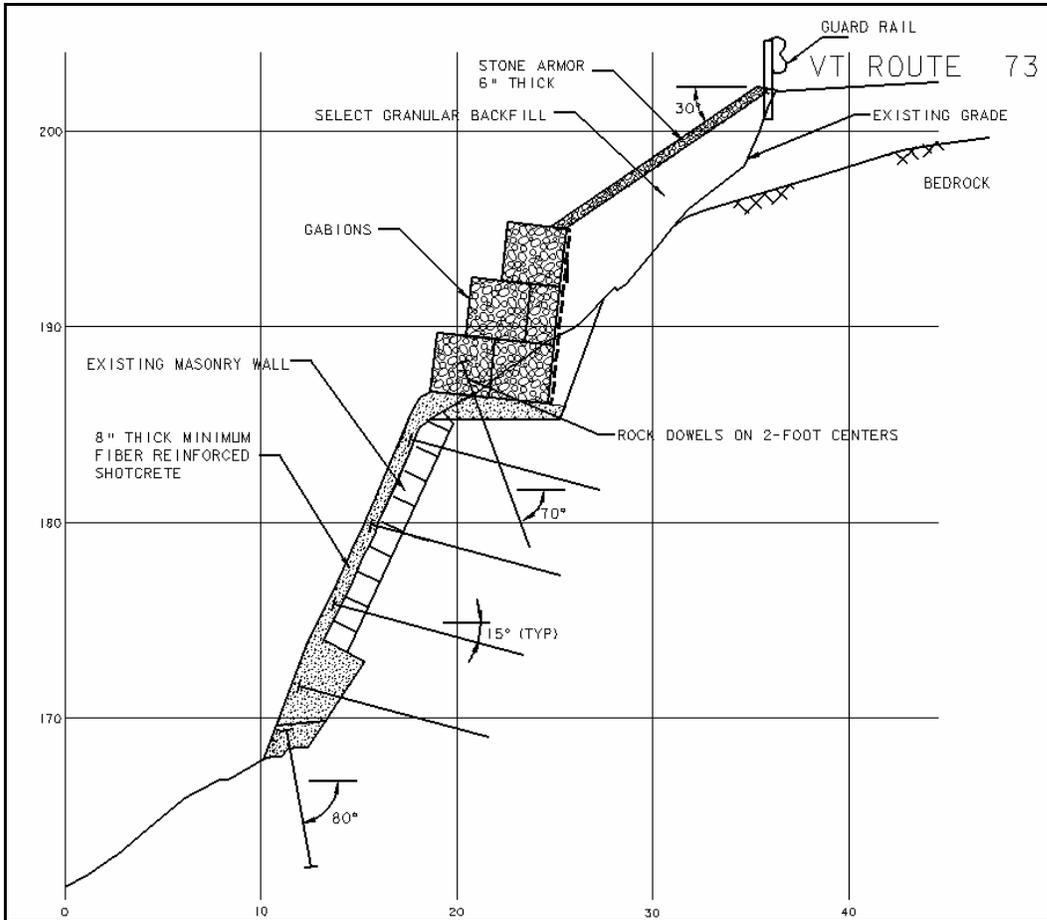
Support of the Gabion wall was checked using the program SLIDE developed by Rocscience. The analysis assumed that the existing masonry wall did not contribute to overall stability, only narrow sliver-type joint failures would be kinematically feasible because of joint orientations, and rock mass failure would occur as a circular failure. The critical cross section was analyzed for rotational stability and initially no rock anchors were considered in the analyses, with shear strength of the rock mass varied to evaluate the need for support. Assuming rock mass cohesion of 1500 pounds per square foot (psf), and a design rock mass friction angle of 40 degrees (conservative), the minimum calculated factor of safety was 2.1. While the calculated minimum factor of safety was adequate to support the Gabion wall, a pattern bolting design and shotcrete

Figure 4a: Section view of mortared masonry wall.

facing (Figure 4a) were included to address potential variability in rock mass strength, seasonal groundwater fluctuations and long-term repair to the masonry wall that had started to ravel at the toe (Figure 7).

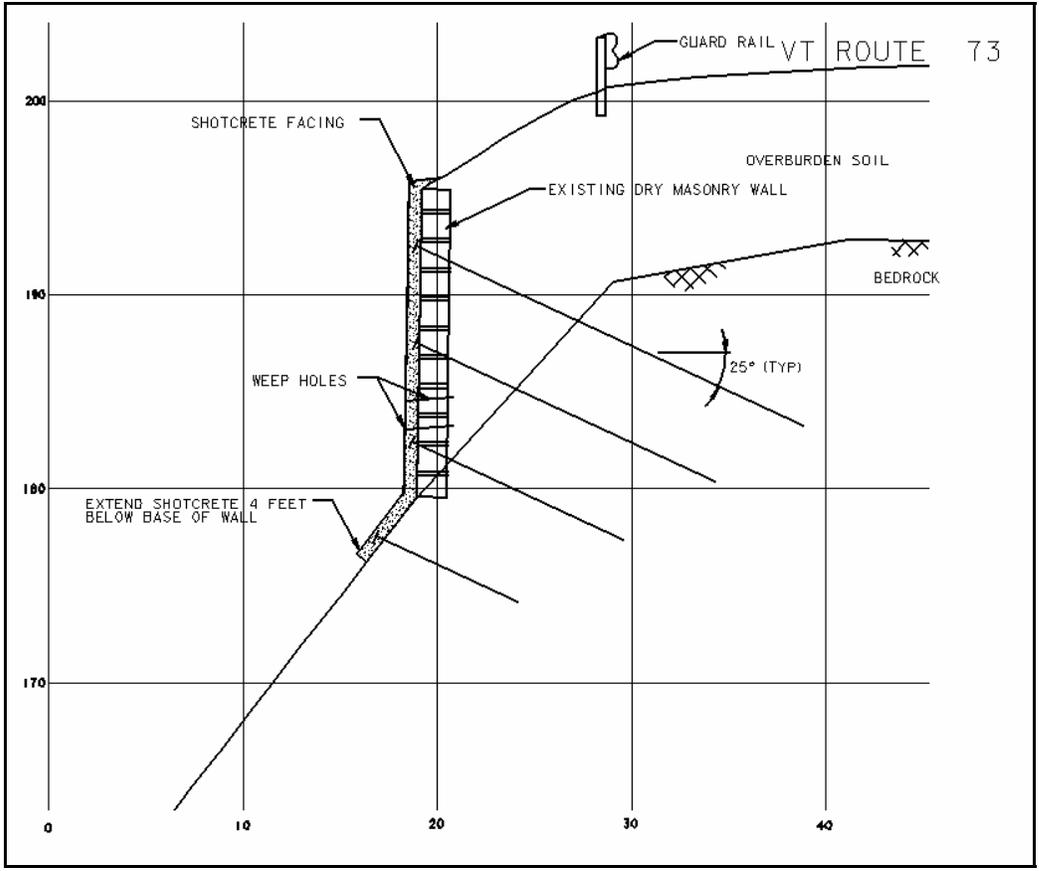
Figure 4b: Section view of laid up masonry wall repair

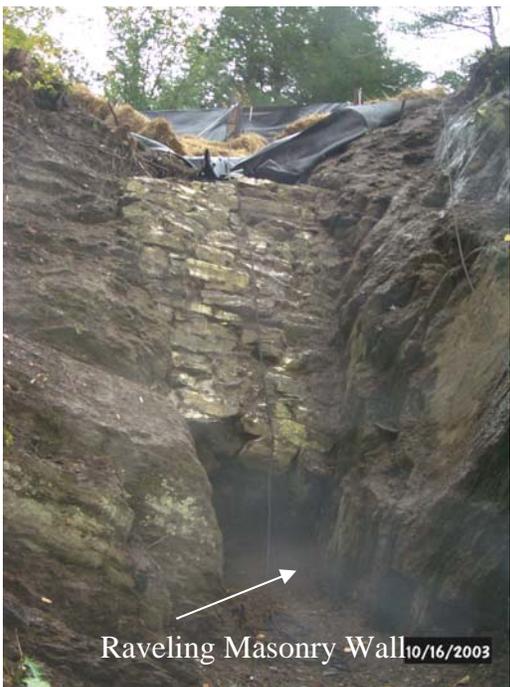
Figure 7: Masonry wall below washout.

between the rocks (Figure 3). The initial layer of shotcrete not only provided reinforcement of the masonry walls during drilling operations, but also provided an even surface for soil nail bearing plates and other reinforcing elements. The raveled void below the mortared masonry wall at the washout area was also backfilled with shotcrete (Figure 7). With the start of winter weather and daily low temperatures of 30-40 degrees, thermal blankets were placed over the shotcrete at night, for a minimum of 2 days to prevent the concrete from freezing during the curing process.

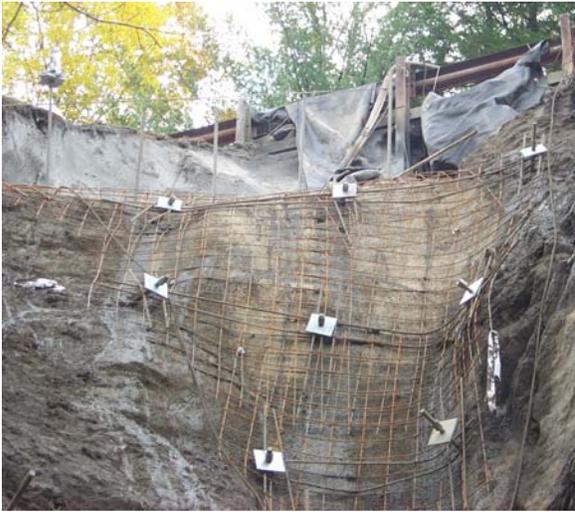
Figure 9: Welded wire fabric and rebar on mortared masonry wall.

After the soil nails and rock dowels were grouted, welded wire fabric was placed over both walls. Reinforcing bar whalers were placed above and below each row of soil nails and rock dowels. A 3 foot piece of reinforcing bar was placed vertically on each side of each soil nail and rock dowel (Figure 9).

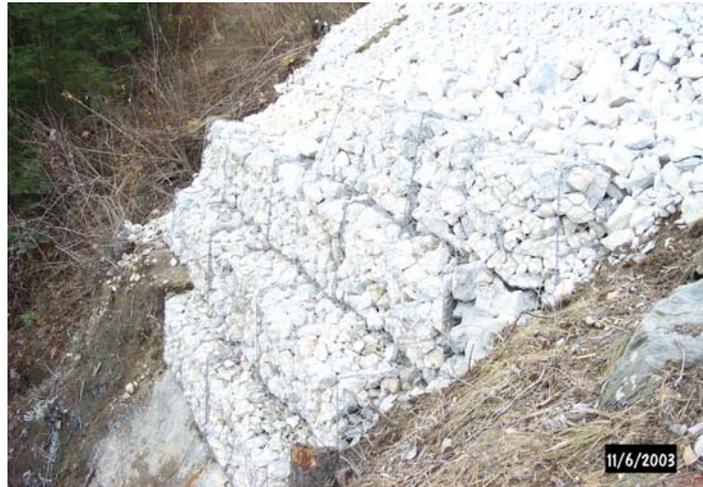
Figure 10: Completed Gabion wall

The gabion baskets were assembled and constructed by VTrans personnel from the District 3 Brandon garage. The bottom row of 2 baskets was placed over the six rock dowels. They were filled $\frac{2}{3}$ of the basket height with stone prior to a 5 inch bearing plate and nut being installed on the threaded rod. The remainder of the baskets were then filled with stone. Additional layers of gabion baskets were installed. Each layer of baskets was laced to one another and to the row of baskets below them. A granular backfill was compacted behind the gabion wall in 1 foot lifts. A Geotextile was placed behind the gabion wall and brought over the top of the granular backfill. Stone fill was then placed on the geotextile to form the slope back up to the road surface. The final gabion wall can be seen in Figure 10.

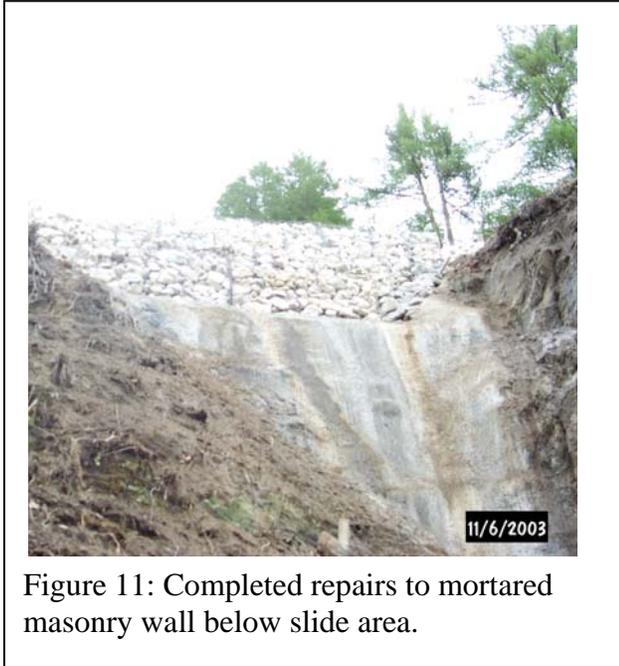
Figure 11: Completed repairs to mortared masonry wall below slide area.

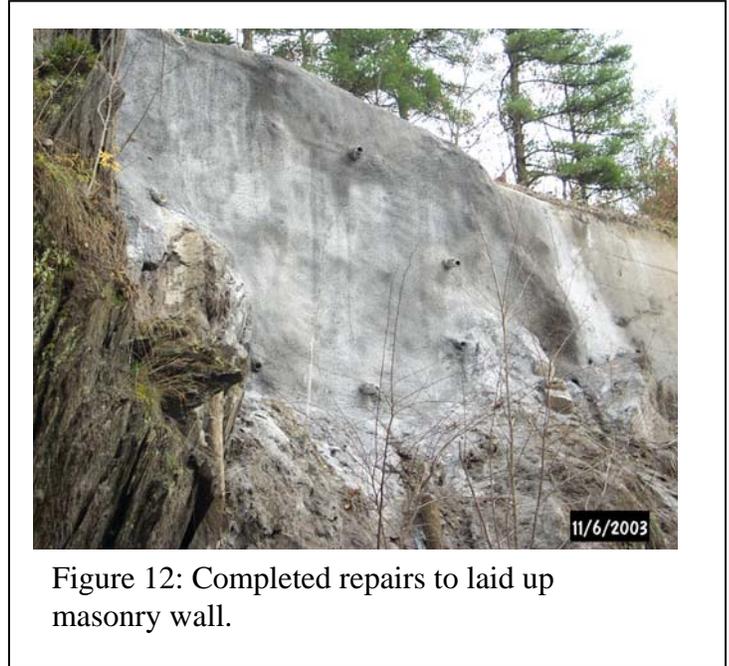
Figure 12: Completed repairs to laid up masonry wall.
