**Insituform Pipe Lining Process
Richmond, Bridport, and Addison, VT
Final Report**

November 2007

**Report 2007 - 15
Reporting on Work Plans 91-R-9 and 92-R-15**

State of Vermont
Agency of Transportation
Materials and Research Section

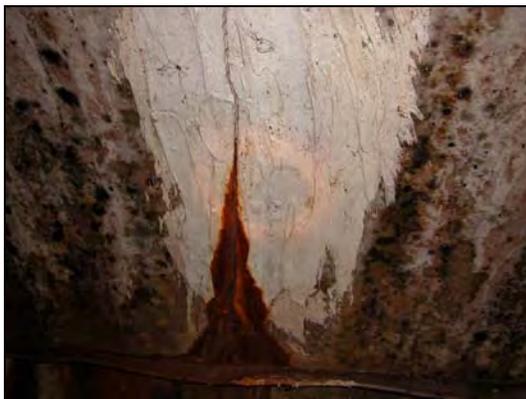
According to the initial inspection report, U96-1, “Insituform Pipe Lining Process,” the culvert at Richmond appeared satisfactory except for a narrow band of irregular texture approximately 49 feet downstream of the inlet of the culvert. This area was described as “scab-like” in addition to a crack, displayed in Figure 1, originating at the fault area and down the left side of the culvert for a distance of approximately two feet. Please note that this crack did not extend the full thickness of the liner or compromise structural integrity. However, it does appear that this area was patched as shown in Figure 2. Some discoloration, wrinkling and blistering was noted along the top of the culverts located in Bridport and Addison. Overall, all liners appeared to be in good condition.

Figure 1 – Cracked in Richmond, 08/26/03

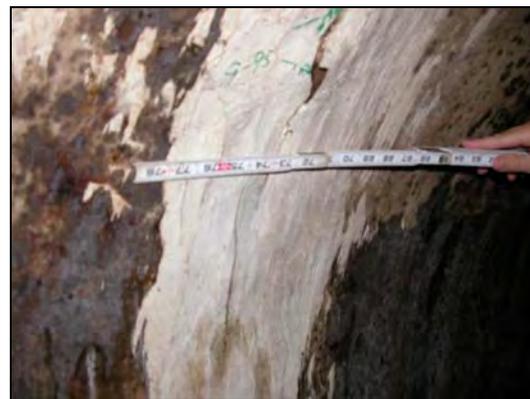
Figure 2 – Patching in Richmond, 7/2/07

monitoring period. A crack was also noted around the fault area in Richmond. This area was patched between 1992 and 1993 and remains unchanged. No debris was noted inside the pipes during any of the inspections however significant debris was observed at the inlet of the culverts in Addison and Bridport. Removal is recommended for optimum performance. The culvert liners appear to be in good condition.

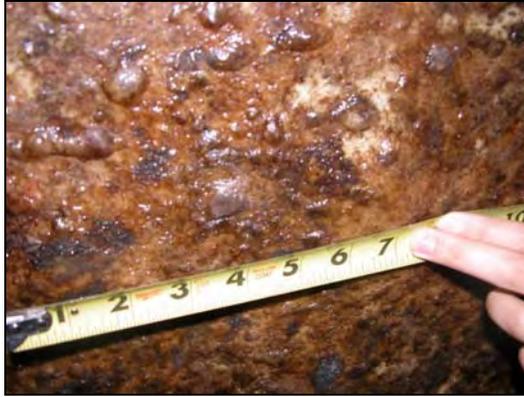
Observation recorded from subsequent visits reported similar conditions at all three culvert locations. Annual dimension measurements collected from the inlet and outlet of the culvert in Bridport were consistent throughout the 15 year monitoring period, indicating sufficient structural support from the liner, eliminating the need for complete replacement. A significant centerline crack along the overlaying pavement roughly 2.5” deep, 3” wide and 16” long was observed during an inspection in 2006 and 2007. This could have been caused by erosion or piping around the culvert, however it is suspected to be due to lateral movement of the subgrade or subbase. In either case, the liner was found to be intact. Finally, blistering was noted along the upper surface on the inside face of all three culvert liners as shown in Figure 3. It is important to note that this phenomenon was found towards the center of each culvert and is most likely due to minimal air circulation in this area allowing condensation to accumulate. However, this blistering does not appear to compromise the integrity of the CIPPs.

Figure 3 – Blistering in Addison, 6/20/06

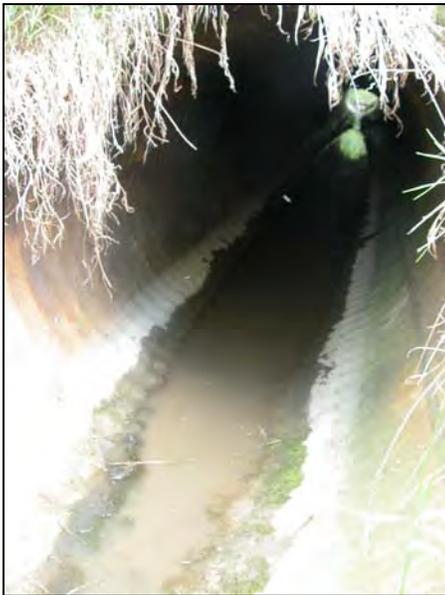
Little to no debris inside the culverts was noted during annual inspections. This is somewhat intuitive as the liner provides a lower friction value as compared to a corrugated metal pipe which allows debris to move more freely throughout the culverts. However, significant vegetative growth and tree branches were evident at the inlet of the culverts in Bridport and Addison. Removal is recommended for optimum flow. Sediment was noted along the bottom of the culverts in Bridport and Addison during the inspections conducted in 2006 and 2007 as shown in Figures 4 and 5. This is most likely attributed to the low flow characteristics of the incoming flow in association with adjacent land uses.

Figure 4 – Low flow in Addison, 7/2/07

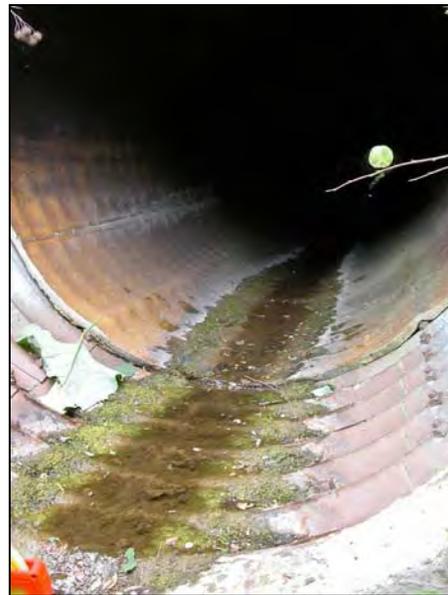
Figure 5 – Low flow in Bridport, 7/2/07
