## FIELD REPORT

U2017-02

### Utilization of Ground Penetrating Radar (GPR) to Detect Shear Bolts in Bridges -- Colchester Bridges 77 & 76 – US I-89

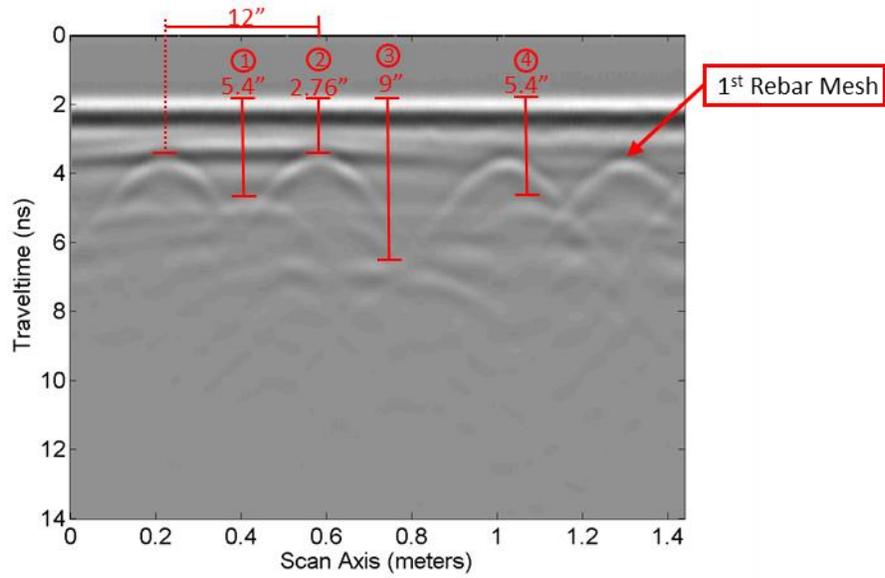
The GPR scan at Area 1 on bridge 77, depicted in Figure (6) [file 135], ran perpendicular to the steel bridge girders and ran a length of 20'' (.5m) on either side of the girder, a total of 60'' (1.4m). The scan went from the white shoulder line and past the drilling layout, seen in Figure (4). The scan clearly shows the 1<sup>st</sup> mesh at a constant depth of approximately 2.5 – 3'' below the asphalt surface and a rebar spacing of about 12''. The GPR scan shown in Figure (7), was taken running parallel to the steel bridge girders along the drilling layout. The scan clearly shows rebar from the 1<sup>st</sup> mesh at a constant depth of approximately 2 – 2.5'' below the asphalt surface and at a spacing of about 6''. Both scans faintly show a similar hyperbola pattern at a depth of 8 – 10'', which might correspond to the 2<sup>nd</sup> rebar mesh. Rebar depth calculations may differ due to the algorithms and the accuracy of the input data used in the GPR scan software. If done correctly the depth calculation error should be minimal. The core samples from Area 1, best seen in Figure (8), verify that the 2<sup>nd</sup> rebar mesh was at a depth of approximately 7.5 – 8'' below the asphalt surface.

Figure 6: GPR Image (File 135), corresponds to a GPR scan on Area 1 on Bridge 77. Perpendicular to steel bridge deck girder.

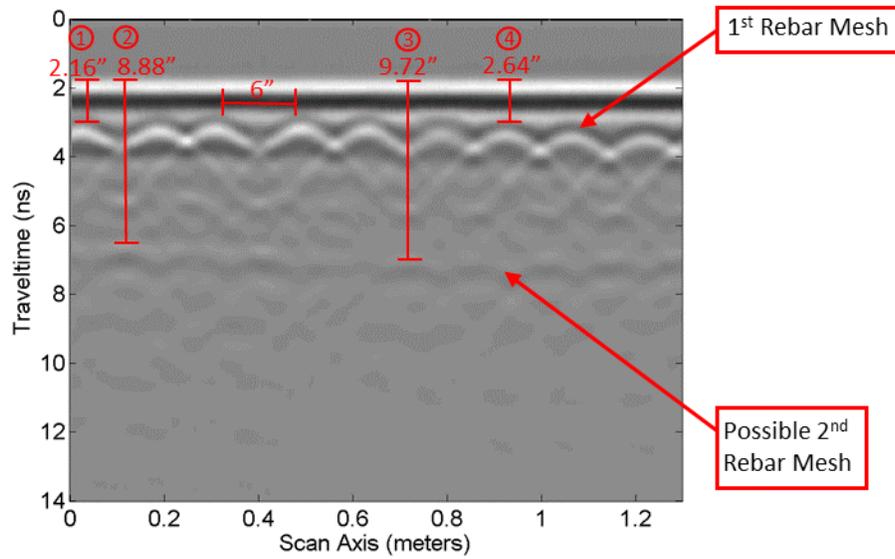
Figure 7: GPR Image (File 134), corresponds to a GPR scan on Area 1 on Bridge 77. Parallel to steel bridge deck girder.

The GPR unit was very successful in determining the presence and spacing of the 1<sup>st</sup> rebar mesh at a depth of 1 – 6” below the asphalt surface. The GPR scans clearly show the differences in the rebar spacing between the rebar running perpendicular to the flow of traffic and parallel to the flow of traffic. The GPR scans show the spacing of the rebar to be approximately 6” intervals parallel to the flow of traffic and at approximately 12” intervals perpendicular to the flow of traffic, which can be seen in Figures (6 & 7).

Determining the depth and presence of the 2<sup>nd</sup> rebar was more difficult. In a number of GPR scans a faint signal of the 2<sup>nd</sup> rebar mesh could be seen at a depth of 5 – 9.5”. A clear example can be seen in Figures (6, 13, 21, 27 & 33). It is difficult to determine if these responses correlate directly to the 2<sup>nd</sup> rebar mesh, due to their variability in depth and how faintly they show up on the images. It should be mentioned that the contrast of the scan images was enhanced post processing to better identify the 2<sup>nd</sup> rebar mesh. The GPR Unit does have options to enhance the images out in the field, but they were not utilized for this investigation due to time constraints. For Figures (6, 13, 21, 27 & 33), it was difficult to correlate to the depth of the 2<sup>nd</sup> rebar mesh on the GPR scan to the measured location of the rebar from the core samples. The detection of the 2<sup>nd</sup> rebar mesh by the GPR Unit could be verified by the core samples, when the scans were conducted parallel to the steel girders. This is evident when analyzing the GPR scan in Figure (34) to the core samples from Area 3 of bridge 76 in Figures (37 & 38). The scan image shows that the 2<sup>nd</sup> mesh lies at a depth between 6.8 -7.5” while the core samples verify that the 2<sup>nd</sup> rebar mesh was at a depth of 7” at the L1 and L3 locations. The GPR scans in Figures (7, 21 & 22) cannot be properly verified by the area core samples because there was insufficient data, because the Research Section was not on site to take measurements on Area 3 cores on bridge 77. The data gathered from core samples in Area 1 on bridge 77 seemed inconsistent to the GPR scan in Figure (7).

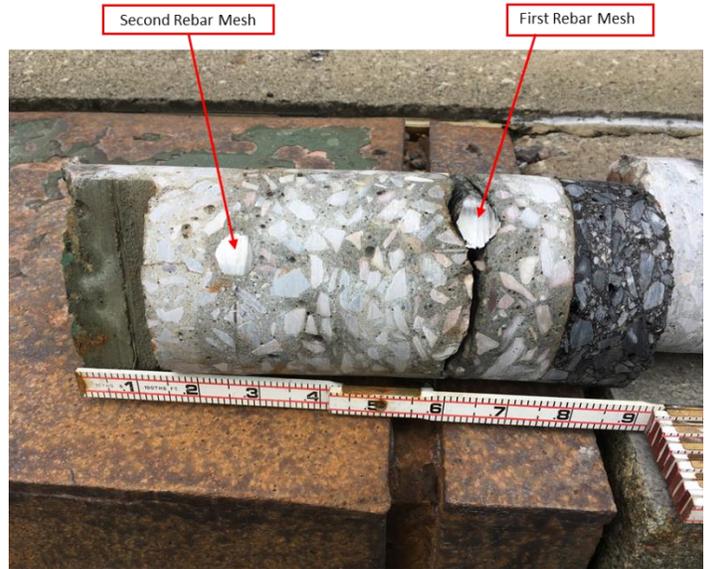
Bridge 77 Area 1 cores can be seen in Figures (8 – 12). The core from L3 was 4'' in diameter and approximately 10'' in length. The 1<sup>st</sup> and 2<sup>nd</sup> rebar meshes could clearly be seen. Other metal fragments were found in the bottom inch of the core. Initially we thought that this might be evidence of shear studs, but upon further inspection it was clear that the metal fragment could not correspond to a cross section of a shear stud. This was concluded when a similar fragment was found within the L6 core and after all core measurements were recorded the core was destroyed, revealing that the metal fragments correspond to mesh seats. The mesh seats are comprised of small diameter stainless steel rods that are used as spacers to ensure that the 1<sup>st</sup> rebar mesh is placed at the correct concrete slab depth. The mesh seats were tack welded to vertical rebar elements to the steel girder at certain intervals along the girder. This can be seen in Figures (11 & 12). The L3 core sample can be seen in Figure (9). Figure (8) shows the L4 core sample that went completely through the concrete bridge deck and missed the steel girder. The core clearly shows the two rebar meshes and it was clear that the initial staggering method was ineffective.

Figure 8: Area 1, L4 4in Core That Missed the Steel Girder. First and Second Rebar Meshes Can Be Clearly Seen. (Ruler in tenths of feet)

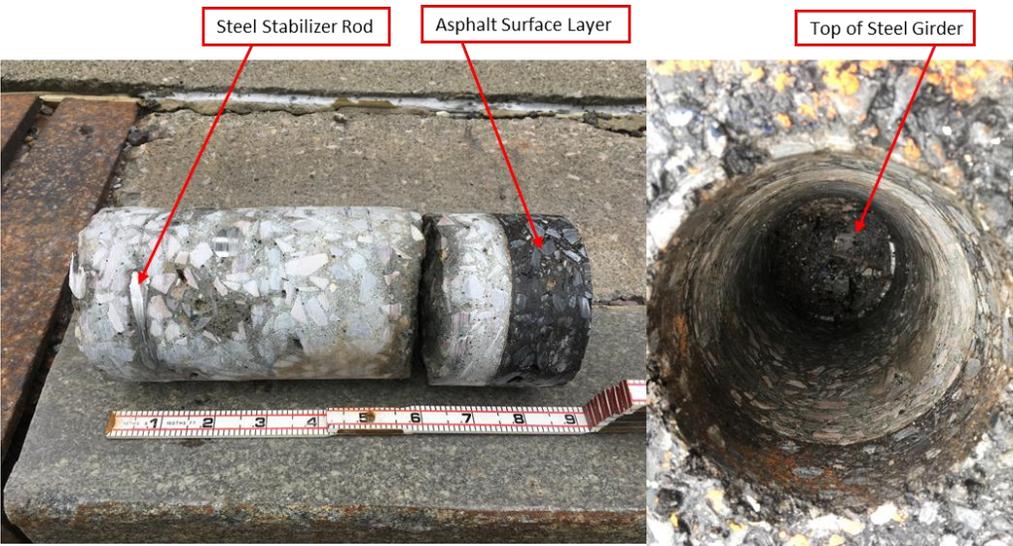
Figure 9: Area 1, L3 4in Diameter Core is Pictured on the Left. The Top of the Steel Girder Can Be Seen on the Image on the Right with no Shear Studs Visible. (Ruler in tenths of feet)

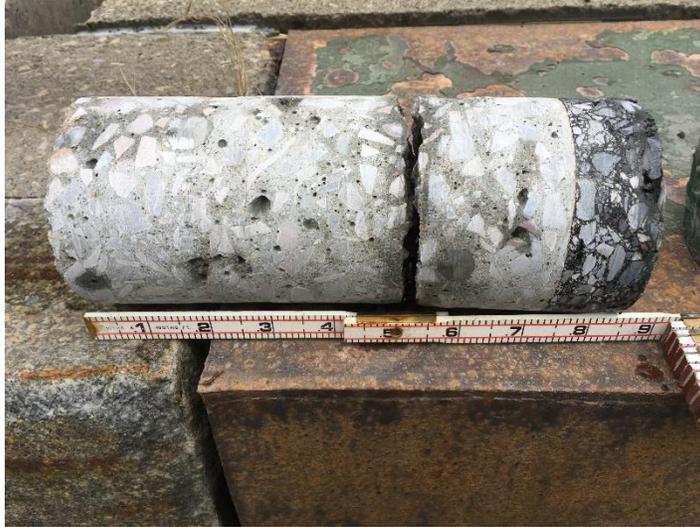
**Figure 10: Area 1, L5 4in Core. Cannot Be Seen in the Image but Had 2 Rebar Meshes were Present.**

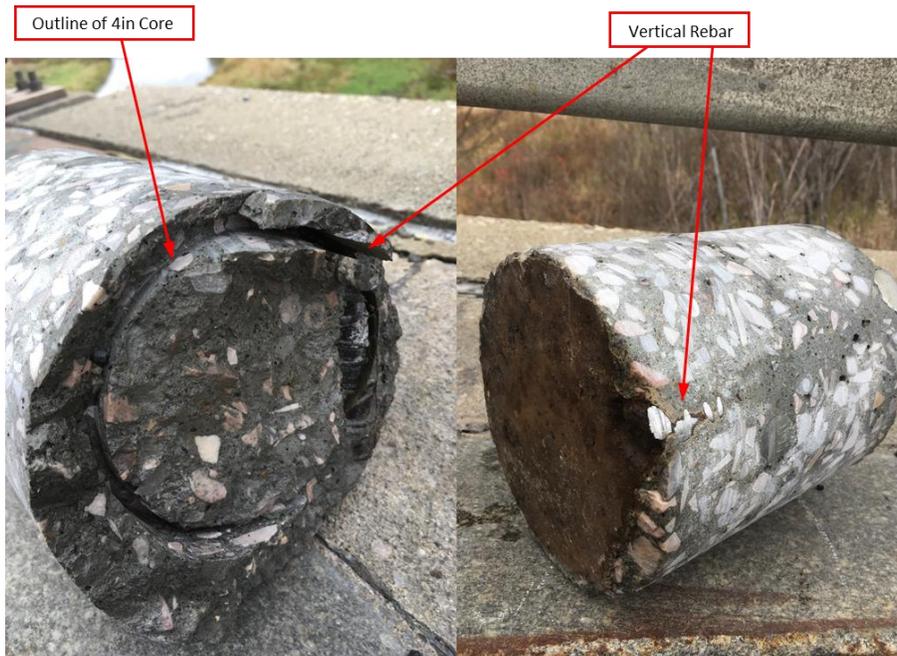
**Figure 11: Area 1, L6 6in Core. Vertical Rebar was Present Which Can Be Seen in Both Images. A 6in Core had to be cut Around the 4in Core Because the Drill Bit was Cutting into the Vertical Rebar.**

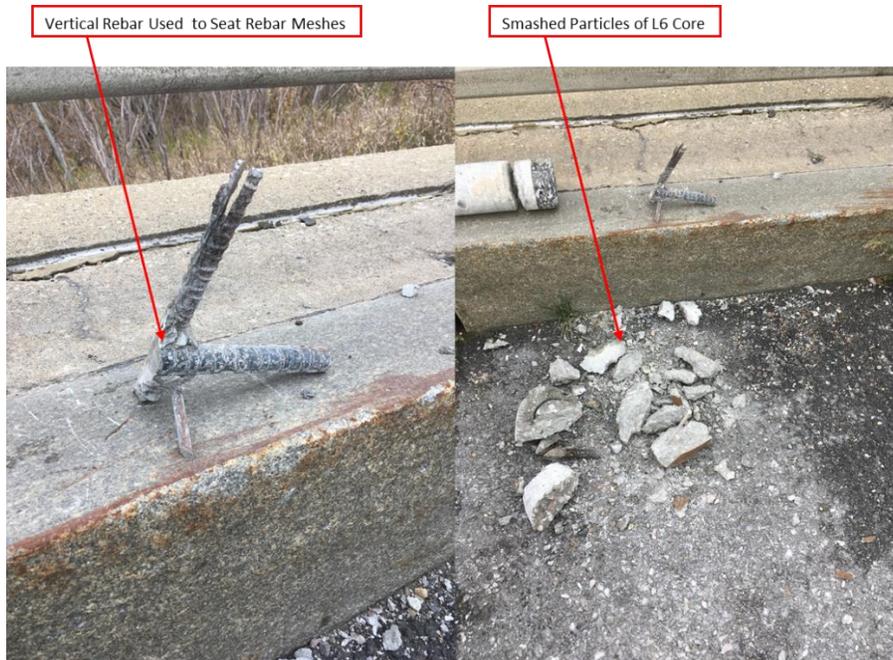
Figure 12: Photos of a Vertical Rebar Found within L6 Core. It's a Mesh Seat Used to hold the Rebar Meshes in Place During Construction.

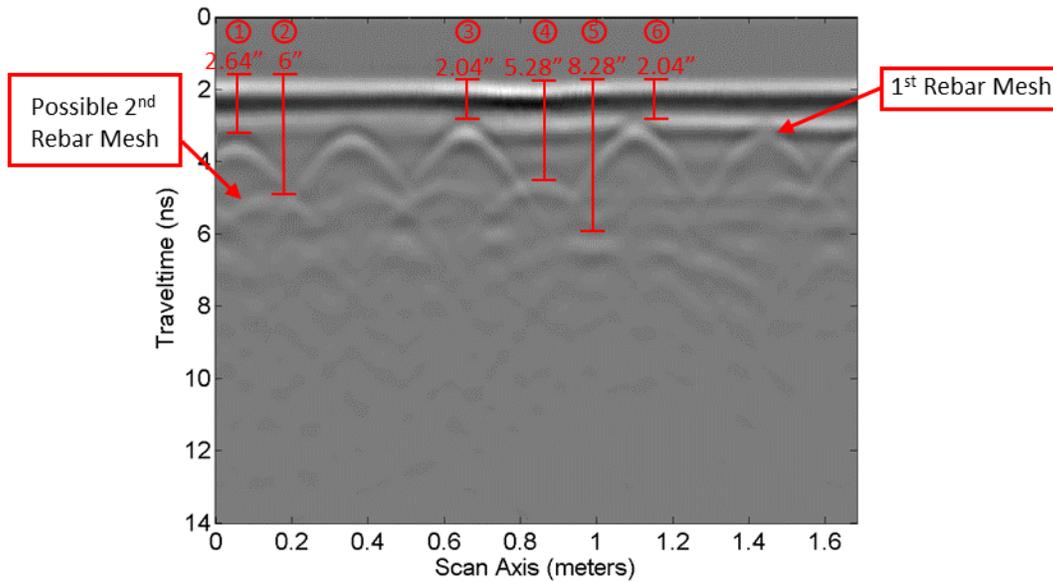
Figure (13) [File 137], corresponds to the GPR scan at Area 2 on bridge 77. The scan section was approximately 60" (1.6m) in length, running perpendicular to the steel bridge girders, from the white shoulder line to the middle of the travel lane, past the drilling layout. The GPR scans clearly show the 1<sup>st</sup> rebar mesh, at a depth of 2 - 3", and what may be the faint definition of the 2<sup>nd</sup> mesh, at a depth of 5 - 6". At approximately 40 - 50" (1 - 1.3m) into the scan something can be seen at a depth of about 8.3". This was approximately at the location of the steel girder and where the Area 2, L2 core was drilled. Initially I thought that this might be evidence of a shear stud but, it could also be reflections from the steel girder along with reflections from the mesh seats. The depth and the prolonged curvature of the anomalies on the scan image help validate this assumption.

Figure 13: GPR Image (File 137), corresponds to a GPR scan on Area 2 on Bridge 77. Perpendicular to steel bridge deck girder.

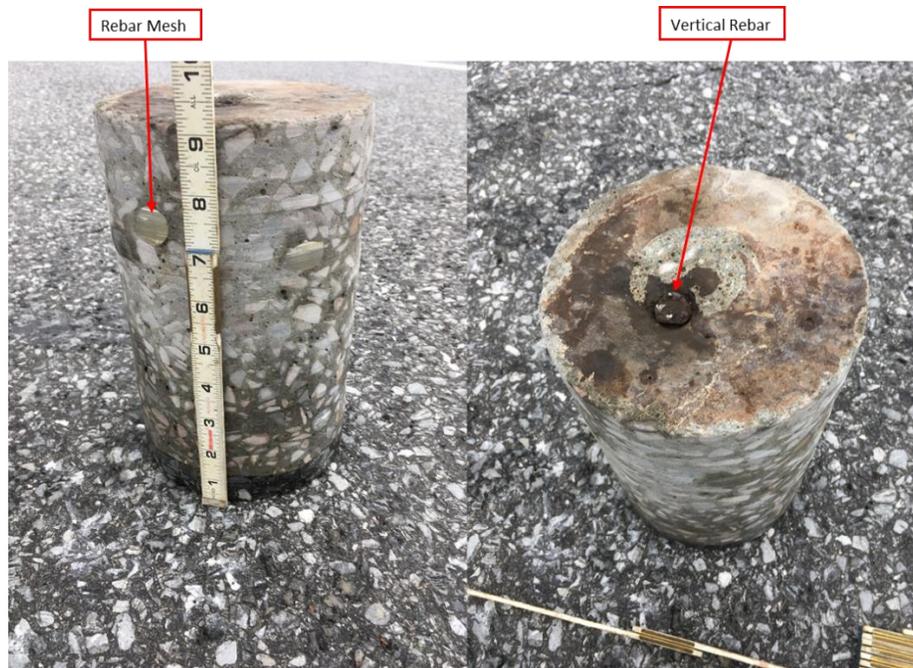
Bridge 77 Area 2 cores can be seen in Figures (14 - 20). All three cores at Area 2 were drilled using a 6" drill bit. The core at L2 was the first one that was drilled at approximately 12pm. The core was approximately 9" in depth with the 1<sup>st</sup> rebar mesh at 2.5" and the 2<sup>nd</sup> rebar mesh at 7". The L2 core, seen in Figure (18), shows no evidence of shear studs. The core at L3 was drilled next. The 1<sup>st</sup> rebar mesh on the L3 core was at 2" and the 2<sup>nd</sup> rebar mesh at 7". The L3 core, seen in Figure (19), shows no evidence of shear studs. The core at L1 was the last to be drilled in Area 2. The 1<sup>st</sup> rebar mesh at 2.5" and the 2<sup>nd</sup> rebar mesh at 6". The L1 core, seen in Figure (17), again shows no evidence of shear studs.

Figure 17: Area 2, L1 6in Core. The Image on the Left Depicts the Rebar Meshes within the Bridge Deck. The Image on the Right Shows the Bottom of the L1 Concrete Core Which Rested on the Top of the Steel Girder. The Vertical Rebar was Tacked onto the Steel Girder.

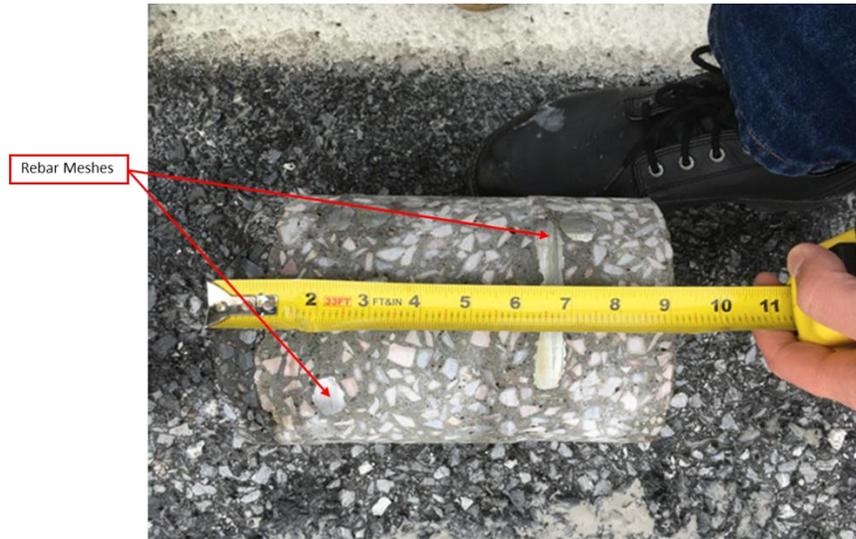
**Figure 18: Area 2, L2 Core on Bridge 77. Rebar Meshes were Present.**

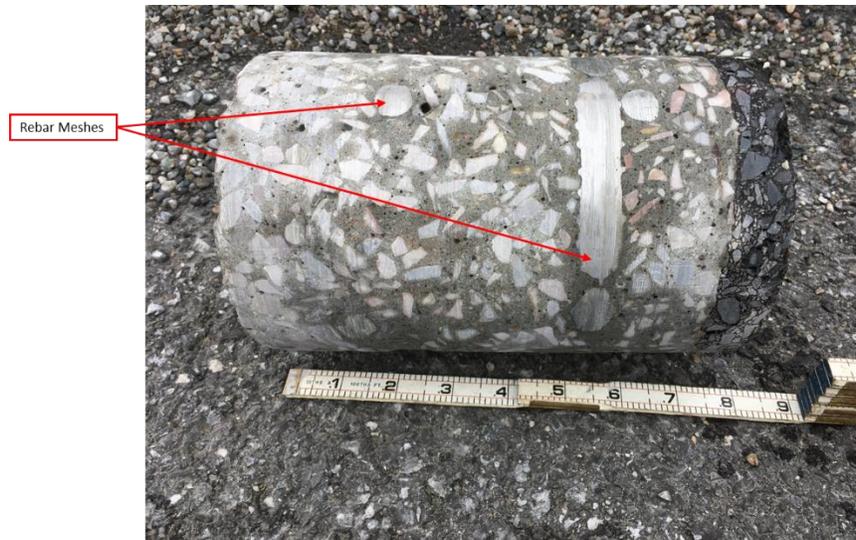
**Figure 19: Area 2, L3 Core on Bridge 77. Rebar Meshes were Present.**

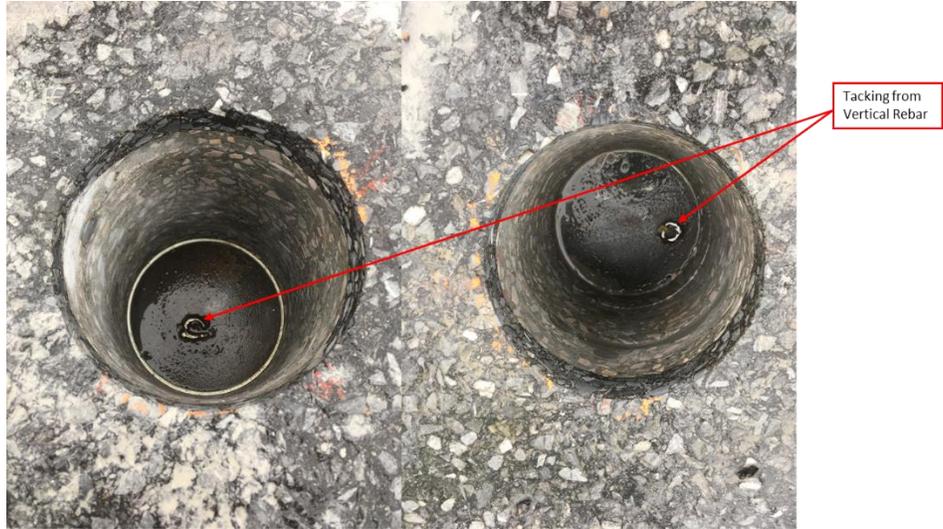
Figure 20: Coring Holes from Area 2, L1 (Left) and L3 (Right). Tacking Material from the Vertical Rebars can be Seen on the Top Surface of the Steel Girder.

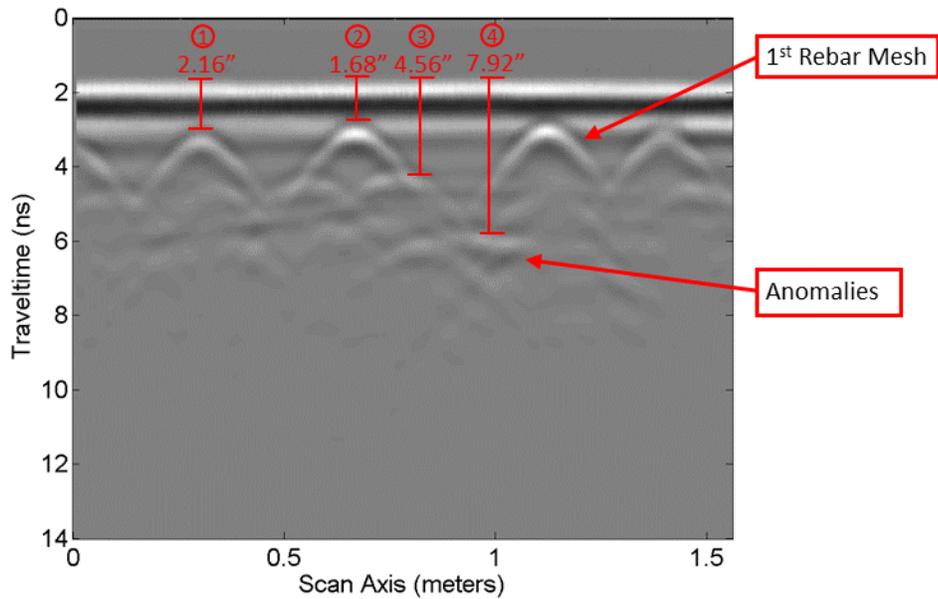
Figures (21 & 22) [Files 138 & 139], correspond to GPR scans at Area 3 on bridge 77. Looking at the GPR scan from Figure (21) the 1<sup>st</sup> rebar meshes is clearly defined and the scan shows faint signs of the 2<sup>nd</sup> rebar mesh. The scan was taken from the white shoulder line to the middle of the travel lane, running perpendicular to the steel girder. At approximately 40" into the GPR scan some anomalies can be seen at a depth of about 8". Because a shear stud has not been found on the bridge, the anomaly is most likely backscatter or a reflection from the steel girder as mentioned in Area 2. The scan depicted in Figure (22) ran parallel to the steel girder along the drilling layout, Figure (23). The 1<sup>st</sup> rebar mesh can be clearly seen at a depth of about 1" and a spacing of 6". It is more difficult to see the 2<sup>nd</sup> rebar mesh because of the amount of backscatter and decrease of reflection energy at a depth of approximately 7".

Figure 21: GPR Image (File 138), corresponds to a GPR scan on Area 3 on Bridge 77. Perpendicular to steel bridge deck girder.

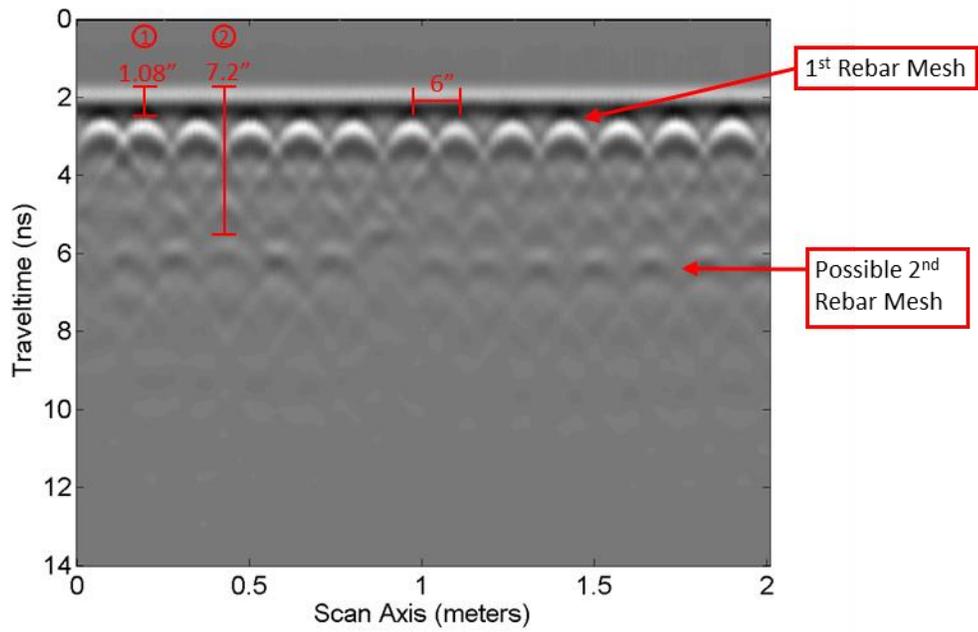
Figure 22: GPR Image (File 139), corresponds to a GPR scan on Area 3 on Bridge 77. Parallel to steel bridge deck girder.

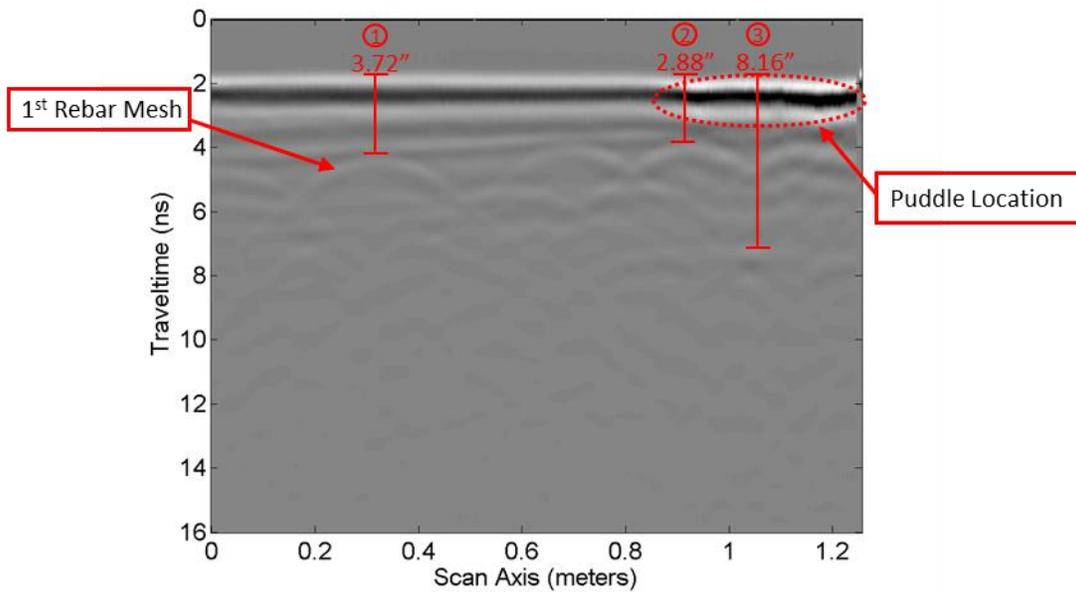
Figure (27) [File 142], corresponds to the GPR scan at Area 2 on bridge 76. The scan was from the white shoulder line to the middle of the travel lane (perpendicular to the steel girders) and went into a puddle, which can be seen in Figure (28). There is a clear distinction on the scan image (greater contrast) when the GPR was in the puddle. A very bright surface reflection is present where the GPR went in the puddle, which can be seen in the upper right of the Figure. The GPR scan clearly shows the 1<sup>st</sup> rebar mesh at an approximate depth of 2.5 – 3.75”, which nicely correlates to the actual 1<sup>st</sup> mesh depth from the core sample in Figure (29). Evidence of a 2<sup>nd</sup> rebar mesh was most likely not evident in the scan image due to the high moisture content within the roadway, which dissipated the electromagnetic energy emitted by the GPR unit into the subsurface material. This occurs because water has a higher relative permittivity value compared to air, concrete or asphalt. Relative permittivity is a material property that describes the decrease in the electric field between charges relative to a vacuum and is a measurement used to differentiate materials.

Figure 27: GPR Image (File 142), corresponds to a GPR scan on Area 2 on Bridge 76. Perpendicular to steel bridge deck girders.

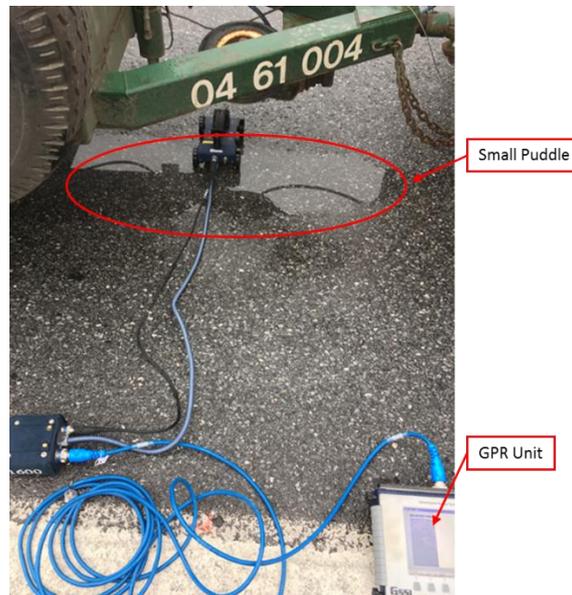
Figure 28: GPR Scan Near Area 2 on Bridge 76. Scanned through Puddle.

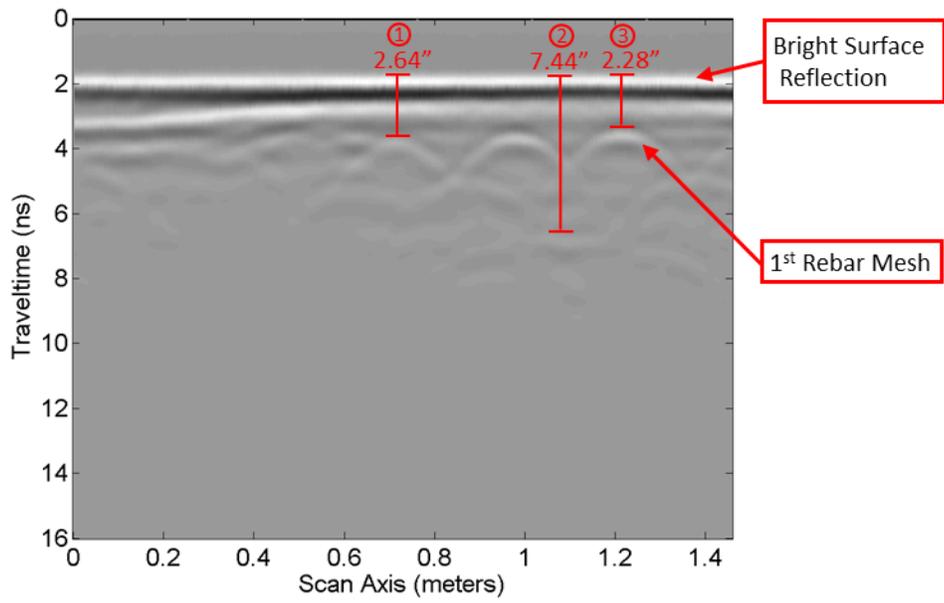
Figures (33 & 34) [Files 143 & 144], correspond to GPR scans at Area 3 on bridge 76. Looking at the GPR scan shown in Figure (33), the 1<sup>st</sup> rebar mesh was visible but it was difficult to see any subsurface features below 5”. This is most likely due to the dielectric properties of the concrete bridge deck being saturated with rain water. The rain water scatters and reflects the electromagnetic radiation emitted from the GPR, penetrating less into the concrete bridge deck. A very bright surface reflection can be seen in the GPR scan in Figure (33). The scan was taken from the white shoulder line to the middle of the travel lane, running perpendicular to the steel girder. The scan depicted in Figure (34) ran parallel to the steel girder along the drilling layout, which ran a length of approximately 5.7”. The 1<sup>st</sup> rebar mesh can be clearly seen at a depth of about 1.5 - 2”. It is more difficult to see the 2<sup>nd</sup> rebar mesh because of the amount of backscatter and energy absorption the high moisture content at a depth of approximately 6.5 – 7.5”.

Figure 33: GPR Image (File 143), corresponds to a GPR scan on Area 3 on Bridge 76. Perpendicular to steel bridge deck girders.

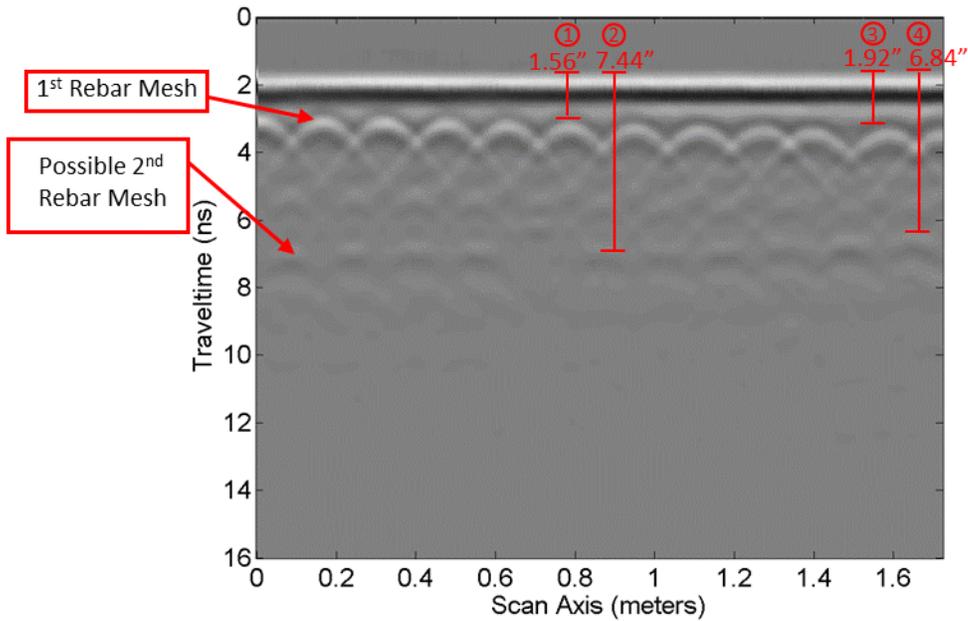
Figure 34: GPR Image (File 144), corresponds to a GPR scan on Area 3 on Bridge 76. Parallel to steel bridge deck girders.
