FINAL FIELD REPORT

U2017 - 06

Assessment of the Stirling Lloyd Eliminator Waterproofing Membrane System

Bridge 1 Site Visit - VT 973, St. Johnsbury VT

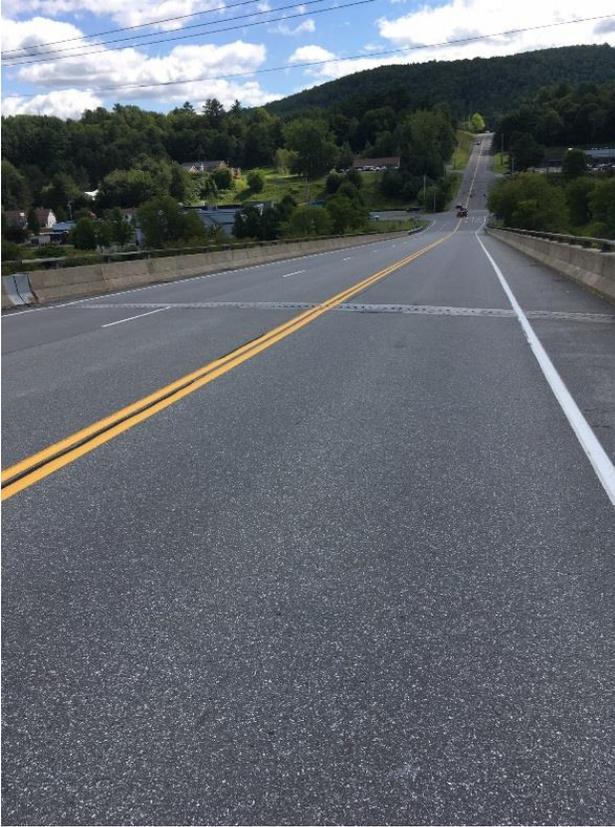
Overall View of Bridge 1 on VT 973, St. Johnsbury VT. The photo was taken on the eastbound travel lane facing east. During the site visit it was evident that the pavement markings had recently been painted.

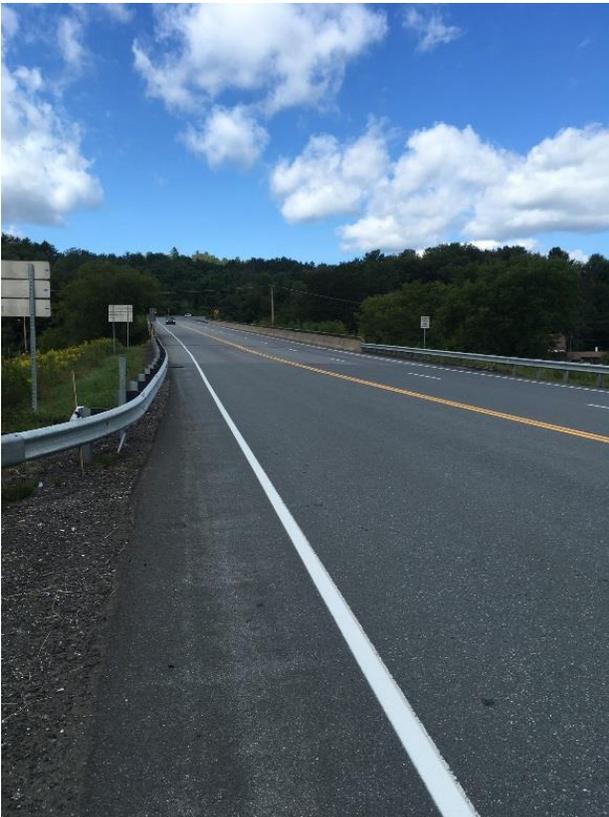
Overall View of Bridge 1 on VT 973, St. Johnsbury VT. The photo was taken on the eastbound travel lane facing west.

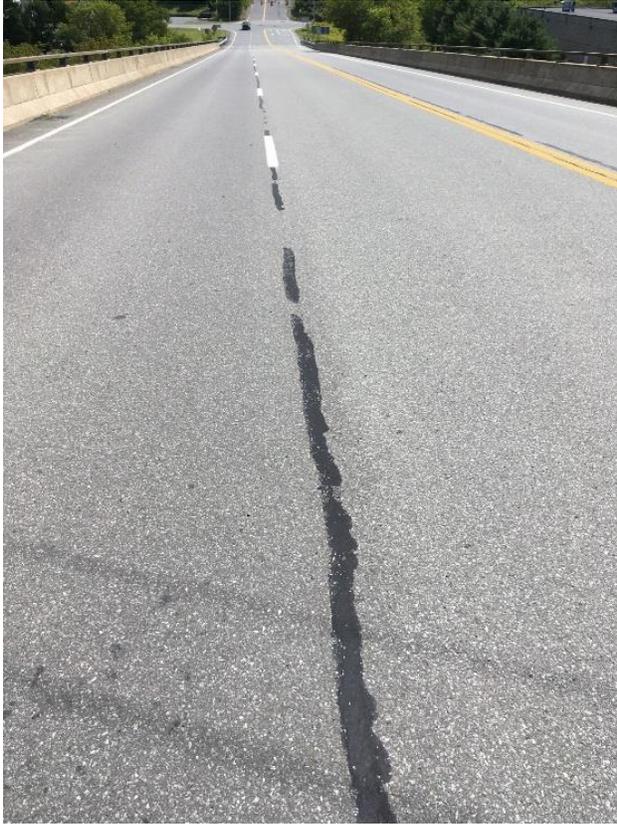
Close-up of paving joints on the Bridge 1 deck from the westbound travel lane, looking east towards US 5. Notice that the cracks have been sealed. Rutting on both the westbound and eastbound lanes were observed during the recent site visit. The slight discoloration/wearing within the wheelpaths shows the start of the rutting on the surface overlay.

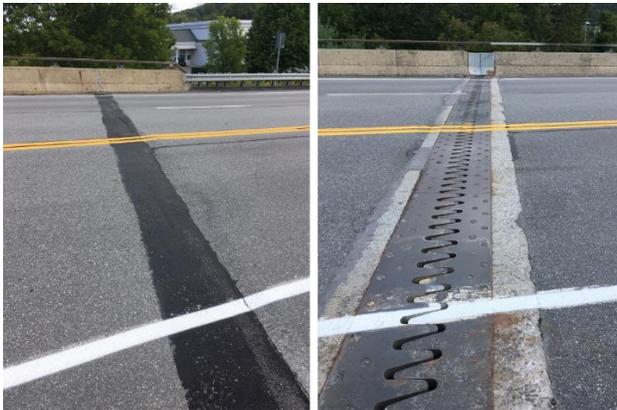
The photo on the left shows the bridge joint on the east end of the bridge while the photo on the right shows the bridge joint on the west end of the bridge. The bridge joints were in good condition. There was evidence of patching around the west end bridge joint. A close-up of the mentioned patching can be seen in the following image.

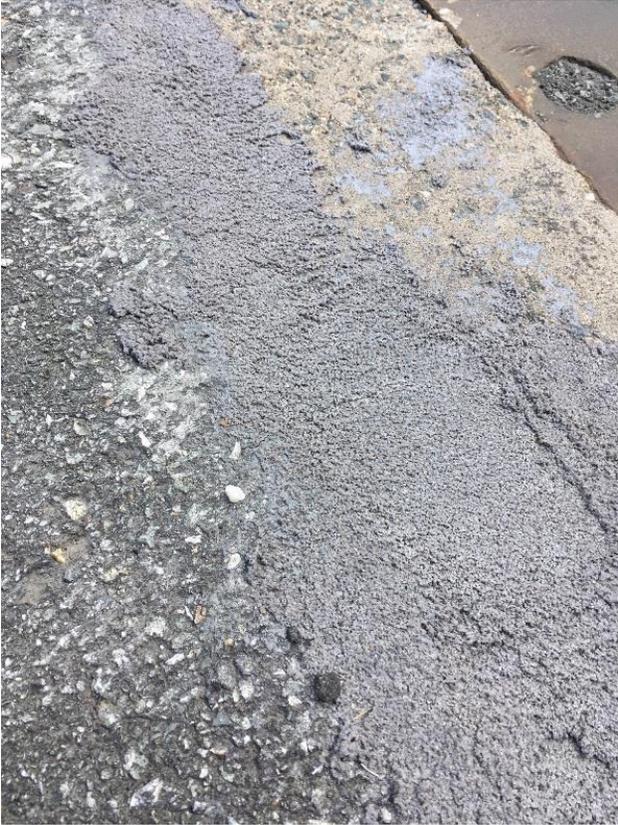
A close-up of the patching around the bridge joint on the west side of Bridge 1.

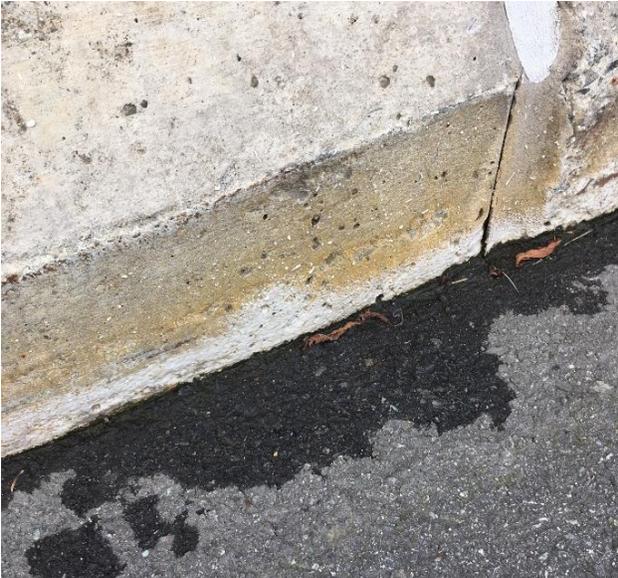
The bridge curb shows overspray (white) that occurred during installation of the Eliminator membrane.

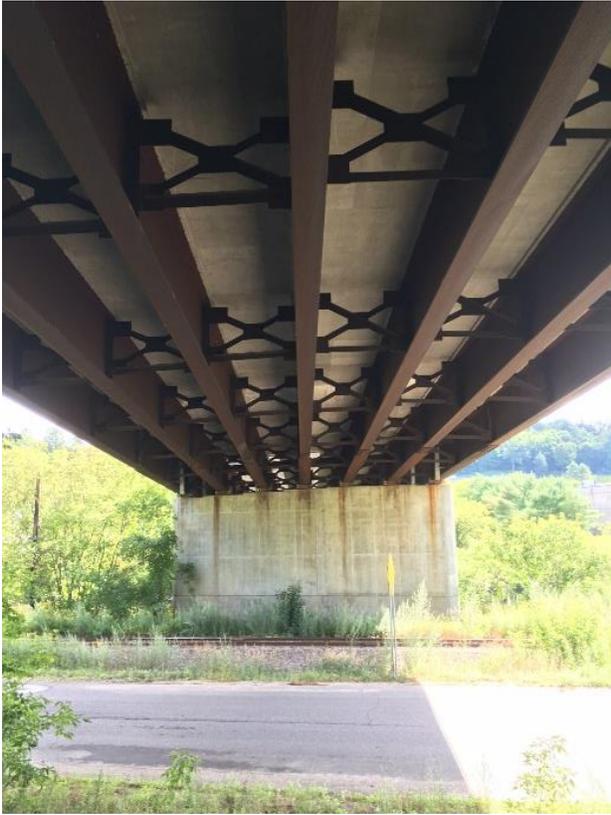
Full view of the underneath of the Bridge 1, near the west abutment looking towards the east bridge abutment.

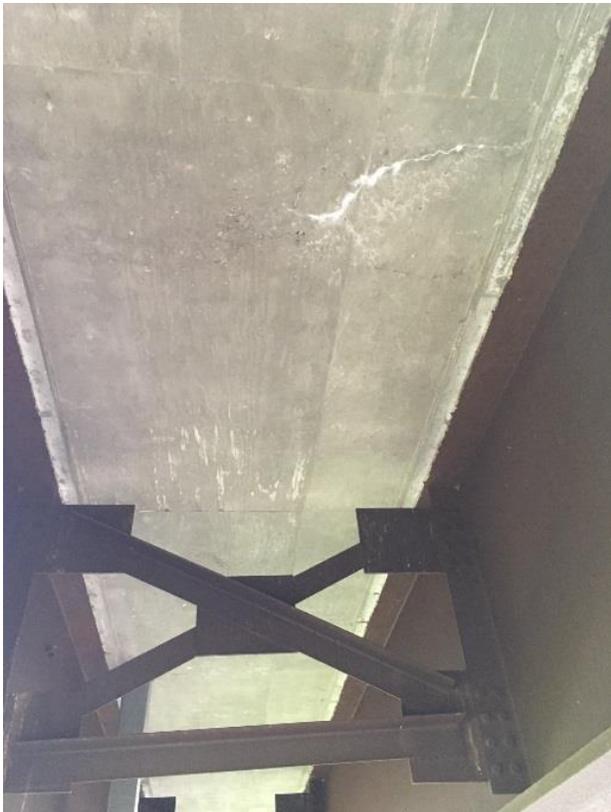
No new cracking or deterioration was visible on the underside of Bridge 86. A white substance was found protruding from what seems to be a crack in a concrete deck slab. No moisture was present along the crack making it likely that the white substance is either evidence of the Eliminator membrane sealing a prior concrete deck crack during the application of the membrane or the leaching of calcium from the concrete structure, a sign that the concrete is degrading and deteriorating. A closer inspection of the crack would have to be conducted to determine whether it's one or the other.

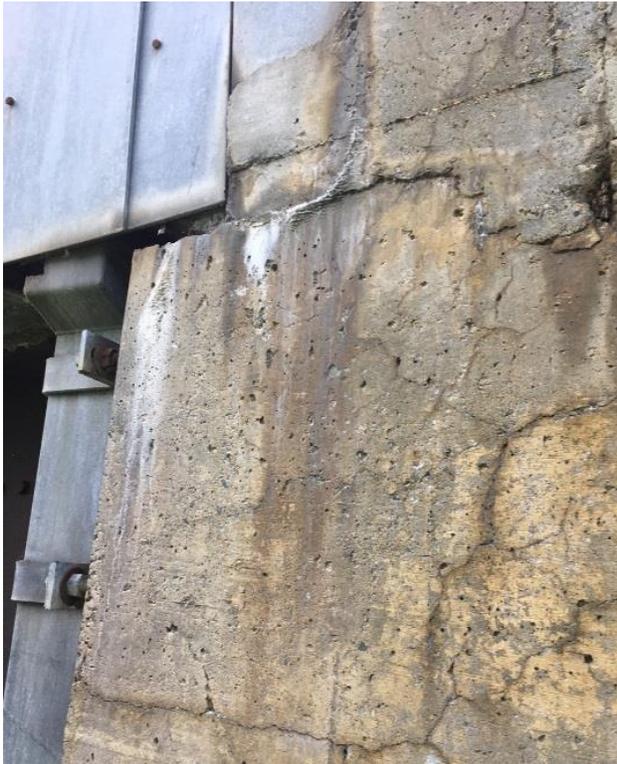
Bridge abutment cracking and deterioration on the West side of Bridge 1.

The Bridge Management and Inspection Unit conducted their last inspection on 7-26-2017. The inspection personnel concluded that Bridge 1 was in good condition, but noted that there was some scaling at the eastern abutment which would need patching in the near future. They also noticed some minor erosion to the northwest corner of the west abutment below the drain, which could also use some repair. This type of deterioration was also observed during the Research site visit and can be seen in the abutment image. The structure inspection, inventory and appraisal sheet can be found ([here](#)) and the July 26th 2017 photos can be found ([here](#)).

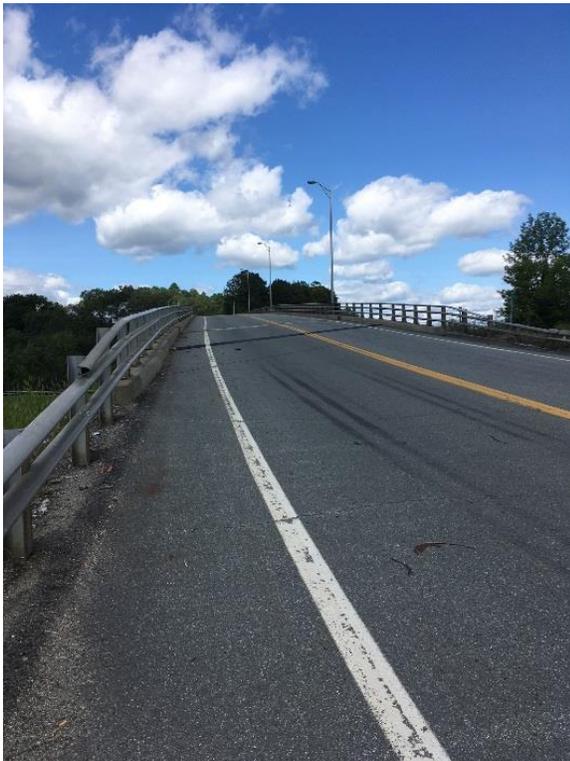
Overall view of Bridge 86 on VT 2B, St. Johnsbury VT. The photo was taken on the Southeastern approach of the bridge, looking Northwest over I-91. Longitudinal and transverse cracks were observed throughout the ramp or approach on the Southeast side of Bridge 86.

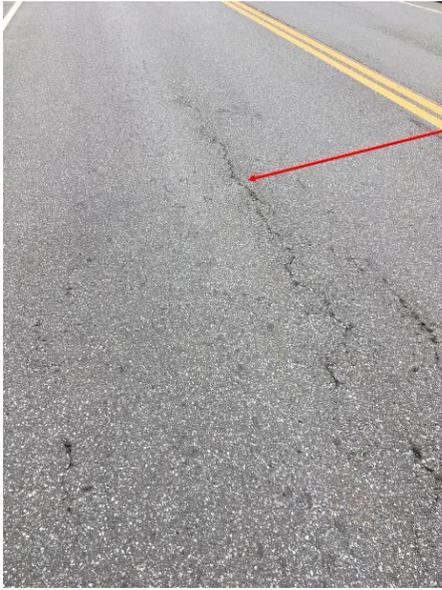
Minor Transverse Cracking in Northwest bound travel lane

Minor localized longitudinal cracking occurring on the Northwest bound travel lane near the Northwest end of the bridge was observed during the recent site visit. It was also noticed during the prior year's site visit. Field observations showed that there were five longitudinal cracks that ranged between 1' to 10' in length. At this point it is inconclusive if the cracking is correlated in any way with the performance of the Eliminator Membrane. Water from the pavement surface through the bridge deck would be evidence of a membrane failure. No water dripping through the sealed cracks was found, when an inspection of the underside of the bridge was conducted during the site visit, shown in the following figures.

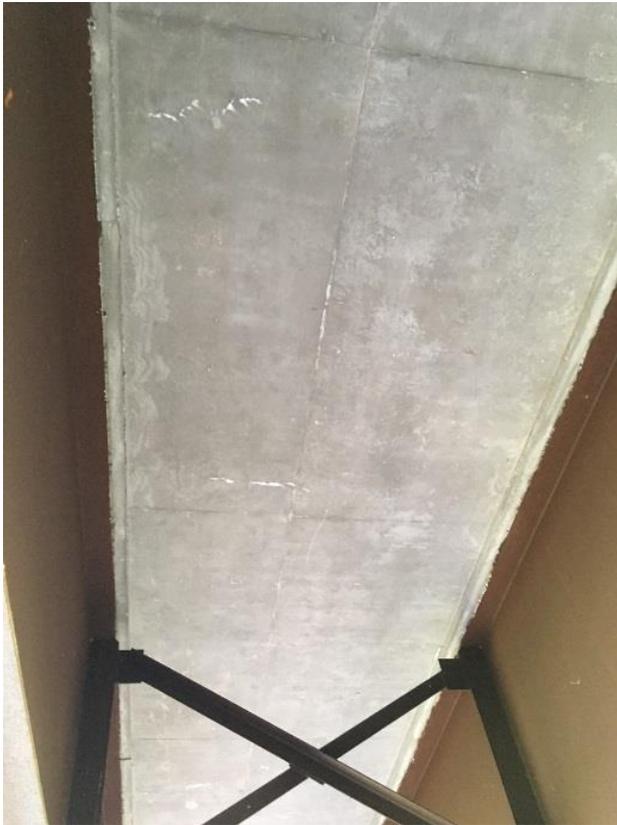
No new cracking or deterioration was visible on the underside of Bridge 86. A white substance was found protruding from what seems to be a crack in a concrete deck slab. No moisture was present along the crack making it likely that the white substance is either evidence of the Eliminator membrane sealing a prior concrete deck crack during the application of the membrane or the leaching of calcium from the concrete structure, a sign that the concrete is degrading and deteriorating. A closer inspection of the crack would have to be conducted to determine whether it's one or the other.

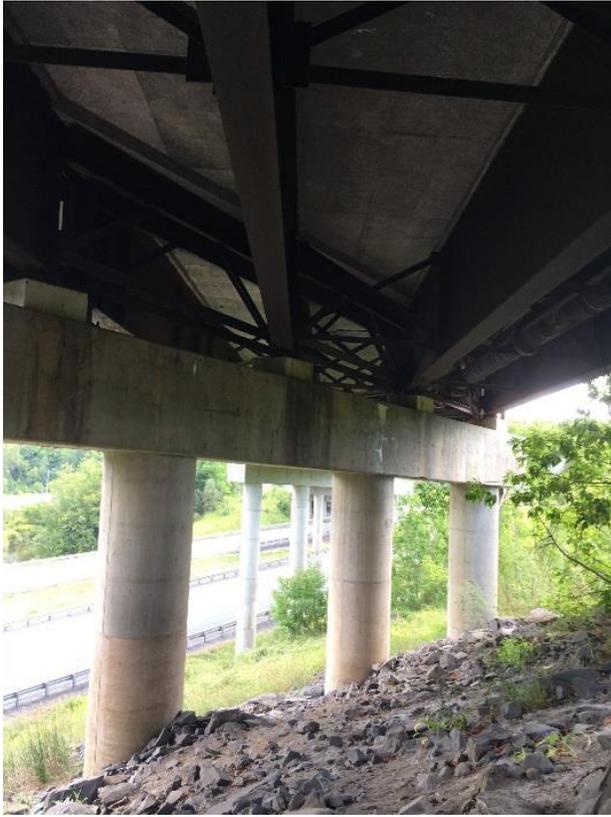
Full view of the underneath of Bridge 86, near the Northwest abutment looking towards the Southeast end of the bridge.

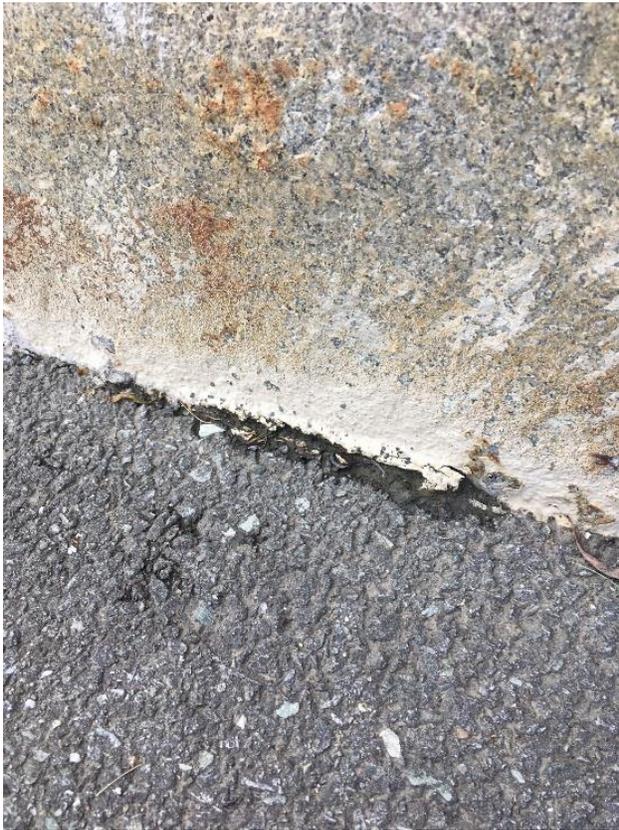
The bridge curb shows overspray (white) that occurred during installation of the Eliminator membrane.

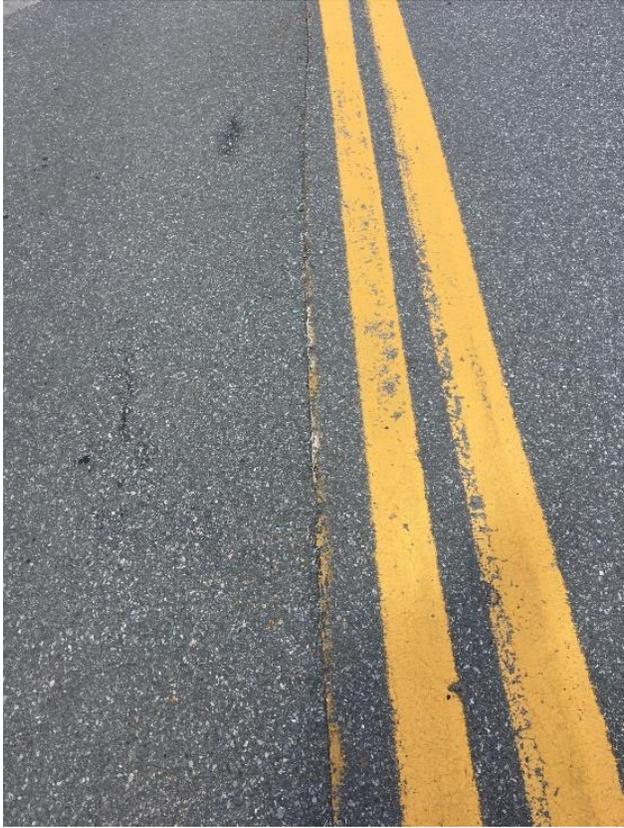
Close-up of the paving joint on Bridge 86.

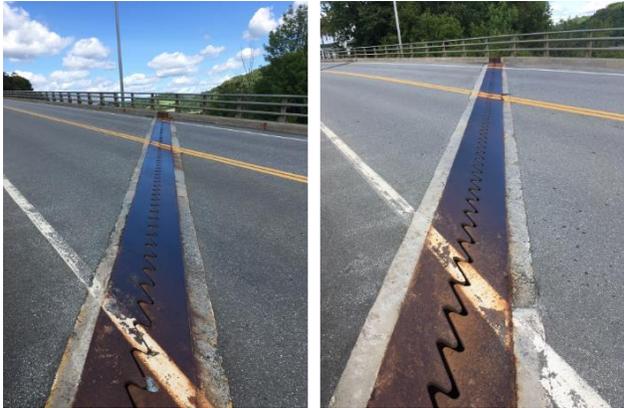
The photo on left shows the bridge joint on the Southeast end of the bridge, while the photo on the right shows the bridge joint on the Northwest end of the bridge. Both the Northwest and Southeast bridge joints were in excellent condition, where little to no deterioration is evident.

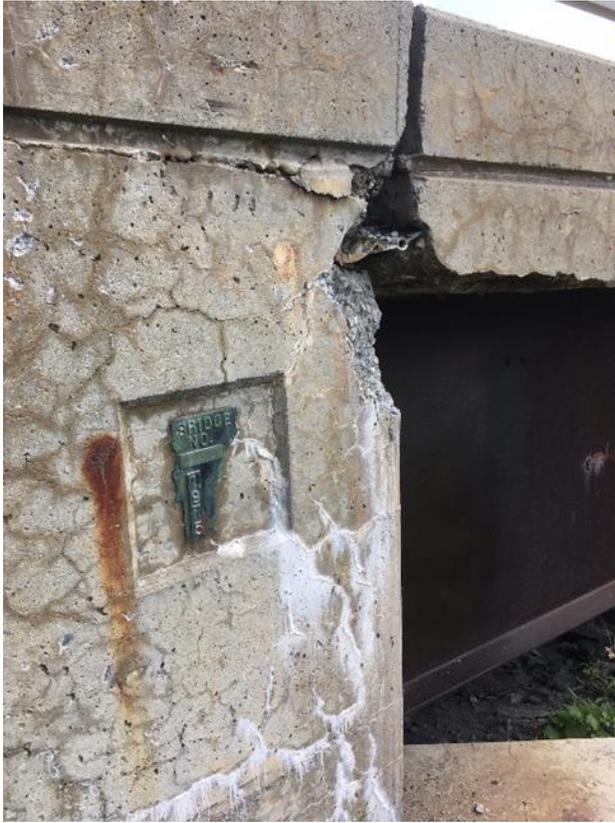
Close-up of Bridge 86 fascia near the Northwest end. As mentioned in the above abutment image, storm water run-off is most likely attributing to the observed fascia deterioration.

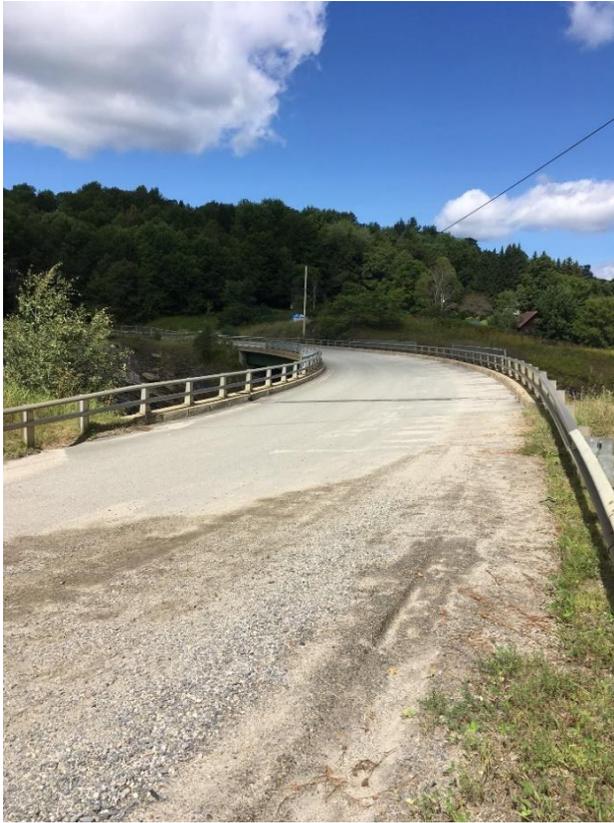
Overall view of Bridge 89 on Pleasant St. (TH 4) over I-91, St. Johnsbury VT. The photo was taken on the westbound travel lane facing west. The section of Pleasant St. is a gravel road and loose aggregate gets pushed onto Bridge 89. The aggregate seems to pile on the westbound lane and minor potholing and washboarding was observed on the east end approach.

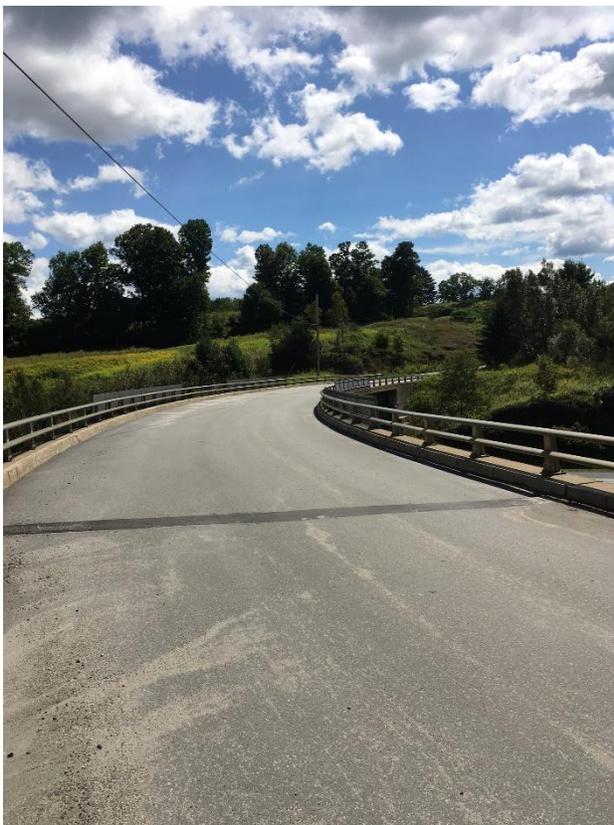
Overall view of Bridge 89 on Pleasant St. (TH 4) over I-91, St. Johnsbury VT. The photo was taken on the westbound travel lane facing east on the west end of Bridge 89. Loose aggregate was observed on the end of the westbound lane.

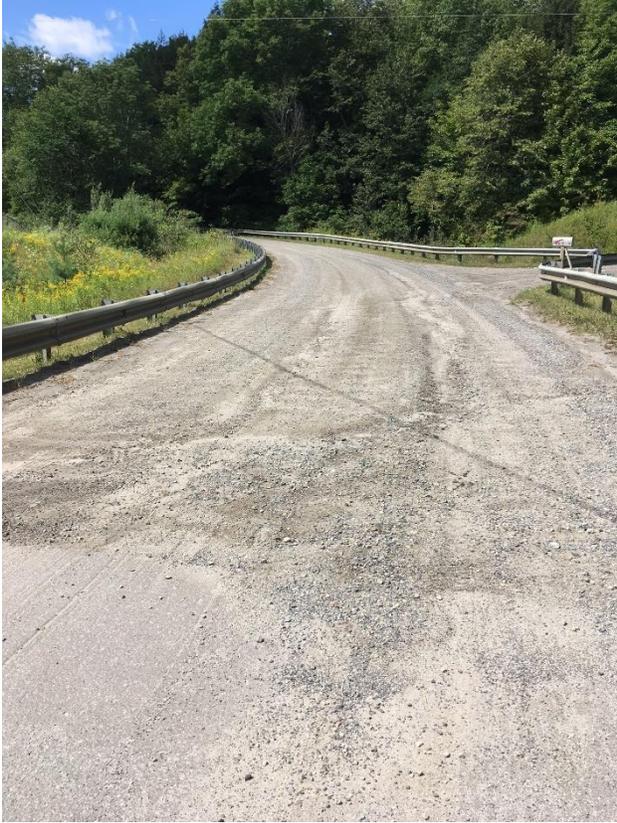
Some potholing and washboarding was noticed on the west end approach of Bridge 89.

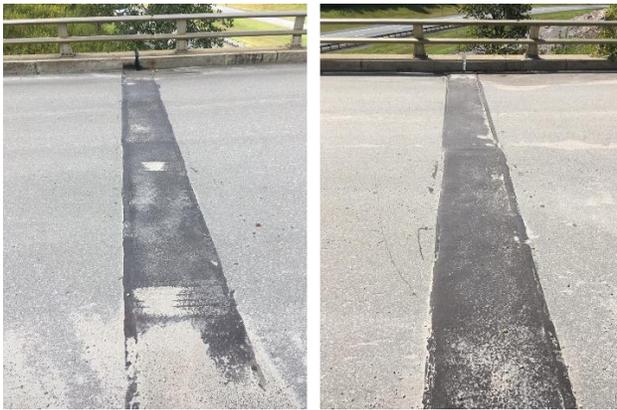
The photo on the left shows the bridge joint on the east end of the bridge while the photo on the right shows the bridge joint on the west end of the bridge. The bridge joints were in good condition.

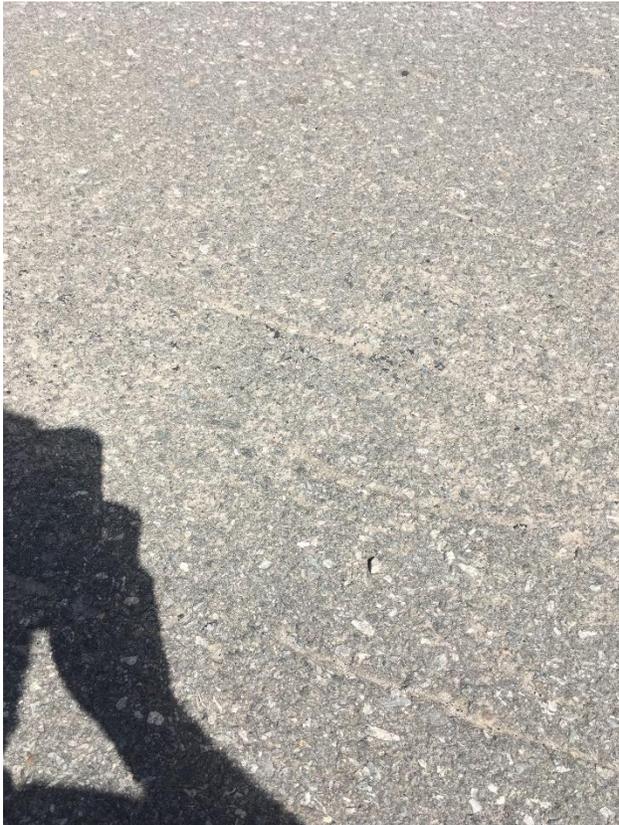
A close-up observation of the Bridge 89 pavement overlay shows some surface deterioration. The observed scratches were seen throughout the bridge deck and are most likely attributed to the loose aggregate being pushed around by the snow plows during the winter months.

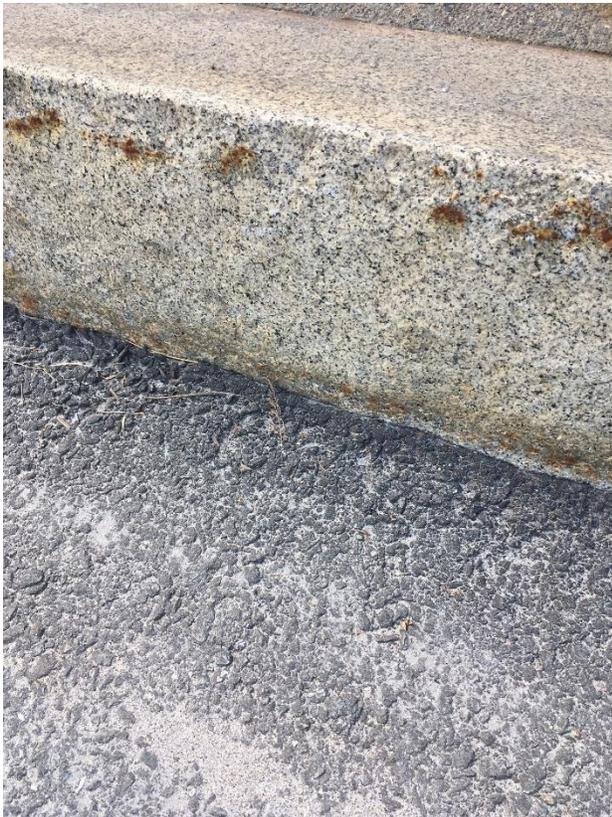
Since a standard torch applied membrane was installed on Bridge 89, the close-up photo of the curb reveals no signs of overspray from the installation of the membrane. This is due to the different application method used when installing the standard torch applied membrane.

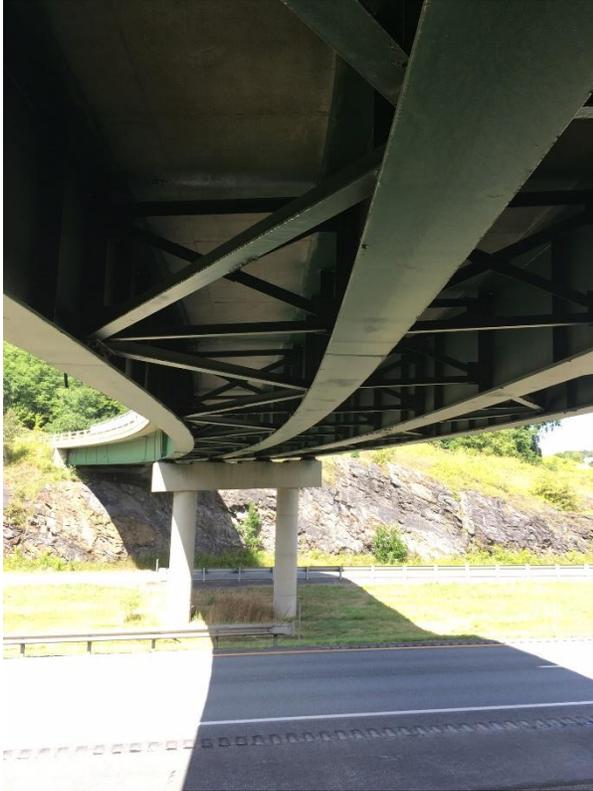
Full view of the underneath of the Bridge 89, near the east abutment looking towards the west end of the bridge. No new cracking or deterioration was visible on the underside of Bridge 89.

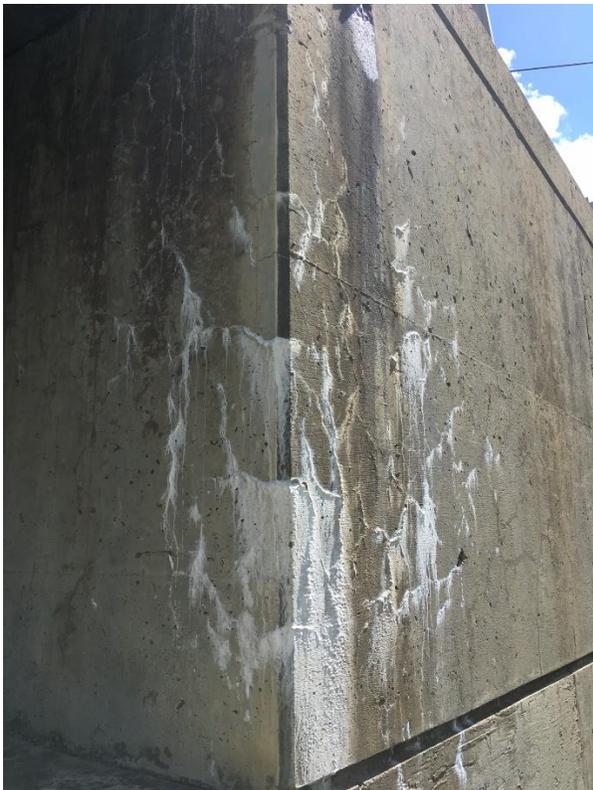
Bridge abutment cracking and deterioration on the east end abutment corner of Bridge 89. The white substance was found protruding from the abutments cracks are most likely leaching of calcium from the concrete structure, a sign that the concrete is degrading and deteriorating.
