FINAL FIELD REPORT

U2017 - 05

**Assessment of the Jahn Permeable Mortar System In a Historic Bridge
Abutment Application**

Bridge 45 Site Visit – Town Highway 2 near US 4, Woodstock VT

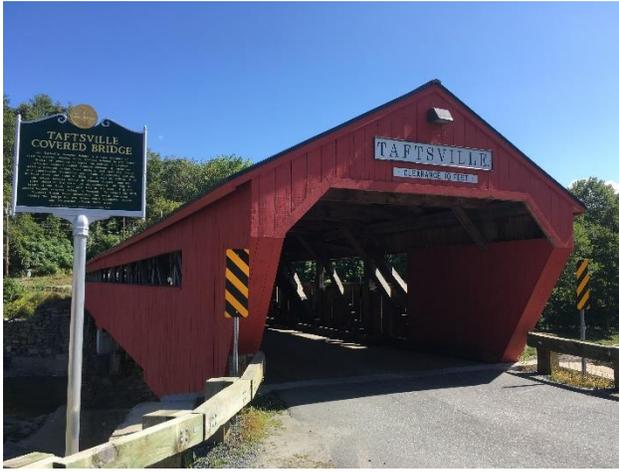
Front view of the Taftsville covered bridge on Town Highway 2, Woodstock VT.

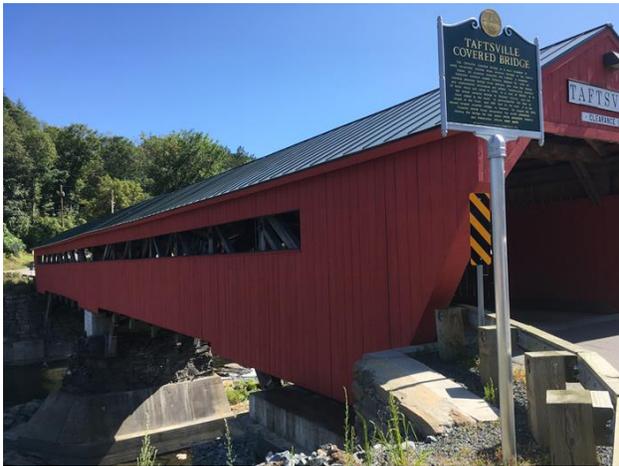
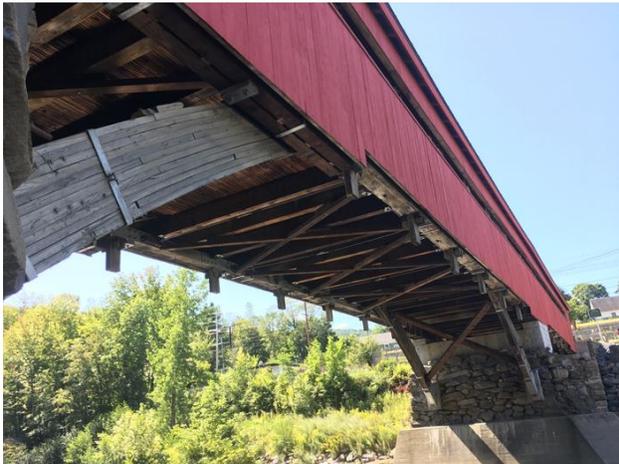
The top photo shows the overall view of the Northside wall of Bridge 45 looking towards the east, while the bottom photo shows the same Northside wall of the bridge, only looking towards the west.

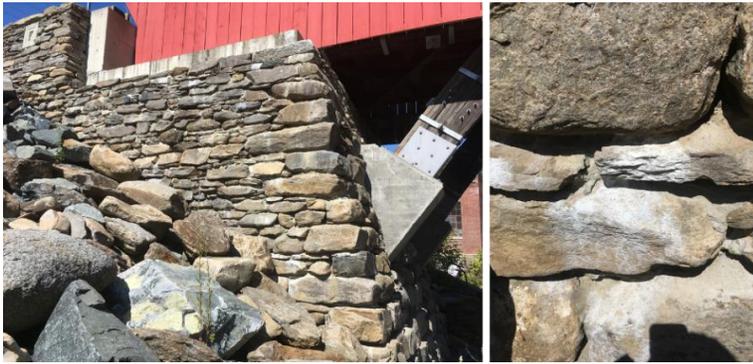
The left photo shows the overall view of the Southside wall of the west abutment, while the photo on the right shows a close-up view of a powdery residue (most likely chlorides) leeching out of the mortar of the Southside wall of the west abutment. The observed residue stains consisted of two different colors, yellow/orange and white/gray. The yellow/orange stains might be indicating that the mortar is drawing out other minerals besides chlorides or that steel elements are deteriorating within the abutment.

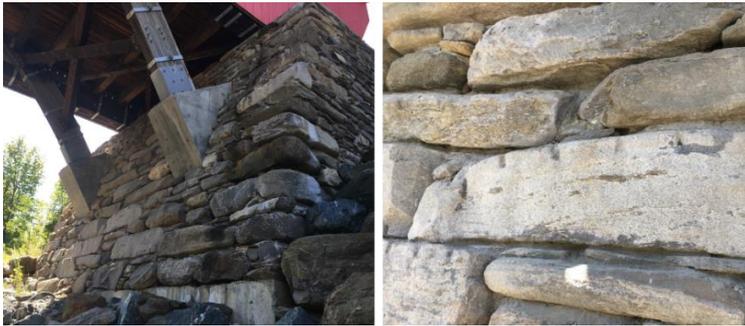
The left photo shows the overall view of the eastside wall of the west abutment, while the photo on the right shows a close-up view of the same wall and the Jahn mortar. Compared to the Southside wall (above photo), the Jahn mortar on this wall seemed to have a more historic and aged, faded gray look. Yellow/orange discoloration or residue was not prevalent on this wall.

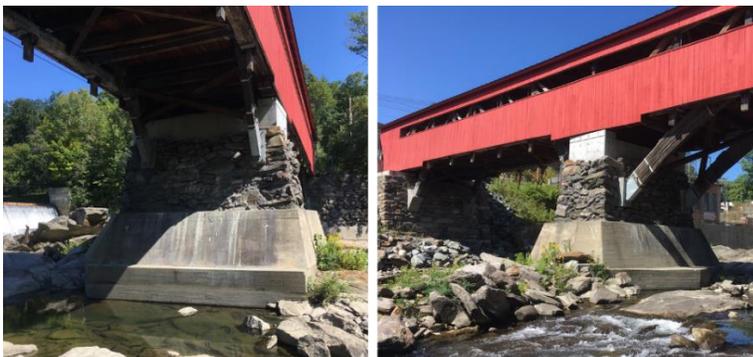
The left photo shows the Westside wall of the middle pier, while the photo on the right shows both the south and east walls of the middle pier. The water level was too high to get a close-up look of the mortar around the middle pier, but from a distance the mortar on the south and west facing walls seemed more of a dark grey color.

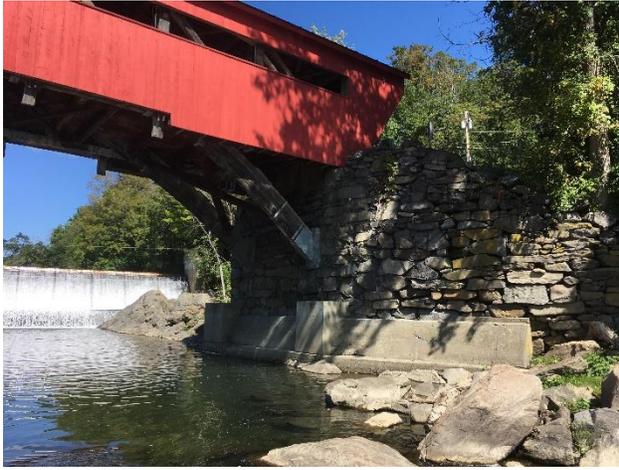
Overall view of the east end abutment of Bridge 45.

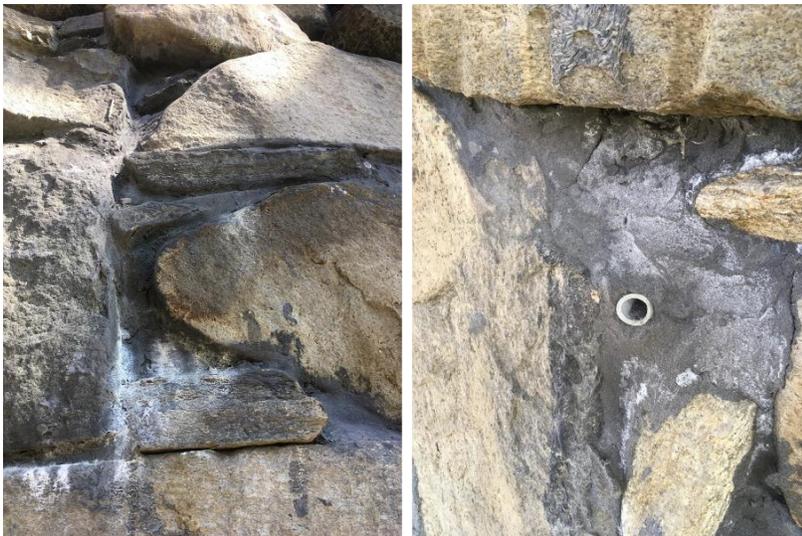
Both the photos are close-up views of the west wall of the east abutment. Both photos show the powdery residue (chlorides) leeching out of the mortar, but the right photo also shows PVC tubes that aid in the draining of moisture within the east end abutment. It was noted that the mortar on the west wall of the east abutment was a darker grey.
