**MATERIALS & RESEARCH SECTION**

**RESEARCH UPDATE**

U2013-03

**Assessment of Detectable Warning Products**

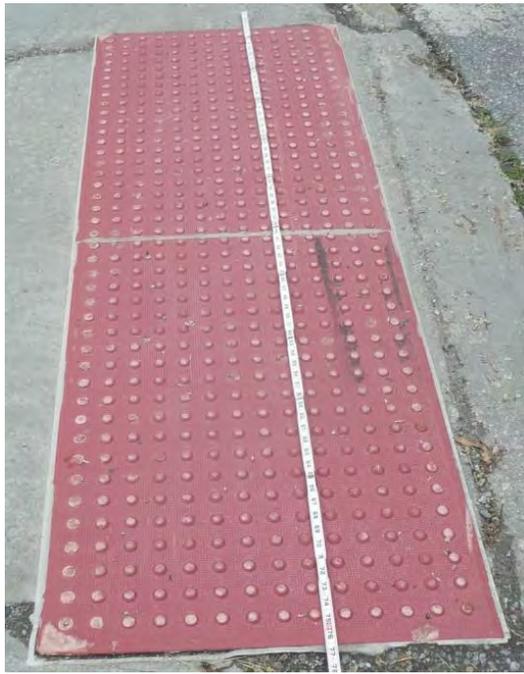
2009

The panel system was still fairing well. The domes on the leading and trailing edges of the panel were missing. The corners show additional wear from the 2006 observations. The joints began to show some wear. Since this is the only surface applied panel on the APL and the overall condition is fair, the product was listed on the APL with conditional approval. It was determined that annual monitoring will be conducted.

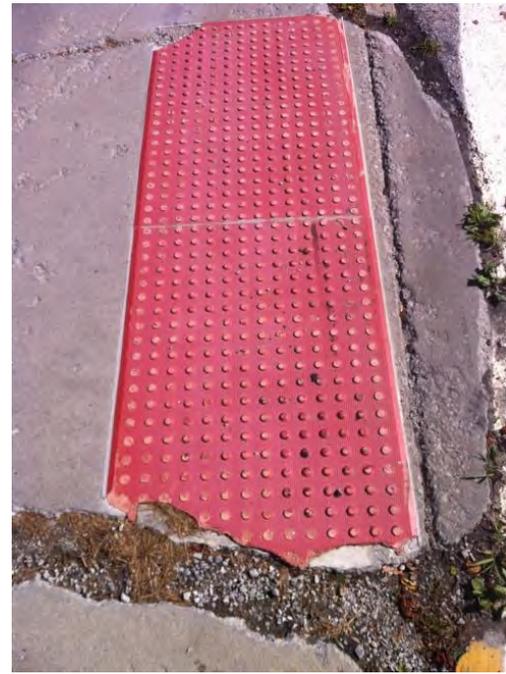
2013

The site visit revealed some significant corner and edge loss. Since the panel is surface applied, the updated pictures reveal the pieces of the panel are missing along where the cracked sidewalk has been removed. The domes are in fairly good shape except for ones closer to the edge which experienced much more wear. The panel continues to exhibit satisfactory friction. The years have faded the color slightly, but overall the panel is in fair shape. The panel could be a viable option if more care was taken during construction.

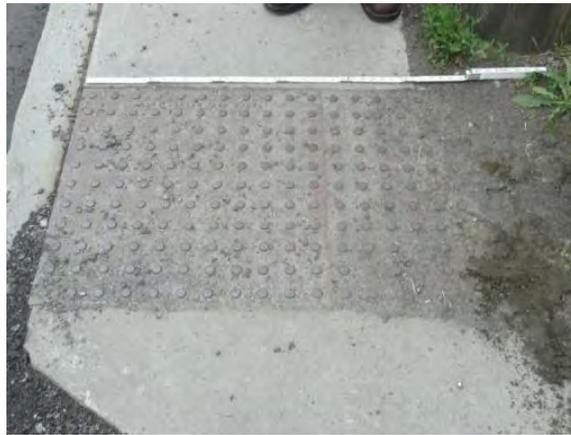
**Figure 3: East Jordan Works – Detectable Warning Plate in 2009**

The panels were in good condition with some domes sheared on the perimeter. There were some concerns over color contrast. It was recommended to leave the product with full approval on the APL. Annual monitoring will continue to be conducted with special attention to the color.

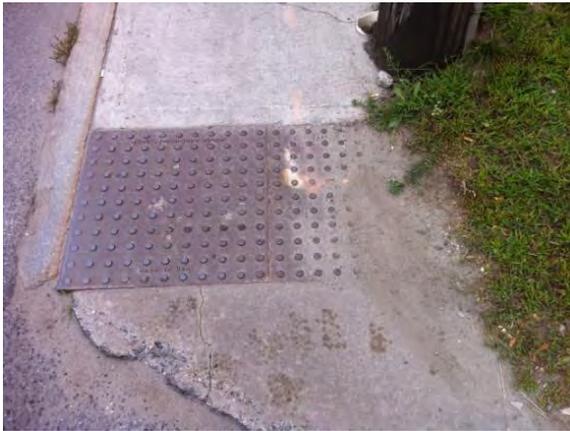
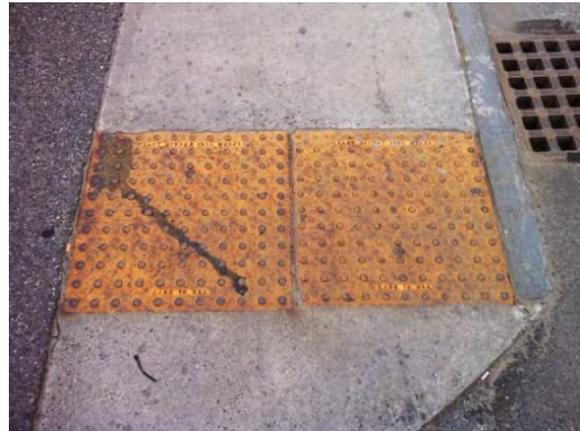
**Figure 4-5: East Jordan Works – Detectable Warning Plates 2013**

After 8 years of its installation, one of the panels is structurally in good condition. The other panel appears to have been replaced between the years of 2009 and 2013 for unknown reasons. The side walk has begun to crack and wear away on its edges and is beginning to wear underneath the panel. Dirt and grass are also covering approximately  $\frac{1}{4}$  of the panel. Both panels have experienced wear and are slightly slick on the domes. Slight rust bleeding has occurred and the color is all but gone on the original panel. The replaced panel still has some of its yellow coating.

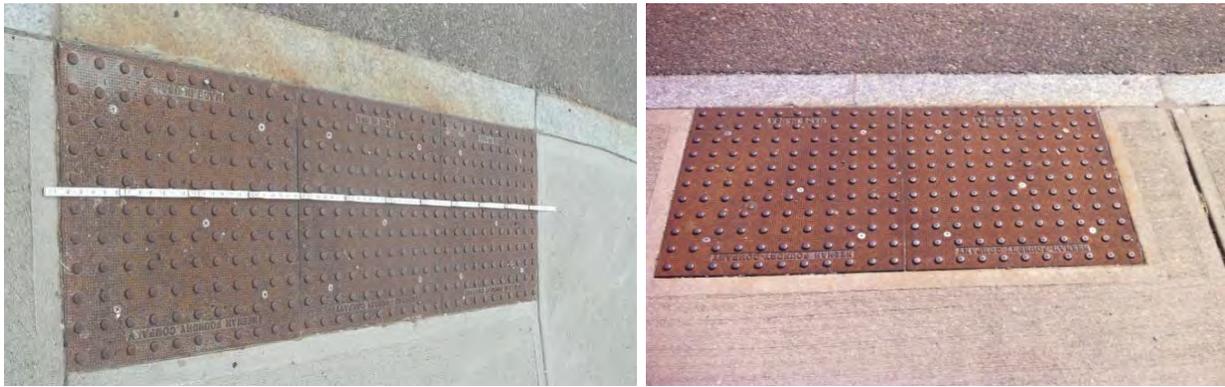
**Figures 6-7: Neenah Foundry Co. – Detectable Warning Plate.**

The panels were in great condition. The rust bleeding has diminished and all domes are intact. It is recommended to keep the product as approved without conditions on the APL. Annual monitoring will be conducted.

Still in excellent condition, the panels show little wear and only minor rust bleeding. The texture on top of the domes is slightly worn away making it possibly slippery in wet conditions. The brown rust colors of the panels stand out well against the pale grey sidewalk. The panel will be continued to be monitored.

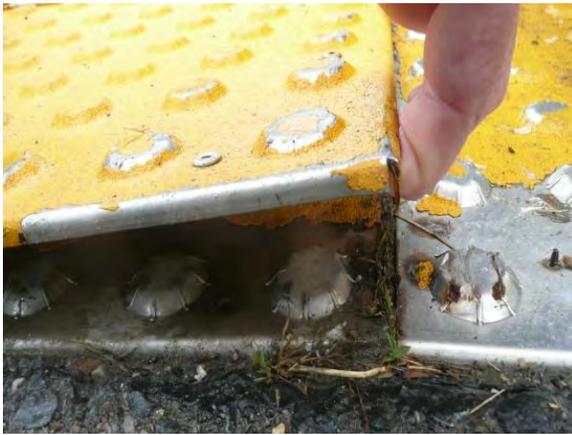
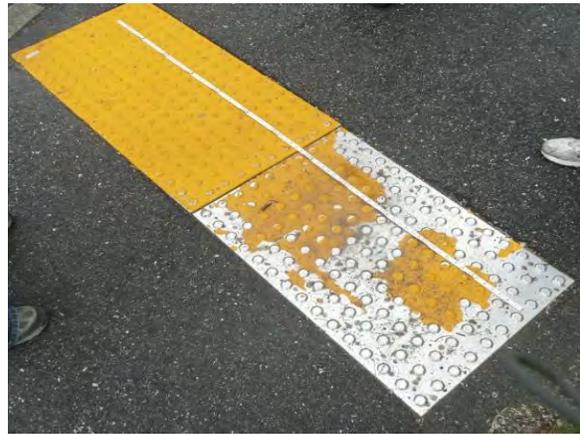
**Figures 8-9: MetaDome, LLC. – Asphalt. 2009**

The original panels were in poor condition. Additional panels had been added to three of the four original panels. The new panels were not bonded well to the underlying panels, causing the panels to deflect. This could potentially cause a safety hazard. The coating had severely diminished, causing the panels to be extremely slippery when wet. At the time it was recommended that the product be removed from the APL. This was the only asphalt panel that was on the APL.

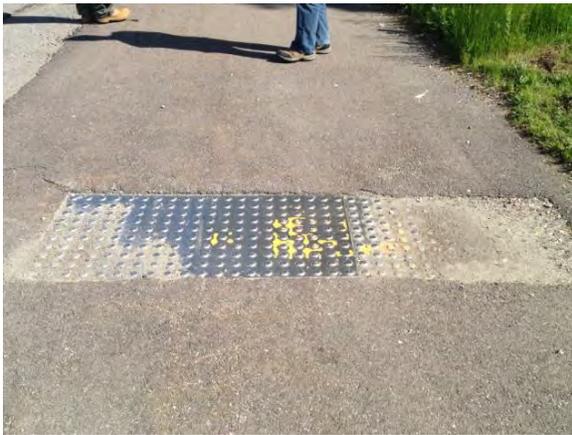
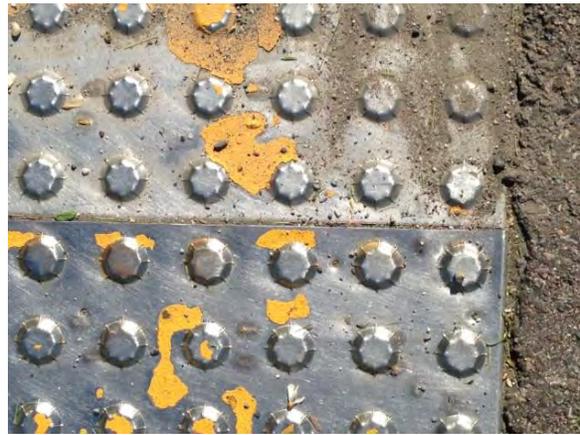
**Figures 10-11: MetaDome, LLC. – Asphalt. 2013**

Site visited in early June. Panels have lost virtually all color and covered with sand and gravel. Roughnesses of panels are low and quite slick. It appears the underlying panels are still not bonded well and in some places can be pulled up. Since 2009, the product has been removed from the APL.

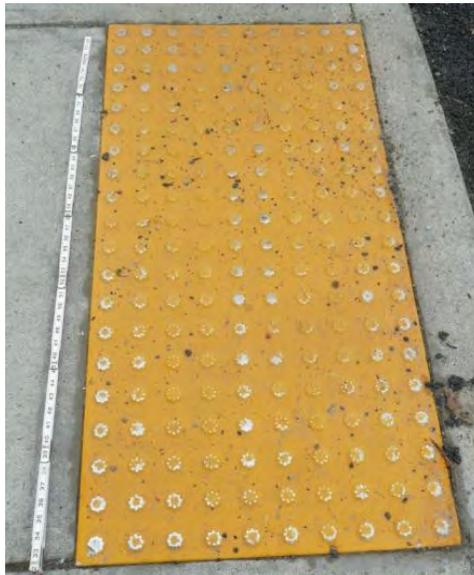
2009

Although much of the surface coating had delaminated, the panels were considered to be in good condition. The panels were accumulating a fair amount of dirt and debris. This is presumably due to the nearby construction project. It is recommended that the product remains conditional on the APL. It was decided that annual monitoring would be conducted.

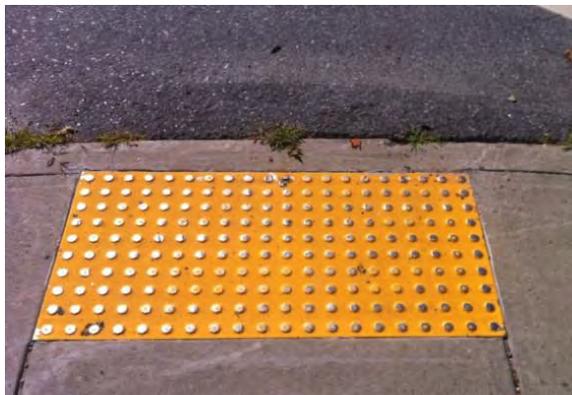
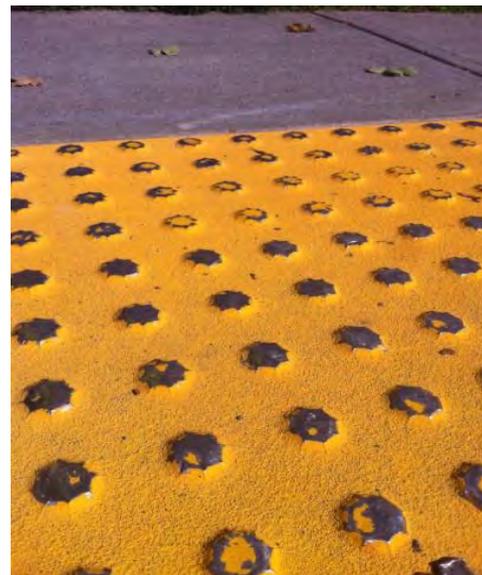
Figures 12-14: MetaDome, LLC. – Concrete.

The panels are in fairly good shape. The prominent yellow color has retained its vibrancy on the face of the plate. Most of the color has worn off of the domes, making them significantly more visible. The plate appears to provide some friction, but with rain the panels could

potentially become slightly more slippery due to the steel. Just about all edges are intact though they display slightly more wear than the middle of the panel. A few of the domes experienced significant removal most likely due to a sidewalk plow. Overall the panel has endured excellently.

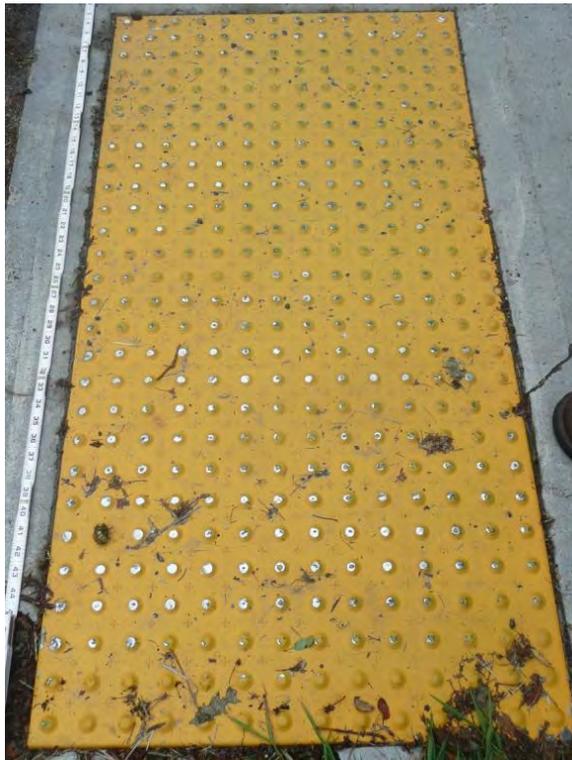
2009

The panels received minimal additional wear. The coating was faring well and had little delamination since 2006. It was recommended to leave the product as conditional approval on the APL. Annual monitoring would be conducted.

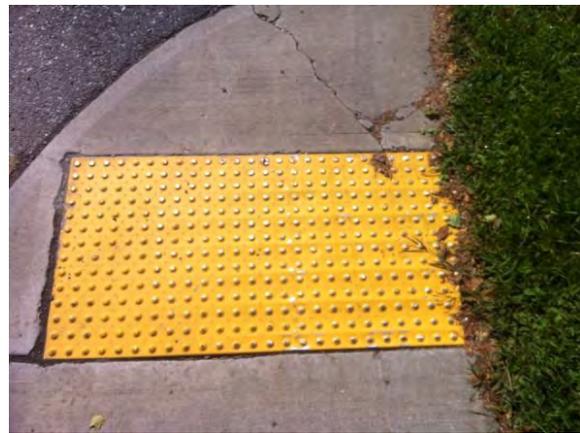
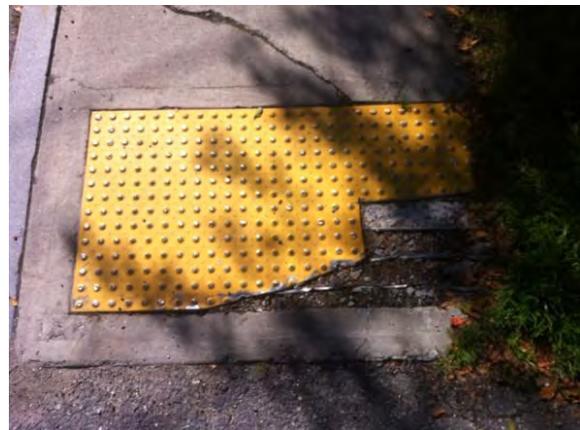
**Figures 15-17: Advantage Tactile Systems, Inc. – Stainless Steel Panel.**

The two panels on the side street have mixed results. One panel is in fairly good condition with excellent color and structural intactness. The other panel appears to have been slightly ripped up possibly due to plowing, and then was cut out. The color and dome integrity is still good on the rest of the panel. Both panels have good roughness and are not that slippery, though conditions could be different when wet. If placed in another location, these panels have potential to a viable product.
