# VERMONT AGENCY OF TRANSPORTATION Research Section

Dr. Ian Anderson, Research Engineer March 6, 2019 – Reporting on Work Plan 2018-R-02 Initial Report 2019-06

# Recycled Asphalt Shingles (RAS) in Town Gravel Roads-Initial Report

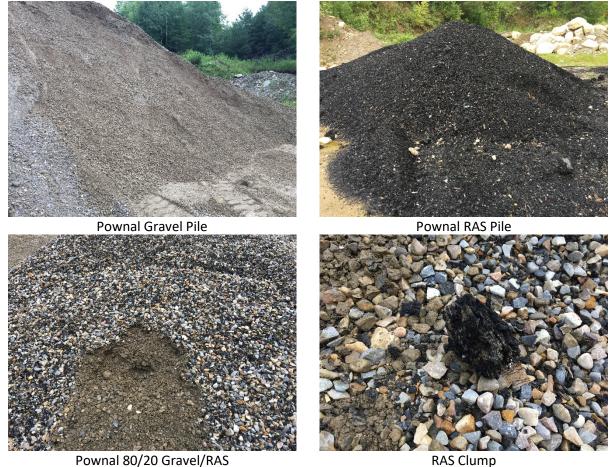
Figure 2: Pownal Materials to be used in test section

The RAS used in the Pownal test section was not compliant with AASHTO MP-23. The RAS used had larger than 3/8" maximum aggregate size, contained a not insignificant amount of debris and particularly worrying 18 nails (two of them steel) were removed by hand from roadway after placement. Photos of the materials are available in Figure 2.

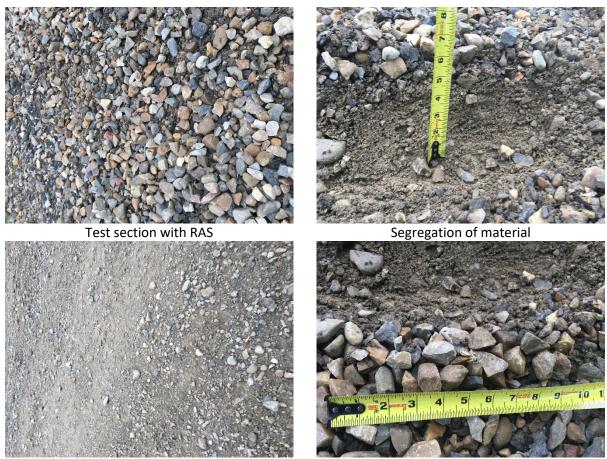
Figure 5: More Failure Photos, September 2018

Washboards quickly developed as a result, and performance was very poor. Investigation of the roadway during VTrans' visit on 9-7-18 showed segregation of materials and that below the coarse surface, a compact and well graded aggregate existed.

Control section with conventional gravel

Dimensions of displaced aggregate

Upon discussion between VTrans, VTANR-DEC, and town staff, the larger stones were raked off of the surface, and the roadway was regraded and rolled with a larger roller in early September. Town staff report good performance of the roadway in the following days until a rain event caused the large aggregate and RAS to again float to the surface. Observations indicate that the second failure was not as severe as the first.

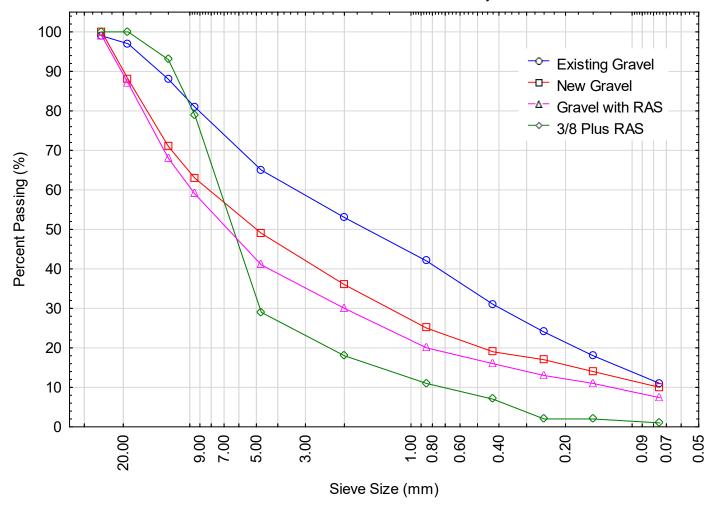
Figure 7: Pownal Grain Size Distribution

Sieve analysis showing the breakdown of the various materials can be seen in Table 1 and the distribution in Figure 7. Samples of the new gravel used in reconstruction show a higher proportion of material above ¾". The RAS sampled was found to be above the 3/8" minus targeted for the project, as shown in Table 1, where 21% of the material is retained on the 3/8 sieve. The combined gravel with RAS has a larger gradation than the virgin aggregate, and is a potential cause of the surface instability.

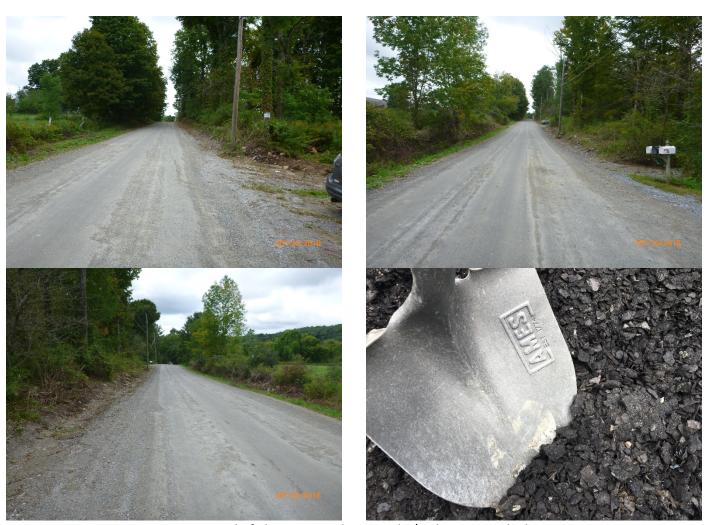
Figure 9: Shaftsbury precondition, and 3/8 Plus RAS stockpile

The town of Shaftsbury, in SW Vermont, was sent 64 tons of RAS from Myers Recycling in Colchester. The RAS was mixed at 20% by mass with gravel from William E. Dailey, Inc. (Peckham Industries Subsidiary). The RAS used was approximately comprised of 50% RAS at minus 3/8", and 50% RAS not passing 3/8". The test section (Figure 8), located on Myers Rd (unrelated to Myers Recycling) is approximately 1000ft long, with a 600ft section of between 6-7% grade, and a flat 400ft section. The roadway is uniformly 20ft wide. The existing roadway had a 3-4% crown, with several sections being noticeably flatter. Precondition of the roadway can be seen in Figure 7.

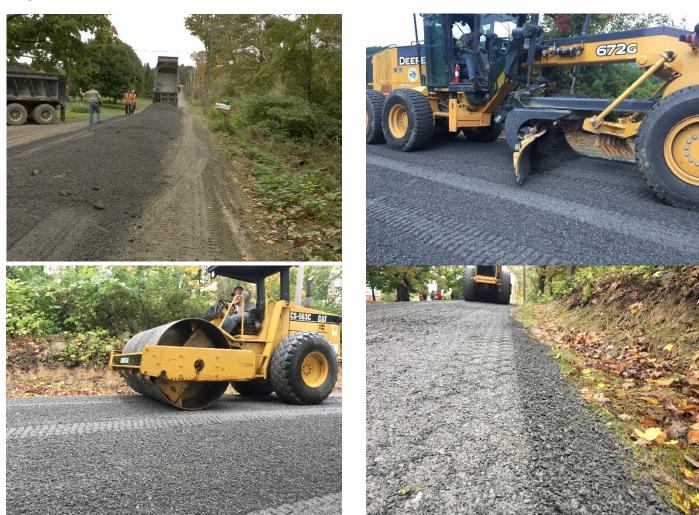
Figure 10: Shaftsbury Resurfacing

Prior to regrading and adding new gravel with RAS, ditch clearing maintenance was performed. Roadway surface construction took place on 10-2-18. Construction of the road followed typical Town procedures, with the additional step of using a roller to compact the material. The existing roadway was regraded to shape, adding crown to achieve 6-7%. Effort was made to ensure the roadway width did not creep out into the ditches, and ensure that surface material was maintained on the 20ft travel section. The gravel was dumped in successive loads onto the center of the roadway, and spread with a grader until a thickness of 2-3 inches was achieved. Large clumps of RAS were observed in the material bring spread on the roadway. These clumps are the result of RAS stockpiling, and self-consolidation when stored for extended periods of time. Compaction was done with a 13.75 ton smooth vibratory roller, with at least 2 passes over each section. During construction, research staff found 10 nails in the new surface material.

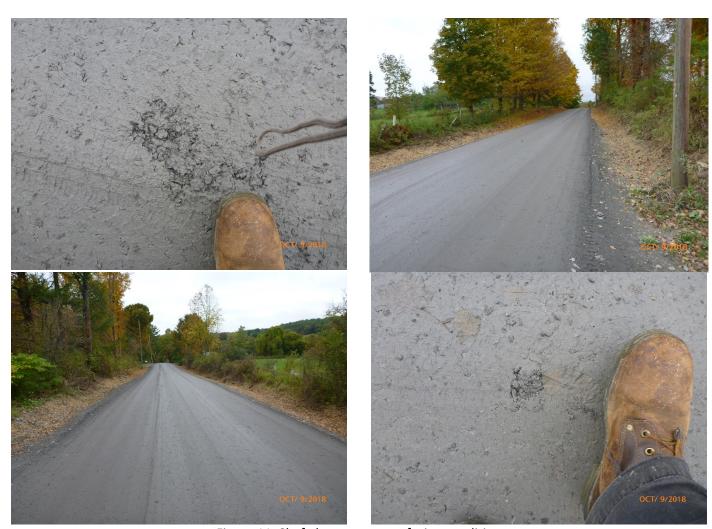
Figure 11: Shaftsbury post resurfacing condition

A follow up site visit on October 9<sup>th</sup>, showed that the roadway is well consolidated, and tightly packed. Feedback from the local road foreman following the reconstruction have been positive, with no maintenance needed as of February 2019.

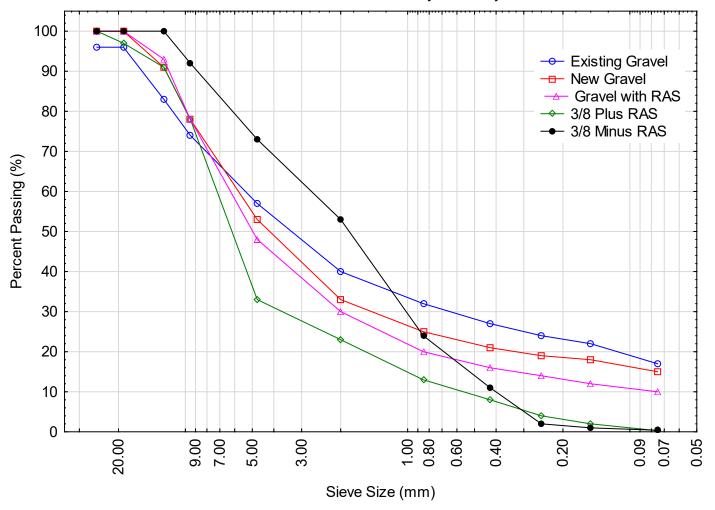
Figure 12: Shaftsbury Grain Size Distribution

Sieve analysis showing the breakdown of the various materials can be seen in Table 2 and the distribution in Figure 13. Samples of the new gravel to be used show similar gradation to existing roadway. The larger RAS sampled was found to be above the 3/8" minus that was intended for the project. A sample of the finer RAS had only 8% above the 3/8" screen, much closer to the proposed material target. The combined gravel and RAS has a larger gradation than the virgin aggregate, but does not yet appear to substantively change its performance.
