ASSESSMENT OF POLY-CARB FLEXOGRID BRIDGE DECK OVERLAY SYSTEM

Ian Anderson, Research Engineer
Vermont Agency of Transportation
Research Section

April 2019

Final Report 2019-09

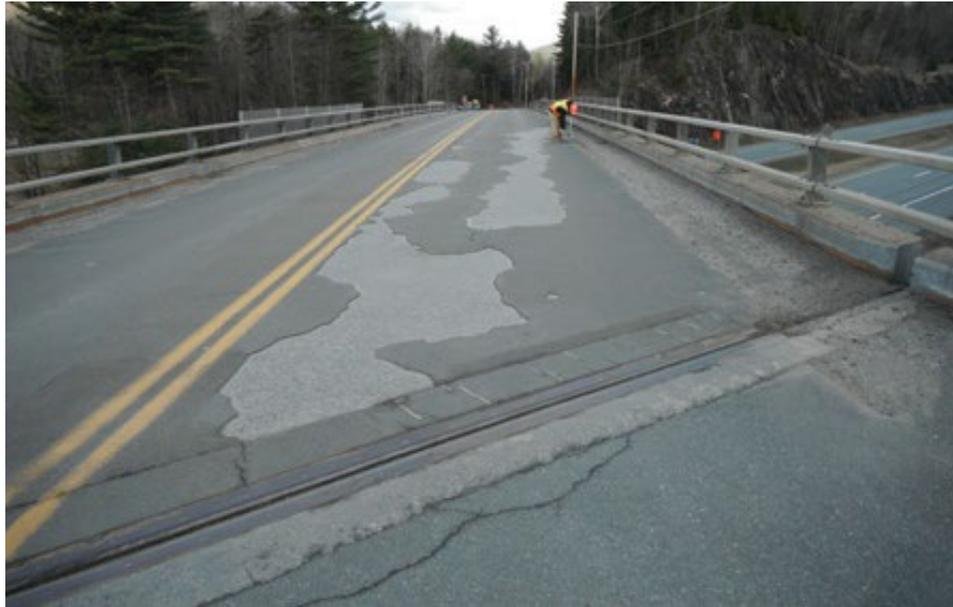
Figure 2: Condition of the previous bridge overlay in 2012

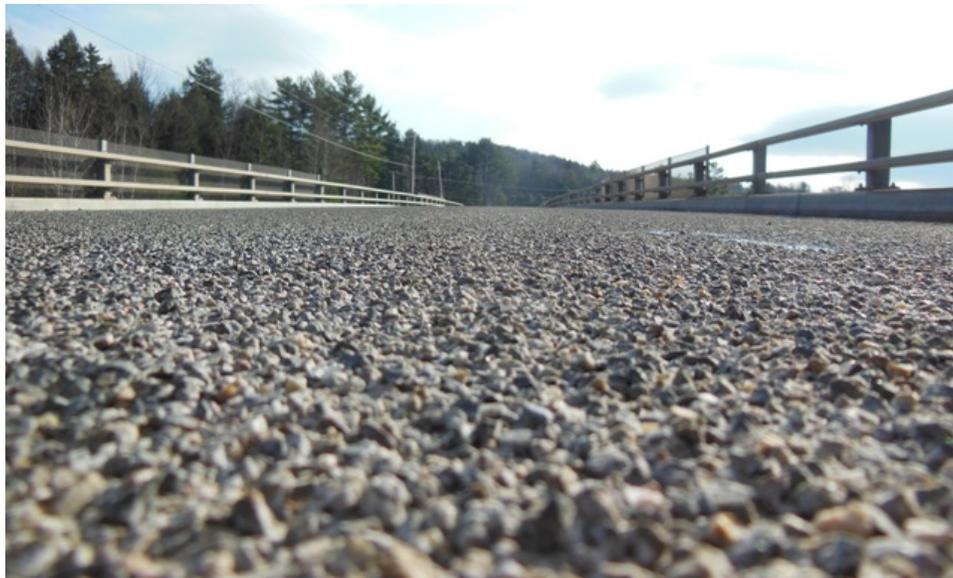
Figure 4: Surface texture of the Flexogrid

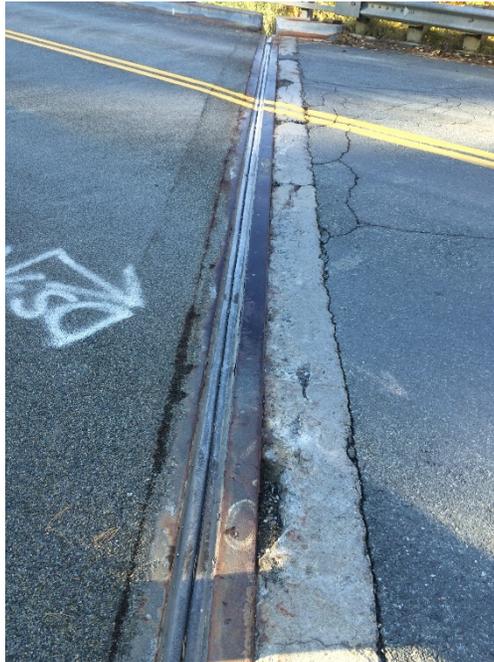
During the third site visit on October 15th 2015, no new surface deterioration was noticed on the bridge deck surface. The only evidence of damage was some evidence of cracking around the bridge joints which can be seen in Figure 5. While the source of this cracking is unknown, it is believed to be caused by damage to the concrete bridge joint underneath the Flexogrid system.

Figure 5: Cracking around bridge joints

The fourth site visit on June 9th, 2016, showed very similar levels of wear to the first site visit a year earlier. The Flexogrid membrane had maintained good condition and showed no new signs of wear. The cracking around the bridge joint had increased slightly since the prior visit. Figure 6 shows the level of wear on the full bridge deck.

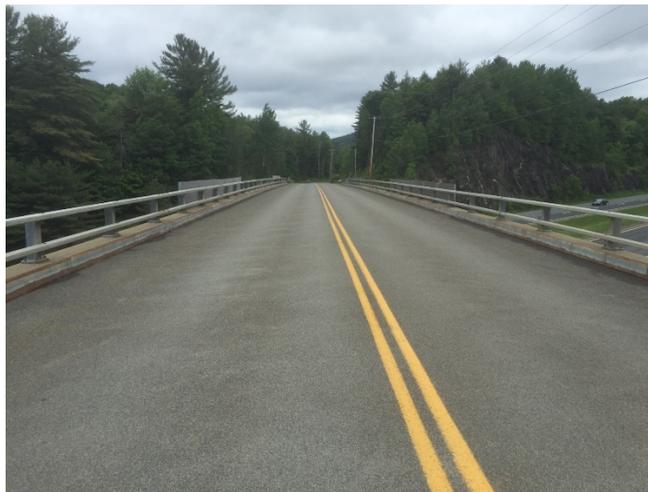
Figure 6: Overall view of Bridge 8 looking northbound

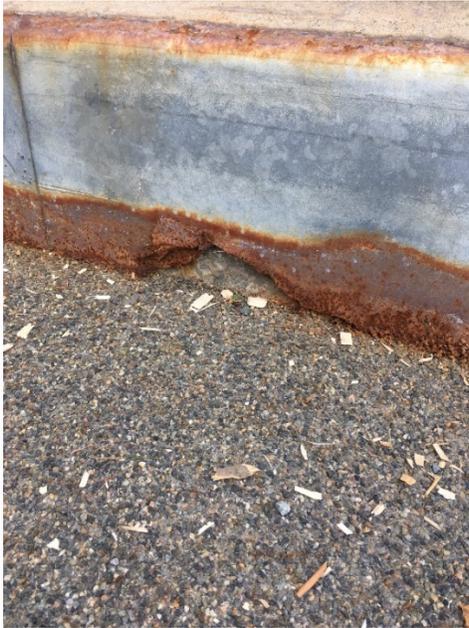
Site visit five was conducted on August 23rd, 2017. During this site visit, slight wear to the wheel paths had begun to appear. Along with this wear, small amounts of loose aggregate from the Flexogrid system surface were found around both the wheel paths and the bridge curb. Given that the Flexogrid system was installed in 2013, the surface is showing excellent resiliency to wear for being in its fourth year of use and had undergone five winter maintenance seasons. Other signs of wear can be seen in the slight rusting of the metal curb protector and the pavement cracking in the north and south approaches to the bridge. This wear can be seen in Figures 7 and 8. The deterioration of the metal curb protector is most likely attributed to the run off from agents used during the 5 seasons of winter maintenance. The north and south-bound approaches to the bridge experienced significant transverse and longitudinal cracking and some alligator cracking. The underside of the bridge along with the bridge abutments were in excellent condition. This is helped by the installation of an extended gutter which has carried the runoff from winter maintenance deicers away from the bridge.

Figure 7: Loose aggregate from Flexgrid surface and rusting of metal curb protector

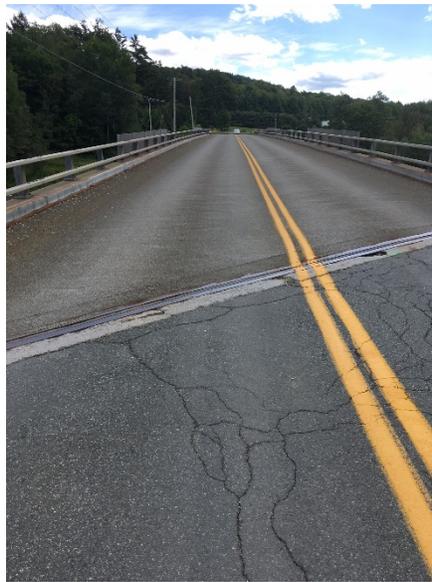
Figure 8: Cracking of southbound approach to bridge 8
