Hydrologic Analysis

History of Rail Line and Channel/Floodplain Modifications  
near Fairfield 2b site, Fairfield, VT.

Attachment E of VTrans Final Report 2018-02

EVALUATING EFFECTIVENESS OF FLOODPLAIN RECONNECTION SITES ALONG THE  
LAMOILLE VALLEY RAIL TRAIL: A BLUEPRINT FOR FUTURE RAIL-RIVER PROJECTS

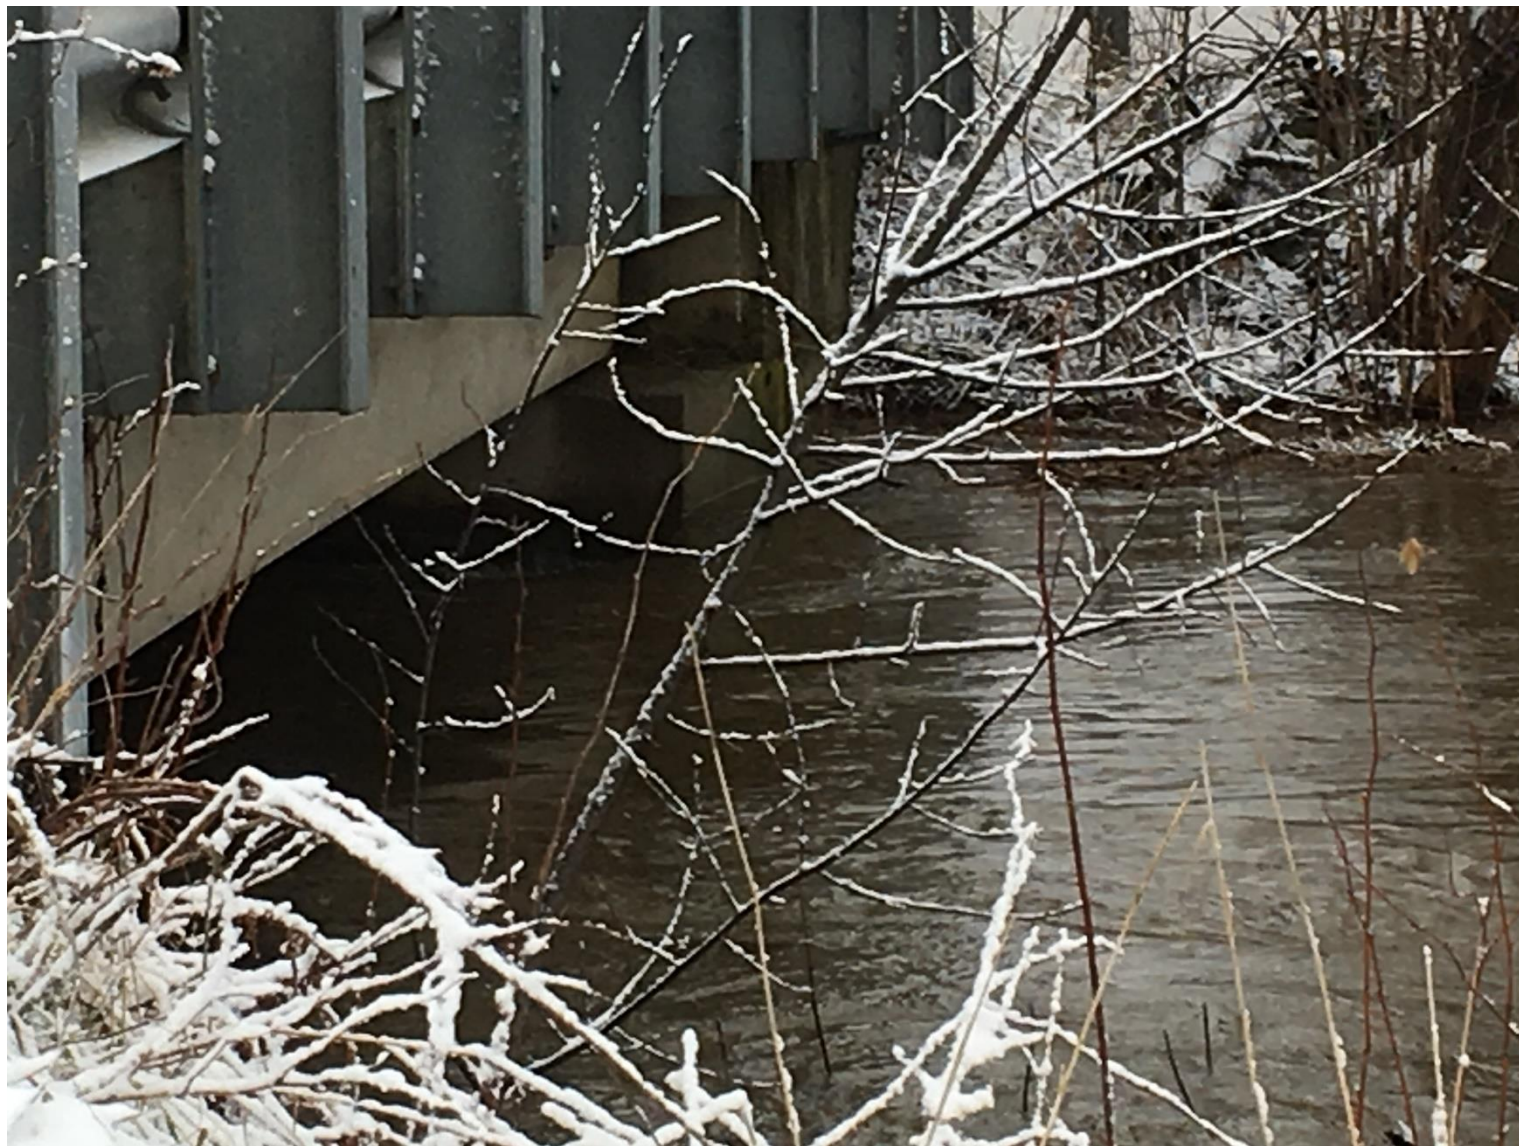
Bridge inlet  
During ~Q5 flood  
12/22/2018

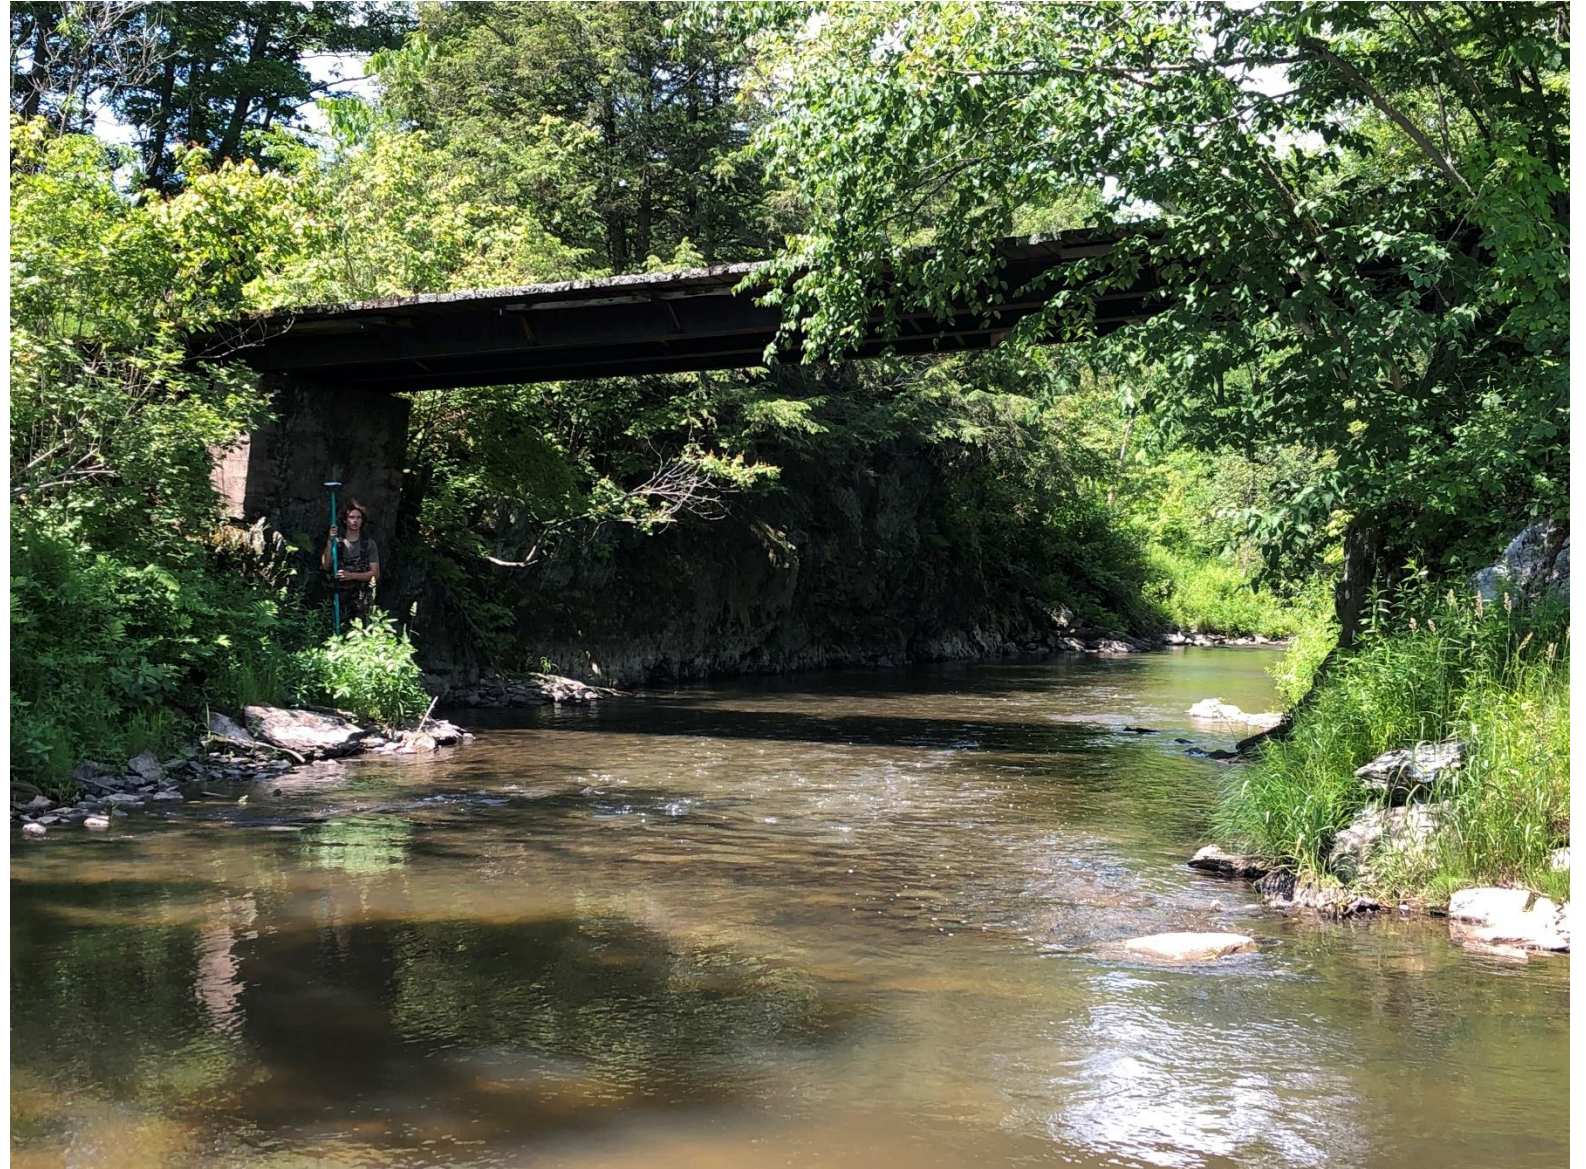
Farm bridge, view  
downstream to bridge  
inlet, 28 June 2019

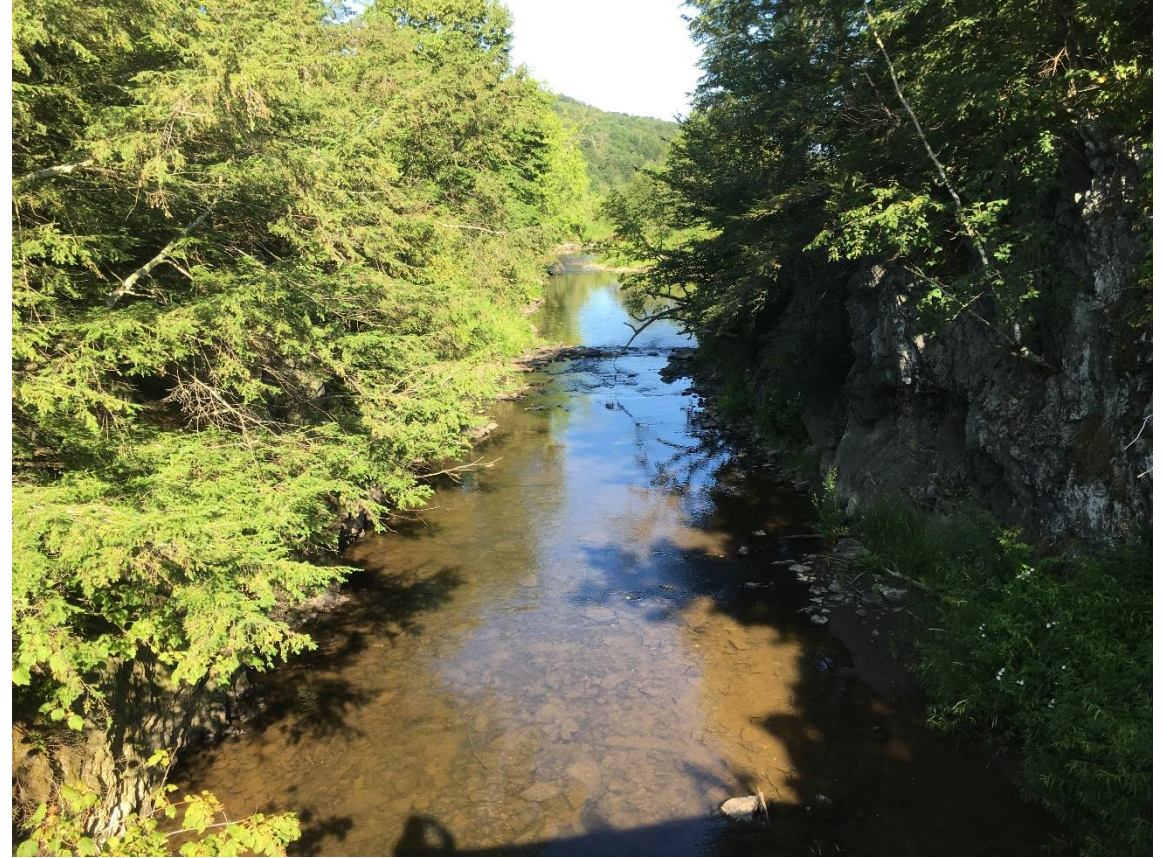
View downstream from bridge deck, 7/24/2019,  
through blasted bedrock channel

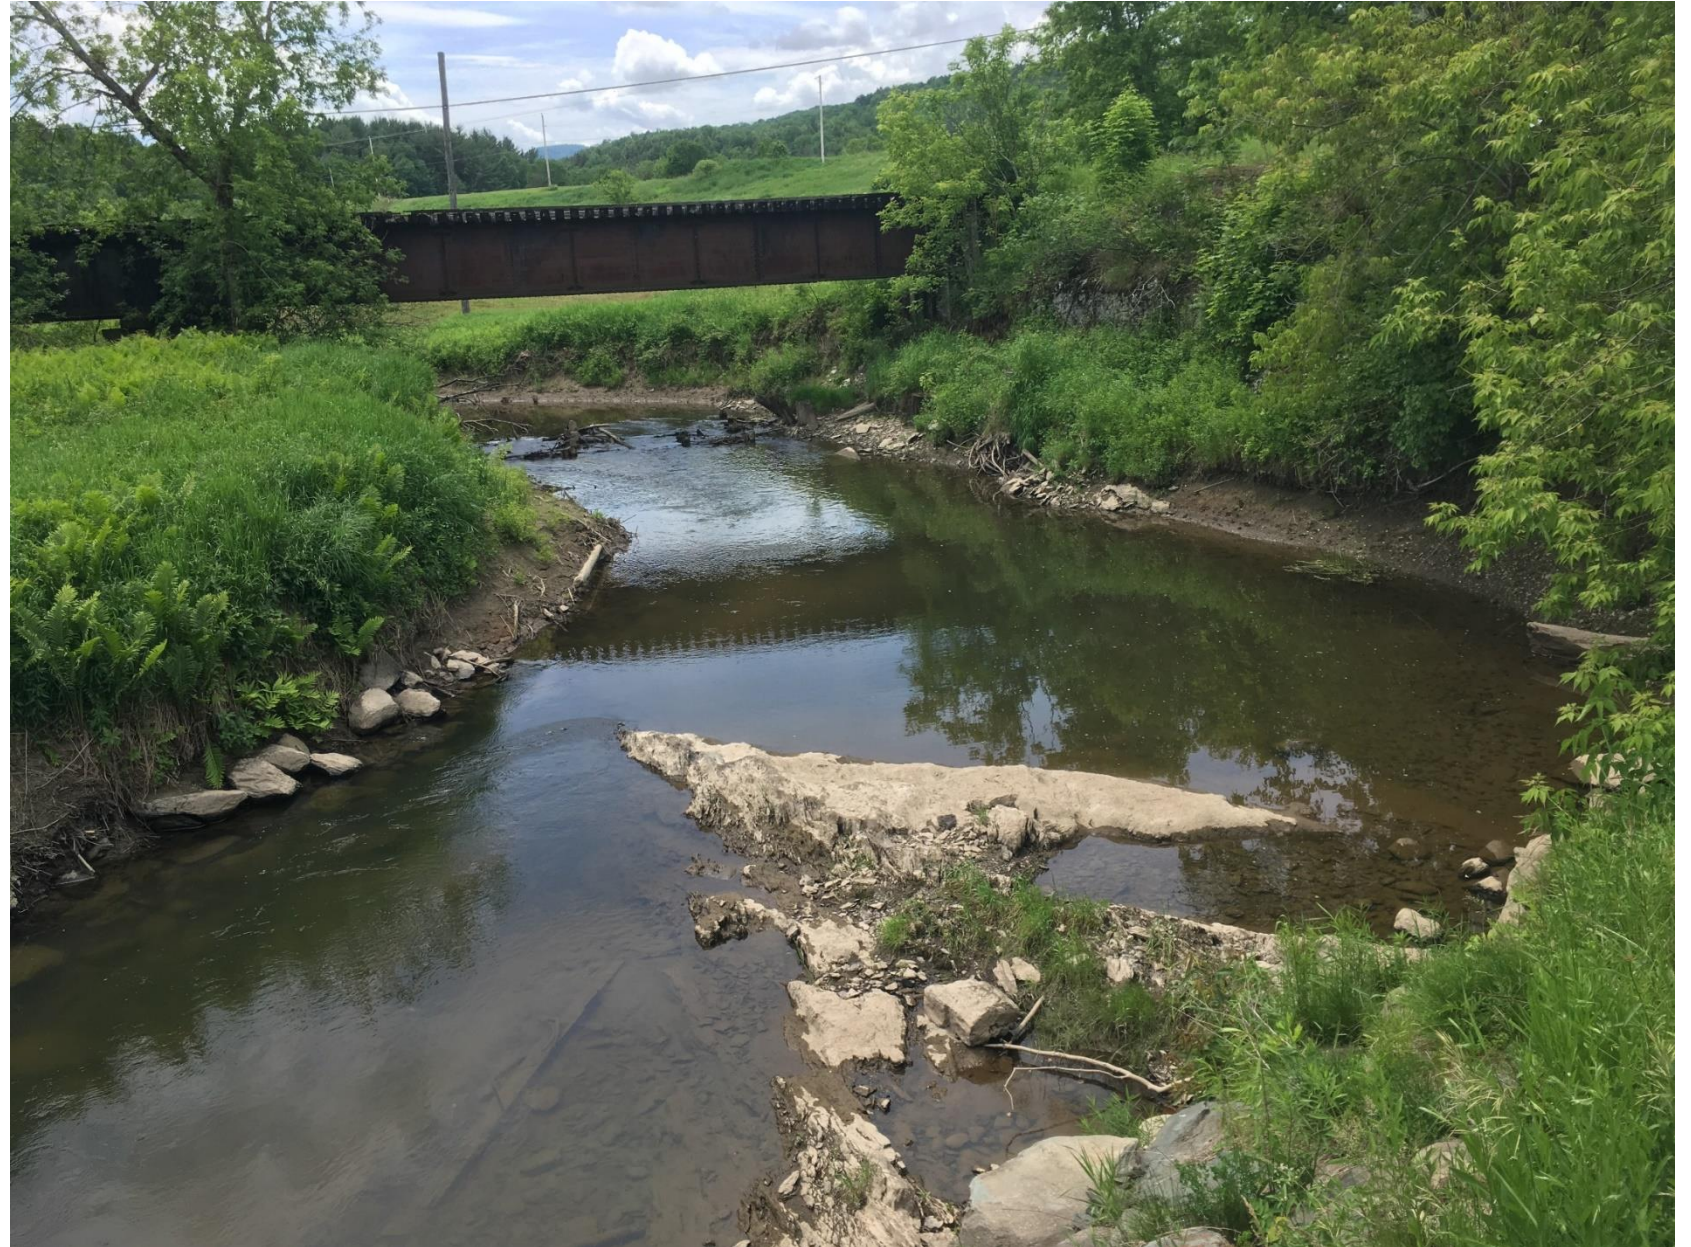
View upstream to  
bridge outlet,  
bedrock exposed  
in the channel.

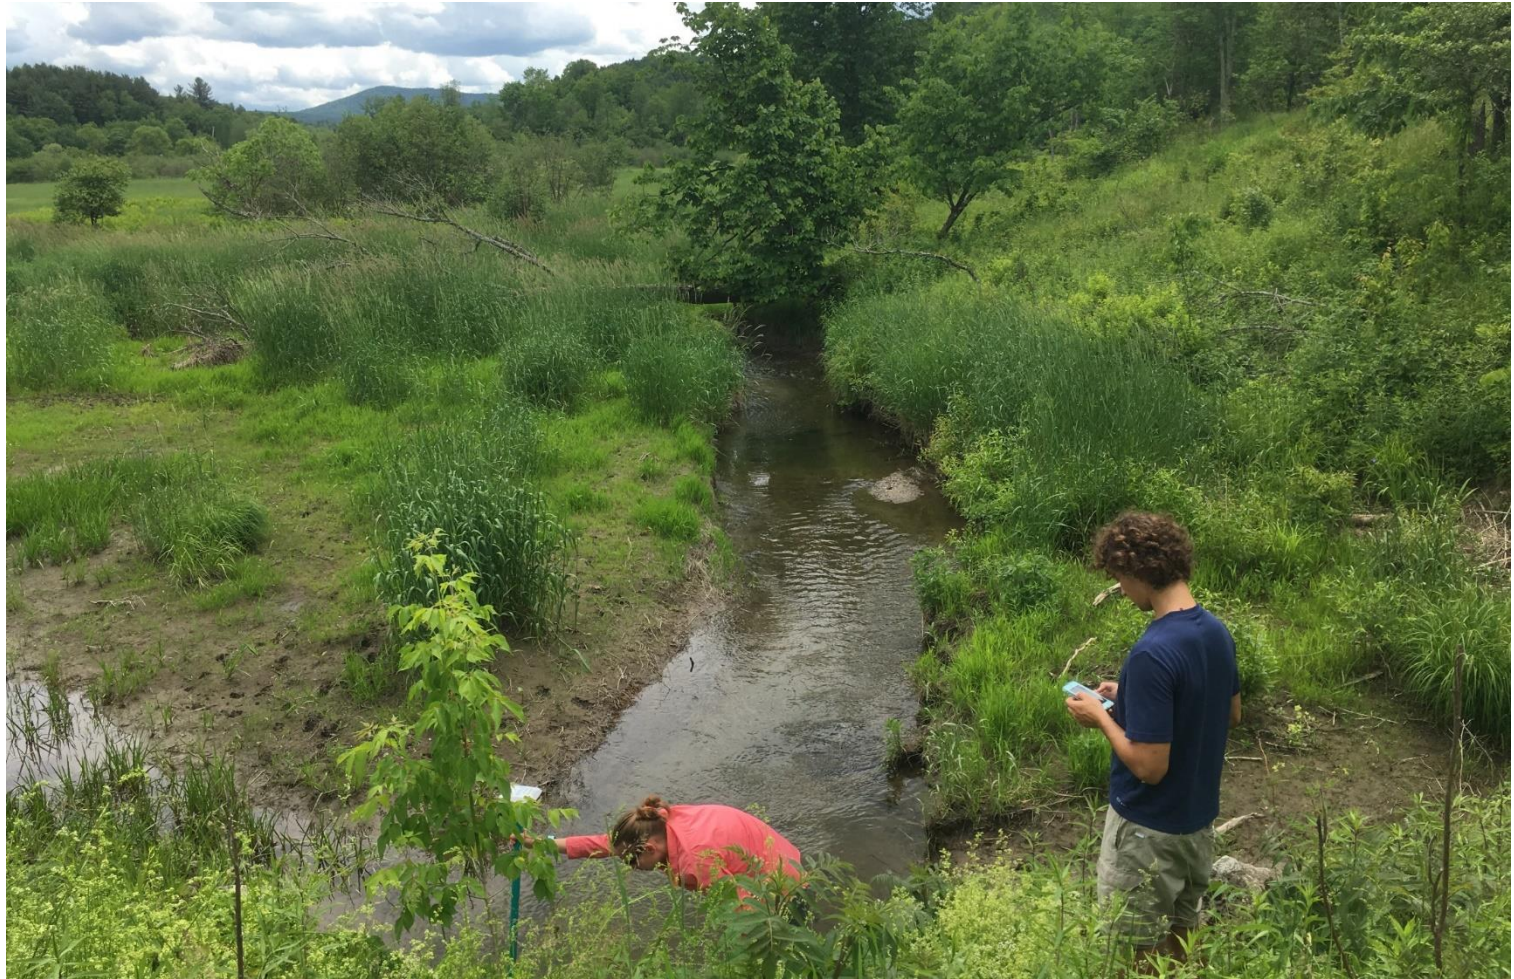
Replaced former smaller culvert in Summer/Fall of **2009** based on photodocumentation by VAST (K. Brown, email, 2/13/2020)

View to south (upstream) from rail trail 19 June 2019; former path of Black Creek prior to 1870.

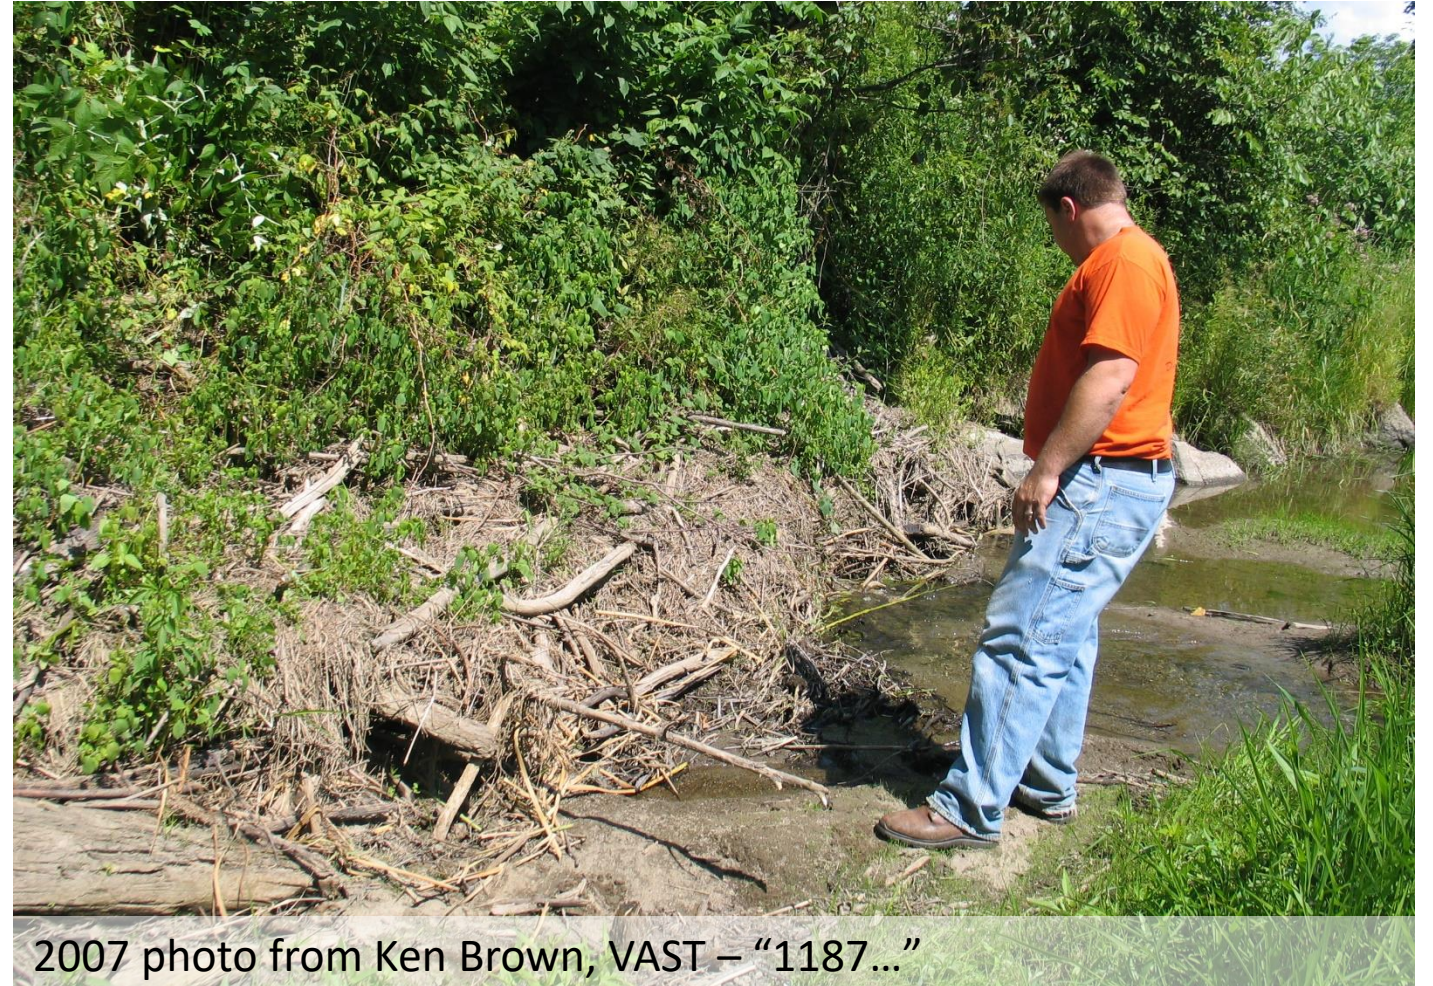
Site of former, smaller-diameter, pinched culvert.

Per Ken Brown, 2/13/20 email:  
This “picture shows condition for the culvert nearest Elm Brook” in 2007

View from south side of rail line in  
Elm Brook floodplain

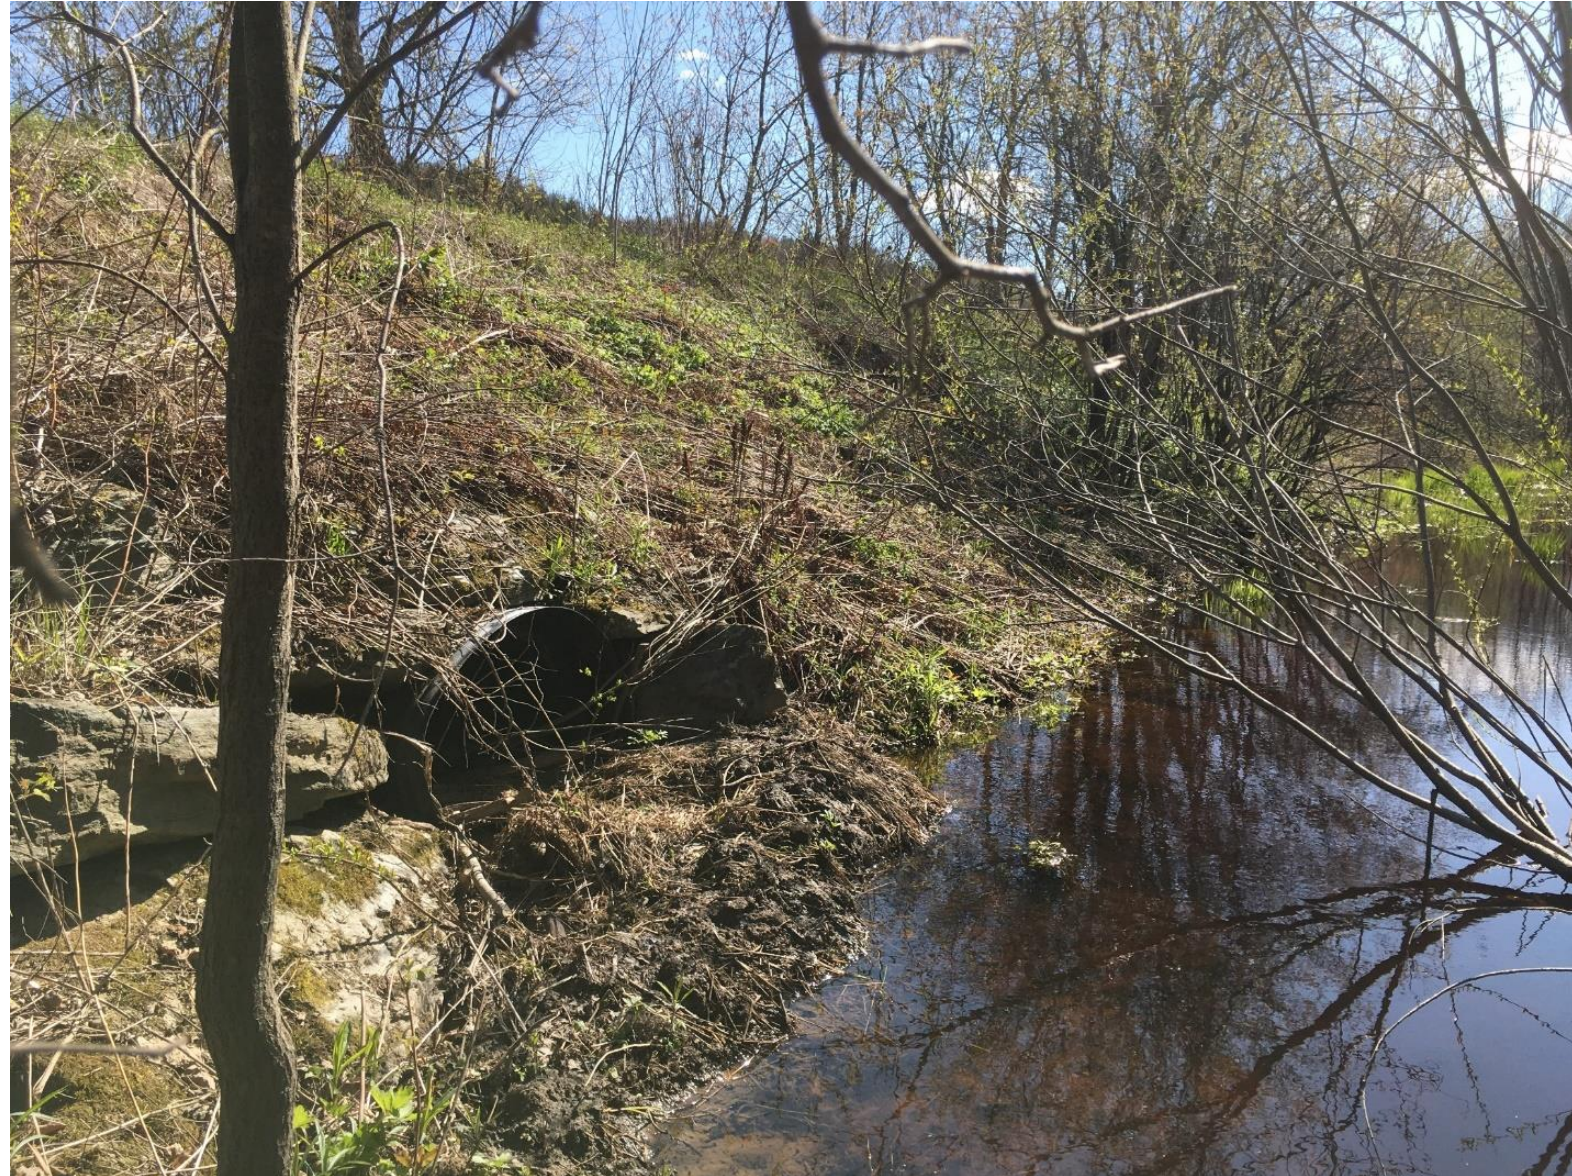
View to southeast from base of rail trail embankment to culvert inlet draining small isolated floodplain pocket blocked by segment 2 of the Fairfield 2b proposed rail line modification site. Inlet partially blocked by beaver-chewed small woody debris, 13 May 2020.
