Hydraulic Inspection Vehicle Explorer (HIVE) Culvert Upgrade

Research Project

Reporting on Project 19-3

Final Report 2021-01

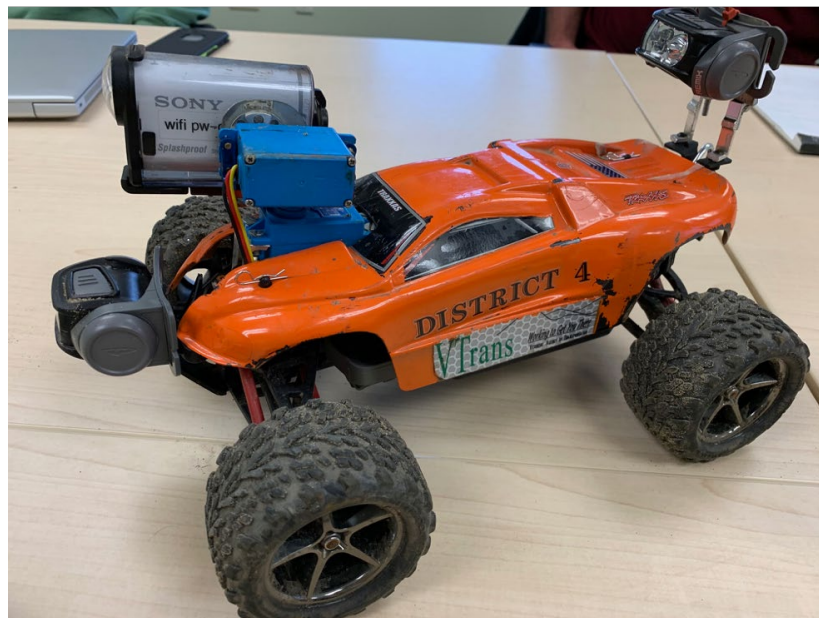
Figure 2 HIVE 1.0 used by VTrans with articulated Sony Action Cam video camera mounted on two servo motors

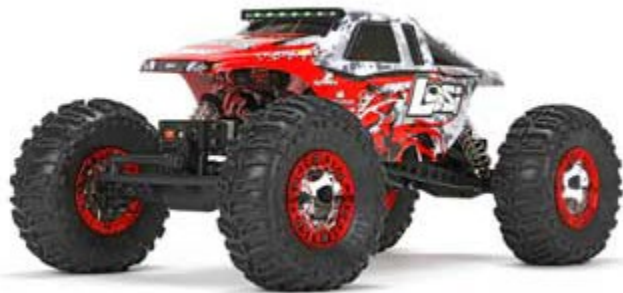
Figure 4 Losi Night Crawler 2.0 with 4-wheel drive and worm-gear differentials that provide self-braking [Losi 2020]

An alternative 4-wheel drive vehicle is the Losi Night Crawler 2.0, Figure 4 [Losi]. This vehicle is larger than the HIVE 1.0 chassis. It has worm-gear differentials that are self-braking and satisfy Specification 9. Concerns about being too big and the ability to span 162 mm (6 inch) gaps led to the non-selection of Night Crawler 2.0 for the HIVE 2.0.

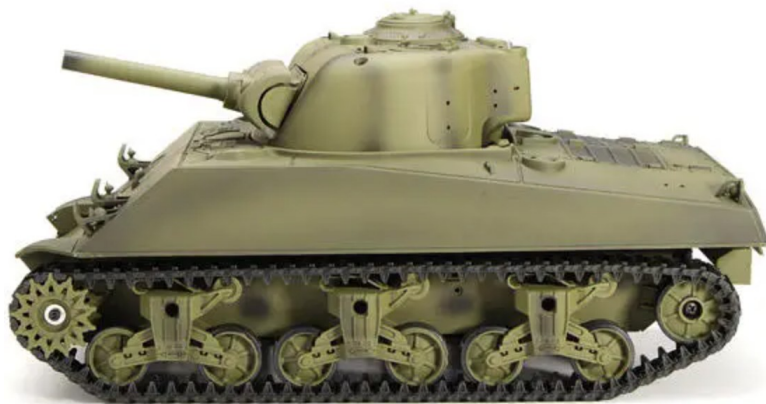
Figure 5 1/16 scale Sherman M4A3 remote control tank

Additionally, many RC tanks include a rotating turret which could be used for rotating the azimuth angle of a camera. There are many RC tanks available in 1/16 and 1/20 scales. The 1/20 scale tanks would likely have issues climbing over larger obstacles due to their smaller size. Most of the 1/16 scale tanks are slightly larger than the VTrans size requirements. However, the 1/16 Sherman M4A3 remote control tank shown in Figure 5 is an appropriate size. Using this RC tank chassis solves several issues that make the vehicle more maneuverable, simpler, and cheaper. The tracks of the tank allow for the vehicle to clear separation gaps up to 150 mm (6 inches). The tank is also able to remain stationary on slopes of at least 20 degrees.

This tank can come with an optional metal drive train for enhanced durability. The cost of this upgrade is less than \$50 (2020 prices). The tank used in this report used a plastic drive train, which performed without any issues, but was not subjected to long term loading. The durability of the metal drive train and potential issues of corrosion have not been verified.

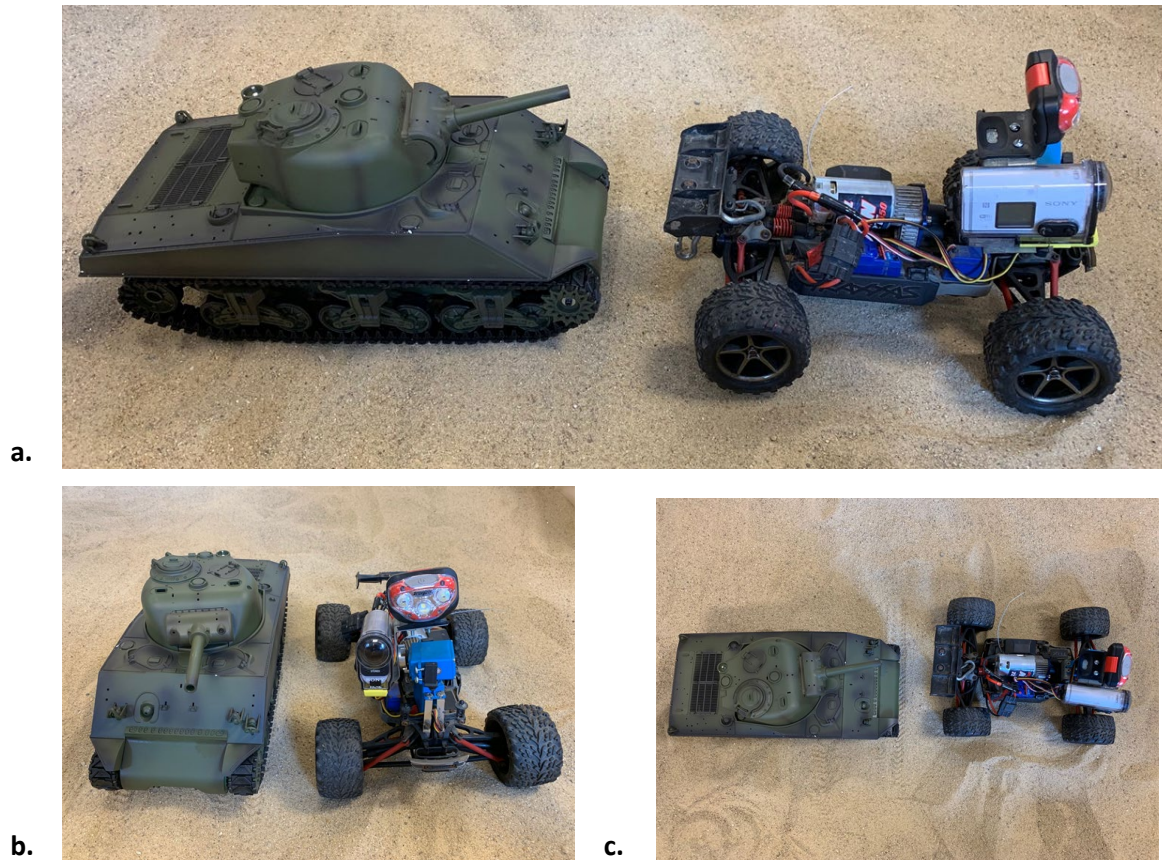
Figure 6 HIVE 1.0 v. HIVE 2.0: a. Side view, b. Front view, c. Top view

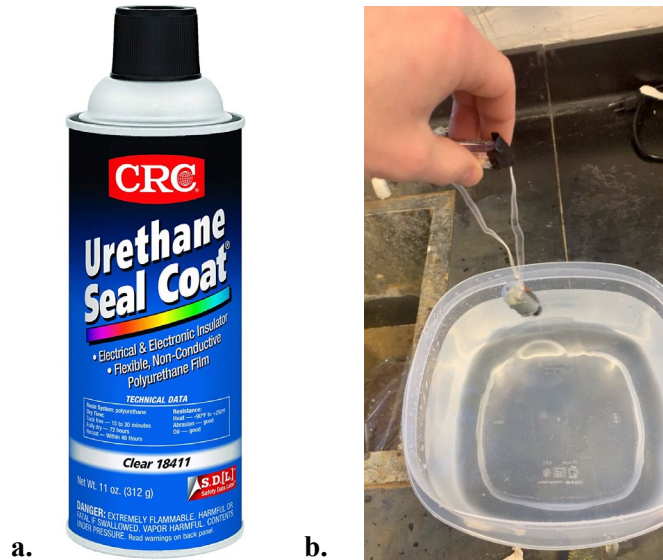
Figure 9 Waterproof coating submersion test: a. Polyurethane spray coating, and b. Submersion test of coated running DC electric motor

Spray-on waterproofing compounds are an alternative to encasement. The application of spray coating can waterproof the internal components of a HIVE 2.0 in a simple process. A series of tests evaluated the viability of these compounds. The first test coated a small DC motor in a polyurethane sealant, and then submersed a running motor in water, Figure 9. The coated motor continued to operate normally while submersed.

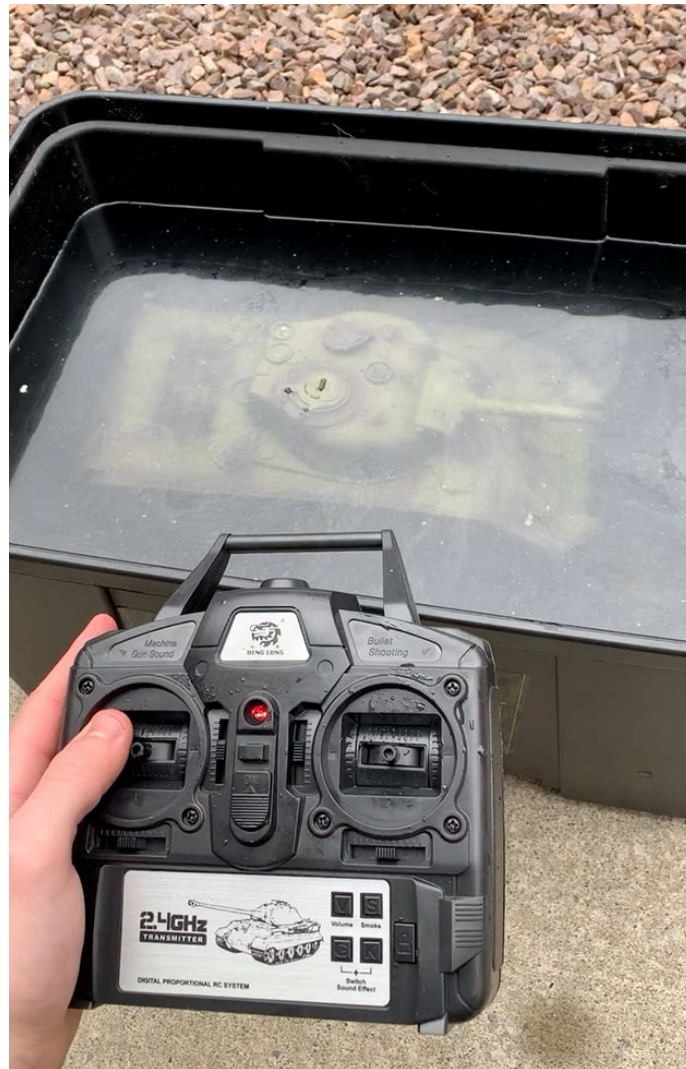
Figure 10 Submersion test of HIVE 2.0 tank that successfully operated under water with wireless remote-control telemetry

The success with spray-on coating for waterproofing motivated the development of a potentially more robust two-layer system. The bottom layer is a spray-on polyurethane. The top layer is a proprietary mix of mineral spirits, liquified petroleum gases and crystalline silica with the trade name CorrosionX Heavy Duty. Applying this double layer of sealing to the inside components of the HIVE 2.0 tank was straightforward but was messy and required proper ventilation. The result was a waterproofed vehicle. The first test was an immersion test which submerged the tank in a water filled tub. The tank was able to operate fully submerged. This included receiving and acting on short range RC telemetry signals, Figure 10. Next the tank underwent water tolerance testing in a nearby stream, Figure 11. The HIVE 2.0 tank withstood the water without any adverse effects.

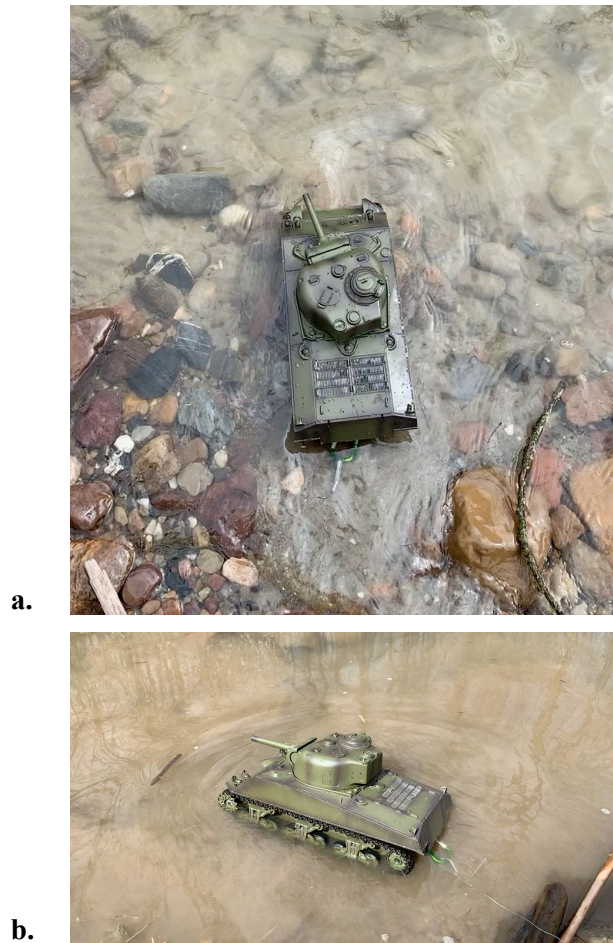
Figure 11 Waterproofed HIVE 2.0 tested for water tolerance in a stream

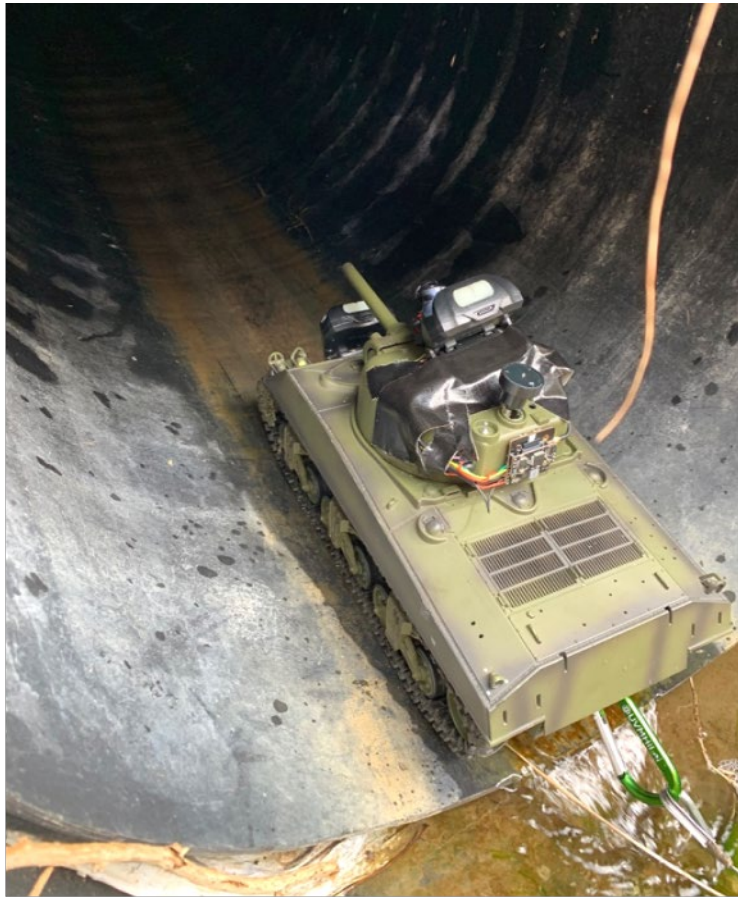
Figure 12 Flowing water in a culvert can be a mobility issue for unmodified HIVE 2.0 tank

The stream tests did identify an unanticipated issue – flowing water exerts lift and drag forces on the low-profile tank body, Figure 12. The forces can lift and push the tank off the intended direction of movement. The HIVE 1.0 car tends to not experience this problem because the elevation of the 4-wheel suspension lifts the body further up and out of the flowing water and presents a more streamlined cross section. After consideration of various options, the choice was to modify the geometric form of the tank body with a set of cutouts and holes that allow for water to flow freely through the body, Figure 13 and Figure 14.

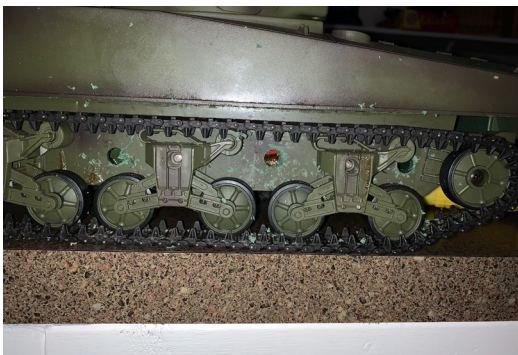
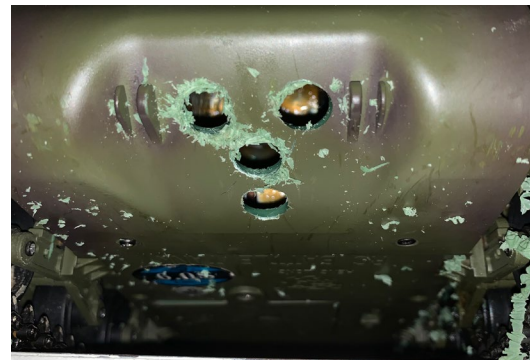
Figure 13 Holes drilled into HIVE 2.0 tank to allow internal flow of water and reduce drag: a. Side undercarriage, b. Bottom

Use the Dremel tool, knife and drill to cut water passage holes in the tank chassis as shown in Figure 13 and Figure 14.

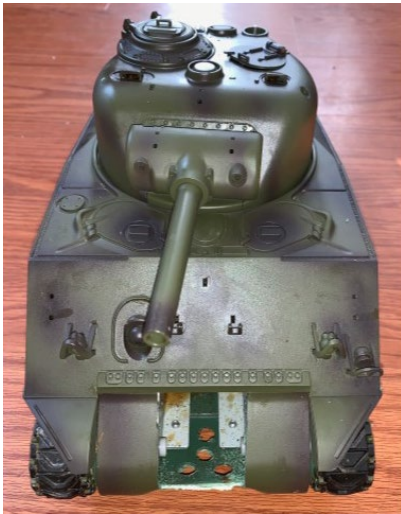
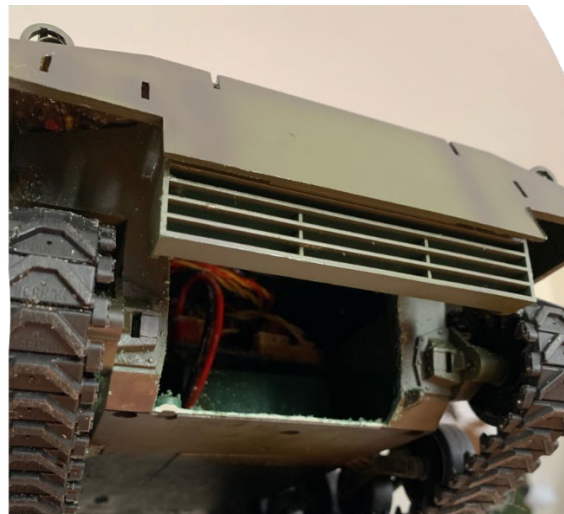
Figure 14 Cutouts in HIVE 2.0 tank body to allow free flow of water: a. Front with cutout, and b. Back with cutout

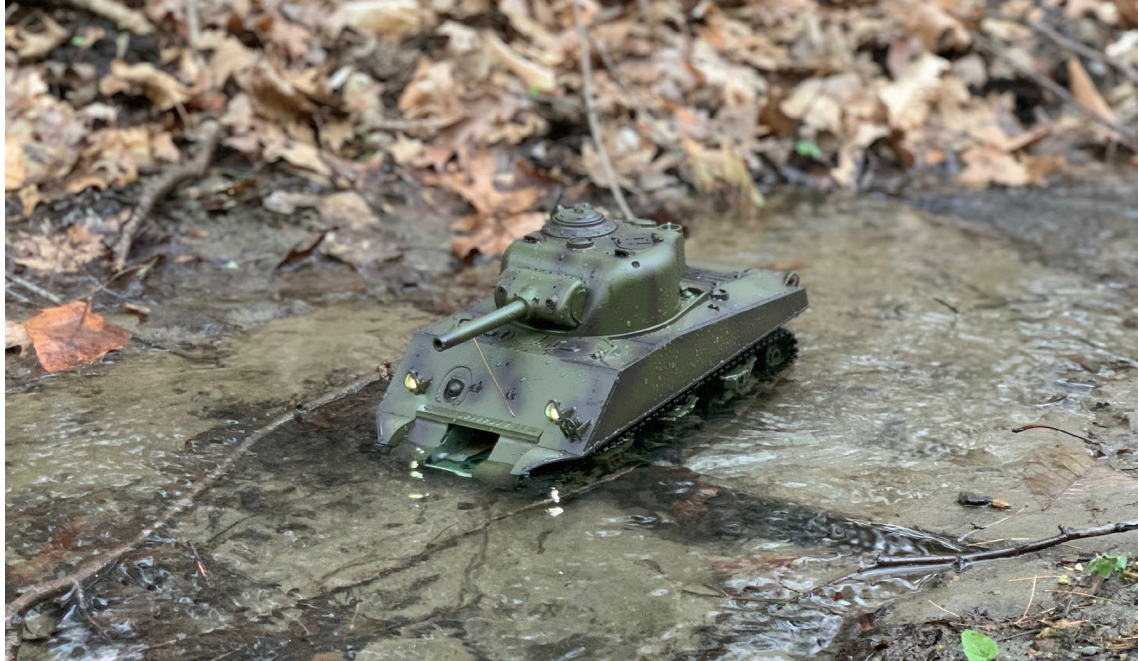
Figure 15 Stream testing confirms viability of cutouts and holes in reducing lift and drag of flowing water on HIVE 2.0 tank

Subsequent testing found these holes and cutouts to be effective in reducing the lift and drag on the HIVE 2.0 tanks by running water, Figure 15.

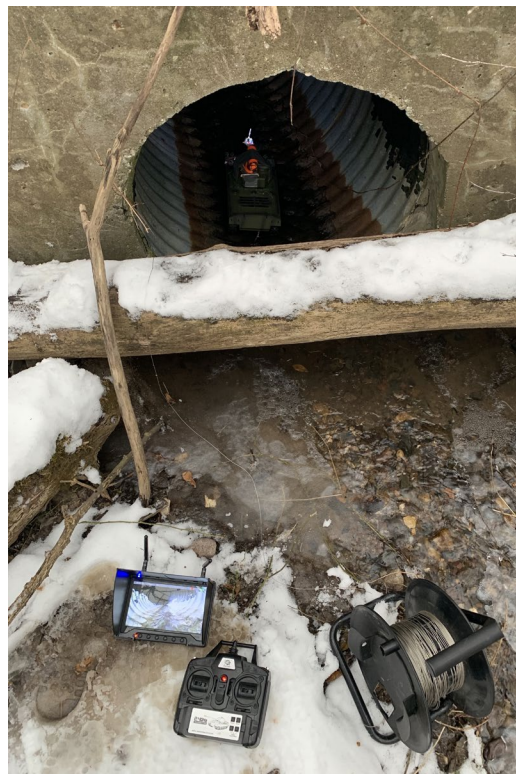
Figure 17 Mobility testing of HIVE 2.0 Tank in metal lined culvert with flowing water and separation gap in Culvert 64099 under U.S. Route 7 in Charlotte, VT

A thin metal cable attached to the HIVE 2.0 provides emergency retrieval capabilities. The cable also enables tracking the distance the tank has traveled by connecting the cable to a spool with a magnetic revolution counter to track this distance. Figure 17 shows the HIVE 2.0 entering a 0.762 m (30 inch) culvert equipped with a 5.8 GHz telemetry system and connected to a cable spool.

The test used the HIVE 2.0 Sherman tank chassis to carry the telemetry options into the culverts, Figure 17. The first step placed the tank at the exit of the culverts and then monitored the reception at the two different DIs for the two different power levels of 25 and 200 mW. The evaluation examined the reception at the DIs using the different antenna types. First, the measurement was an inspection of the signal was inspected with the antenna above ground at the DIs. The next measurement compared to the reception with one antenna suspended from a 0.914 m (3 foot) coaxial extension cable down into DI as shown in Figure 49. The test examined both the linear and circular antenna types.

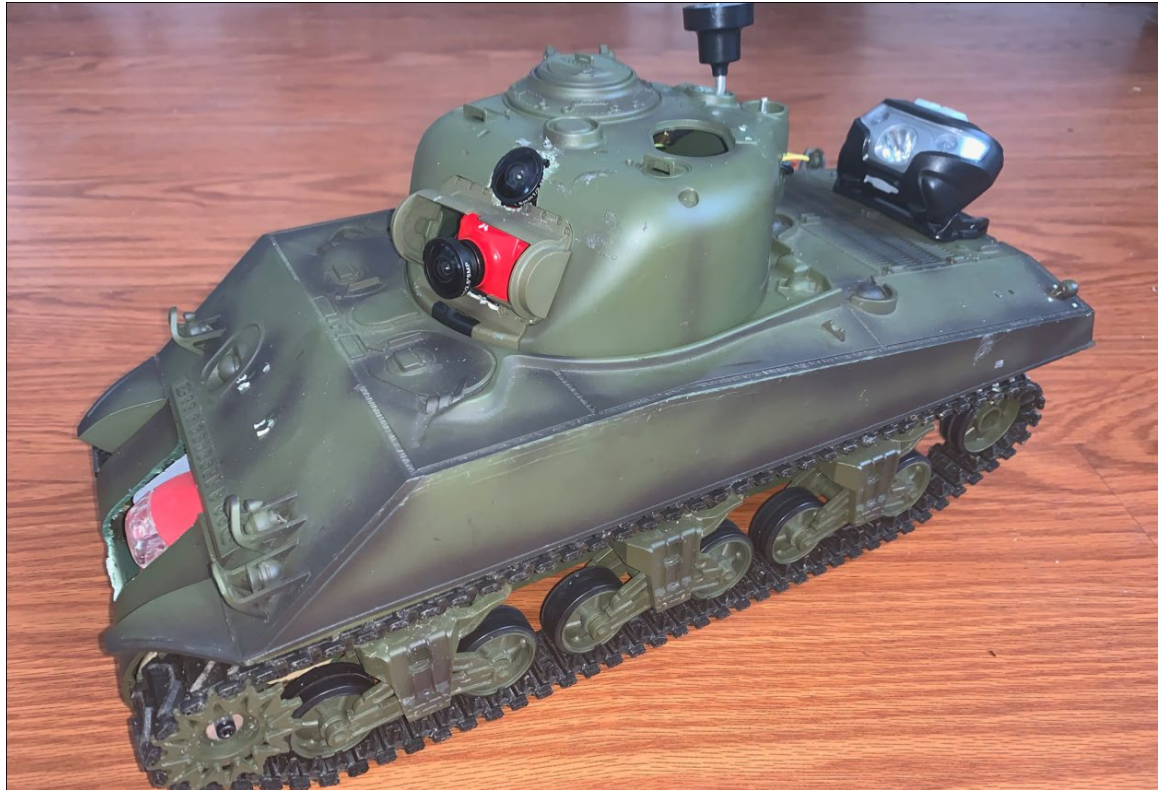
Figure 18 Modified HIVE 2.0 showing water passage cutout in front, modified turret with forward looking and elevated cameras, jogging headlamp light and circular antenna.

An optimized camera configuration used two cameras inserted into a modified turret. The modifications included removing the gun barrel, cutting openings for apertures for the cameras and using jogging headlamps for lighting. The telemetry configuration uses a circular antenna and places the telemetry system on an isolated battery power supply. Figure 18 shows a prototype assembled HIVE 2.0.

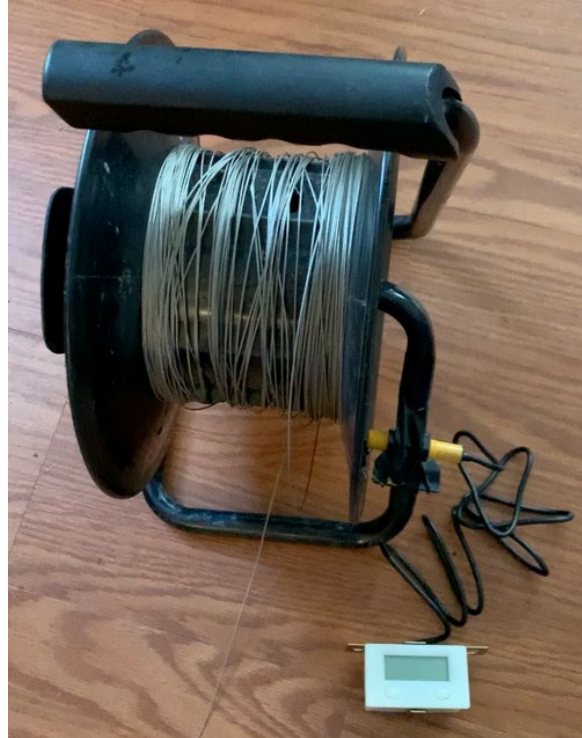
Figure 20 Retrieval wire spool with magnetic revolution counter

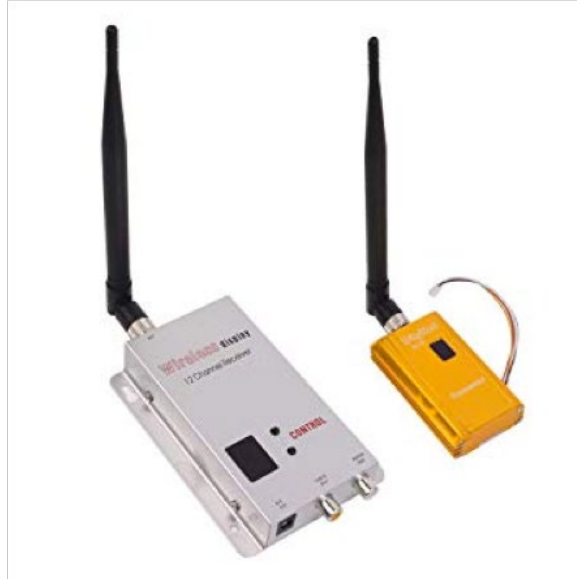
Figure 32. 1.2 GHz video transmitter and receiver

The video telemetry options at 1.2 GHz are somewhat limited. Transmitters and receivers at 1.2 GHz generally are used for closed-circuit television (CCTV) video surveillance and tend to be too large to mount on a vehicle for small culvert inspections. There was one small system available, Figure 32. The yellow device is the transmitter which mounts to the vehicle, while the grey device is the receiver which connects to the monitor. This system has an output power of 1.5 W and an advertised range of 965 m (0.6 miles) in open space. The transmitter has dimensions of 12.7 x 50.8 x 102 mm³ (0.5 x 2 x 4 inches³). The system costs \$70.

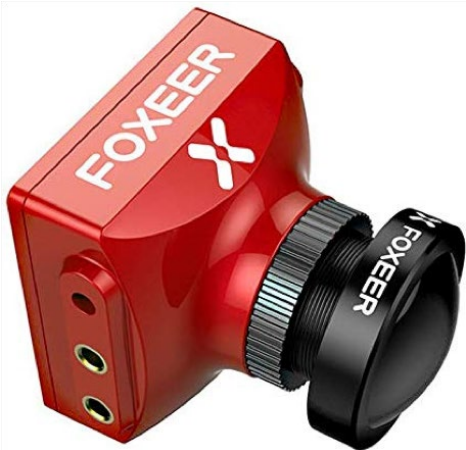
Figure 33 Foxeer Falkor camera

Transmitters and receivers that use the 5.8 GHz band are widely available. The hobby of first-person view (FPV) drone racing has led to the availability of many small wireless transmission cameras. Most of the FPV cameras operate at 5.8 GHz. Two cameras selected for detailed evaluation and testing are small and can easily mount to the chassis of the HIVE 2.0 tank. Figure 35 shows an integrated camera and 5.8 GHz transceiver. The power output of the transmitter can toggle between 25, 50, and 200 mW and costs only \$17. However, the camera has a TVL specification of 600 which is on the lower end of desired image resolution. A Foxeer camera provided a TVL of 1200 in a form factor small enough for a HIVE, but did not have an integrated telemetry unit, Figure 33. The image received from this camera is high quality and provides detailed information about conditions inside the culvert, Figure 34. A separate 5.8 GHz transmitter connects to the camera to transmit the video. The camera and transmitter costs around \$70.

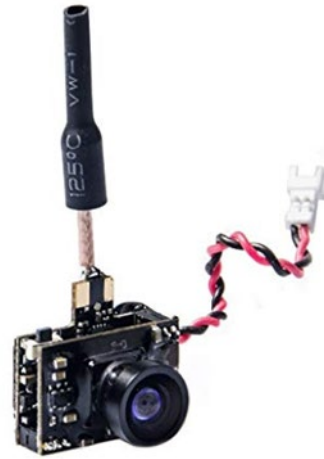
Figure 35. Camera with integrated 5.8 GHz transmitter

The goal was to determine which of the three different video transmission systems (1.2, 2.4 and 5.8 GHz) provides the longest range in an 18 inch (0.457 m) concrete culvert. Culvert 64104 shown in Figure 36 off Route 7 in Charlotte, VT was chosen for its length of 30.8 m (101 feet) and ease of access. At the time of this test the HIVE 2.0 prototype was not waterproofed, the tests used the HIVE 1.0 to carry the various telemetry options into the culvert, Figure 37. The tests of 5.8 GHz telemetry used the integrated camera and telemetry system in Figure 35 since it was inexpensive and easy to set up.

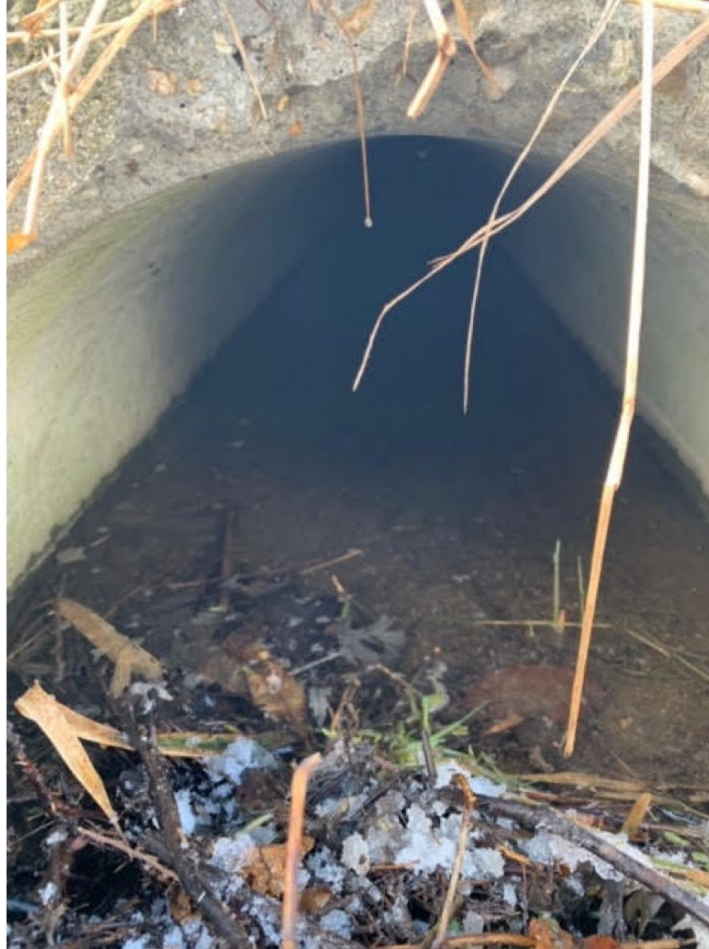
Figure 36. Telemetry Option Test 1 Culvert ID: 64104, 0.457 m (18 inch) diameter, 30.8 m (101 feet) long, concrete, U.S. Route 7, Charlotte, VT

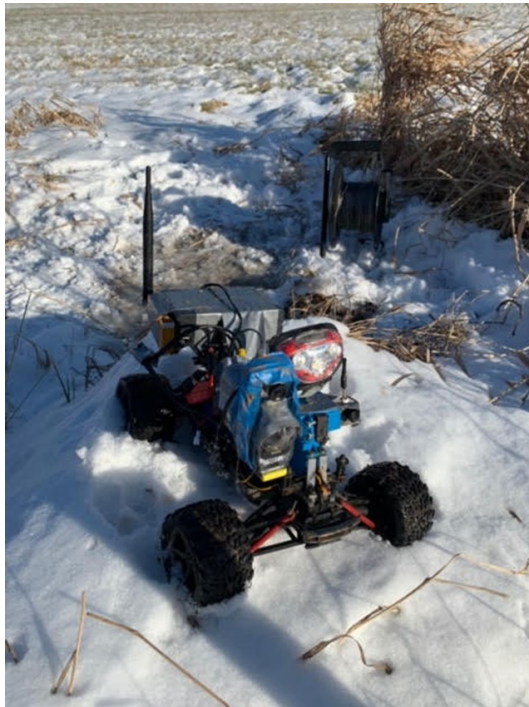
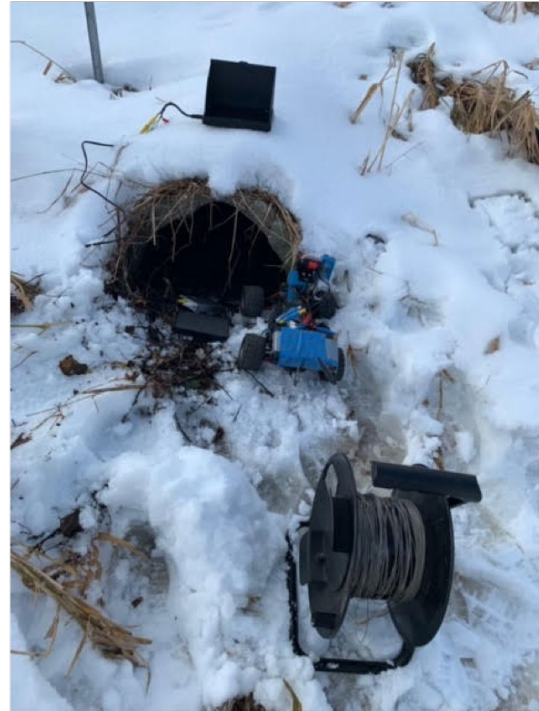
Figure 37 Telemetry Option Test 1 using HIVE 1.0 instrumented with 1.2, 2.4, and 5.8 GHz video systems: a. HIVE 1.0 with added telemetry options, and b. Setup with telemetry modules and retrieval wire spool

The testing protocol was first was to mount an individual monitor telemetry system onto the HIVE 1.0, then drive the HIVE 1.0 into the culvert until the video signal failed or became unreadable. Winding the spool of cable shown in Figure 37 retrieved the HIVE 1.0. Counting the revolutions needed to retrieve the HIVE 1.0 and using Equation (5) with a spool diameter of 127 mm (5 inches) determined the distance traveled into the culvert.

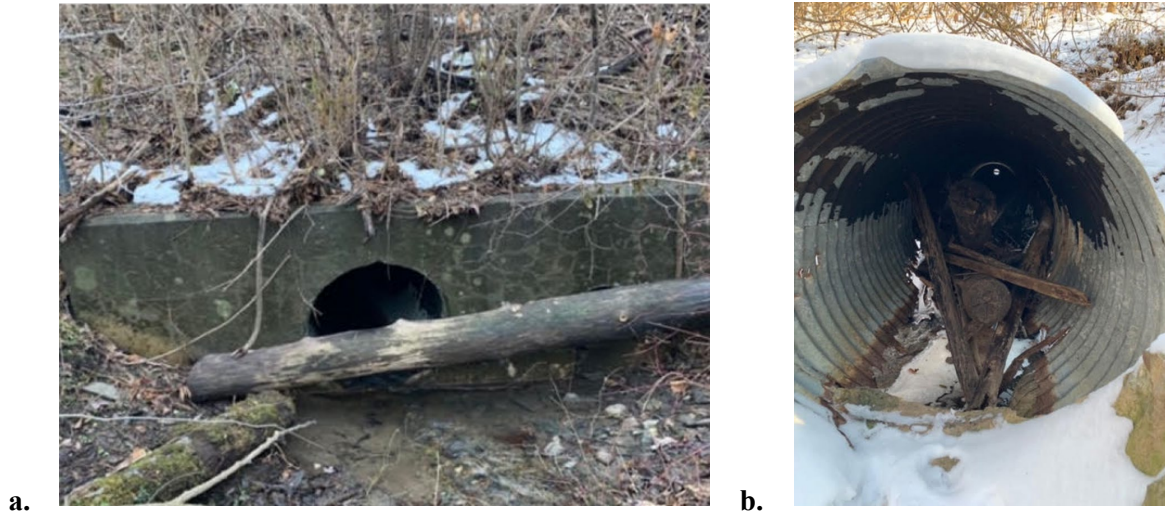
Figure 39. Telemetry Option Test 2 Culvert ID: 64099, 0.762 m (30 inch) diameter, 51.2 m (168 feet) long, metal liner: a. Entrance, and b. Internal debris

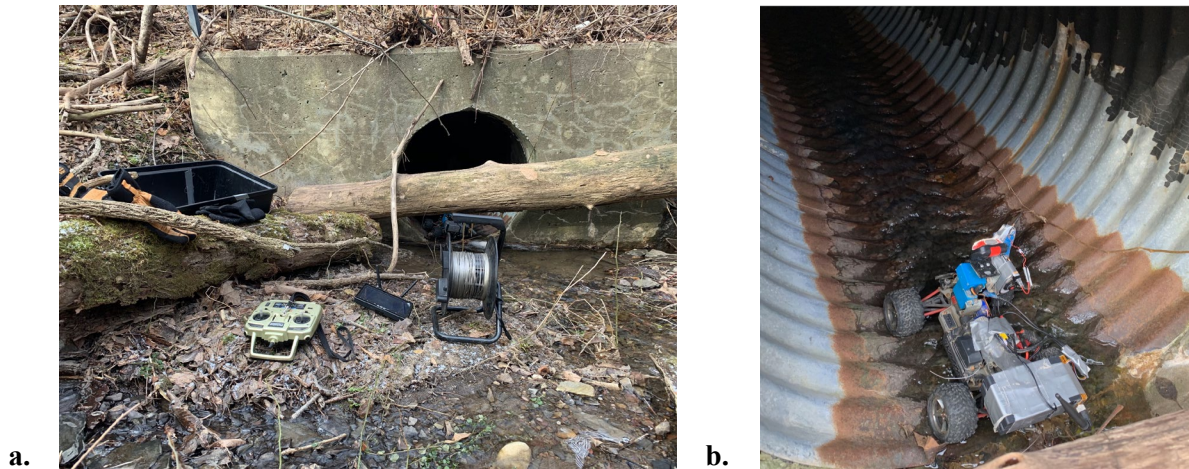
Figure 40. Telemetry Option Test 2 setup, HIVE 1.0 instrumented with 1.2 and 5.8 GHz video systems placed inside Culvert 64099 entrance for reception test at the other end

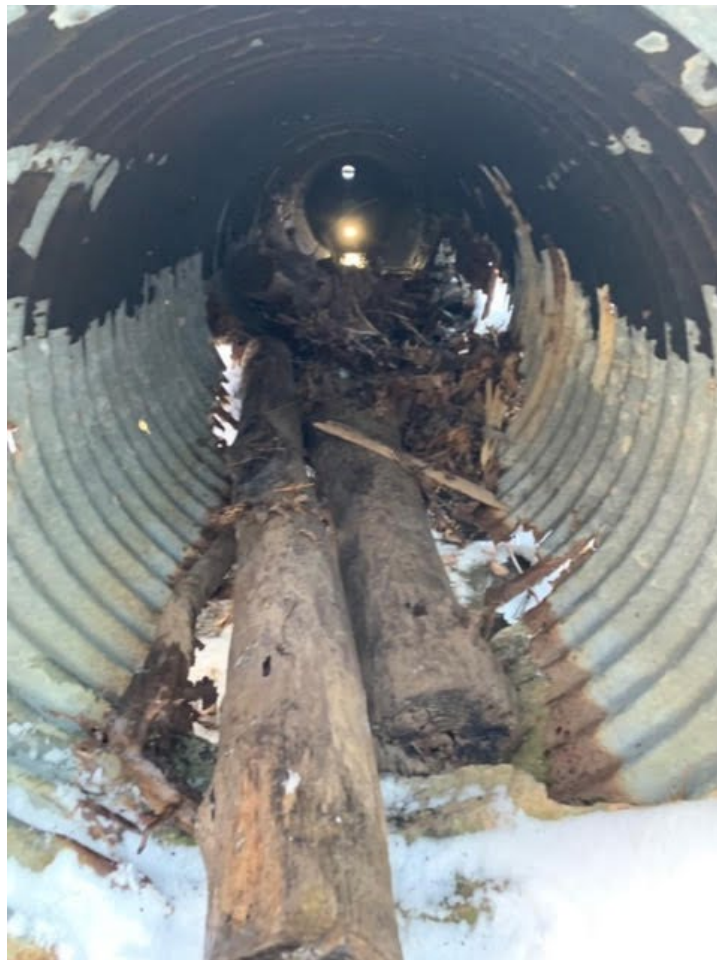
Figure 41 HIVE 1.0 stuck in separation gap of Culvert 64099, vehicle headlamp is visible.

The first run of Telemetry Option Test 2 used the 1.2 GHz telemetry system for the video monitor. The modified HIVE 1.0 made it 43.9 m (144 feet) until a wheel became stuck in a separation gap in the culvert. After many failed attempts of driving and pulling the vehicle from the steel cable, the HIVE 1.0 was eventually retrieved by crawling into the culvert from the exit. To avoid the risk of getting the HIVE stuck a second time, a pass-fail test was conducted to test the 5.8 GHz system. This test placed the HIVE just inside the entrance of the culvert as shown in Figure 40, and walking over to the exit to see if the video would transmit the entire length of the culvert, Figure 42.

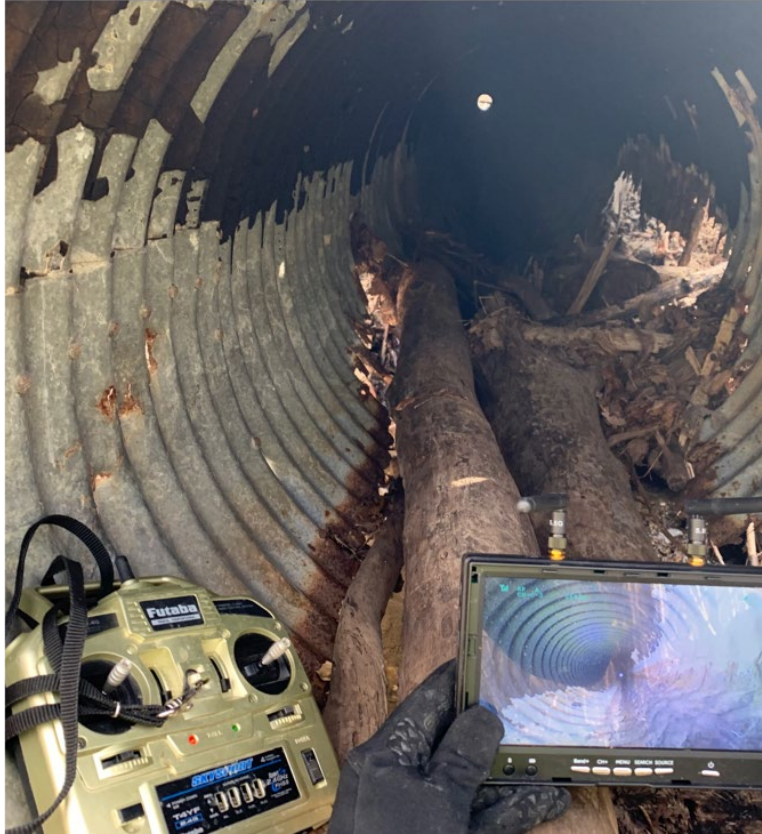
Figure 42 Test 2 setup, monitor at exit of Culvert 64099 with vehicle at entrance

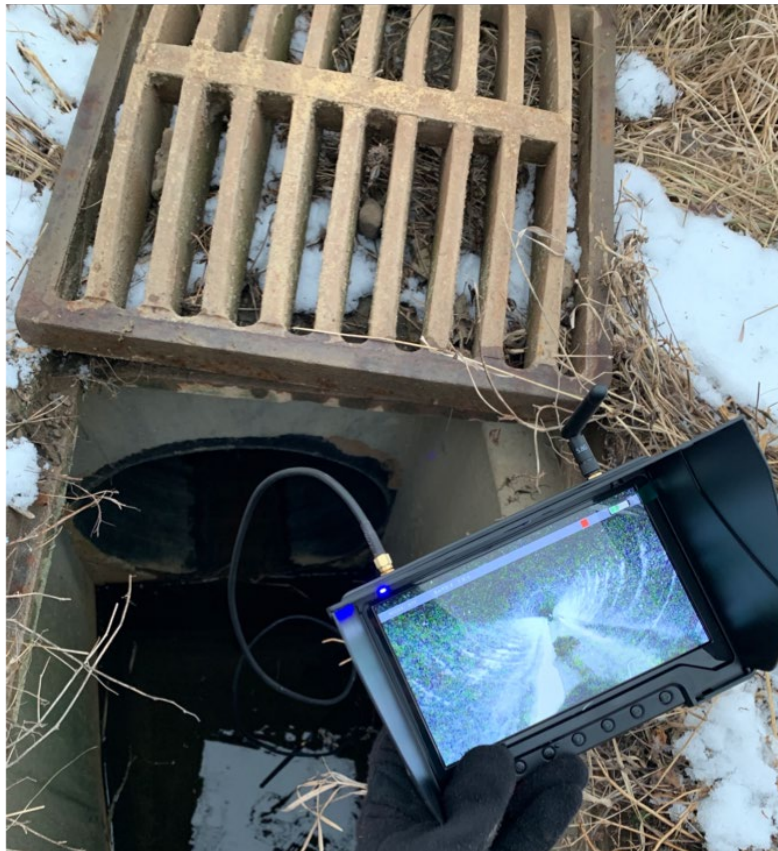
Figure 49 Telemetry Option Test 4 Monitor with antenna placed into line of sight of culvert exit using coaxial extension cable in DI

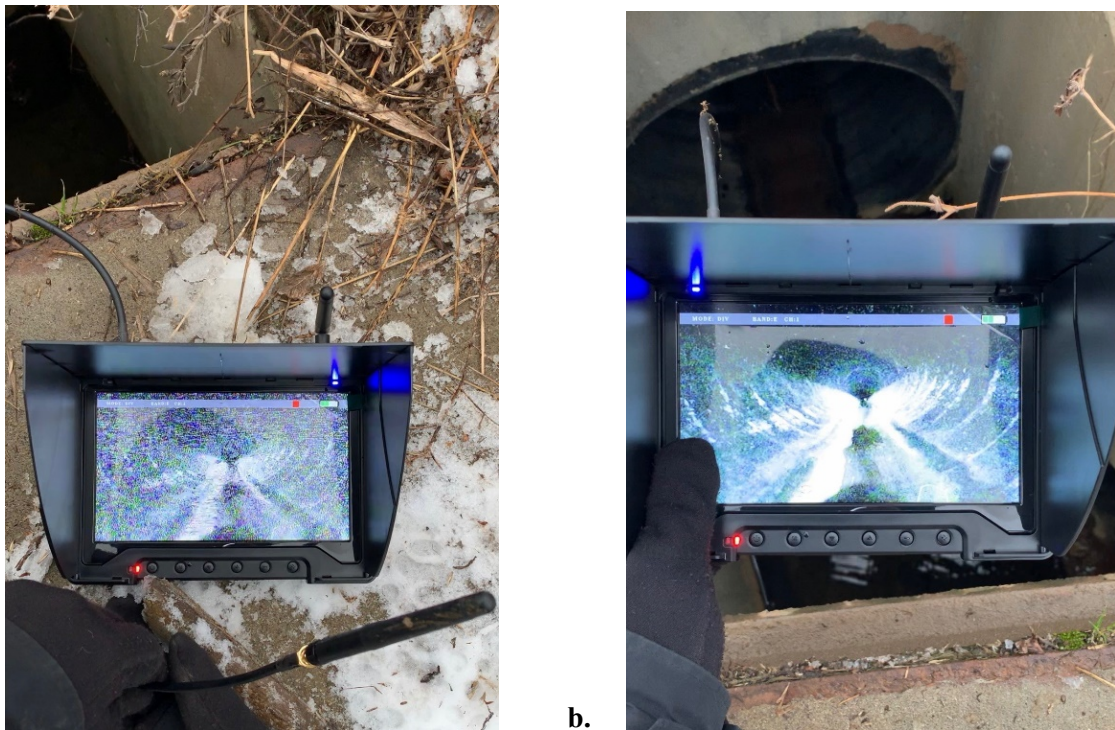
Figure 51 Telemetry Option Test 4 results comparison between antenna in and out of DI: a. Antenna out of DI, b. Antenna in DI

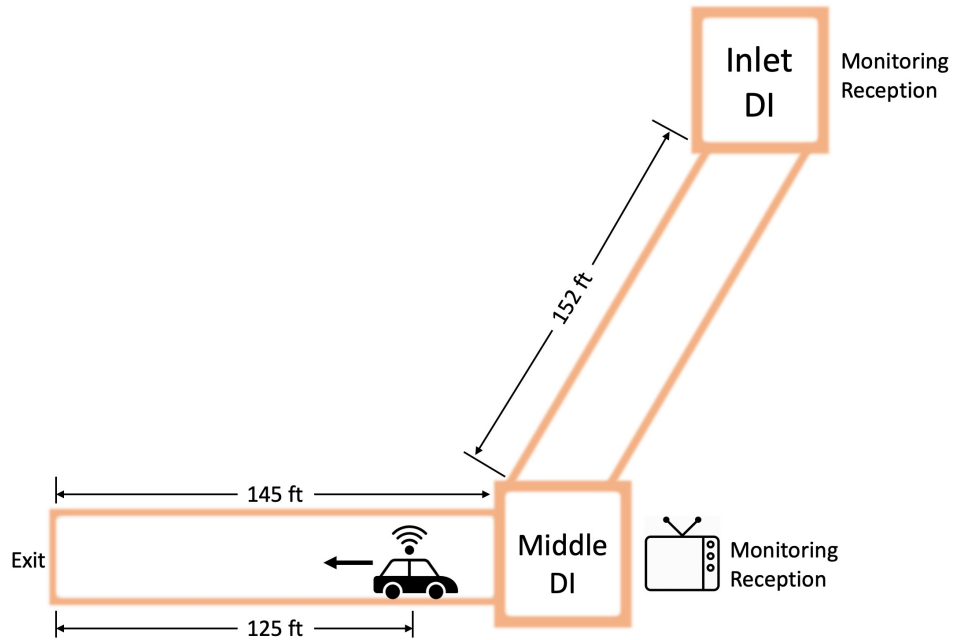
Figure 52 Telemetry Option Test 5 setup

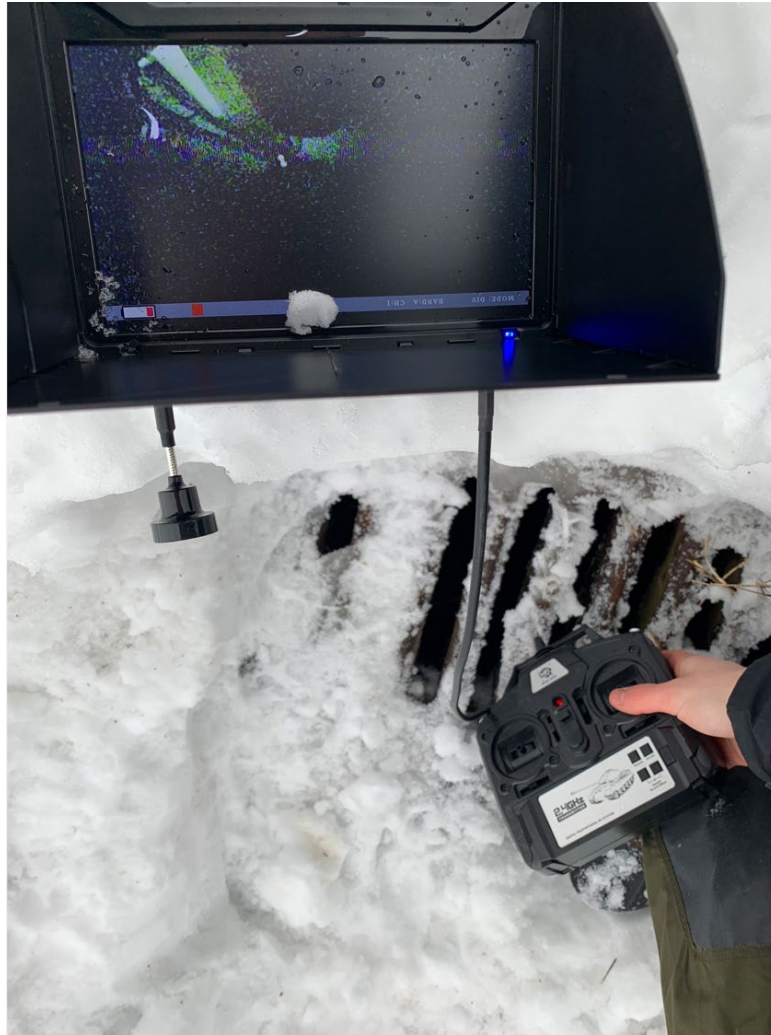
Figure 55 Tank remote held above middle DI grate to drive HIVE 2.0 tank back to exit

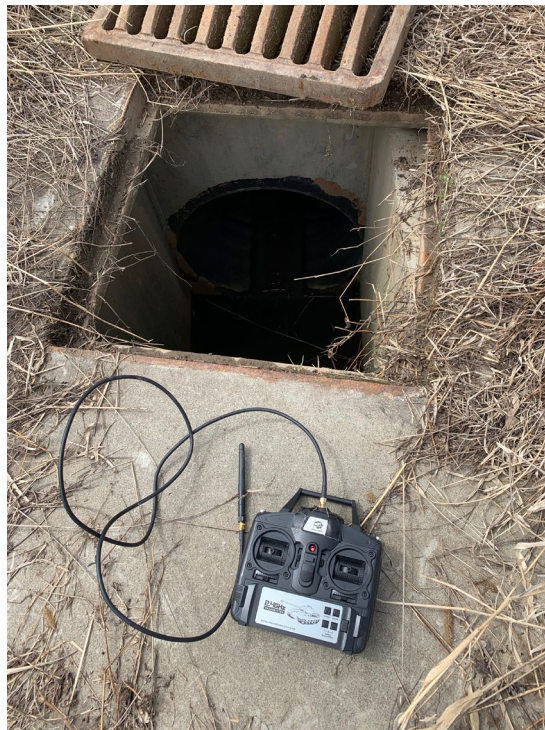
Figure 58 Radio control unit modified with SMA antenna connector and extension cable attached to antenna for possible improved drop inlet telemetry

This test determined the effects of modifications to the controller telemetry hardware of the HIVE 2.0 tank on the telemetry range. The modifications included removing the original antenna on the controller and replacing it with a soldered connection to a short SMA cable, Figure 57. The SMA cable allowed for the attachment of a 0.914 m (3 foot) antenna extension cable and a low noise amplifier, Figure 58. A second tank with an unmodified controller provided baseline data for comparison.

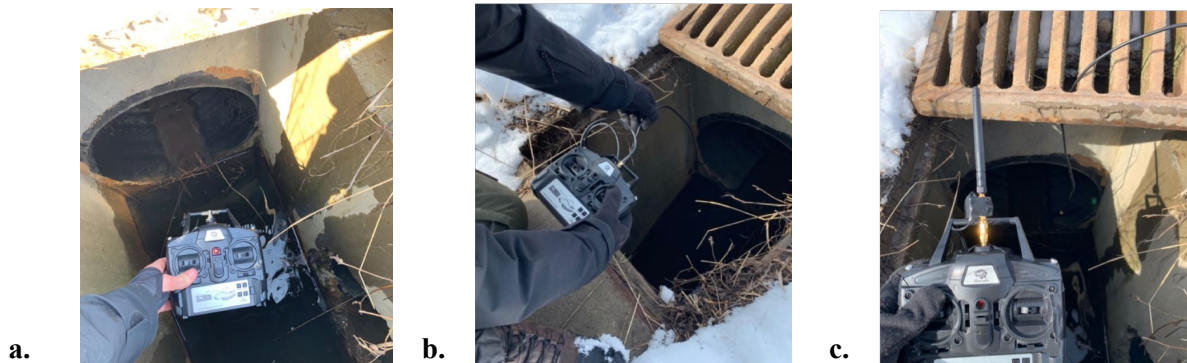
Figure 59 Telemetry Option Test 7 HIVE 2.0 controller modification effects on range: a. Unmodified controller, b. Controller with extension cable, and c. Controller with amplifier

The test site was Culverts 161158 and 161150 in Ferrisburgh, VT with DIs. The setup first attached an antenna extension cable to the controller and then a low noise amplifier, Figure 59. The test protocol was the same as Telemetry Option Test 6, Figure 60. The controller drove the tank from the middle DI toward the exit until losing the remote connection. Counting the revolutions on the retrieval wire spool determined the distance traveled.

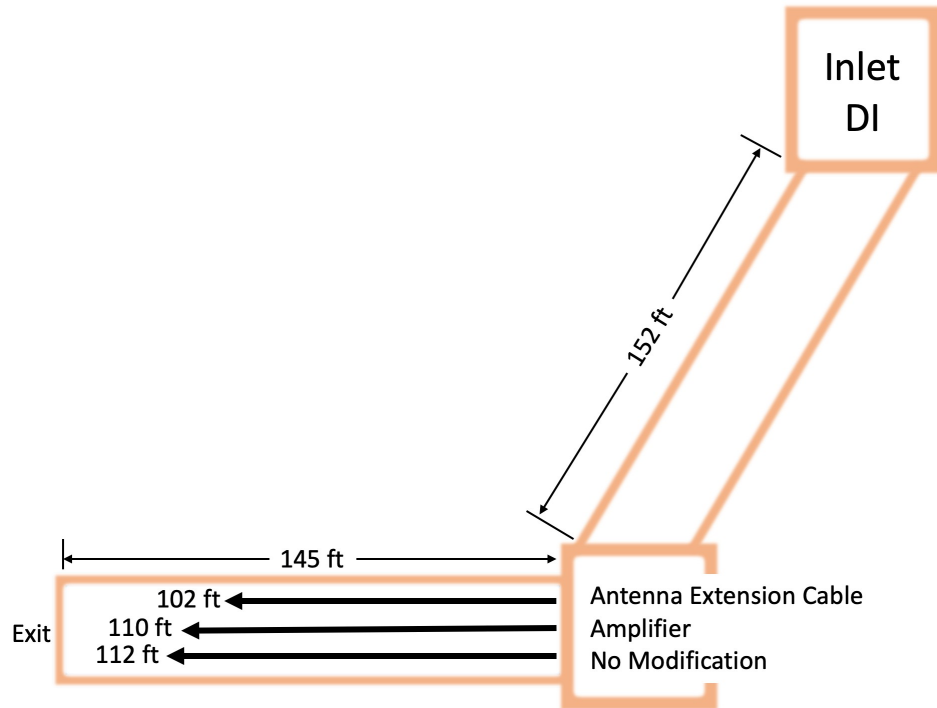
Figure 61 Results of Telemetry Option Test 7 remote control transmitter/receiver modifications

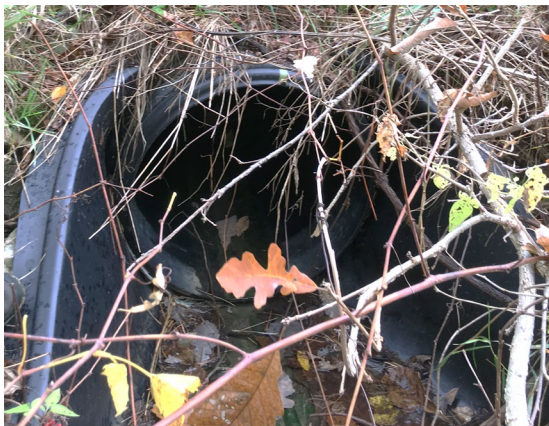
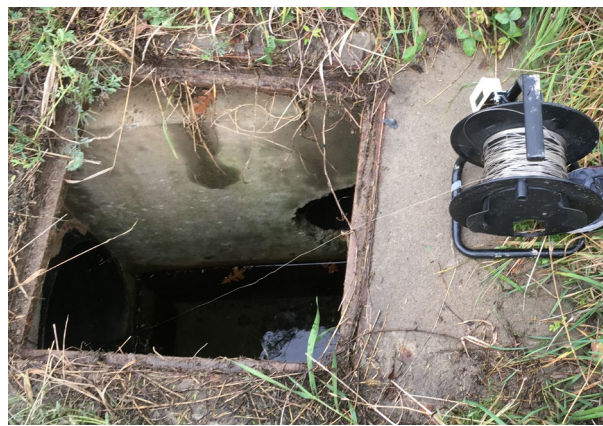
Figure 62 (a) Simplified aerial view of VTrans Culverts 161158 and 161150 near U.S. Route 7 in Ferrisburgh, Vermont. Three inspection routes are shown. In “Path A” the inspection vehicle enters through the culvert outlet. In “Path B” the vehicle enters the left leg through the central drop inlet. In “Path C” the vehicle enters the top leg through the central drop inlet. Note the indirect route required to access Path C. (b) Photograph of culvert outlet. (c) Photograph of central drop inlet.

Culverts 161158 and 161150 are 0.76-meter (30 inch) HDPE-lined culverts arranged in an “L” configuration with two concrete DIs, as shown in Figure 62.a. Accessing a culvert via a DI presents a challenge for HIVE inspection because the configuration of the DI disrupts line-of-sight from the operator to the culvert inspection vehicle, as in Figure 29. Line of sight is important for both video reception and remote-control functionality. Without a line of sight, signals must reflect off the absorptive concrete walls of the DI, reducing power and decreasing range. To overcome this challenge, the handheld video monitor on the HIVE 2.0 has a custom 2-meter (6.56 foot) antenna extension cable. Lowering the antenna on the extension cable into the DI to the appropriate height can maintain line of sight for communication with the vehicle. This implements the principle described in Figure 30. There is a possibility of extending the reach of the antenna further with a longer SMA extension cable. This option remains untested.

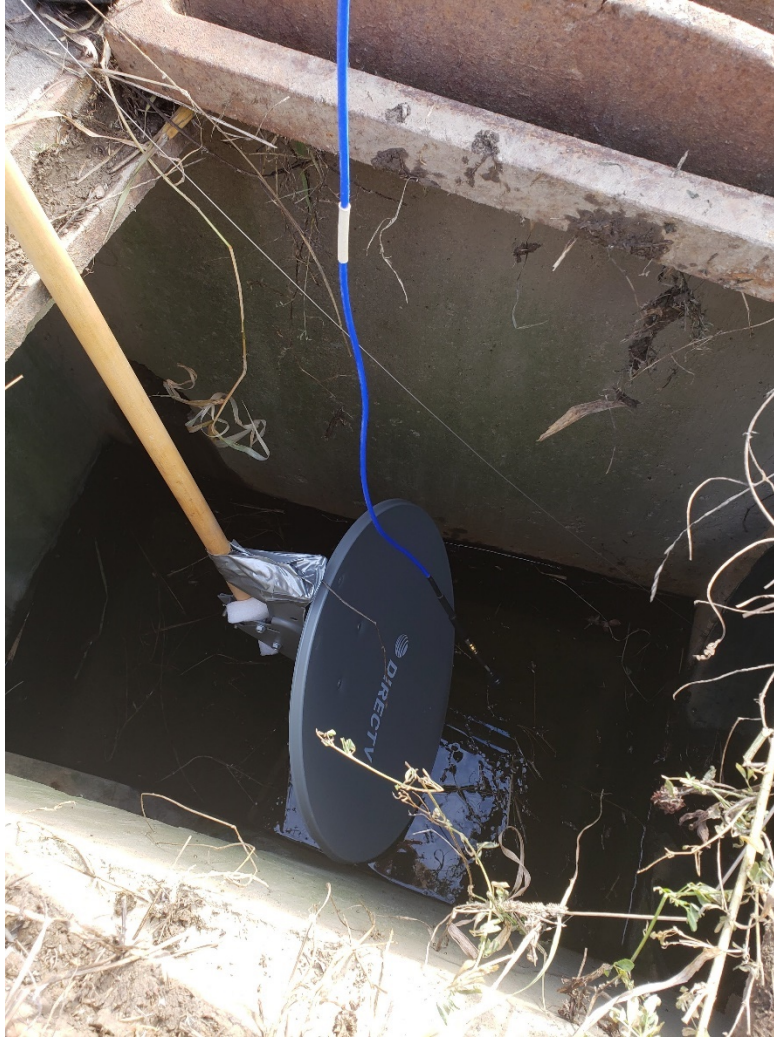
Figure 63 Antenna on extension cable and reflector dish inserted through drop inlet utility hole into telemetry beam line projecting from culvert
