Hydraulic Inspection Vehicle Explorer (HIVE) Culvert Upgrade

Research Project

Reporting on Project 19-3

Final Report 2021-01

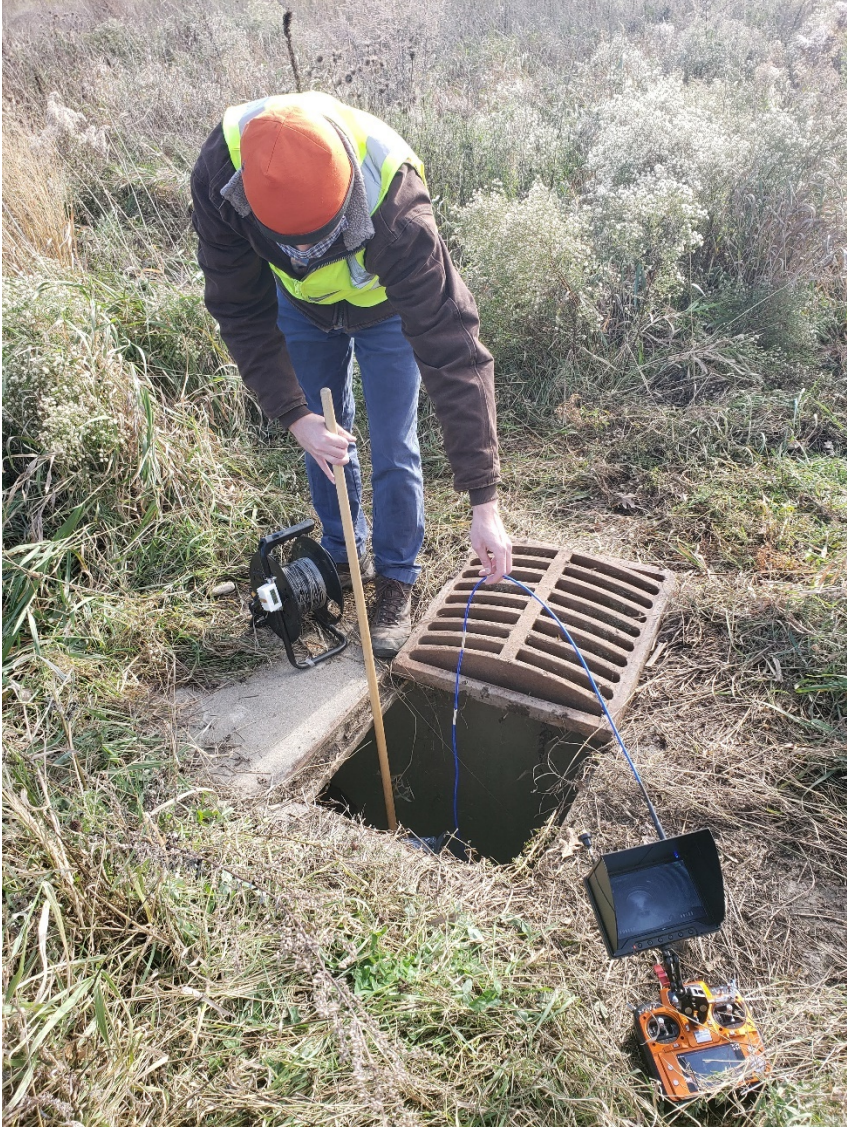
Figure 64 Insertion of video telemetry antenna on extension cable and reflector antenna into drop inlet through utility hole

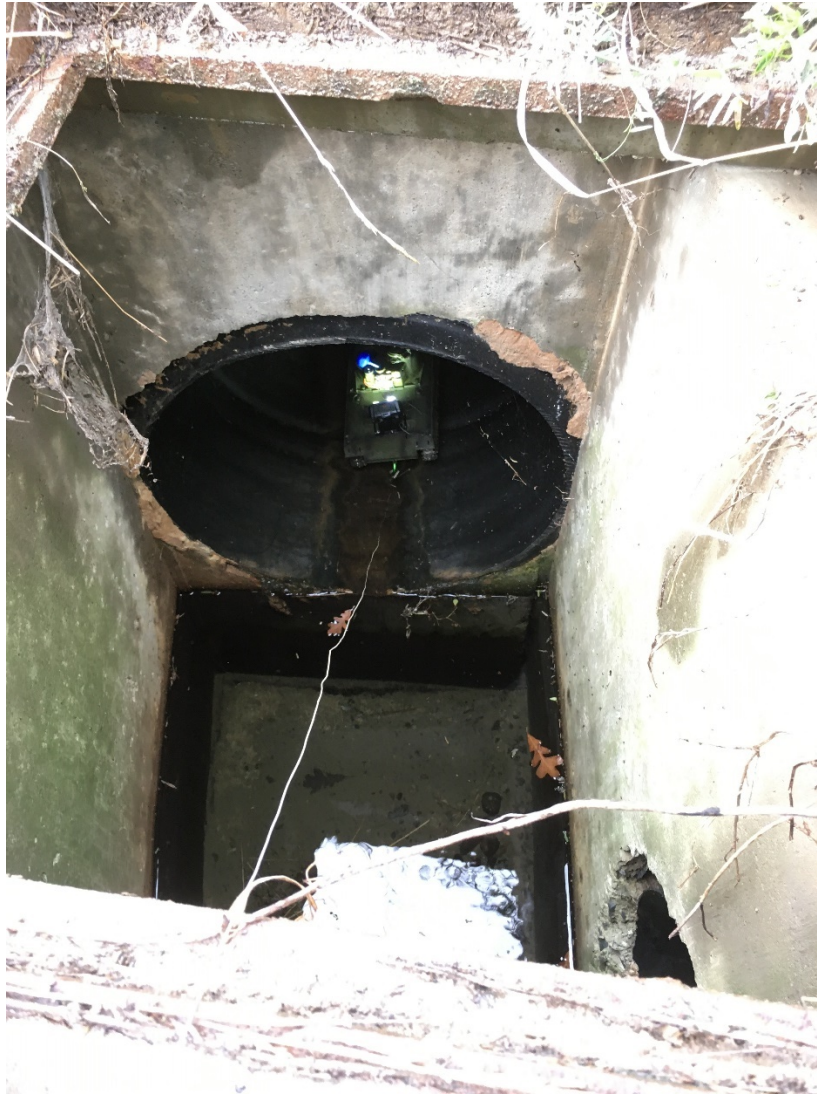
Figure 65 HIVE 2.0 tank at entrance of culvert through drop inlet

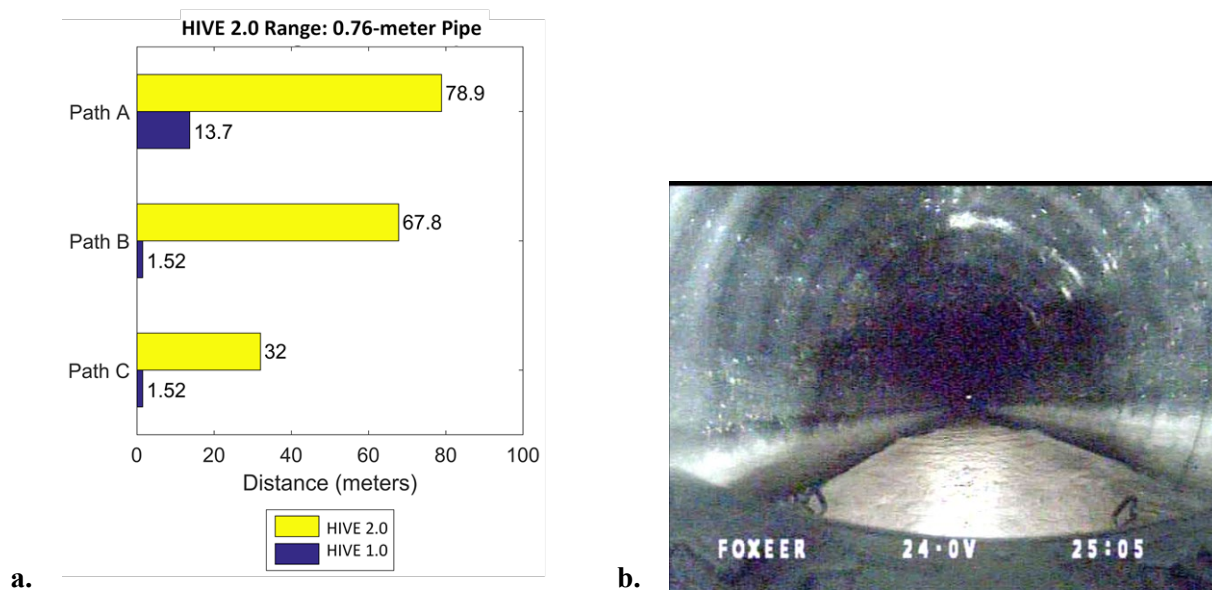
Figure 66 Results of Telemetry Option Test 8 evaluation of range extension by antenna on extension cable and reflector dish: a. Range comparison of HIVE 2.0 and HIVE 1.0, and b. A single frame from a HIVE 2.0 inspection video streamed to the operator’s monitor. Here, the HIVE 2.0 traverses the culvert with several inches of flowing water while taking Path C.

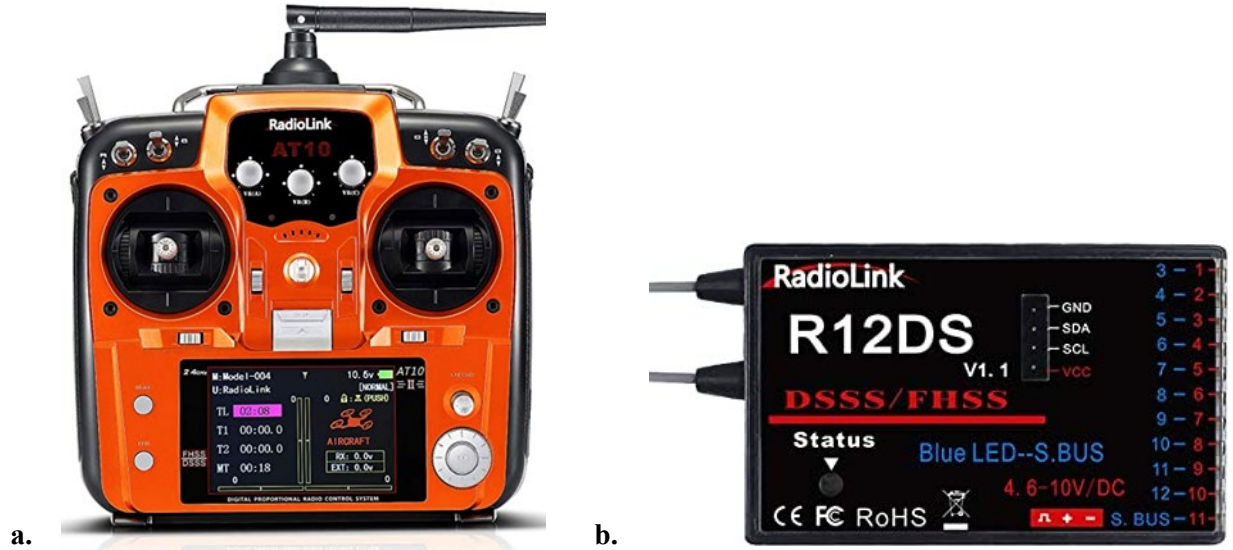
Figure 69 Selected remote control telemetry system: a. RadioLink AT10 controller, and b. RadioLink R12DS receiver/relay controller

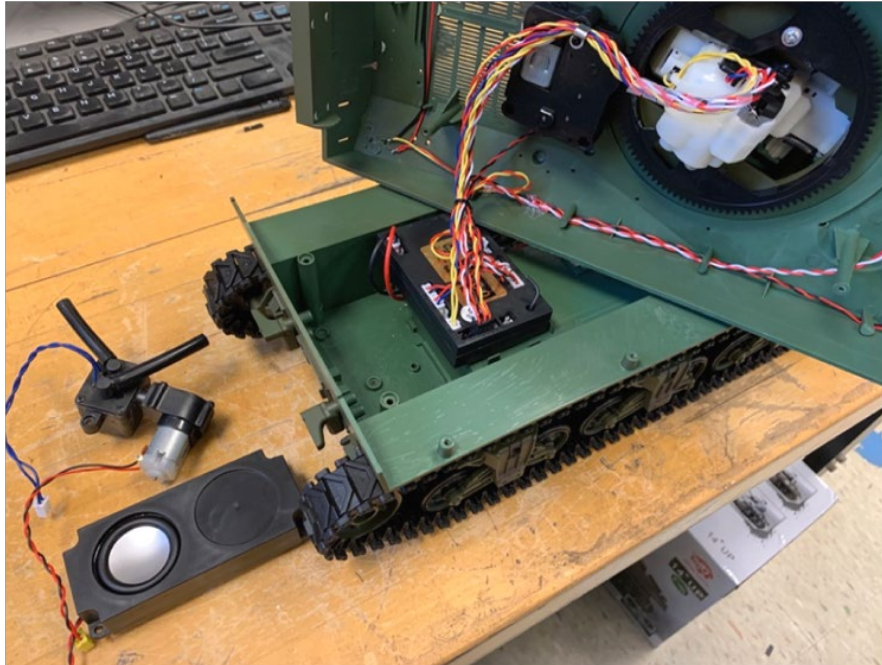
Figure 70 Tank with speaker and smoke generator removed

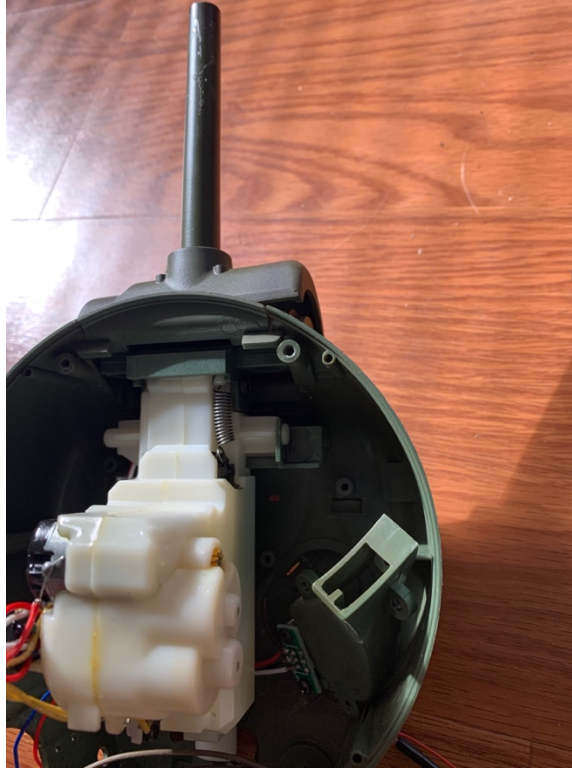
Figure 73 BB holder removed

To the right of the turret there are 3 screws securing the green BB holder. Unfasten the screws and remove the BB holder as shown in Figure 73.

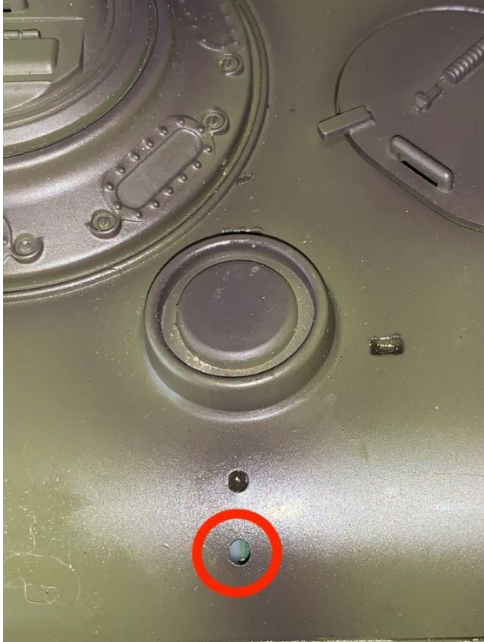
Figure 75 Stock hole for Camera 1 position

Mounting the top camera requires drilling a hole through the turret shell. Start by drilling a pilot hole through the turret shell to locate the position and angle of the top camera. If the stock hole, as shown circled in red in Figure 75, is in the desired position, it can serve as the pilot hole. The stock hole produces a camera elevation angle of about 60 degrees which is recommended. Drill out the pilot hole with a 1/2-inch drill bit. Note that Figure 76 shows the 1/2-inch hole drilled in a pilot hole below the stock hole for a camera elevation angle of about 45 degrees.

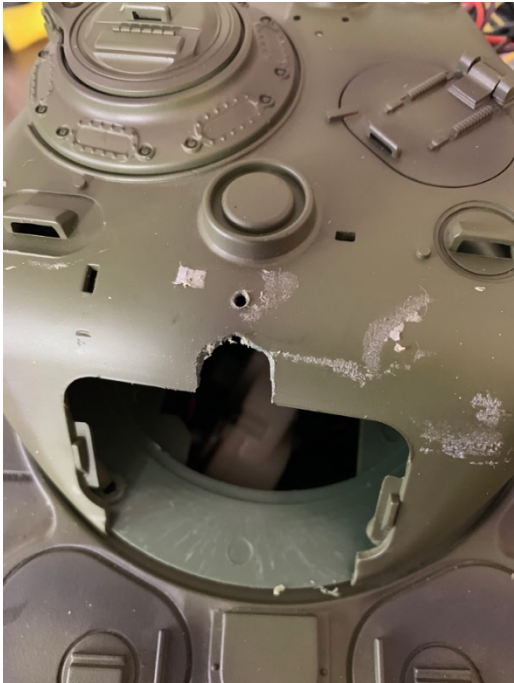
Figure 76 1/2-inch hole drilled for Camera 1 mounting

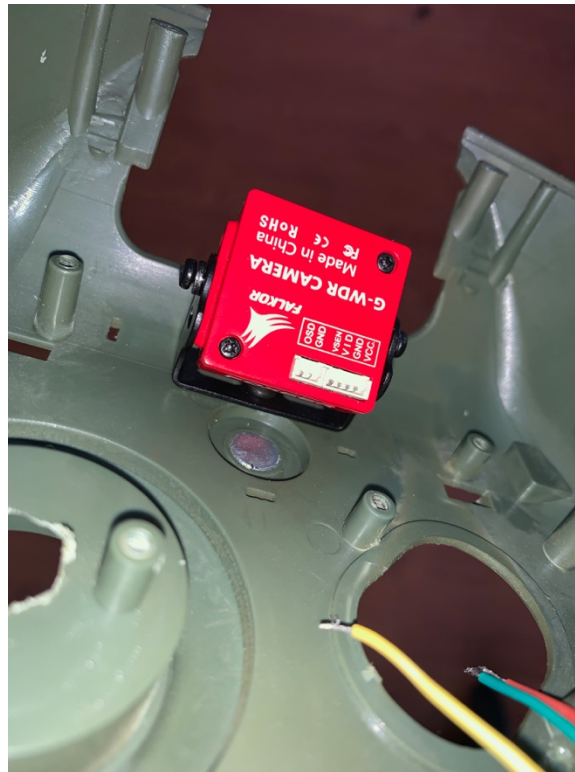
Figure 77 Camera 1 bracket mounting position

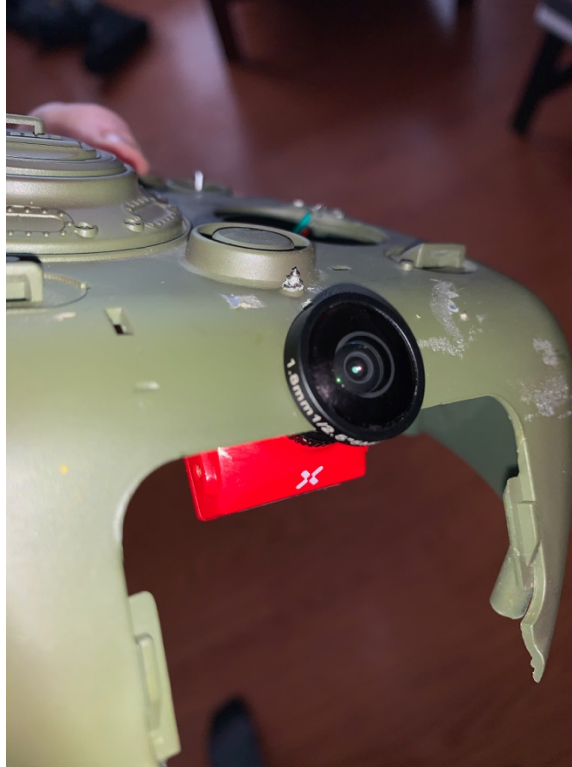
Figure 78 Camera 1 position in turret

Remove Foxeer camera from shipping box and fasten the mounting bracket to the camera using the middle position as shown in Figure 77. Unscrew the camera lens shaft from the body of the camera. Place the camera lens shaft through the 1/2-inch hole and screw it back onto the camera body.

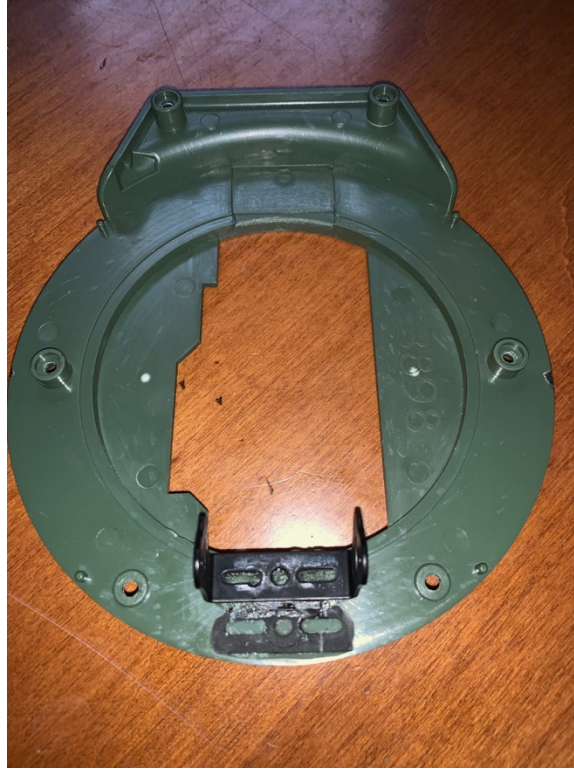
Figure 79 Camera 2 bracket position

Mounting the second camera requires gluing the bracket of the camera to the base of the turret, with a strong adhesive, such as fast curing epoxy. Bond the bracket to the turret as shown in Figure 79. Be sure to position the bracket so that the corners of the bracket touch the inner diameter of the turret base. If the bracket is mounted too far out on the diameter, the cover will not fit in the following steps. Also be sure to orient the bracket as shown in Figure 79 to allow for adjusting the camera elevation angle downward as desired. Once the epoxy has cured, mount the camera to the bracket with the four provided screws and washers. The screws should be manually tightened to that the camera can pivot for elevation angle adjustment.

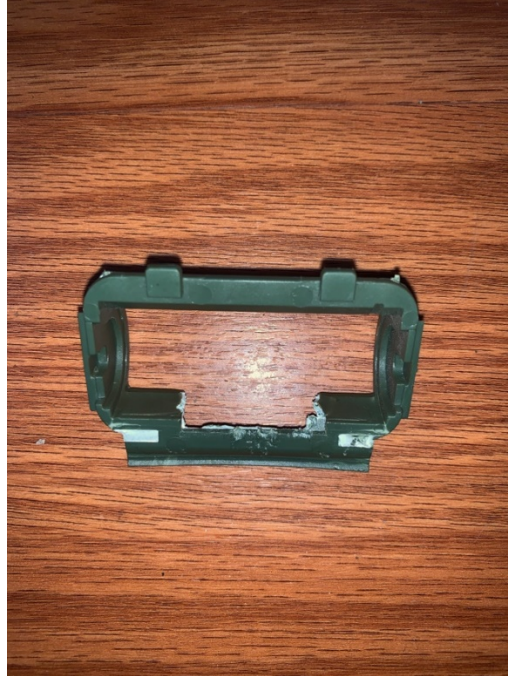
Figure 80 Camera 2 cover with plastic connectors removed

Modify the turret cover as shown in Figure 80 and Figure 81 to fit in place to shield the camera. Remove the connectors on the back side. Use a pair of needle nose pliers to make the rough modifications. A razor blade, X-Acto knife or Dremel tool can make more precise cuts.

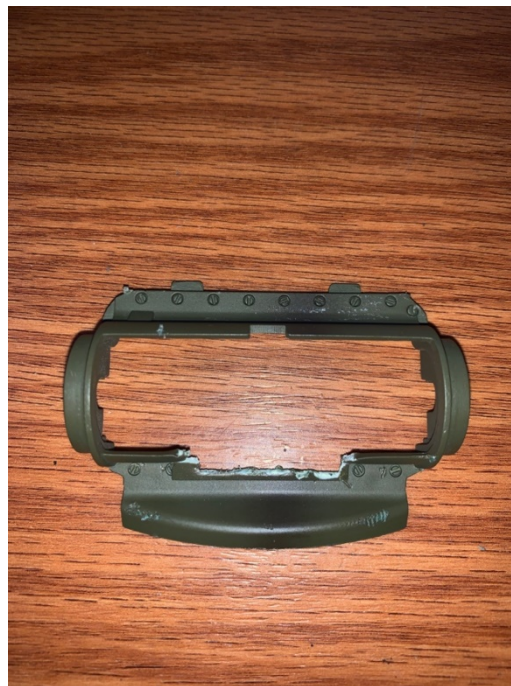
Figure 81 Camera 2 cover with cut made for camera

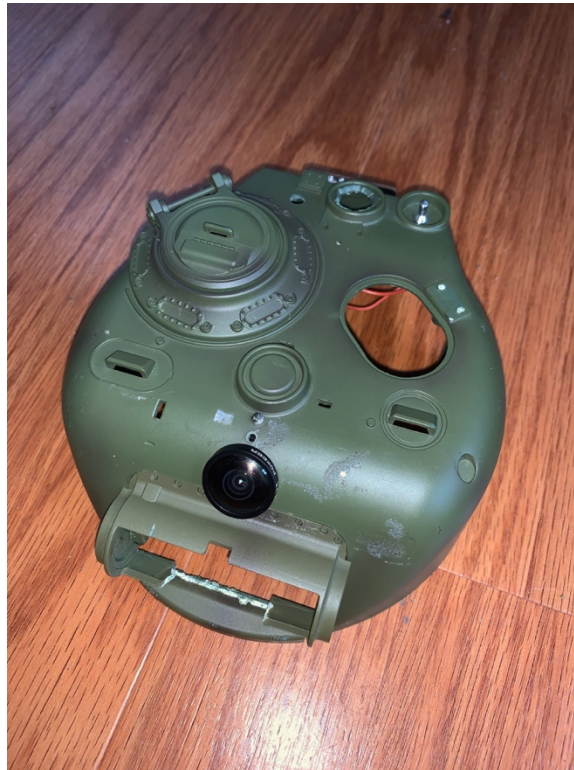
Figure 82 Camera 2 cover bonded to turret shell

Use epoxy to bond the Camera 2 cover to the turret shell as shown in Figure 82.

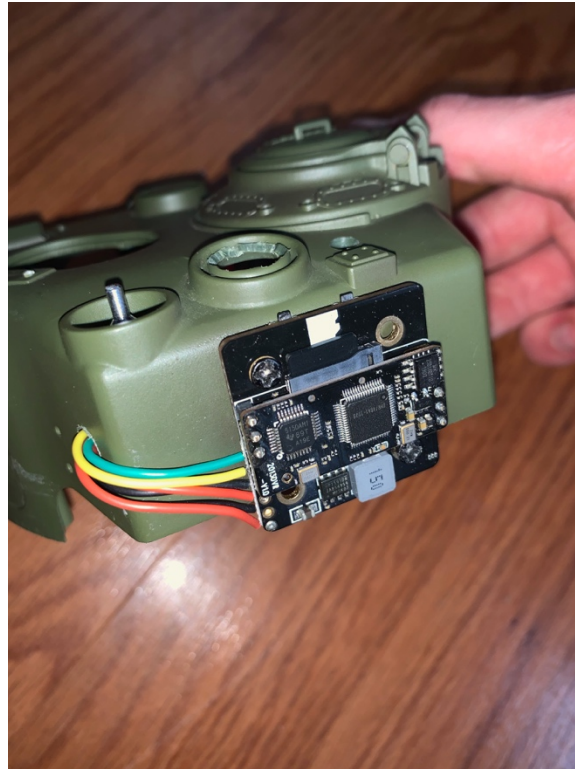
Figure 84 Transmitter screwed to back of turret

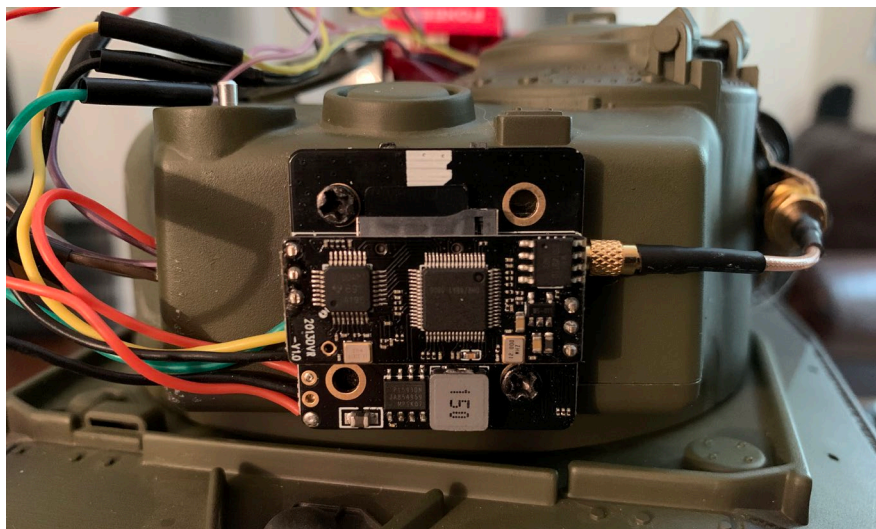
Figure 85 Transmitter board attached to back side of turret in assembled HIVE 2.0 tank

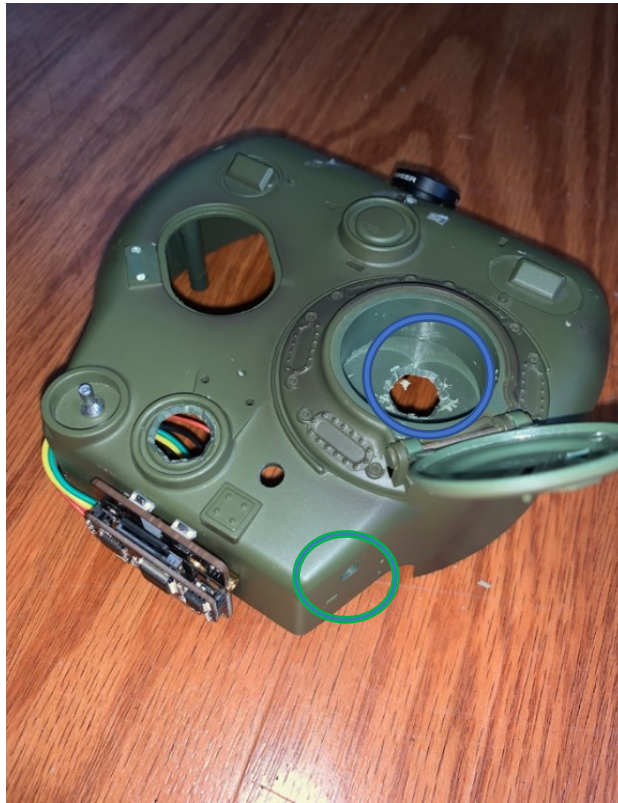
Figure 86 Holes drilled for antenna

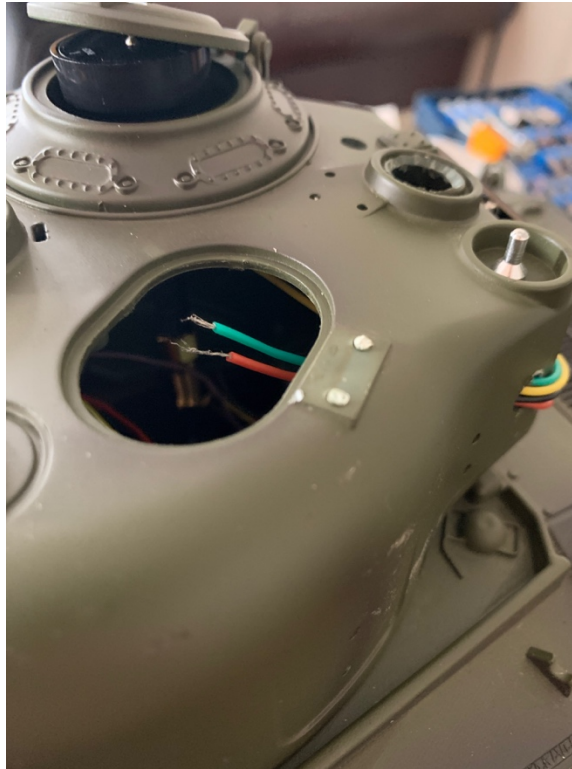
Figure 87 Hatch door removed and partially protruding antenna mount

Remove the hatch door on the turret as shown in Figure 87. This can be done easily with a pair of needle nose pliers. Sand the surface flat it before mounting the light.

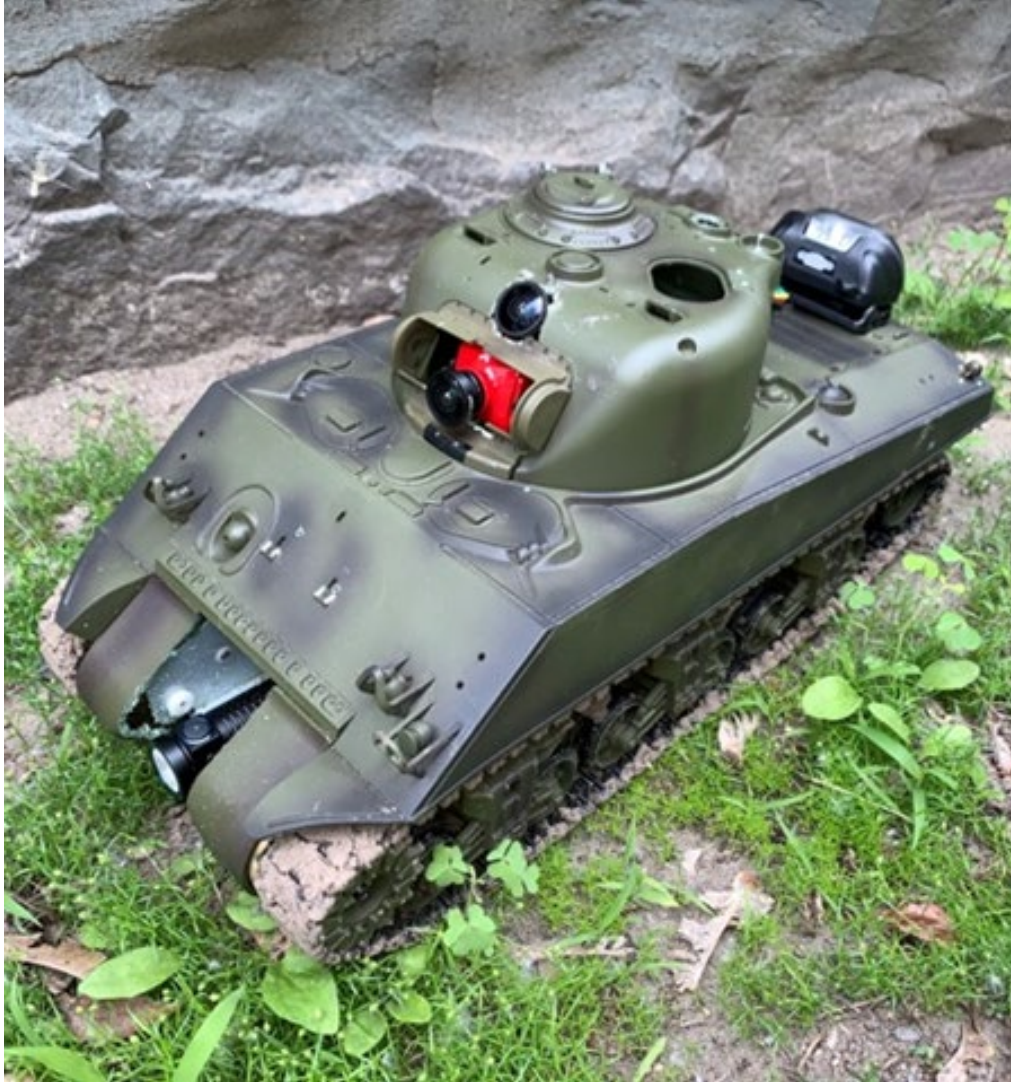
Figure 88 Fully assembled HIVE 2.0

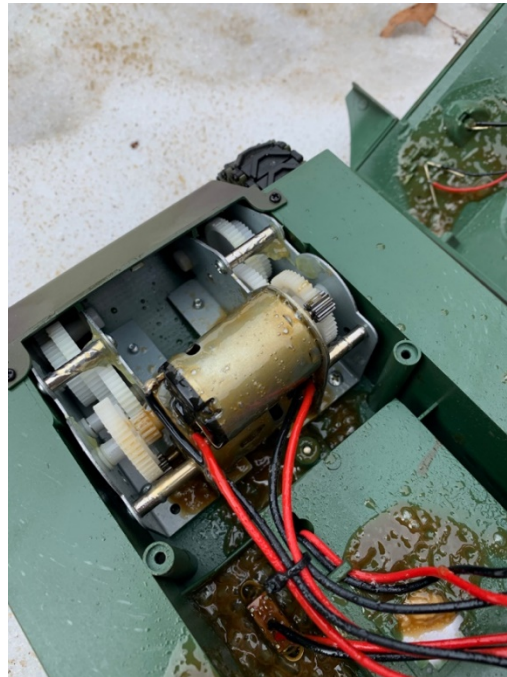
Figure 94. Tank waterproofing Photo 3
