## MATERIALS AND RESEARCH

INITIAL REPORT

U 2006-4

### Brifen Wire Rope Safety Fence

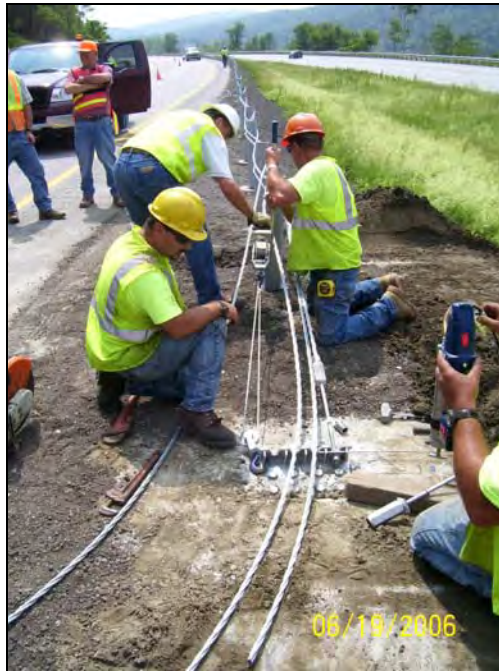
Figure 1 – Brifen Wire Rope Installation

Construction of the Brifen Wire Rope Safety Fence began the week of May 30, 2006. In accordance with the associated Category II Work Plan, WP 2005-R-11, the experimental test section of safety fence was installed on the shoulder of the north bound passing lane of I-89 from MM 56.545 to MM 56.860. Pre installation activities included the removal of underlying substrate for all post hole locations and the application of concrete into round paperboard forms known as “sonotubes”. The sonotubes contained rebar cages in order to support the line of posts required for the fence system. The sonotubes were spaced 10.5 feet apart on average. The spacing decreases to 6.5’ at each end terminal. On June 19<sup>th</sup> the wire and posts were set for erection. (See figure 1) Following the arrival of the representative from Brifen, assembly began on the test site.

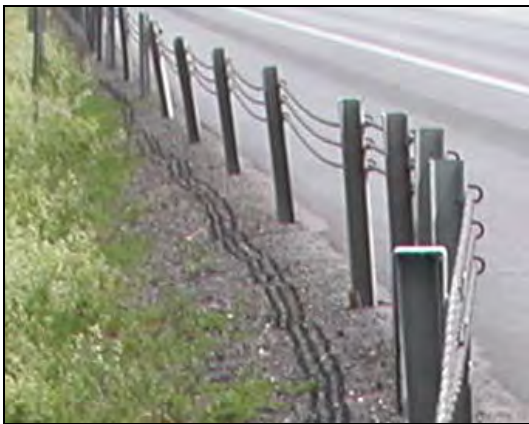
Figure 2 - Three Rope Fence

During the initial post installation site visit conducted on June 21<sup>st</sup>, the fence appeared to be very highly tensioned and visibly stronger than the standard three rope safety fence which seemed to sag in the middle between posts(See Figures 2 and 3). The referenced three cable barrier is located on the shoulder of the break down lane of I-89 northbound diagonally across from the brifen test site and end at MM 56.53. It was also observed that all four wire ropes were secured at the end terminals. While the three cable wire fence is hung on the front face of the post, the Brifen system weaves two wires around both sides of the posts as shown in Figures 2 and 3.

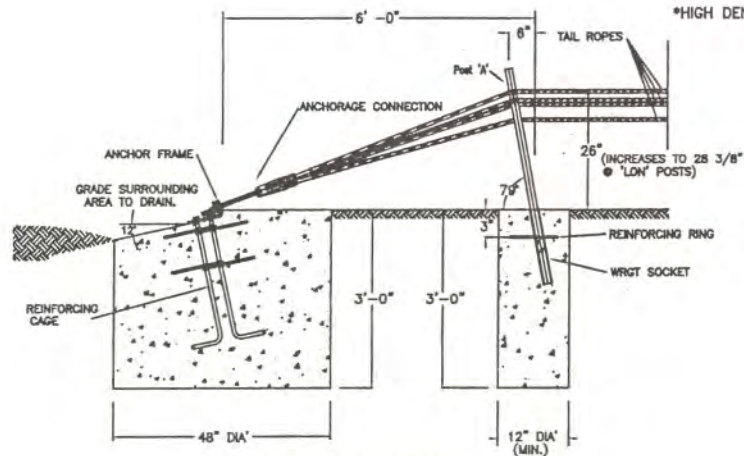
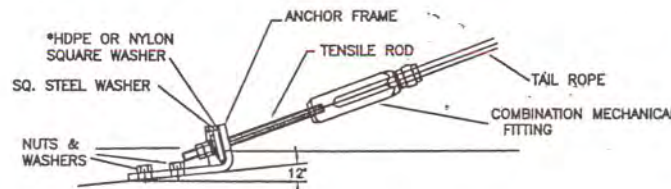
**END ANCHORAGE DETAIL**  
SEE NOTE 9.

ends of the ropes are attached to anchors embedded in the ground or to surface mounted anchors. Where the length of the fence is greater than 1385m intermediate anchors are used. To provide continuity two ropes (i.e. one upper and one lower) of the four ropes are anchored at each intermediate anchor. The connection between each rope and its anchor is designed to uncouple when a vehicle impact occurs in the vicinity of the anchor. The movement of the released rope is restrained by a safety check rope.” Please see Appendix A for an overall view of the fence. It should be noted that the actual height of the top rope is 762 mm (30 inches) and the bottom rope is placed at 533.4 mm (21 inches) from the top of the concrete sonotube. Additionally, the end anchorage detail included in Appendix A does not represent the end anchorage that was installed for this project. The two end anchor terminals were held in place by 6’ x 6’ x 10’ reinforced concrete blocks.
