MATERIALS & RESEARCH SECTION

RESEARCH UPDATE

U2013-01

Assessment of the Bridge Preservation LLC's BDM Waterproofing Membrane System

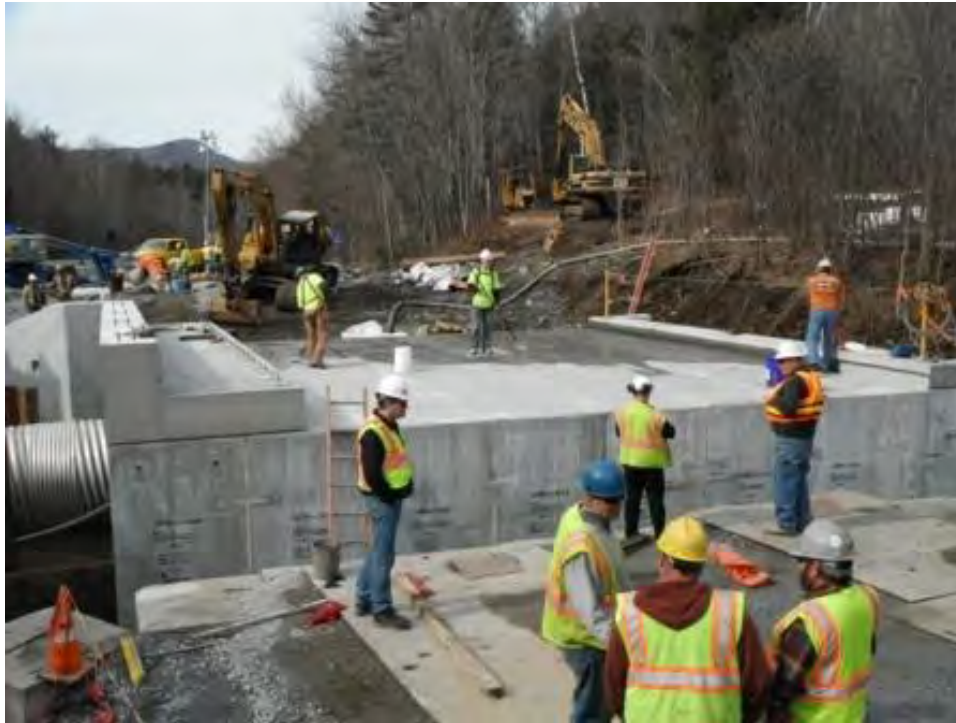
Figure 1 Installation of the BDM system, application of the primer

On the day of membrane application, the surfaces which it was to be applied to were shot blasted and cleaned thoroughly. Foam backer rods were wedged into any open joints. The primer was then rolled on all surfaces. The membrane was then sprayed onto all surfaces, using a mechanized spraying apparatus in a truck, hoses, and nozzles. The membrane is bright orange in color, which makes it easier to observe if all surfaces have been covered to a uniform nominal 80 mil thickness.

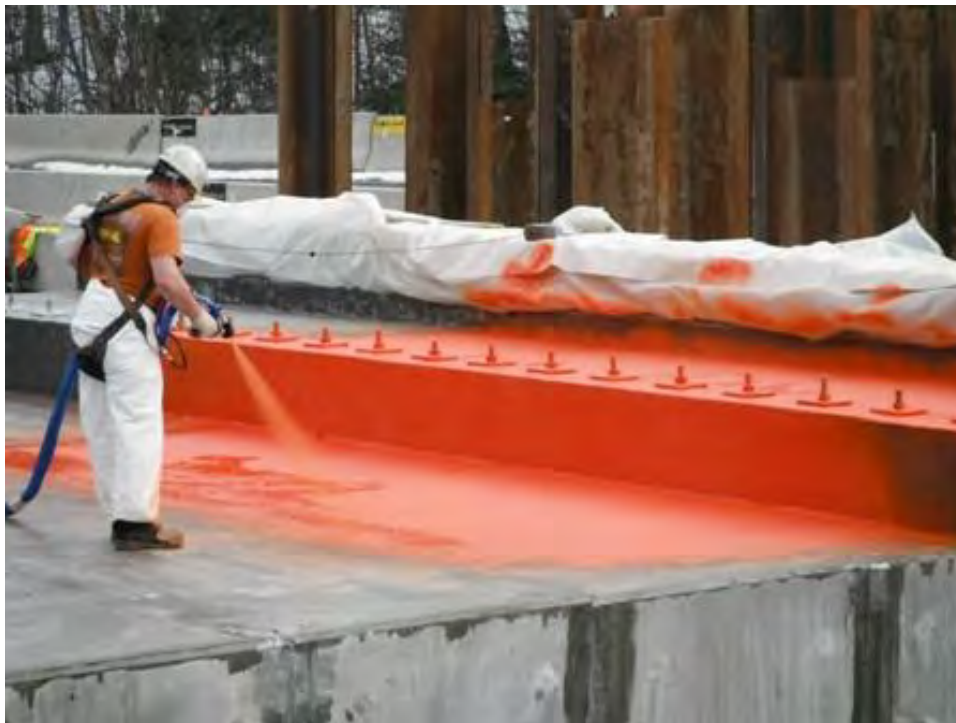
Figure 2 Spraying of the membrane
