**AEXCEL ROADZILLA™ METHYL METHACRYLATE
PAVEMENT MARKING**

Report 2014 – 15

Reporting on Work Plan 2009-R-1

The Aexcel Roadzilla™ Methyl Methacrylate was applied on the Chester Bridge #49 deck replacement BHF-ST 0134 (31) project, located along VT Route 11 at approximately mile marker (MM) 5.7 by the manufacturer, Aexcel Corporation of Mentor, Ohio. The rolled beam bridge structure has approximately an 82'-0" span. A total of 34 readings were taken on both the white edge lines and yellow centerlines on the concrete surface. On the bituminous concrete bridge approaches, 18 readings were taken on the white edge lines and 12 readings were taken on the yellow centerlines. Following the placement of the markings, retroreflectivity and wear readings were collected using uniform methods. Retroreflectivity readings were taken on each line (white edge, white skip, yellow edge) at five-foot intervals on both the bare concrete bridge deck surface and bituminous concrete bridge approaches using the LTL 2000 Retroreflectometer. Readings were collected four times over the course of the first year of the evaluation. At the fourth site visit, it was determined that due to the poor performance o

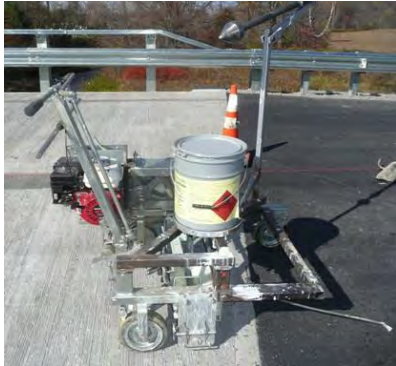
Figure 1: Push handcart applicator.

the system adhesion activator, was added in a 5-gallon pail which initiated the chemical heating process. The amount of peroxide needed is dependent upon ambient conditions and the temperature of the application surface. Typically, 4 ounces of peroxide per gallon of MMA is used. Once the system was mixed, the markings were applied using a push handcart (see Figure 1.) A spiked bar on the handcart was used to create a splatter effect as the markings were applied to the bridge deck (see Figure 2.)

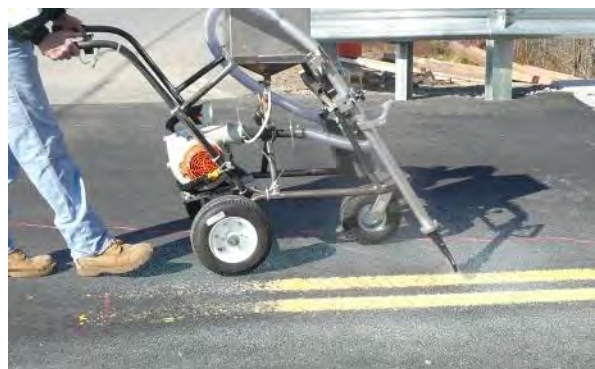
Figure 3: Bead applicator.

After the handcart passed, the optics were dropped onto the marking substrate (see Figure 3.) White markings typically provide higher retroreflective values due to the nature of pigments in white paint as compared to yellow. Because of this, the yellow markings used strictly Duralux beads whereas the white markings received a 50/50 blend of Duralux and Megalux beads. The white markings did not use strictly Duralux beads because these beads are much more expensive. Approximately 10 to 12 lbs of beads per gallon of MMA paint were applied. Figures 4-7 show the markings immediately following application (2).

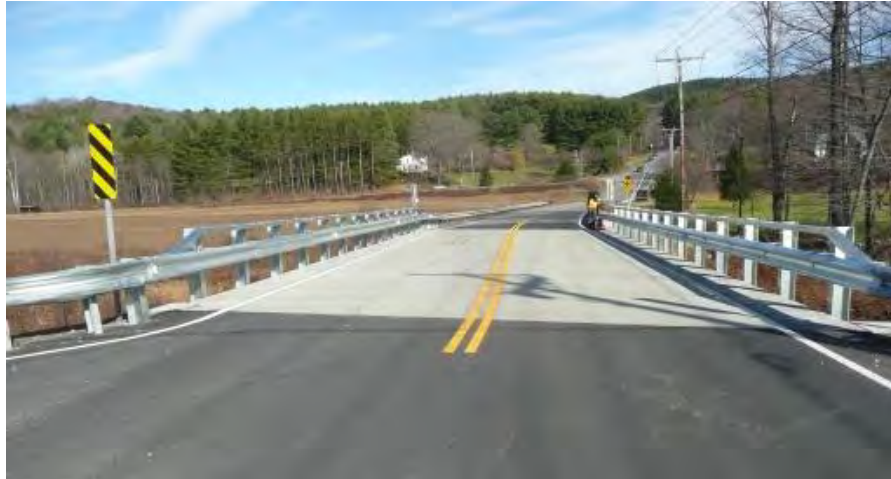
Figure 8: Bridge overview looking eastbound.

The initial site visit was conducted on November 10, 18 days after the MMA markings were applied because the Delta Retroreflectorimeter LTL 2000 was being serviced and calibrated. Figure 8 below shows an overview of the markings.

All markings were noted to be in excellent condition and far above the FHWA recommended minimum retroreflective values which are 85 mcdl/lx/m² for white and 55 mcdl/lx/m² for yellow for non-freeway roads when the speed limit is less than or equal to 40 miles per hour. The average initial readings of the white edgelines on concrete (WC) and asphalt (WA) were 950 mcdl/lx/m² and 1185 mcdl/lx/m² respectively. The yellow centerline readings averaged 330 mcdl/lx/m² on concrete (YC) and 208 mcdl/lx/m² on asphalt (YA).
