Accelerated Innovation Deployment (AID) Demonstration Project  
Field Metalizing of a Steel Beam Bridge  
Vermont Agency of Transportation  
Structures Design Section  
Final Report  
J. B. McCarthy, VTrans Project Manager  
August 11, 2023

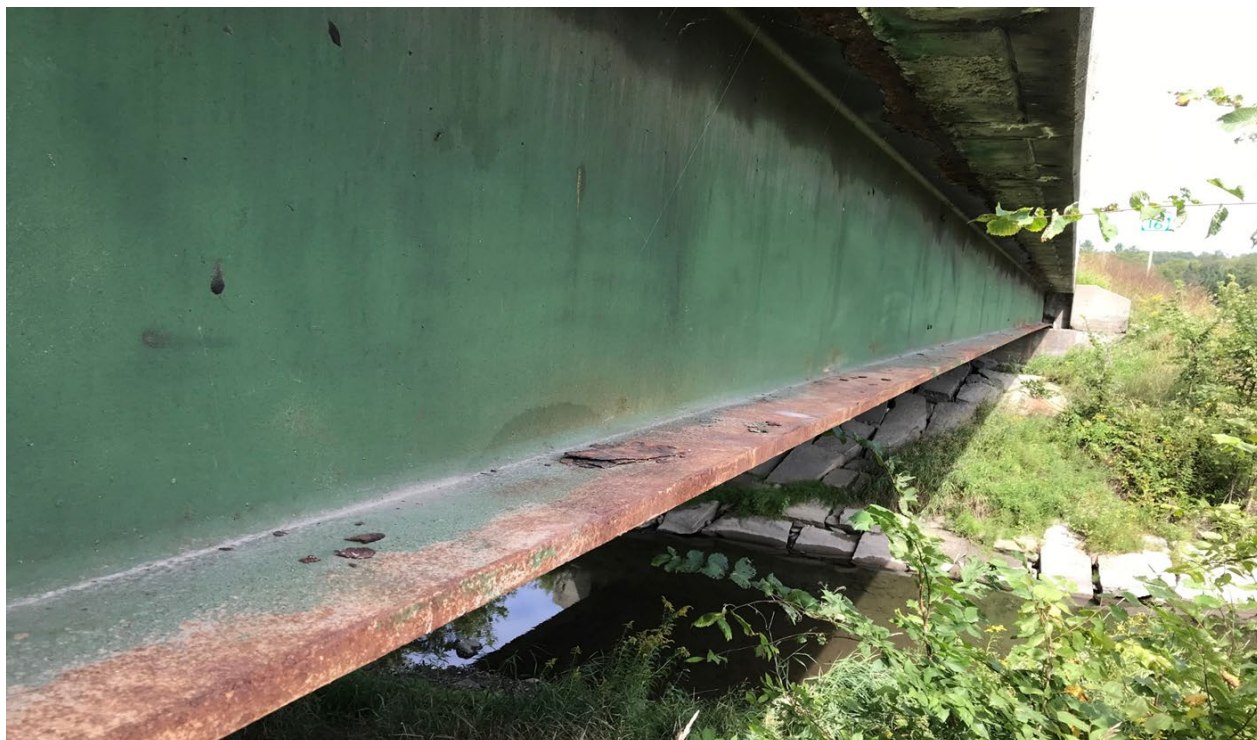
Hardwick VT Br. 1 (Fascia beam paint deterioration)

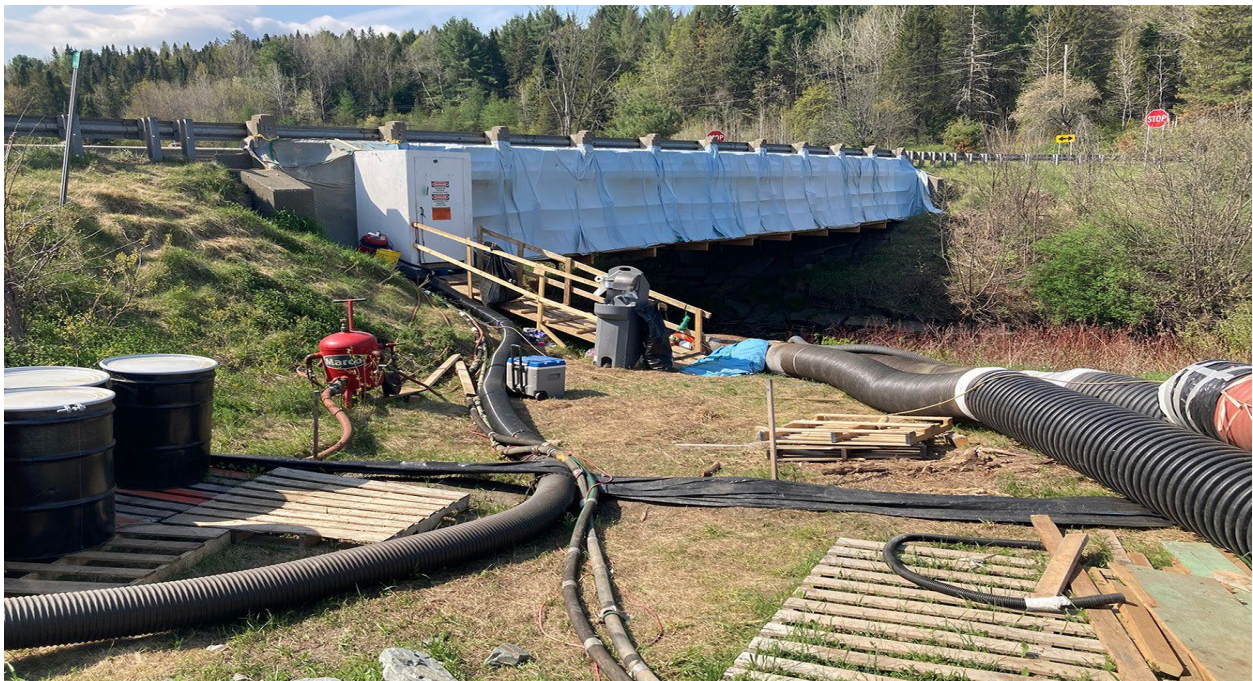
Structure Containment in Place

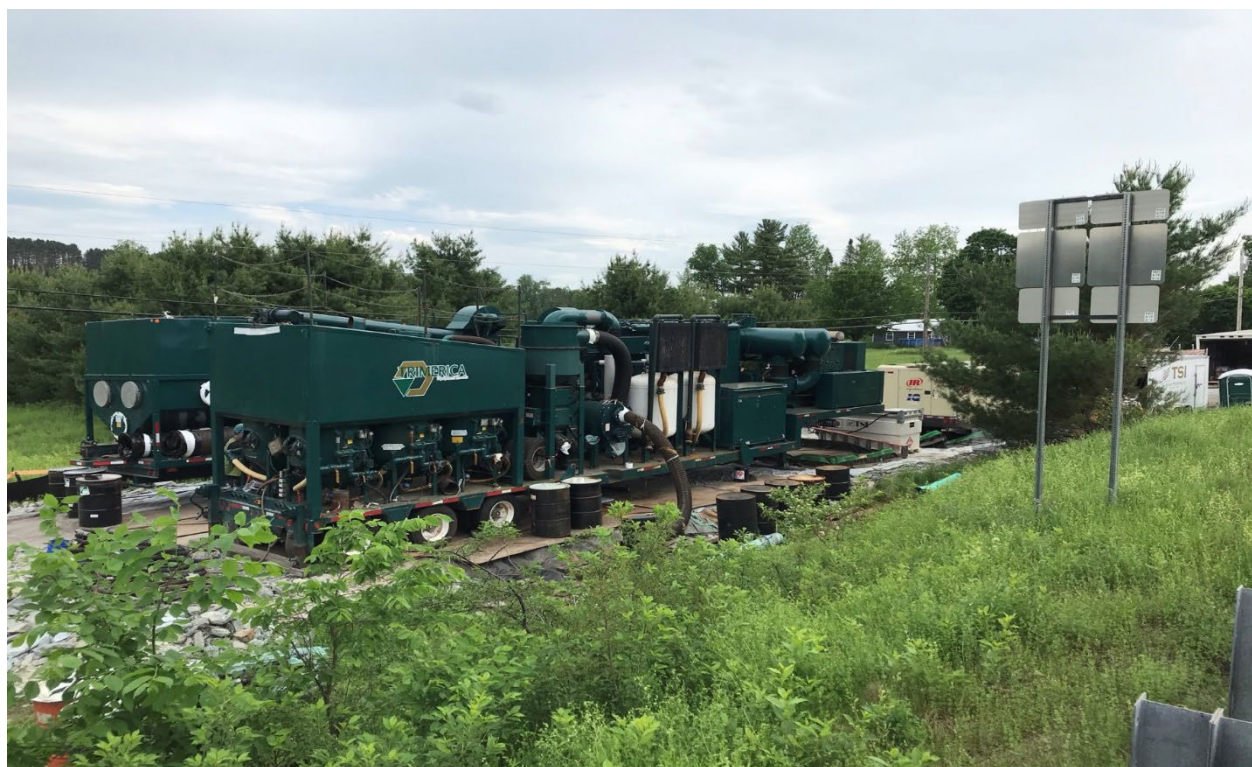
Air Filtration Equipment

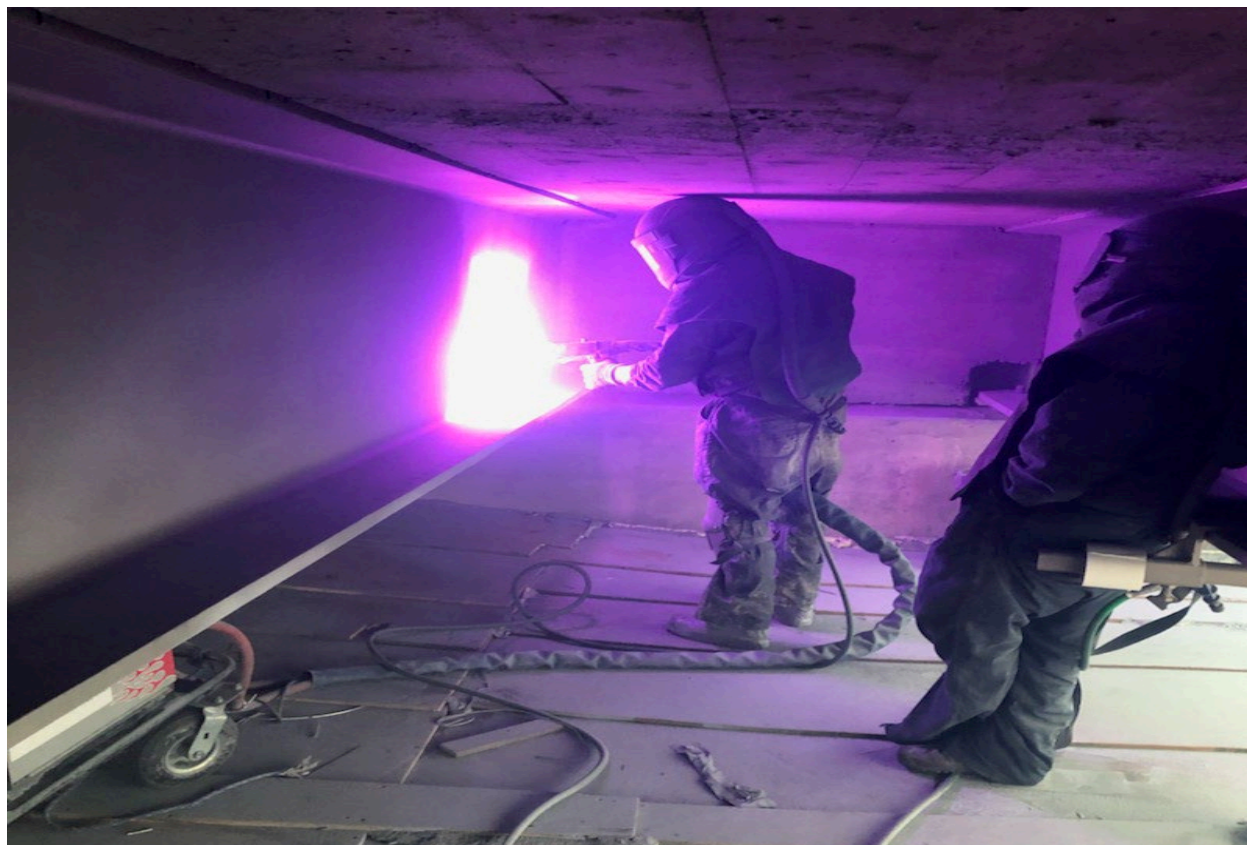
- Sealer shall be applied by spray and supplemented with rolling or brushing.
- Metalizing inside the enclosure is relatively difficult as compared to metalizing in the shop due to tight dark conditions.

- There was relatively poor visibility inside the enclosure during the metalizing even with dust collectors and air scrubbers running.
- Perhaps the uneven final appearance was a result of this poor visibility or uneven application of the sealer.

Metalizing Inside the Enclosure

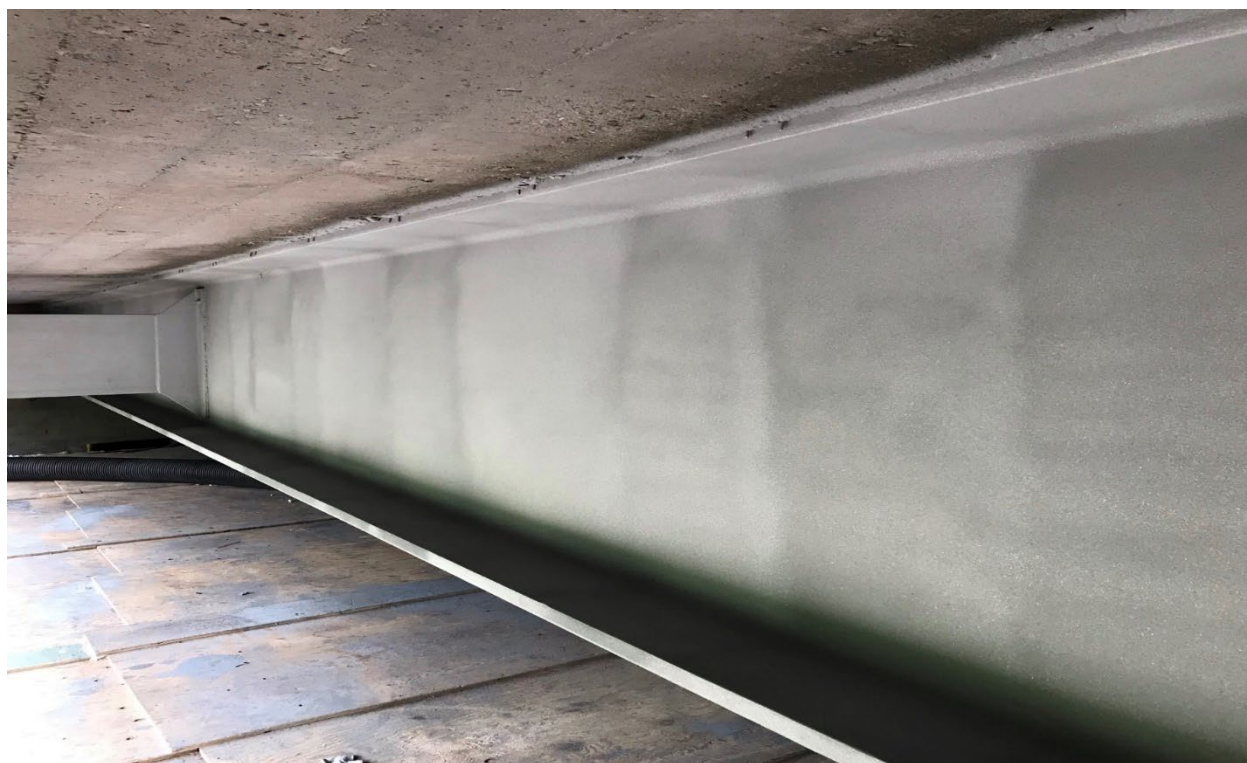
- The contractor used 1/8" zinc wire. Using 3/16" wire would increase the rate of production but may be more costly.
- A considerable amount of the zinc wire simply rebounds off the substrate creating a dusty environment within the enclosure which may have contributed to the final streaks in the coating.

Streaks in the Final Coating

- Different color sealers are available or the final surface can be painted in areas where aesthetics is a concern.
- Overall weather conditions were good during the metalizing with no rain or damp humid weather to contend with.

Aesthetic concerns were not an issue for this bridge. The streaks in the final coating can be corrected with a colored seal coat or subsequent coats of paint.

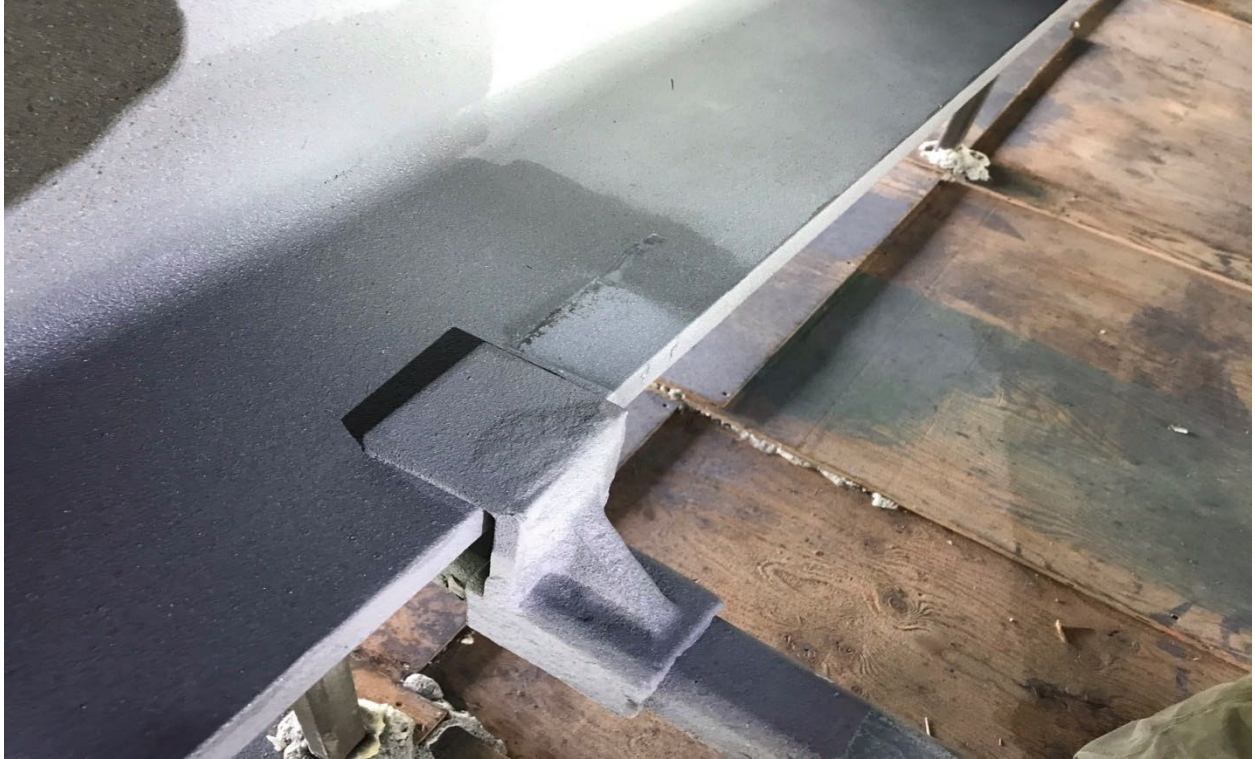
Repair Areas for Hanger Attachment

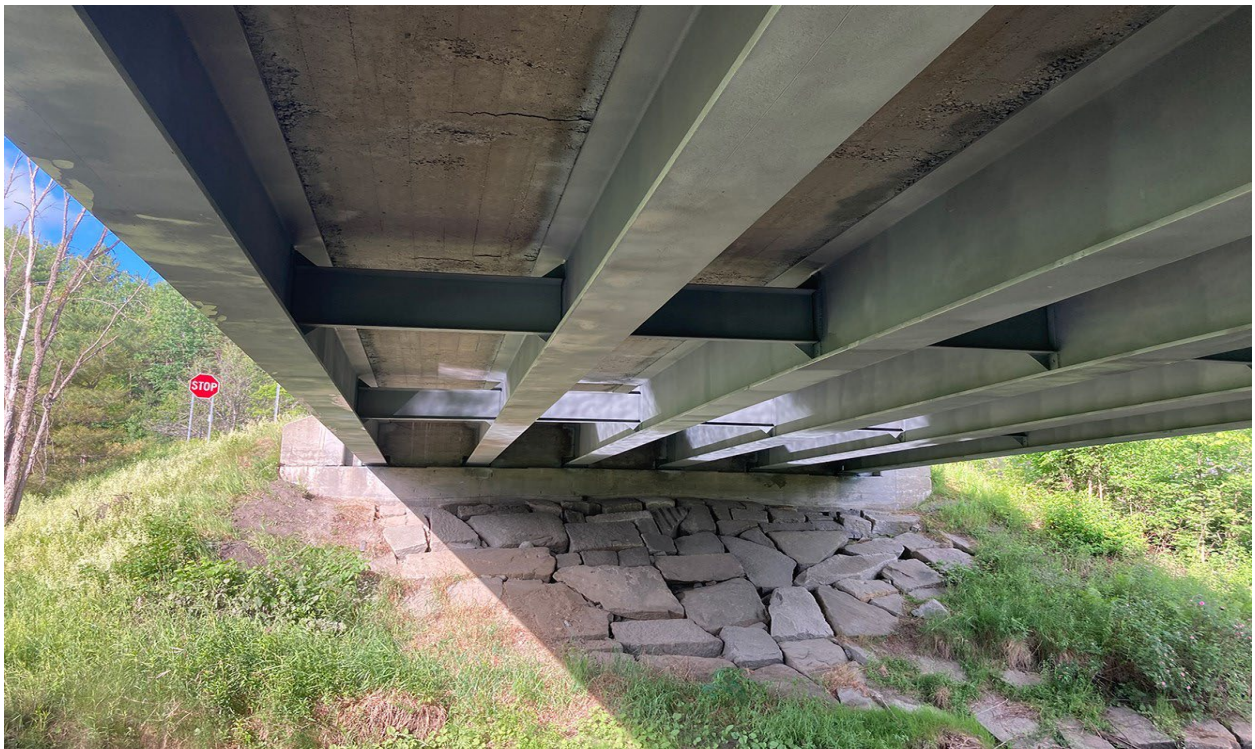
Finished Metalizing (Interior Beams)

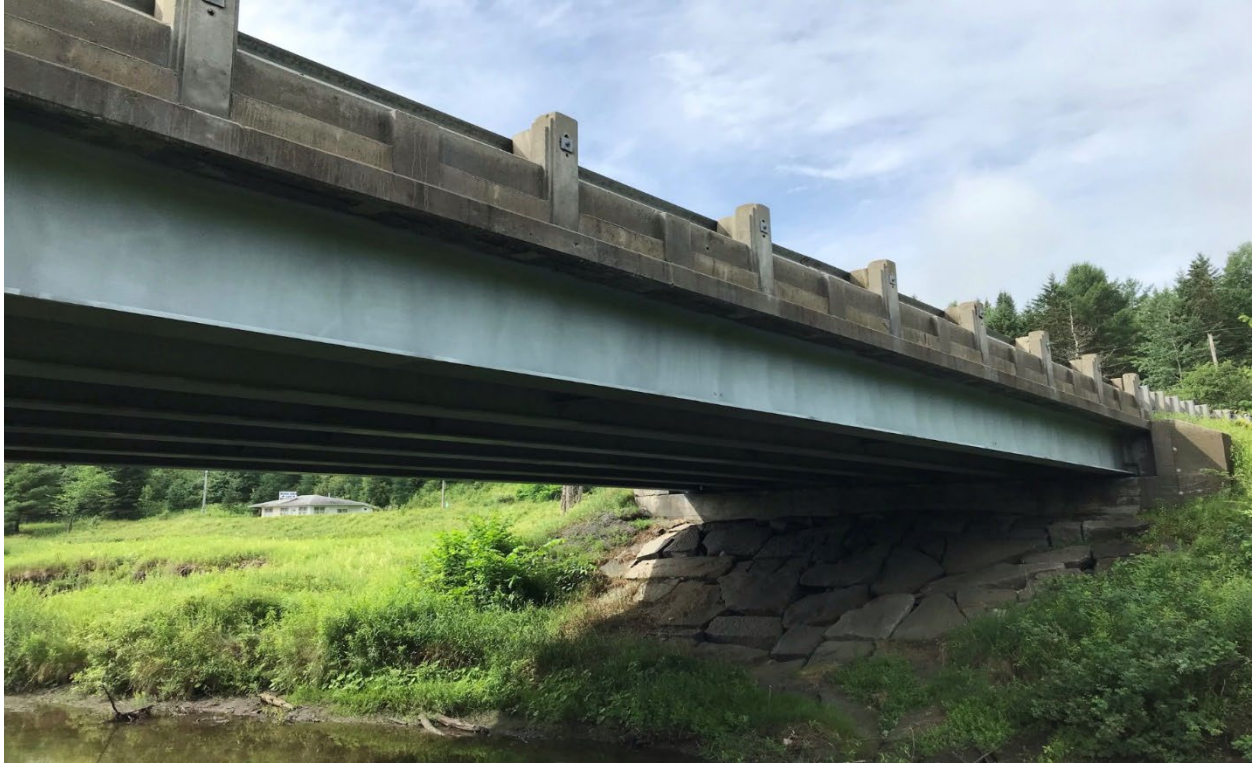
Finished Metalizing (Fascia Beam)
