**Materials & Research Section
Research Report**

**CENTERLINE RUMBLE-STRIPES
CAMBRIDGE, VERMONT**

Report 2014 – 03

March 2014

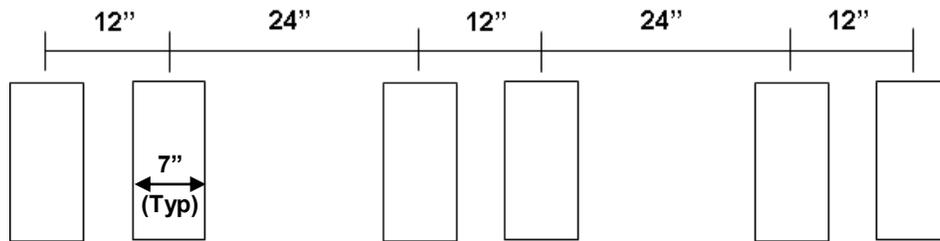
In Vermont, centerline rumble stripes are typically installed in a repeating pattern shown in Figure 1 with sets of two rumbles spaced at 12" on center with each set spaced 36" on center. According to the Resident Engineer, it was determined that the centerline rumble stripes were installed in a different pattern where the rumbles were placed continuously at 12" on center as shown in Figure 2 below. This change was due to equipment availability and time constraints.
(4)

Figure 1 Standard Vermont Centerline Rumble stripe Pattern

From what has been gained from this research effort, it is recommended that rumble stripes be placed according to current Agency details, with no alternatives. Until further research provides adequate alternatives that optimize the overall reduction of ambient exterior sounds while, providing an effective interior warning indicator for the driver, the current pattern as shown in Figure 1 should not be altered.

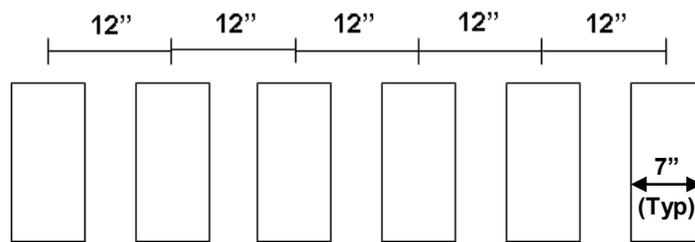
On VT 104 in Cambridge, VT., VTrans installed rumble stripes as part of a highway-resurfacing project. The revised pattern was a series of closely spaced depressions with equal lengths of smooth and rutted surface. Due to a series of factors during construction, the typical rumble strip pattern was changed.

Figure 2 Altered Rumble Stripe Pattern as Placed in Cambridge-Fairfax

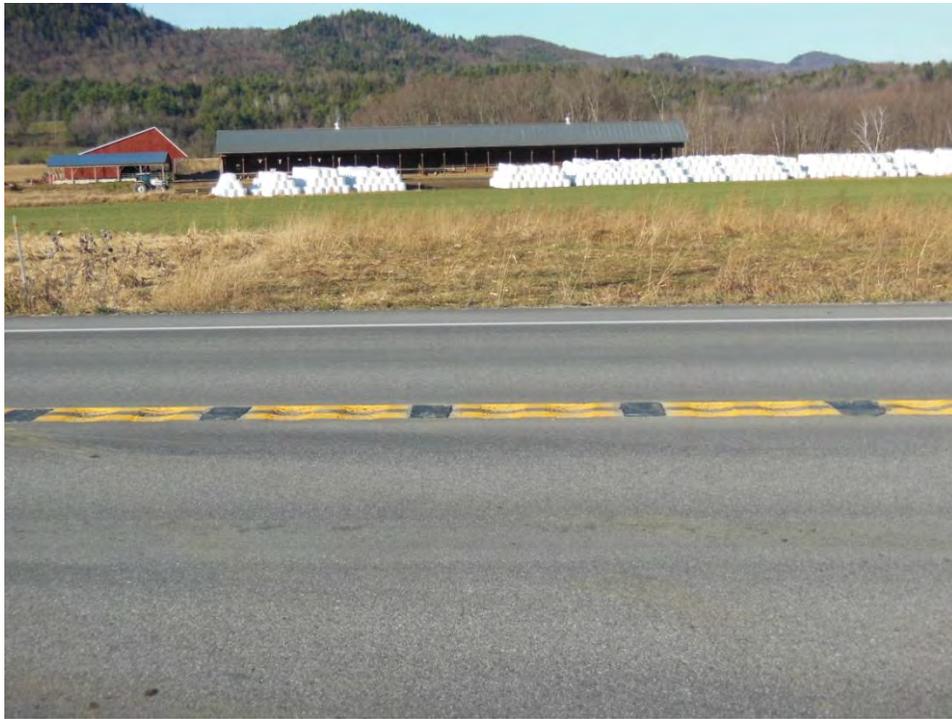
According to the change order (#7), the contractor was to fill every third rumble along the stretch of centerline rumble stripes for approximately two miles along VT Route 104. Figure 3 shows the repair. The order also called for filling the rumbles in the shoulder rumble strip at the northern corner of the VT 104 and VT 15 intersection. Lastly, the order called for filling every rumble in the centerline stripe in front of the Boyden Farm for a distance of 75 feet.

Figure 3 Initial Repair Pattern - Patched every third rumble to approximate standard.

According to the daily work comments report, the initial repair work began on Thursday, November 15, 2012. The first of attempt of filling the rumbles failed due to lack of bonding and thin edges. The second failed attempt involved heating the in-place pavement to a higher temperature. The third attempt appeared to work well which involved using angle grinders to cut vertical edges and using duct tape to mask the area to keep the hot rubber material within the limits of the rumble. The method was selected to continue the repair. The contractor repaired 232 shoulder rumbles the remainder of the first day. The remaining shoulder rumbles were filled the next day along with filling the 75-foot section of centerline rumble stripes in front of the Boyden Farm. The following Monday, November 19, 2012, the contractor attempted to install the material without vertical cut edges. It appeared that there were moisture bubbles coming through the material to the surface. Regardless of the bubbles, when the material was pulled up, stones also came up, indicating a strong bond. Although the bond appeared to be good, the Resident Engineer requested that the contractor continue the repair using the method used on the first day. Work continued though the next week, however due to slow progress, cold temperatures, and escalating costs, the decision was made by VTrans to halt the repair after 1500', of repair (about 15% of the total distance needing repair.) With slow work progress when the work was halted the cost resulted in \$42,000, almost at the total original estimated repair cost. (4)

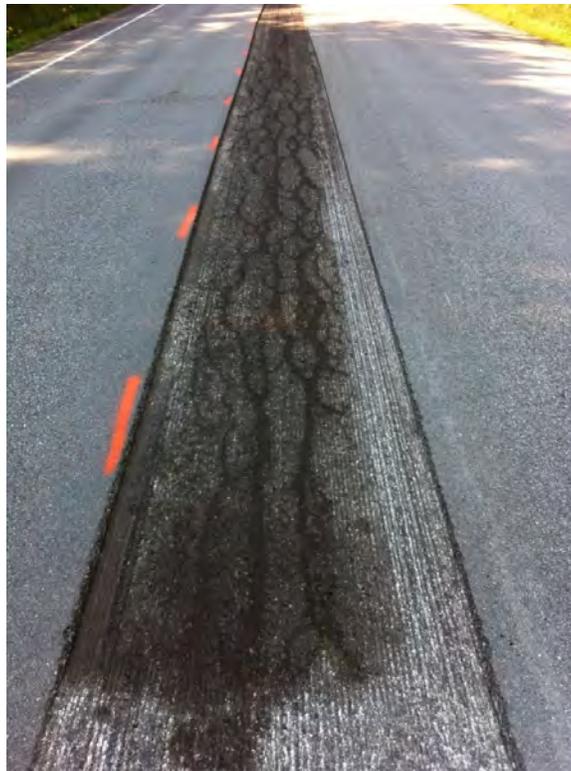
After the difficulty and associated costs, VTrans chose a different repair method, which included removing all rumble stripes by milling the center of the roadway and repaving the milled area, as shown in Figure 4. This was completed by ST Paving and VTrans District 8 personnel during the following construction season. The repair including equipment rental, labor, pavement mix, and traffic control totaled \$61,186.29. (7) The repair was completed between August 19 and 20, 2013.

Figure 4 Roadway centerline after milling.

It was found that rather than patch individual rumbles, the most cost effective approach to repairing rumbles was to mill the rumbles out and then repave with new asphalt mix. Individual patching proved to be slow and more expensive. Patching did not provide an adequate solution for sound reduction. Milling and filling proved to remove the rumble pattern quickly and effectively while at the same time provide a fresh new surface in which to place a different rumble pattern.

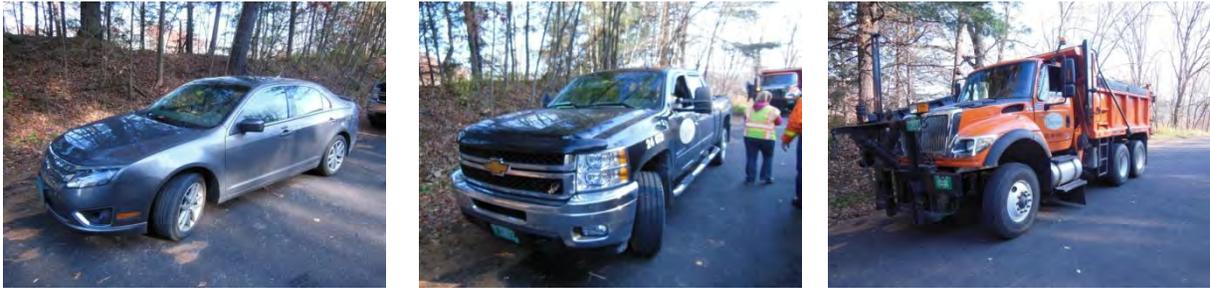
Research personnel along with District 8 assistance conducted Pass-by sound measurements to evaluate the rumble stripe noise. To conduct the test a passenger car, pickup truck, and one of the Districts' tandem plow trucks was used (See Figure 5). Each vehicle made four passes at 30mph, 40mph, and 50mph. For each speed, an initial pass was made within the travel lane without encountering the rumble stripe, and then three subsequent passes were made with the vehicle's wheels riding on the rumble stripe. While the vehicles were driving by, two Agency Researchers were standing 25 feet and 50 feet away from the stripes on the side of the road taking respective sound readings at each distance. In the analysis, for each speed and distance away from the rumble stripe, the three readings from the vehicle riding on the rumble stripes were averaged, and then compared to the initial reading of the vehicle within the travel lane.

Figure 5 Test Vehicles: A passenger car, a pickup truck and a district plow truck.
