**Evaluation and Comparison of
Cold Weather Waterborne Traffic Paint with XSR
Middlesex/Moretown VT 100B
Final Report**

**Report 2007 – 12
Reporting on Work Plan 2006-R-3**

State of Vermont
Agency of Transportation
Materials and Research Section

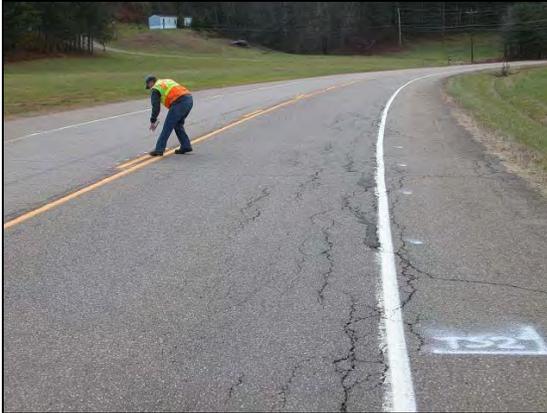
Figure 1 – XSR 11/09/06

The initial drop in retroreflectivity is also important to examine as it relates to proper curing. If properly cured, both the binder and the beads retain higher bond strength to all surrounding substrates and should be less susceptible to wear and tear from tire treads. Over a six day period, the initial retroreflectivity readings of the standard markings decreased by an average of 129 mcdl while the XSR marking decreased by 35 mcdl, suggesting that the experimental markings cured more readily at lower temperatures. As stated previously, wear readings were also collected. Wear readings are a visual assessment of the amount of substrate remaining and are rather subjective. This variable is dependent on several parameters, including proper application, wear from tire treads and winter maintenance practices, and ultraviolet radiation. Figures 1 through 4 display the marking materials immediately and seven months following application.

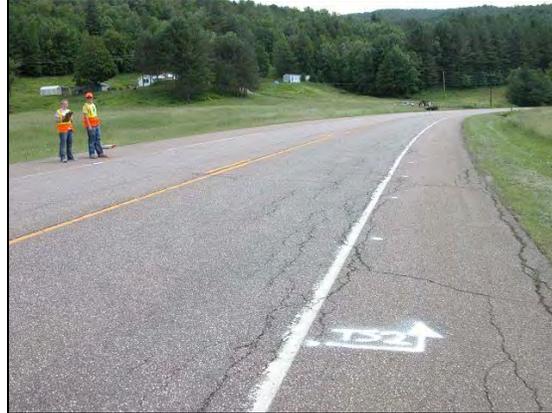
Figure 2 – XSR 06/20/07

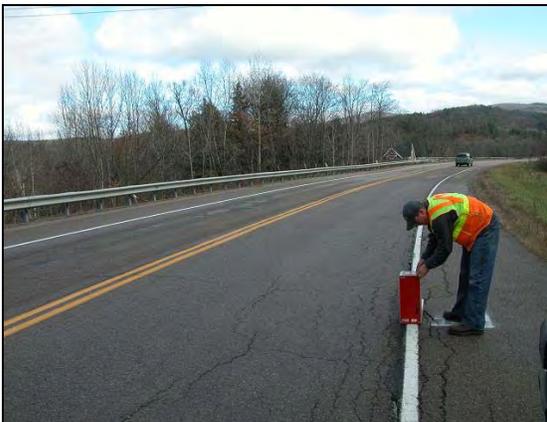
Figure 3 – Waterborne 11/09/06

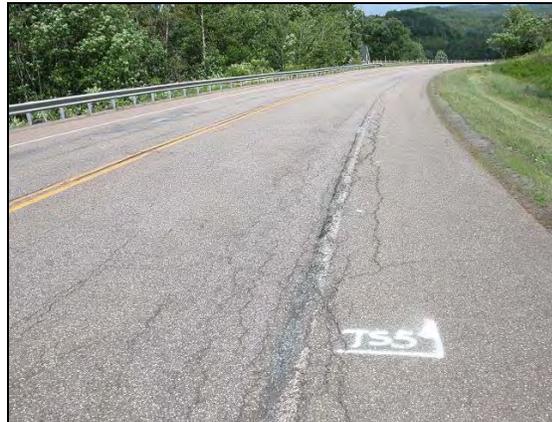
Figure 4 – Waterborne 06/20/07
