**INVESTIGATION OF ALKALI-SILICA  
REACTIVITY IN PORTLAND  
CEMENT CONCRETE**

**PHASE I  
VERMONT AGGREGATE  
EVALUATION**

**Vermont Agency of  
Transportation  
Research, Development and  
Technology Transfer Project  
RSCH004-910**

1. Report No. <b>FHWA-VT-RD-0301</b>		2. Government Accession No.		3. Recipient's Catalog No.	
4. Title and Subtitle <b>INVESTIGATION OF ALKALI-SILICA REACTIVITY IN PORTLAND CEMENT CONCRETE, PHASE I VERMONT AGGREGATE EVALUATION</b>				5. Report Date <b>NOVEMBER 20, 2003</b>

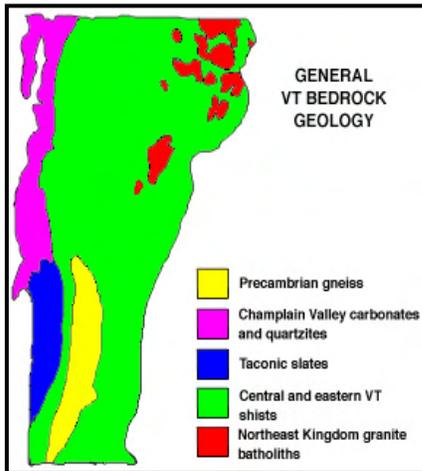
**Figure 1 Simplified geologic map of Vermont**

Figure 1 presents a simplified geologic diagram of the State of Vermont. The geology of the state is characterized by northeast trending zones of bedrock geology that reflects the sedimentary, metamorphic and igneous rock types found in the state. The bedrock aggregate sources throughout Vermont vary widely in rock type, crystal grain size, mineral composition, grade of metamorphism and degree of weathering.

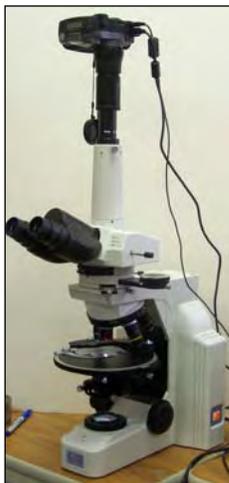
Several samples from those sources that tested as potentially reactive (expansion of 0.10 % or greater at 14 days) using the T303-00 testing procedure were examined. The petrographic examinations were conducted to identify the reacting aggregates within the concrete, ASR gel and the micro-structural distress caused by ASR. Samples were viewed under 40X and 100X, however, in some instances magnification up to 400X was used.

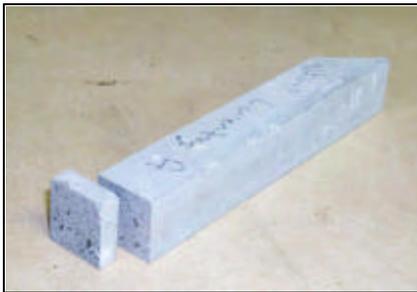
The first step in preparing the thin section samples were to cut  $\frac{3}{4}$ " blocks from the mortar bars. This was accomplished utilizing a diamond trim saw lubricated with propylene glycol. For the first six sample sources, cubes were cut at random portions of the bars. Later, it was determined that it would be advantageous to cut cubes for thin sections from areas of mortar bars that showed precipitate or other possible evidence of ASR. Therefore, the remaining five sample sources were cut from areas of the bar that showed an abundance of white precipitate.

**Figure 1 Mortar bar showing  $\frac{3}{4}$ " cube cut from bar. Cubes were cut utilizing a Raytech 10" Trim Saw cooled with RV propylene glycol antifreeze coolant.**

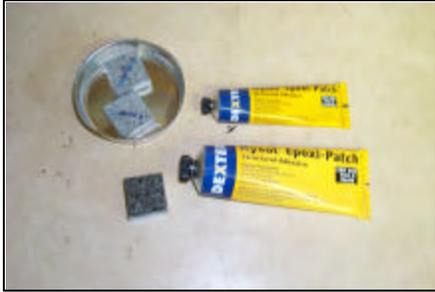
After being cut, each  $\frac{3}{4}$ " cube was washed then dried overnight in a 112°C oven. After drying, the blocks were impregnated on one side with a two-part epoxy resin that was

**Figure 2 Mortar bar cubes and two-part epoxy used to bind sample to slide .**

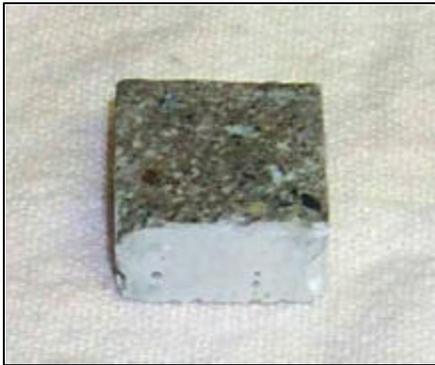
**Figure 3 Mortar bar cube showing epoxy coated surface.**

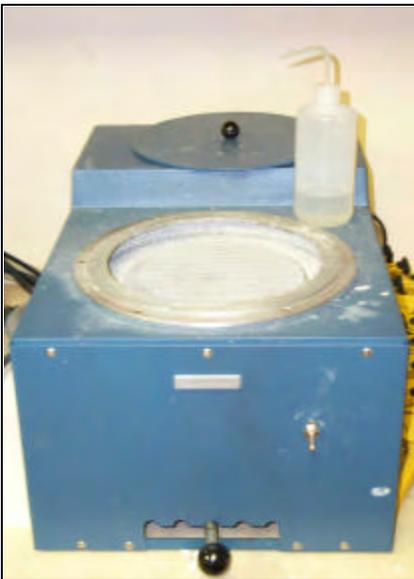
Samples were then air-dried overnight and lapped with three levels of diamond disks using a specimen polisher until the sample surface was perfectly flat and smooth.

**Figure 4 Grinder/Polisher used to prepare sample for mounting to slide. Samples were polished by holding the cube to the wheel using progressively finer grit disks while carefully applying water to cool the sample and to wash away waste cuttings.**

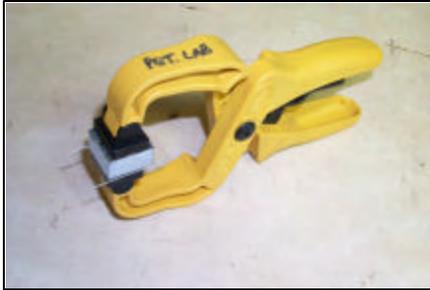
After each cube was ground to a sufficiently flat surface, they were allowed to dry overnight. After drying, the flat and smooth sides of the cubes were epoxied to a glass slide using the two-part epoxy (uncut with thinners), clamped and allowed to cure for a minimum of three days.

**Figure 5 Clamp used to hold slide securely to sample while curing.**

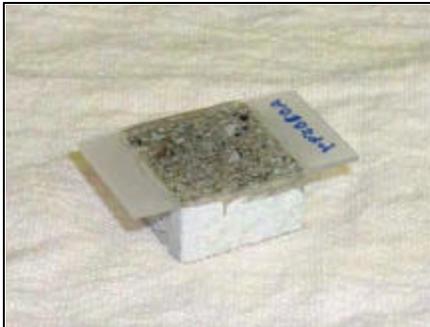
**Figure 6 View of underside of epoxied sample.**

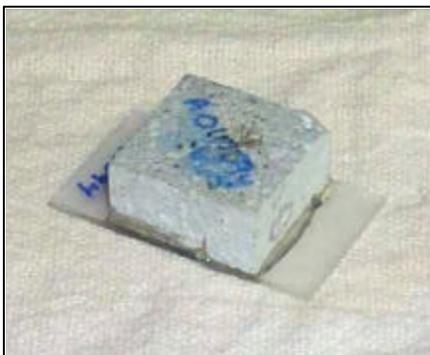
**Figure 7 View of top sample of epoxied sample.**

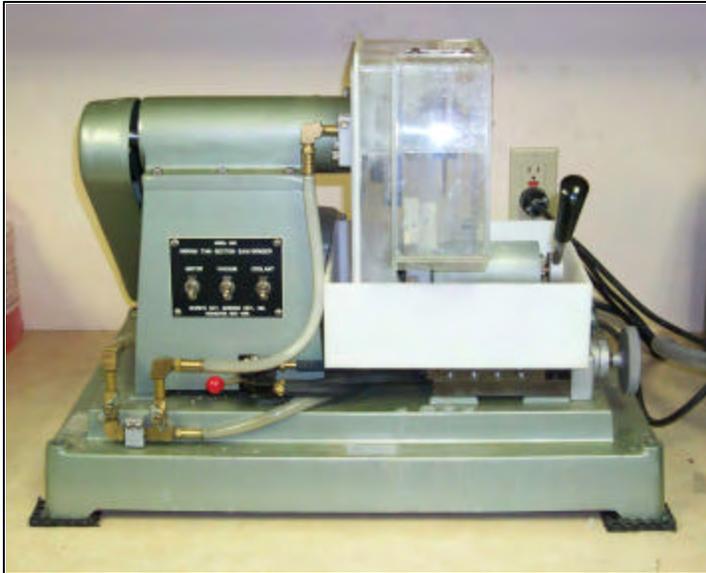
Samples were then cut and ground to approximately 30-microns in thickness using a thin section machine with a diamond saw and grinding wheel.

**Figure 8 Thin section saw/grinder used to prepare sample. This equipment allows the sample to be ground down to 30 microns or less.**

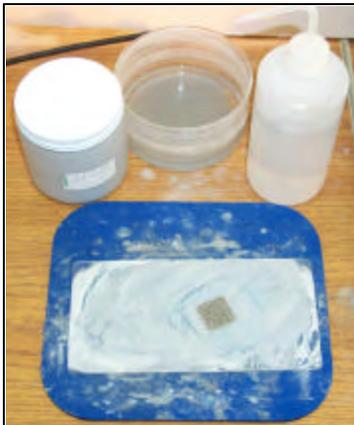
Final polishing of the thin section was accomplished by hand using water and #600 grit silicon carbide on a thick piece of glass.

**Figure 9 Photograph showing hand lapping equipment.**

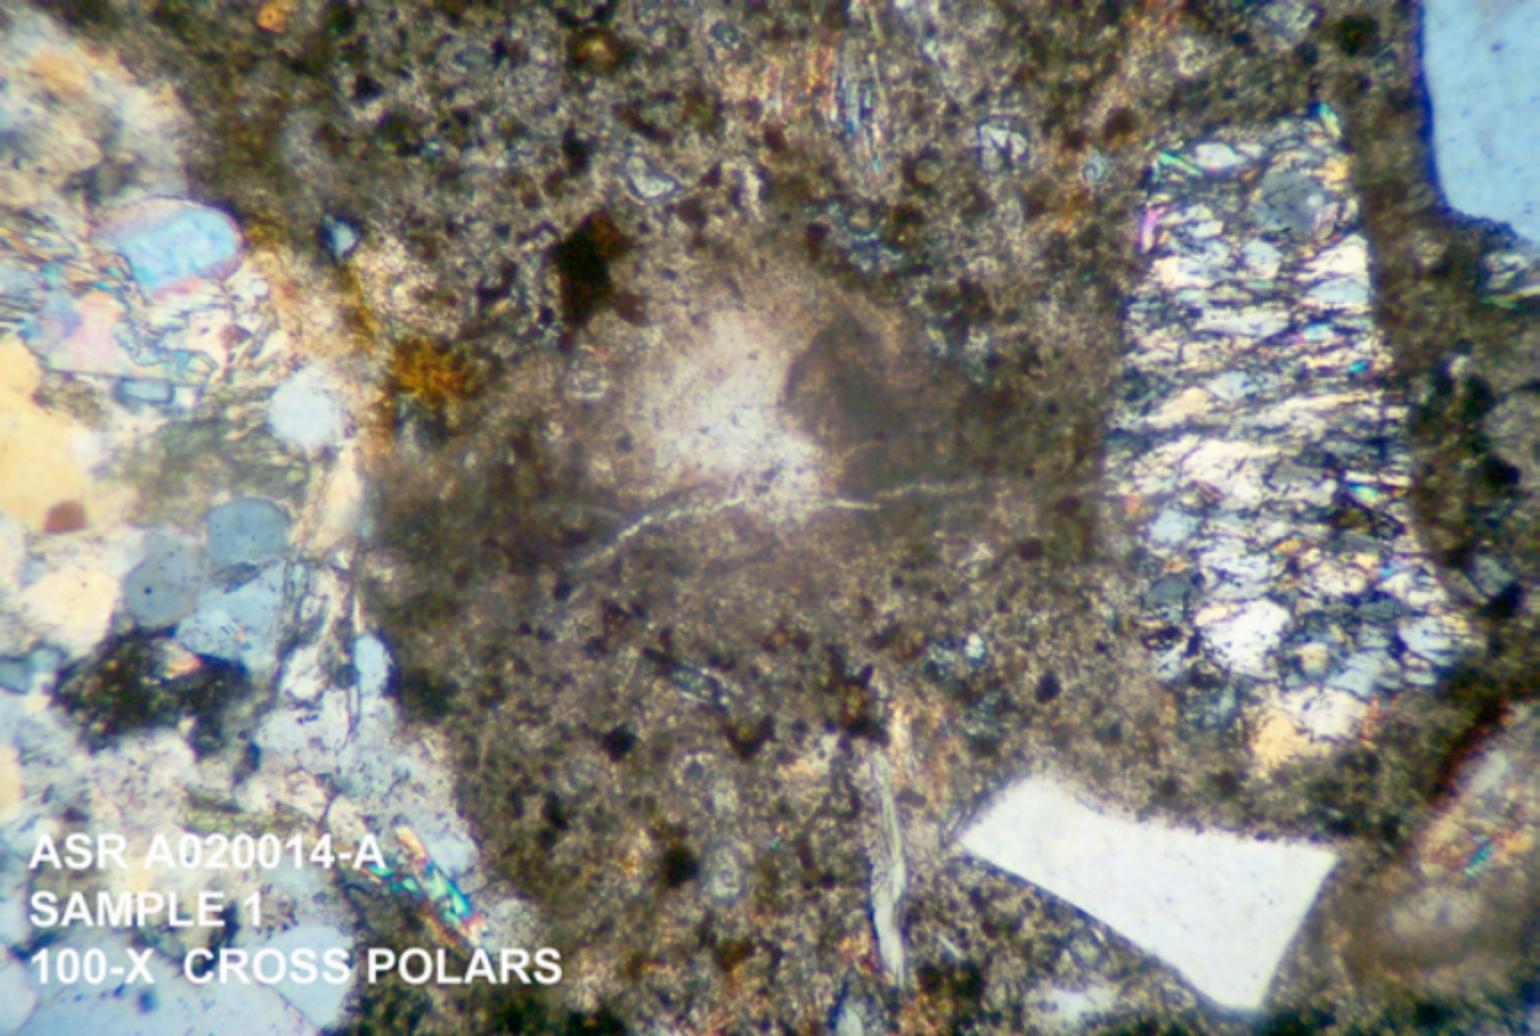
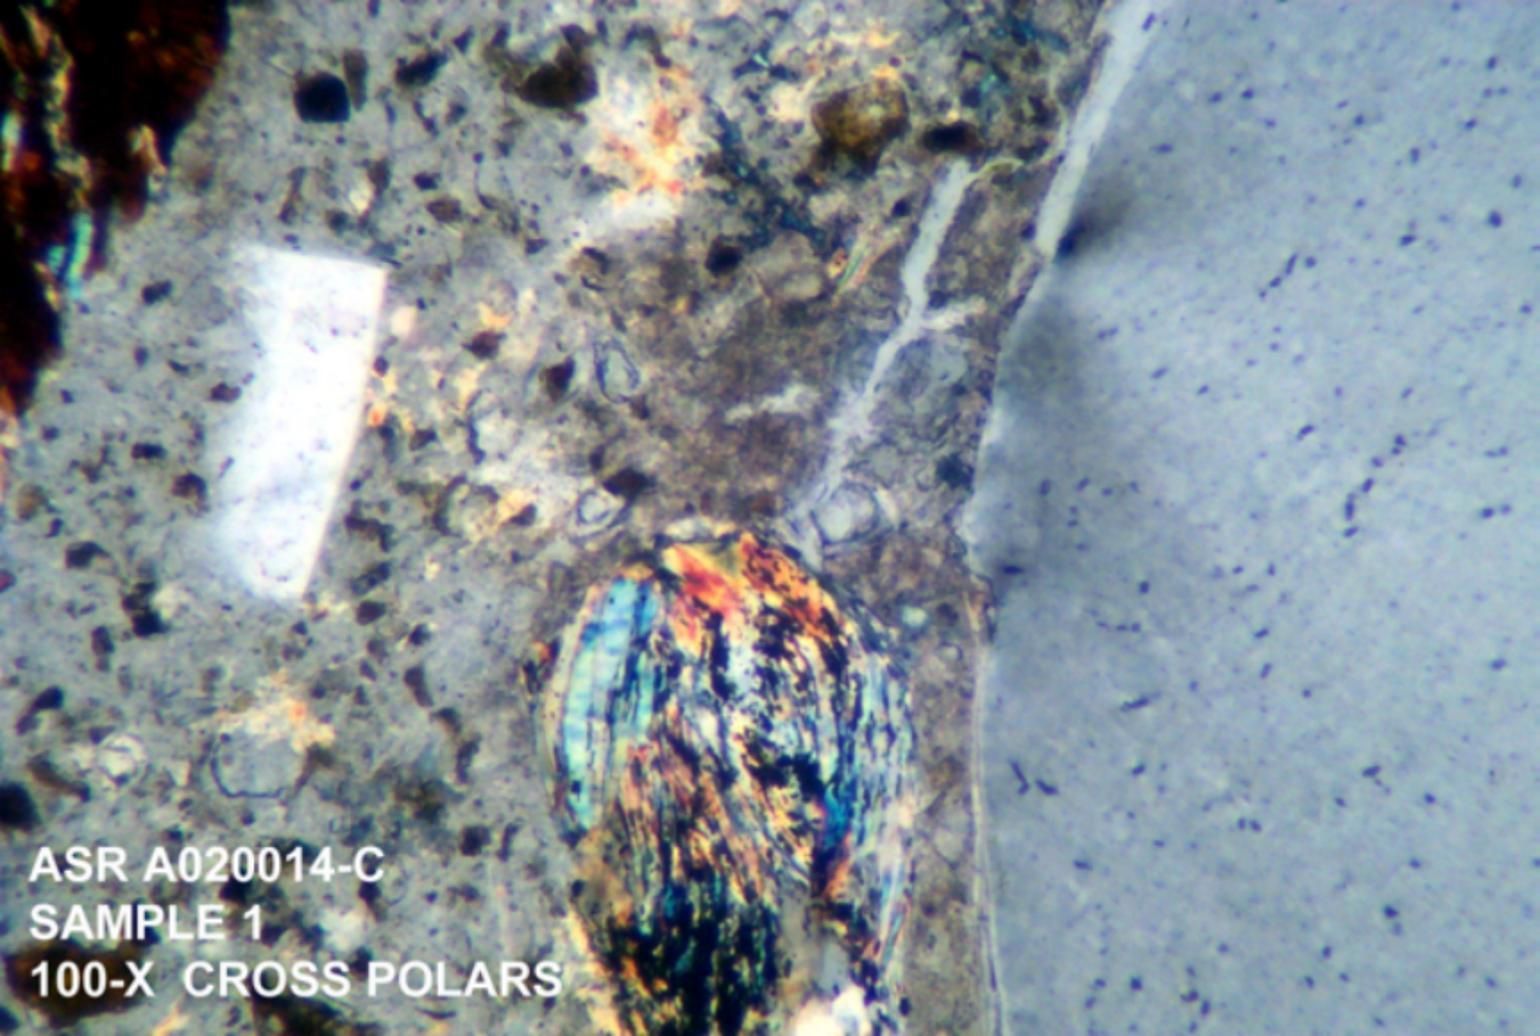
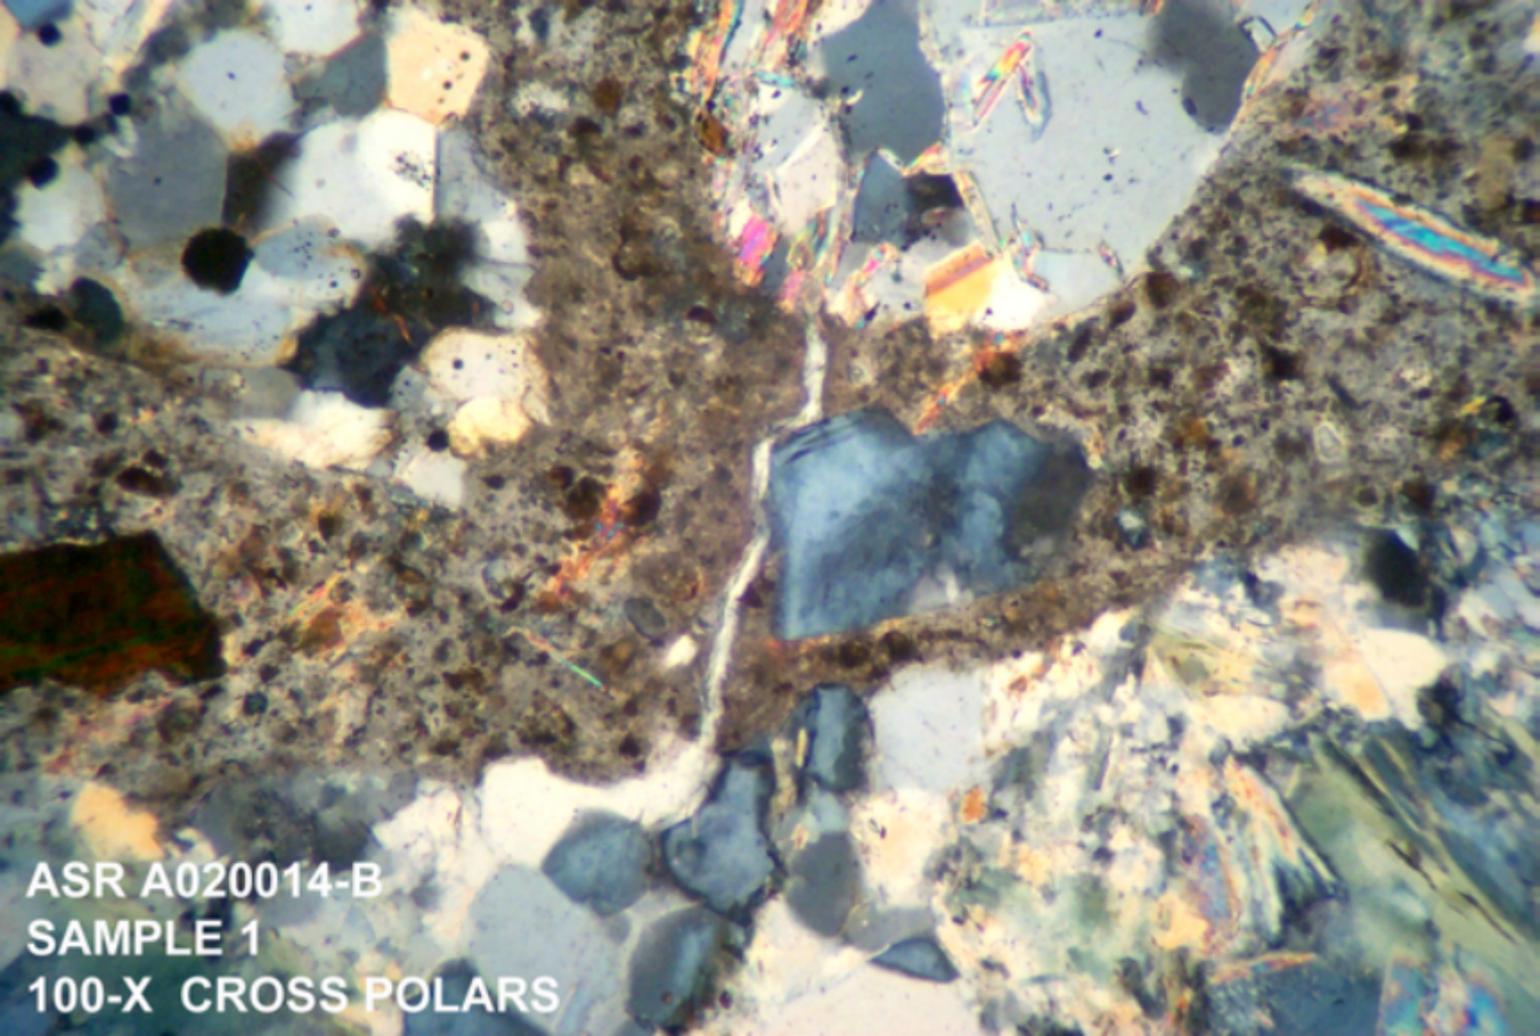
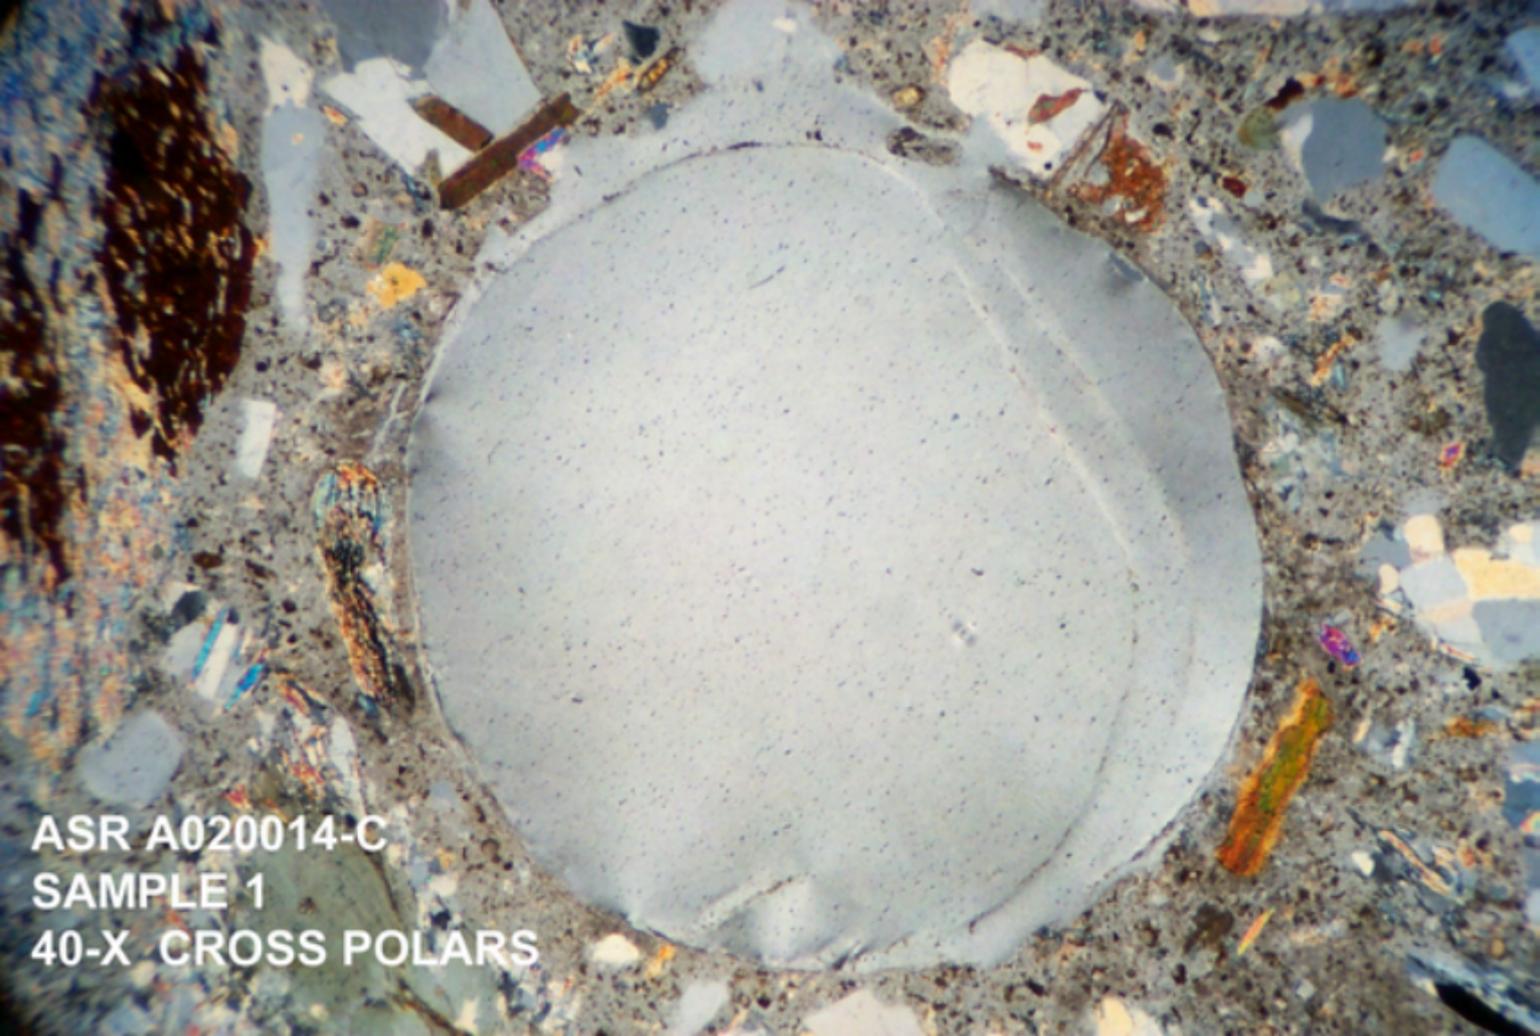
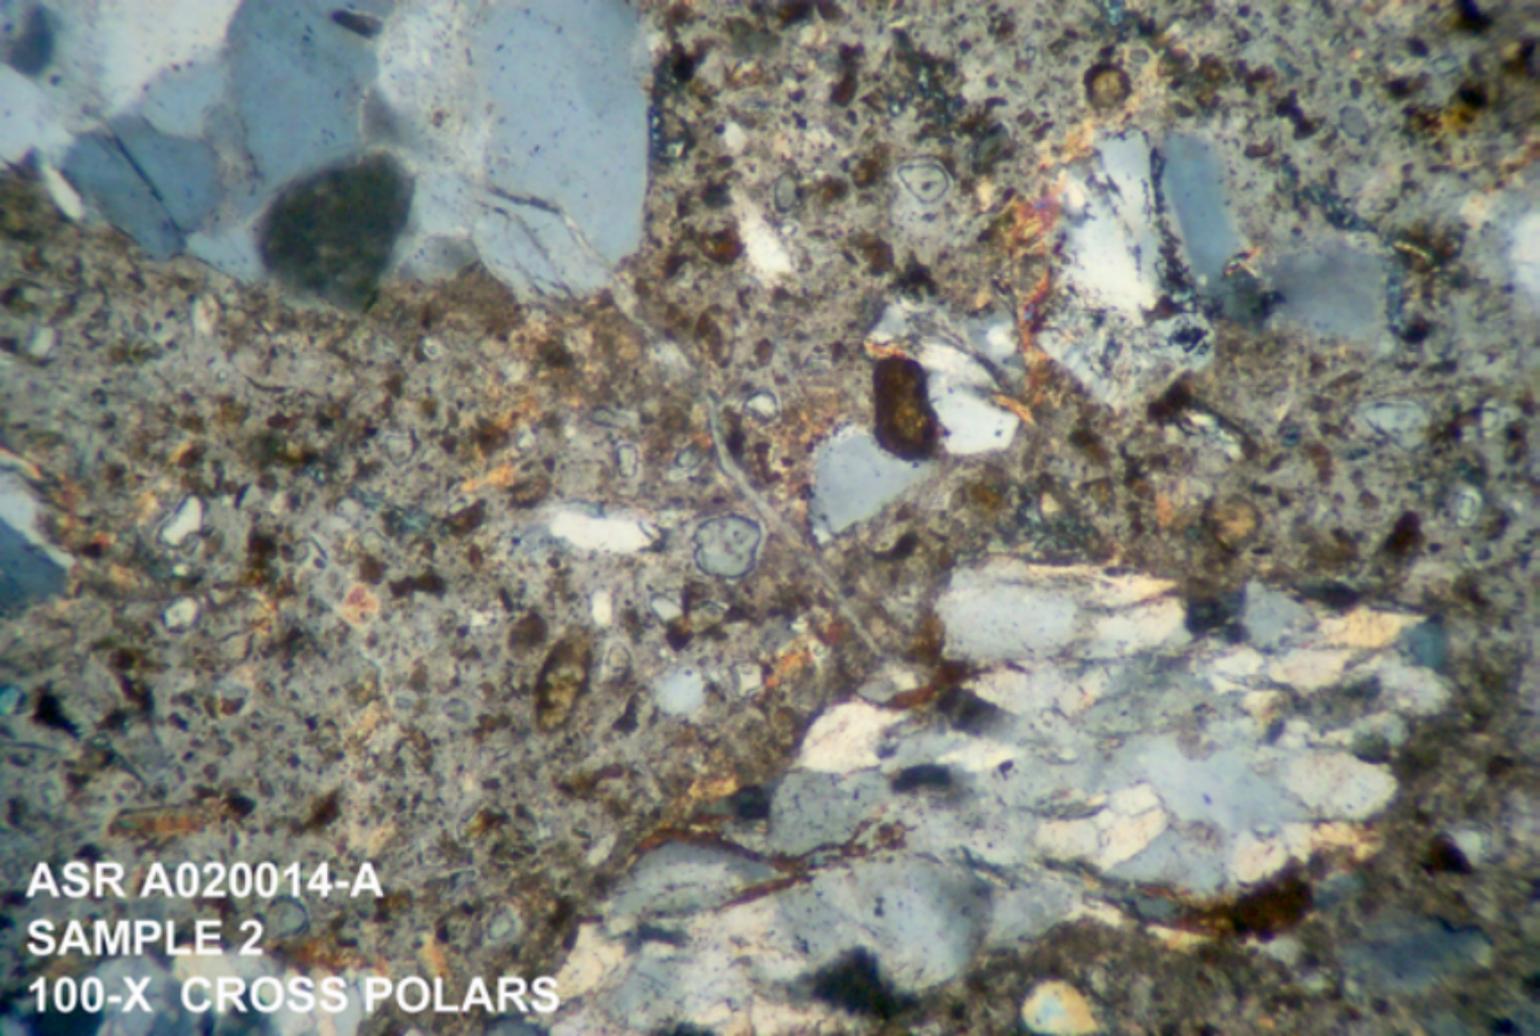
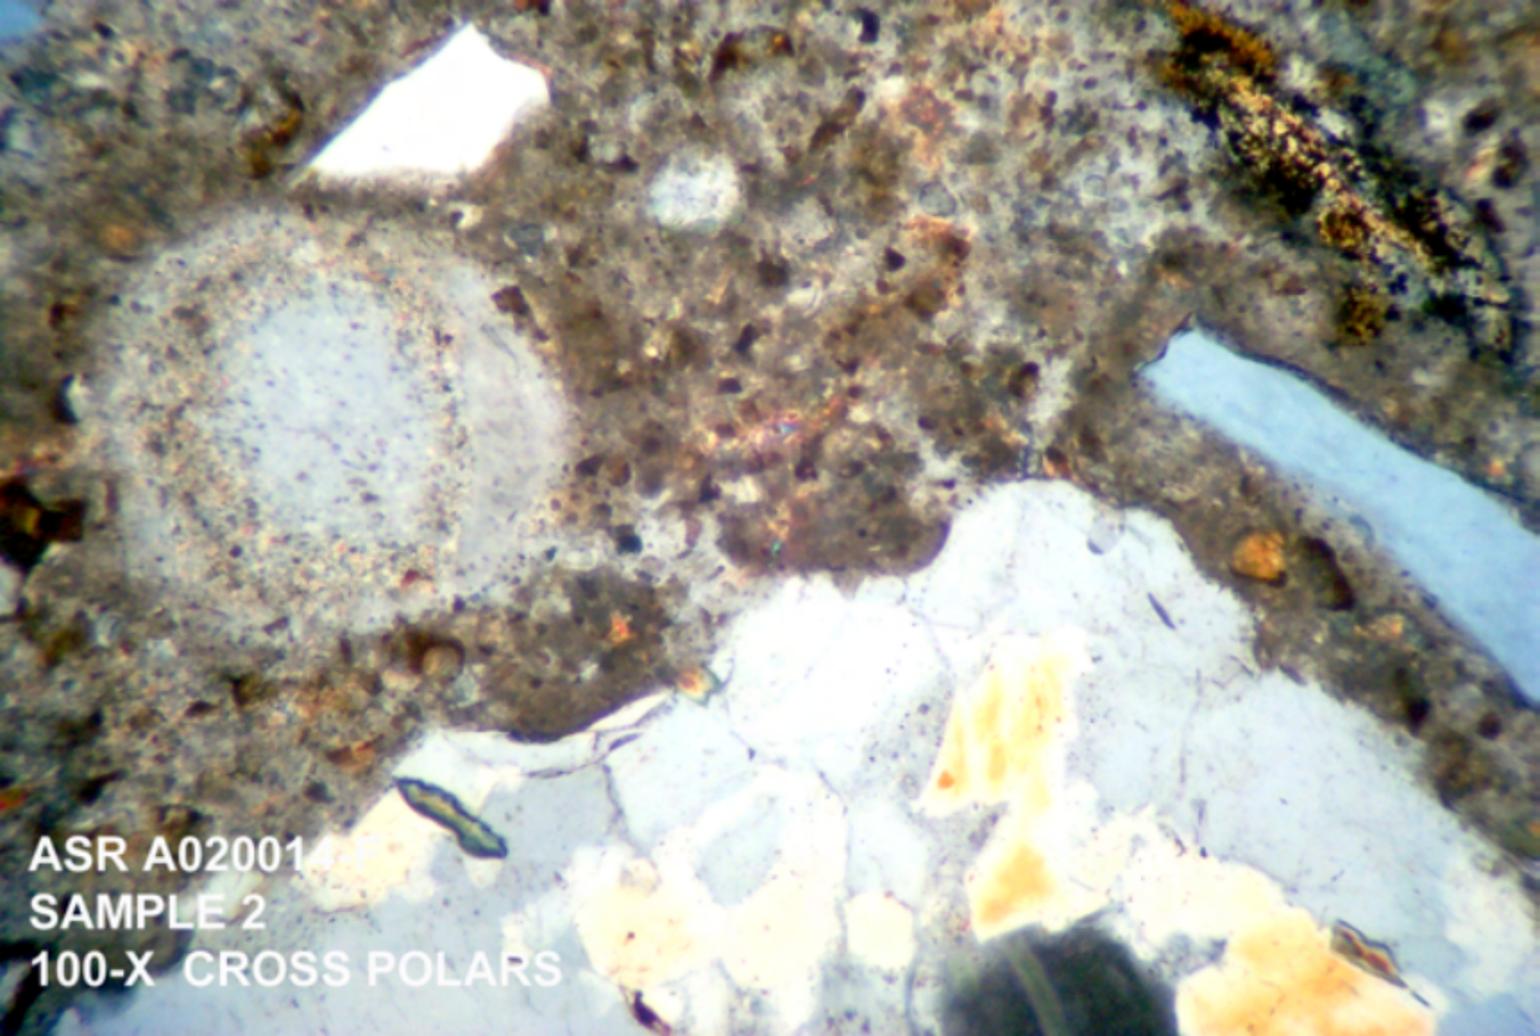
**SAMPLE ASR A020014**

- Sample A020014 and A020020 exhibited the greatest abundance of micro-cracks and ASR gel development.
- The development of ASR gel and micro-cracks appeared to be evenly distributed throughout the samples (there seemed to be no “edge effect” for the development of micro-cracking).

Generally, ASR gel filled cracks were observed within cement paste, either between aggregate particles and air voids or aggregate-aggregate particles. The ASR observed appeared to be associated with micro-crystalline quartz, strained quartz, schist/phyllite, and some amphibolites. Many of the samples contained darkened paste around the rim of aggregate particles and air voids.

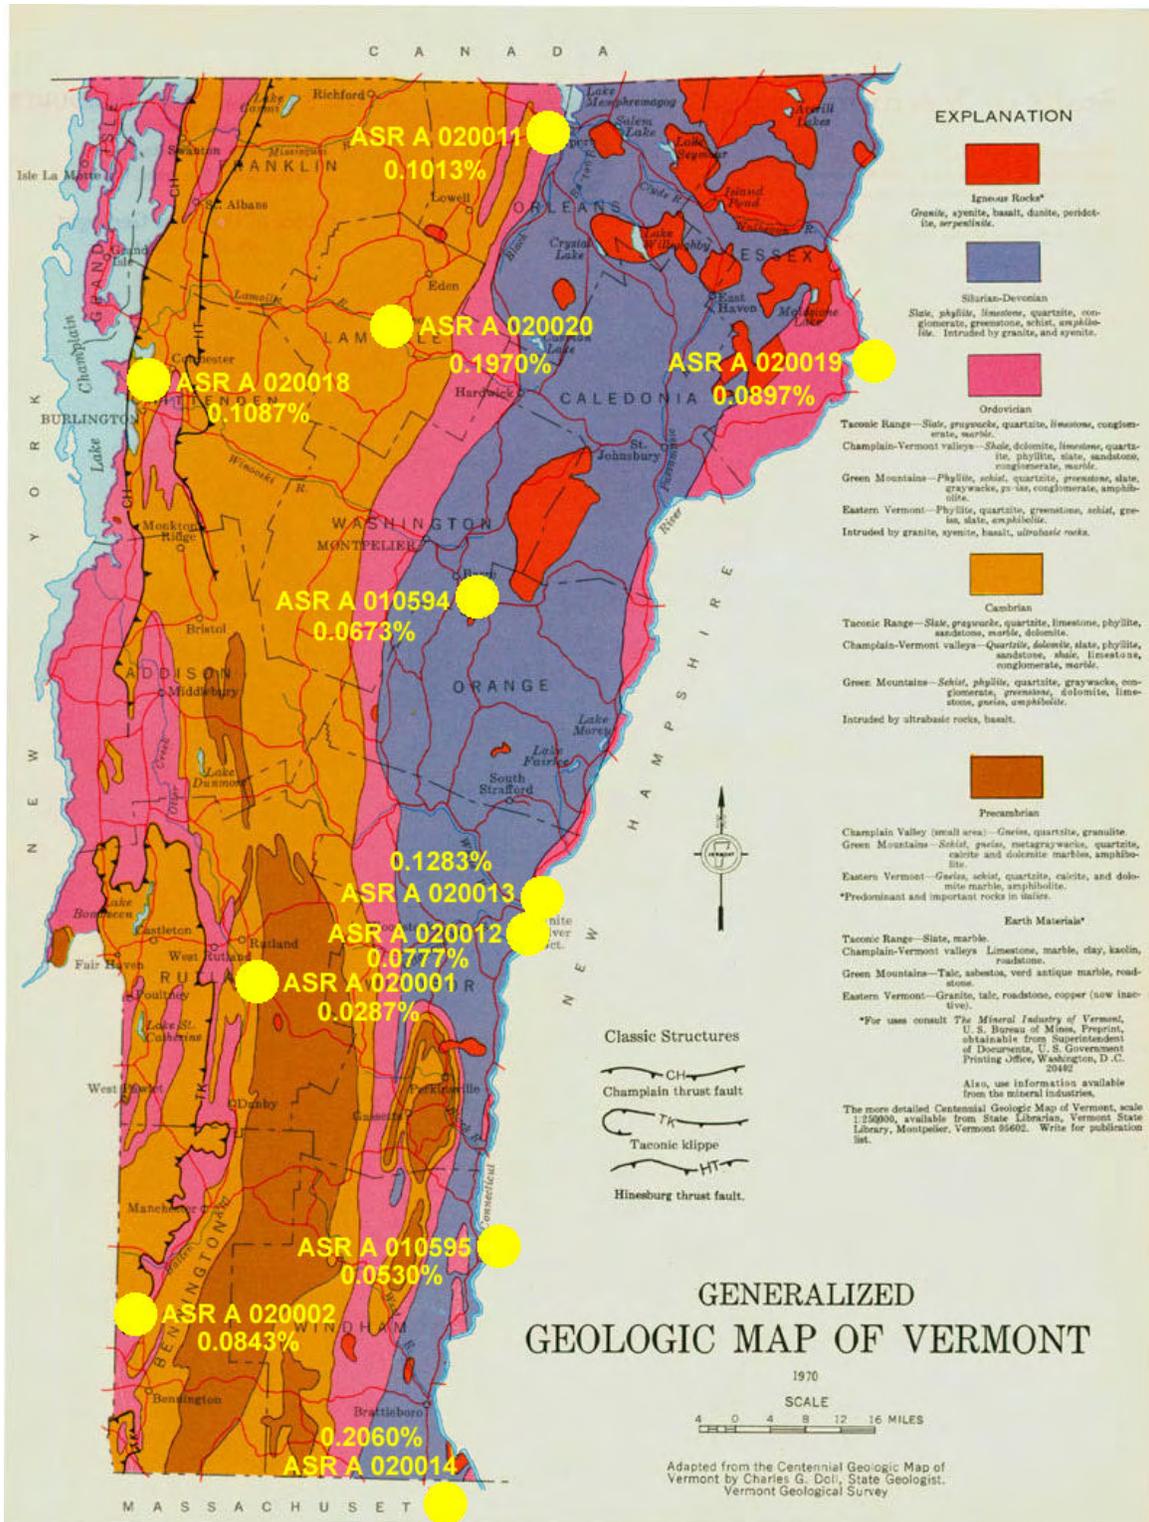
**Generalized bedrock geologic map of Vermont showing aggregate source locations and AASHTO T303-00 Test Results.**

- Based on mortar bar testing of eleven sources, five were found to have expansions equal to or greater than 0.1% and two had expansions equal to or greater than 0.08% but less than 0.1%. Appendix D presents aggregate source locations showing AASHTO T303-00 test results depicted on a generalized bedrock geologic map of Vermont.
