**VERMONT AGENCY OF TRANSPORTATION**

**ASSESSMENT OF ASTM D 6690-12  
TYPE II AND TYPE IV JOINT SEALERS**

Report 2014 – 08

November 2014

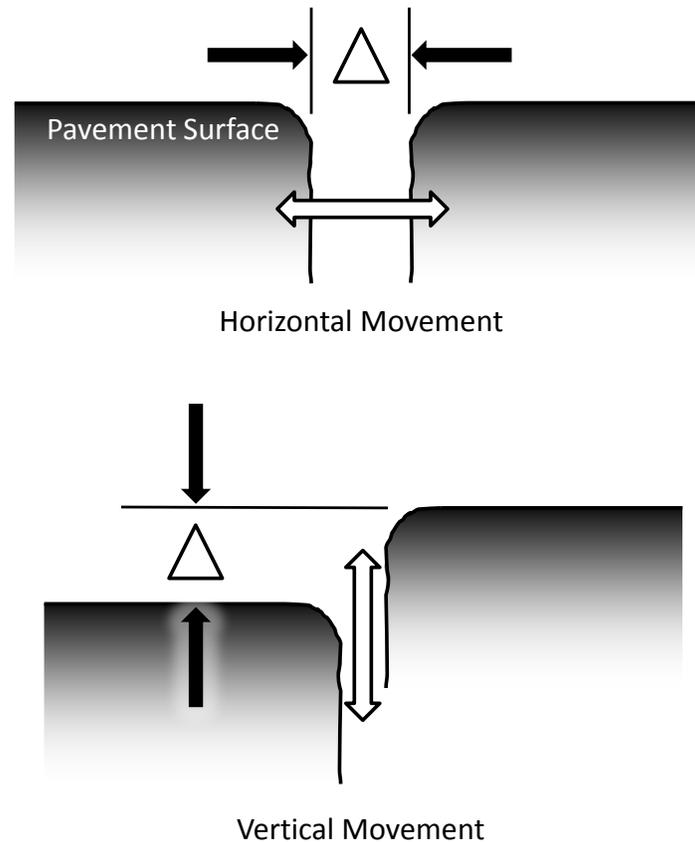
**Figure 1 Definition of Movement.  $\Delta$  is 1/8 inch or greater for working cracks.**

According to the Federal Highway Administration (FHWA) cracks must be evaluated prior to specifying the appropriate sealer or filler to discern whether they are a working or non-working crack and whether the crack undergoes horizontal or vertical movement. Working cracks are defined as having 1/8 inch or more in vertical or horizontal movement (see Figure 1.) Typically, working cracks are transverse to the direction of the highway; however, longitudinal and diagonal cracks can be classified as working if they meet the movement criteria. Horizontal

movement is driven by shrinkage and expansion of the pavement due to thermal changes within the pavement material. Vertical movement is driven mostly by moisture related changes within the substrate and typically applies to concrete pavements. Non-working cracks typically have minimal or no movement because of the relatively close spacing of free edges between the cracks (5). Cracks can be classified as working or non-working after one year of monitoring the horizontal movement of the crack (6).

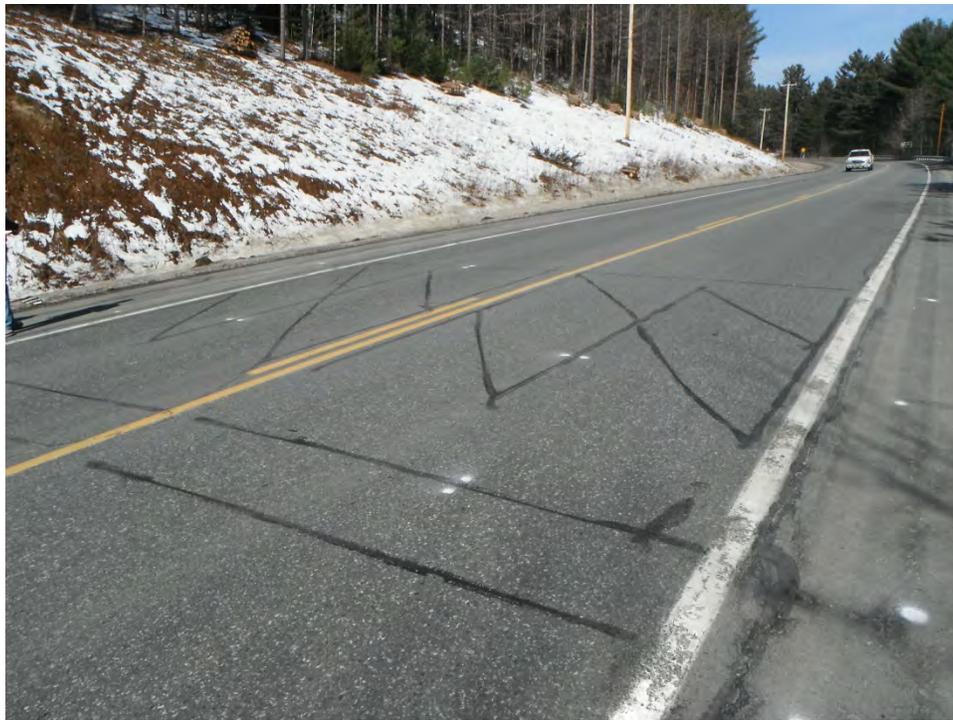
**Figure 2 An example of a Manufactured Cracked Test Site**

Manufactured sections contained no natural cracking, but rather a specific pattern was routed out and filled for a controlled comparison where both products would be tested within the exact same pattern (see Figure 2.) The manufactured test sites were also included in the project to study if tire tracking was a concern. Every test site stretches over both lanes of travel, and extends 100 feet lengthwise. Table 1 exhibits the different test site locations within each project location. For this project, the crack seal was evaluated in four different categories: spalling, adhesion, cohesion, and overall crack width spreading. Crack filling operations occurred between June 21 and July 1, 2010 in both locations. Test sites were chosen prior to material installation to determine pre-existing conditions but were not revealed to the contractor, with the exception of the manufactured sites.

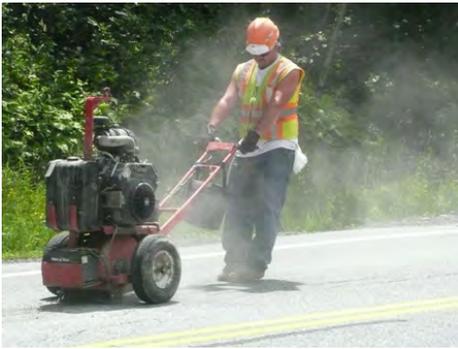
A. Routing the crack.

Installation of all materials at all locations was completed without incident. Figure 3 depicts a typical installation. In all instances, cracks were first routed with a routing cart, cleared off with a blower, further cleaned with a heat lance/blower, and the cracks filled via a wand that is attached to the kettle. On warm days, filled cracks can be cooled quicker with the application of a water spray.

**Figure 3 Steps of the Crack Filling Process.**

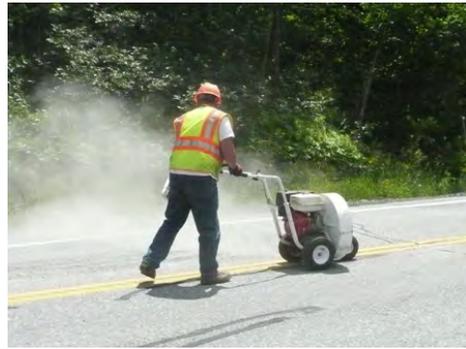
B. Cleaning the crack with a blower.

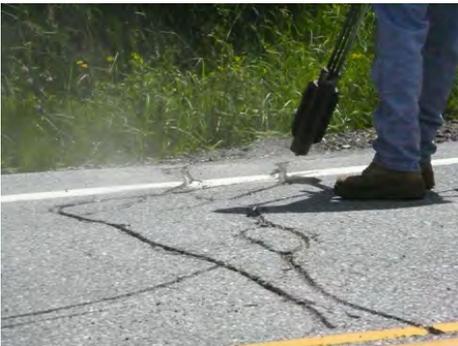
C. Further cleaning with a heat wand.

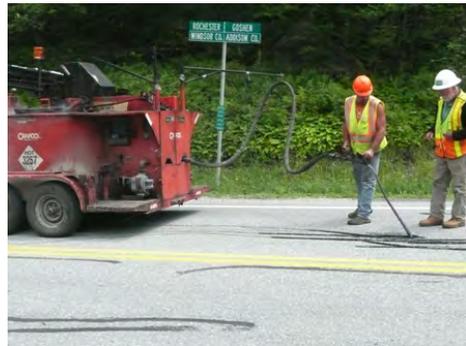
D. Filling of routed cracks with fill material.

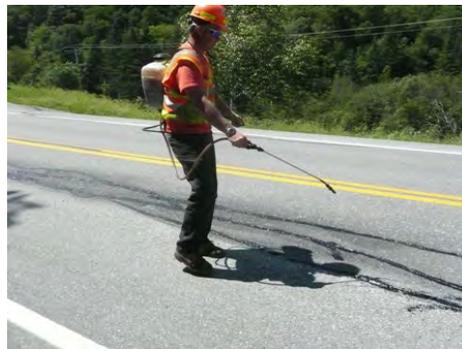
E. Water spraying to cool cracks quicker.

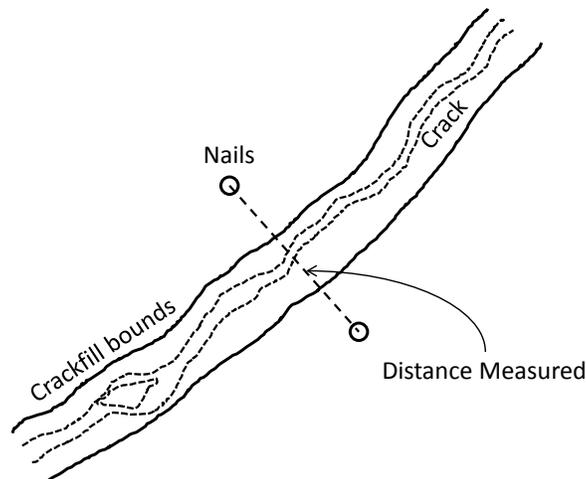
**Figure 4 Typical Test Location**

The first site visits after installations were performed on July 28 (Rochester) and September 20 (Killington). During these visits, cracks were chosen within each test site to be monitored. Nails were placed approximately 6 inches apart perpendicularly on either side of these cracks (see Figure 4.) The distance between the nails was measured. These distances will be measured during each future site visit to determine the amount of movement of each crack. Cracks that move more could be expected to develop more crack fill distresses in the future. The nail distances were measured with the use of a set of calibrated calipers with a 1/1000th of an inch resolution. The majority of cracks to be evaluated are transverse, going full width across both lanes of road when possible so that the two types of material can be evaluated on the same crack. A few sets of longitudinal cracks were also chosen, where there was similar cracking in both lanes. Table A1 in the appendix shows a list of all cracks chosen in each test site, the original nail distances recorded, and the overall length of the cracks. Two other important items of note related to crack fill inspection are tracking and debris retention. Tracking is the tendency for material to stick to vehicle tires and spread across the asphalt before it is fully cooled and solidified. Debris retention comprises of stones or other contaminants embedded into the material, usually prior to being fully cooled. Both of these are negative aspects attributed to crack fill; neither was found to have occurred on any test site on either project.
