VERMONT AGENCY OF TRANSPORTATION

ASSESSMENT OF URETEK DEEP INJECTION PROCESS

Report 2015 – 09

Reporting on Work Plan 2012-R-04

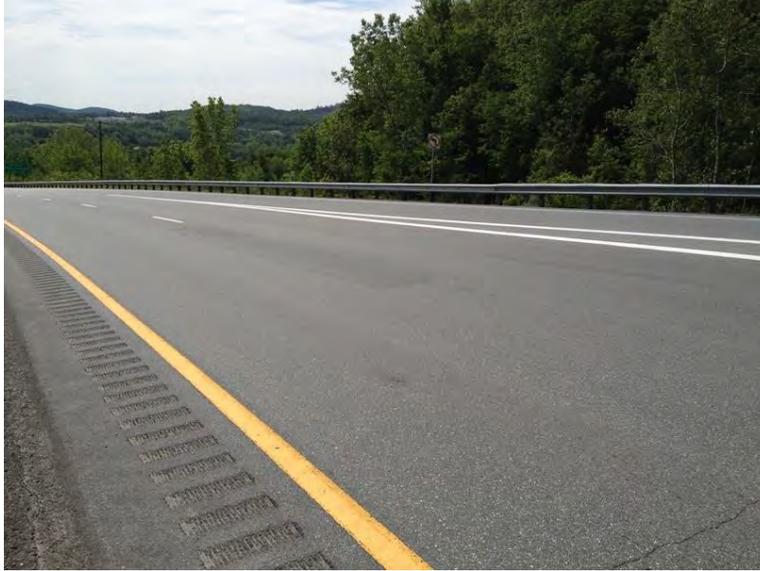
Figure 1: Deep Injection Site – Prior to Injection.

A stretch of Interstate 89 southbound from mile marker 0.124 to 0.153 in Hartford, VT has been showing signs of substructure instability for over two decades. The annual average daily traffic is amongst the highest in eastern Vermont, averaging 38,000 vehicles per day. Historically, the roadway section was originally constructed in the 1950's and it is believed that the majority of the fill material used was taken from the rock cut sections in the connecting ramps on the south side of the I-89/I-91 interchange (3). The site is shown in Figure 1.

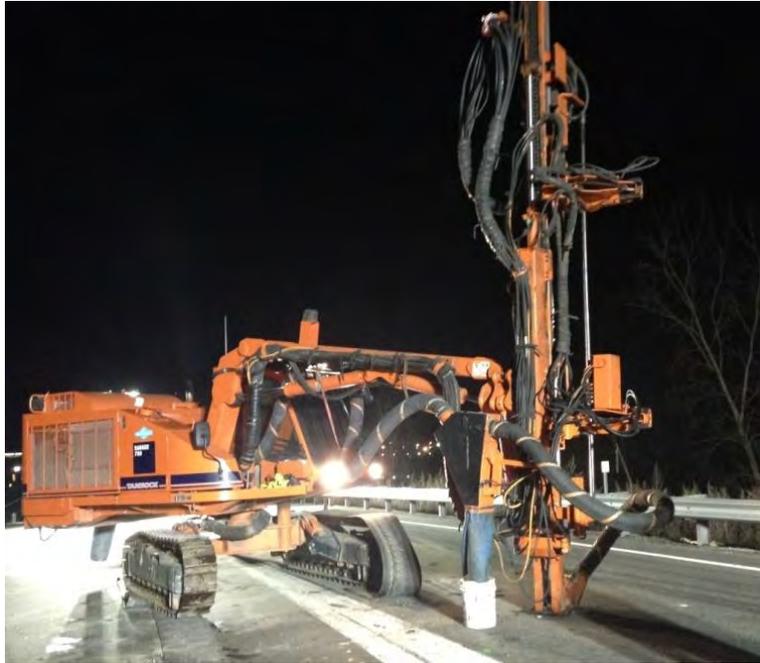
Figure 4: Tamrock 700 Drill Rig – Drilling 2.5-inch Injection Holes.

J. A. McDonald, the prime contractor drilled all injections holes using a Tamrock Ranger 700 Drilling Rig, a hydraulic, self-propelled, self-contained, crawler based surface drilling rig equipped with a cabin and rod handling system. The Contractor began drilling the 2-inch diameter injection holes 20 feet in depth in the travel lane on October 29, 2013 once the injection plan based on DCP testing was approved. Once drilling commenced, vibration from drilling operation paired with the undersized drilling equipment caused unstable material along the shaft to collapse into the hole (11). The Contractor ceased operations until the following day and began drilling 2½-inch diameter holes in order to expedite drilling, produce a straighter hole, and reduce sloughing of the material into the holes (12). Drilling operations continued through November 4. Some holes had to be redrilled because URETEK encountered problems with inserting the injection tube bundles. The Contractor redrilled holes on November 5 and 6 and then inserted some injection tube bundles for the Subcontractor. The passing lane holes were drilled without incident from November 19 to 21 (11).

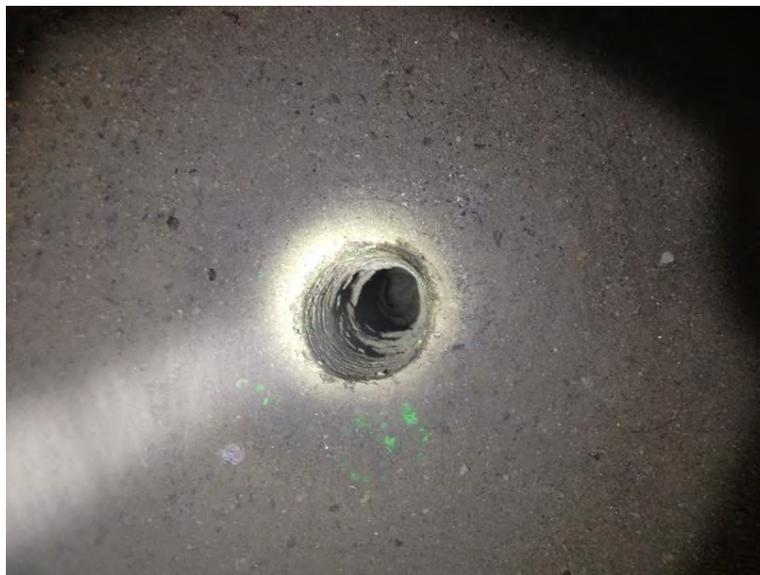
Figure 5: Drilled Injection Hole (2.5 inches x 20 feet)

URETEK USA began injecting the site at the 7-foot depth from the southern end of the project in the travel lane once the Contractor had drilled a sufficient amount of holes ahead to ensure no disruption of the stabilization process on October 30 (11). Figure 4 through Figure 9 show the tube insertion and injection process.

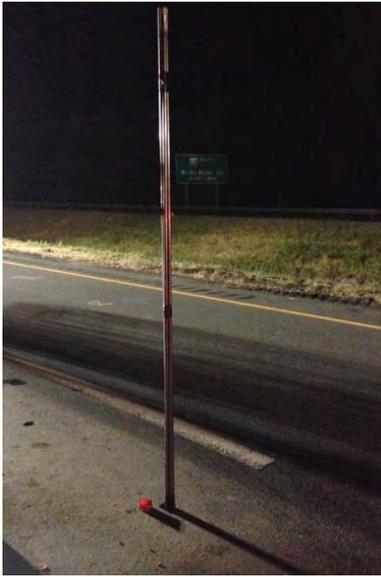
Figure 6: Injection Tubes.

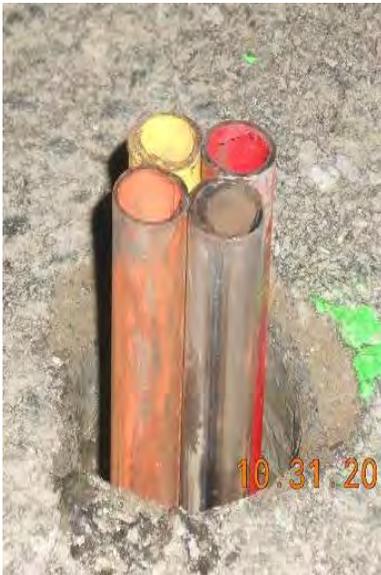
Figure 8: Injected Tubes.

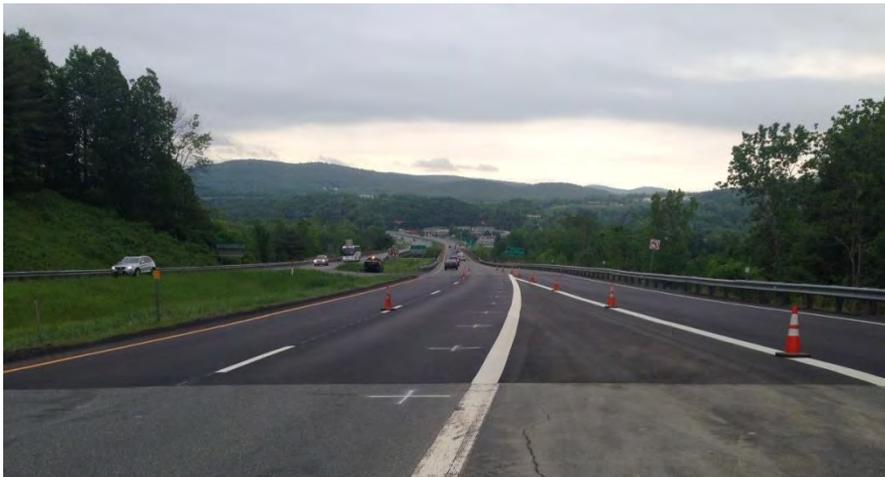
Figure 10: Deep Injection Site – Post Paving.

Due to the late season injection phase, all cold planing and paving activities were postponed until the spring of 2014. J.A. McDonald hired subcontractor Frank W. Whitcomb Construction of Colchester, Vermont to complete cold planing and paving operations, completed on May 29 and May 30, 2014. Figure 10 below shows the site after paving while conducting Falling Weight Deflectometer (FWD) testing.
