ASSESSMENT OF THE COMPOSITE ARCH BRIDGE

Ian Anderson, Research Engineer
Vermont Agency of Transportation
Research Section

Experimental Feature
Reporting on 2013-PIF-01

Final Report 2018-08

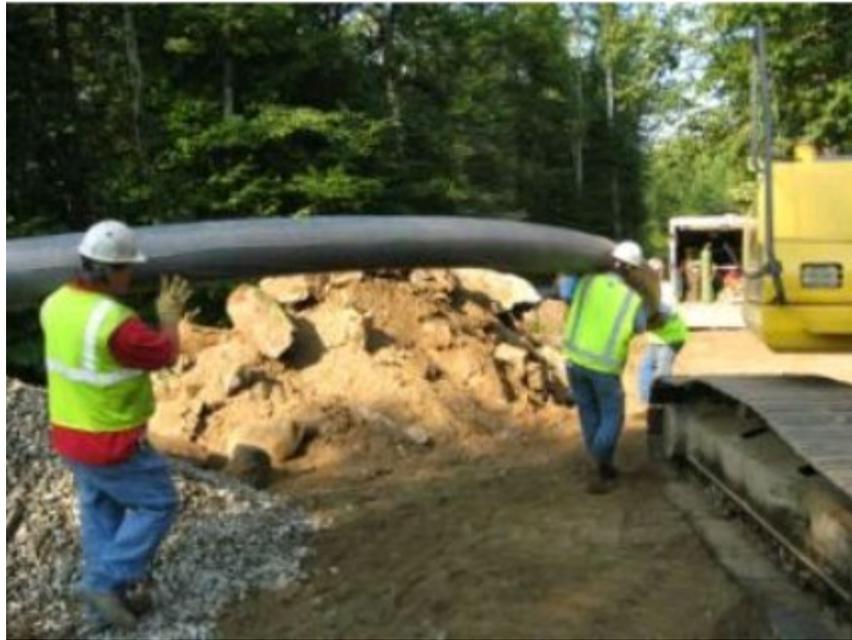
Figure 1: FRP tubes can be carried into place by hand labor (1)

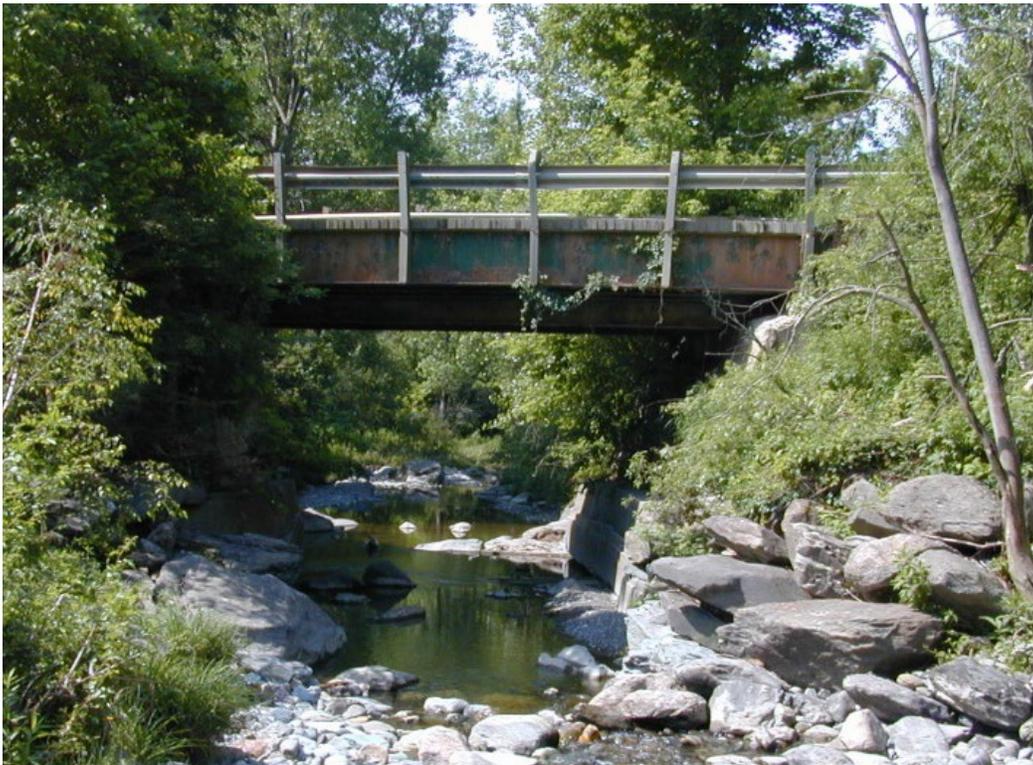
Figure 4: Bridge profile

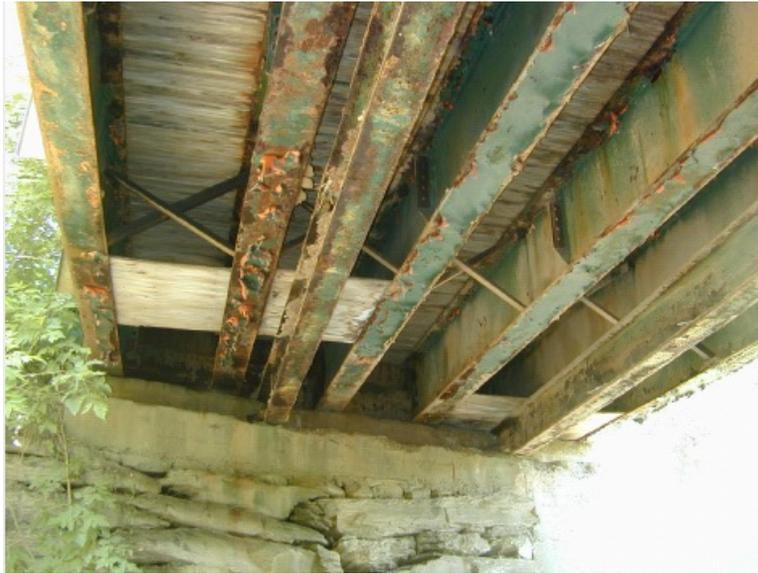
Figure 5: The underside of bridge showing the added beams

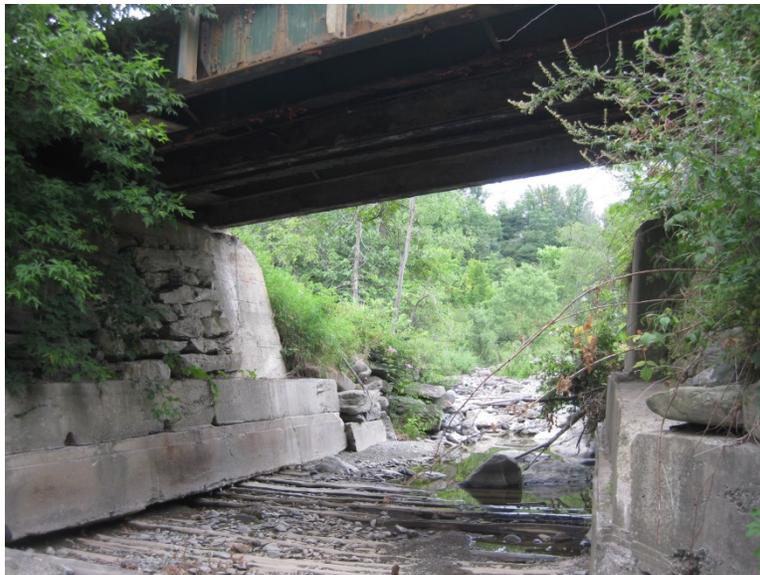
Figure 6: Existing substructure

The existing substructure consisted of abutments comprising of a concrete cap on laid stone walls fortified at the base by concrete knee-walls. The abutments were placed on a timber mat to control downcutting (see Figure 6). The clear span was 25.5 ft, just below the bridge seats and above the knee-walls. The knee-wall clear span was 16 ft. Hydraulic engineering recommendations suggested that the knee-walls and timber matting could remain in place. Further recommendations suggested that a concrete wall should be constructed to a height that exceeded the Q25 storm event to keep debris from coming in contact with the FRP tubes. VTrans Structures design staff, working with AIT came up with a plan for FRP arches with a span of 30 ft, radius of 18.75 ft, which provides a rise of 7.5 ft. The initial assumption was that new integral abutments with steel piles would be used for the substructure.

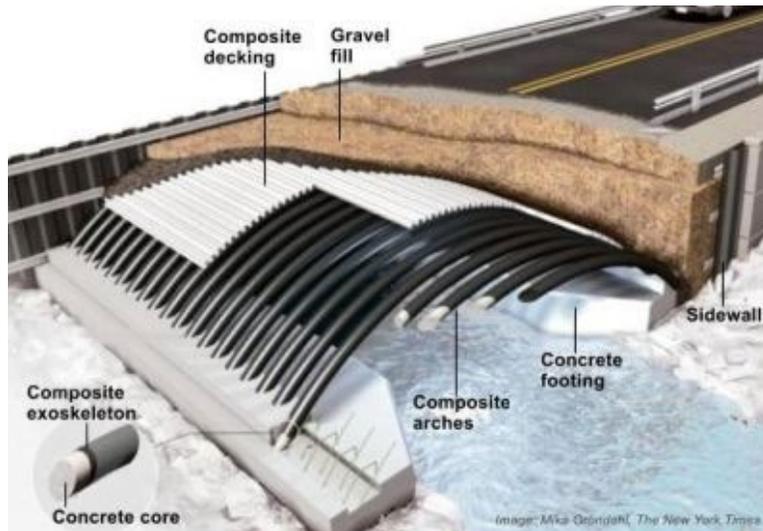
Figure 7: 3D rendering of the CAB (5)

The CAB system, as stated earlier, comprises primarily of ribbing made up of FRP tubes shaped into arches. A single tube is essentially a composite exoskeleton, which fortifies the concrete within. The tubing provides significant strength, durability and protects the concrete from corrosion. Each tube acts as external reinforcing and can eliminate the need for internal steel reinforcing which is common with concrete construction. The fabrication of an FRP tube fuses several layers (including carbon fiber) with resin to create the composite material. The exact blend is engineered to optimize the efficiency of the bridge design. The completed FRP tubes are relatively lightweight, making transportation and placement cheaper and easier. Transporting them to a project site will not require special loading permits and when they reach the project site, they can be carried into position by construction workers as shown earlier in this report, or with an excavator for ease of placement (5). The spacing and diameter of the tubes will vary depending span length and results from ongoing design research.

Once the ribbing is in place and anchored into the footings, corrosion resistant FRP corrugated decking is fastened over the top of them. The FRP decking is essentially higher-grade corrugated roofing panels one could purchase at any lumberyard. The decking is fastened using corrosive resistant screws, which will later act as concrete anchors. Though not taken advantage of in the Fairfield project, the panels can be used to shore up and accurately position the tubes, rather than using temporary bracing, thereby eliminating a construction step. At the crest of each tube, a single access hole is drilled with vent holes being drilled at points along the arch of each tube. Self-consolidating expansive concrete is placed through the access holes and allowed flow down the arches (5). Vent holes can show where the concrete is during the placement and can allow air to bleed out. The CAB system was initially designed to allow soil to be placed directly on the decking. Several installs have also included placing a reinforced concrete shell over the decking before placing the roadway materials. A headwall system is attached and the bridge is backfilled. The system components can be seen in Figure 7.

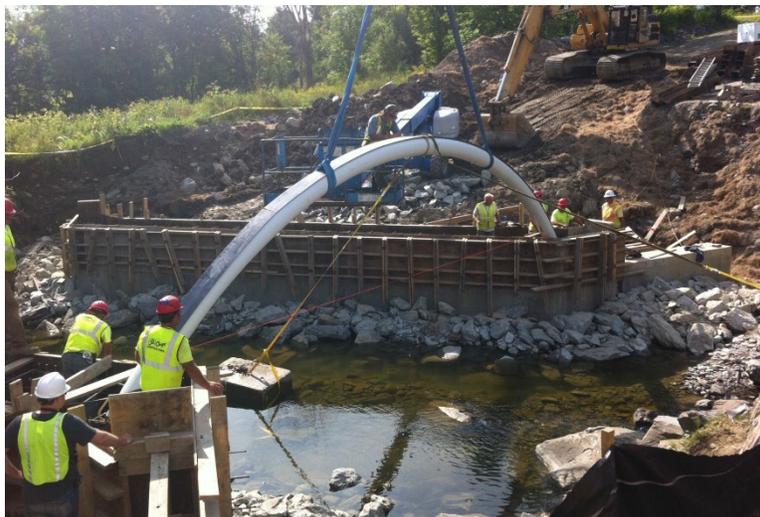
Figure 8: Installation of the first tube

Construction of the superstructure began on August 20, with the setting of the first arch (see Figure 8.) The only superstructure steel reinforcing were anchors inserted in each end of the FRP tubes (see Figure 9.) FRP tube were placed using a medium duty crane. The contractor chose to use the crane due to the rough terrain for the safety of the construction workers and to prevent potential damage to the tubes. Within a week, the tubes were set and the decking was installed (see Figure 10.) In the next week, final concrete placement in the abutments, effectively anchoring the tubes in place, was completed. Grouting within the tubes followed. As mentioned earlier, grouting was done with self-consolidating concrete (SCC) with expansive admixtures included, to ensure the concrete expanded into and adhered to the FRP tubes during the concrete cure. SCC was chosen due to its ability to flow within and adhere to the walls of a form without segregation of the aggregate from the concrete matrix. SCC also does not require vibration. The desired slump of the SCC is 24 to 30 inches. Once the SCC was placed, no loads, other than light foot traffic was allowed on the structure for 48 hours. According to AIT, it took only 22 crew hours from the beginning of setting the first tube to completing the final placement of the SCC within all the tubes.

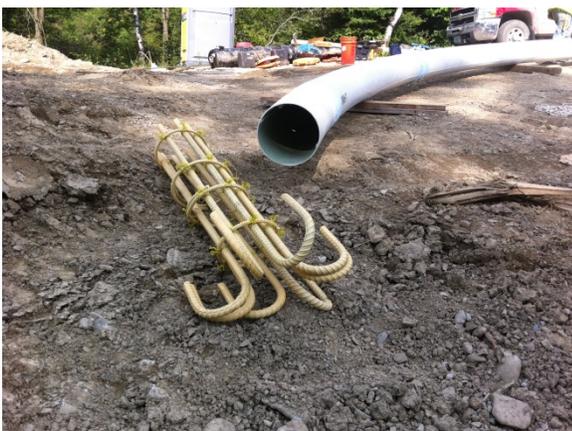
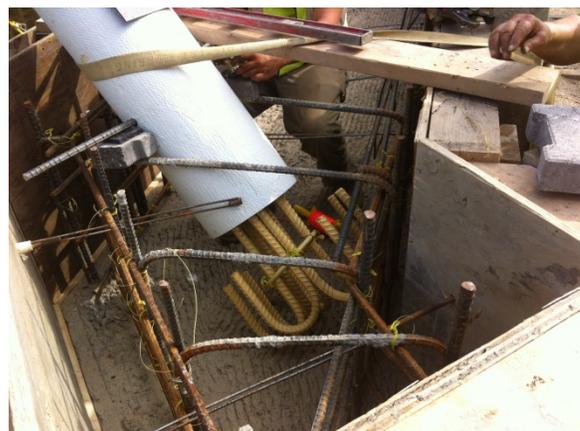
Figure 9: Anchorage reinforcement of the tubes

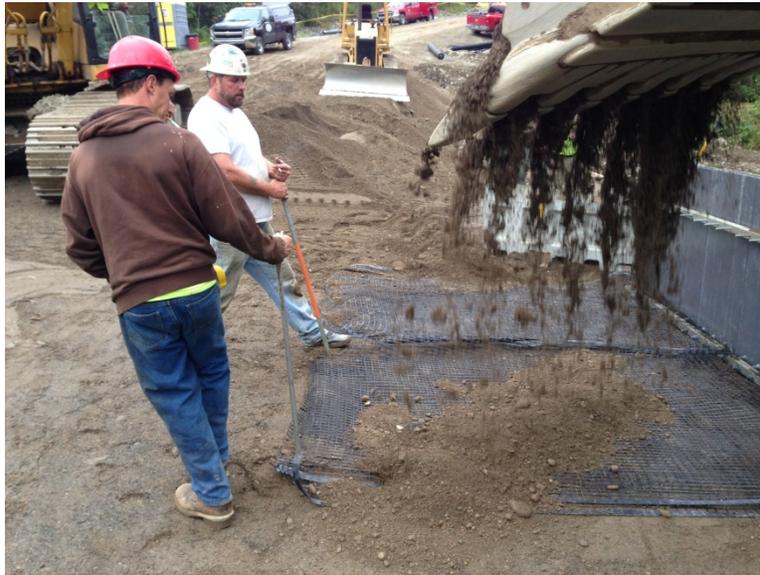
Figure 12: Applying subbase material over geotextile layers (1)

The headwalls are intended to contain the highway grade using MSE. MSE uses geogrids, which are rigid high strength synthetic polymer sheets, either woven or are manufactured in a grid configuration, that are bolted or otherwise attached to vertical panels, which then extend into the supported soil, in lifts, for the purpose of holding the panel in place. The layered system of strips forms a reinforced mass which is sufficiently stable to provide structural support. For the headwall panels, geogrid reinforcement was attached to the panels at vertical intervals in horizontal planes, which extended from the headwall into the highway gravel towards the centerline of the roadway with compacted gravel holding it in place (see Figure 12). Figure 13 shows the final bolting pattern where the geotextile was attached to the headwall. In September, the final effort involved constructing wingwalls from precast MSE panels, final grading of Wanzer Road, including constructing stone reinforced drainage and then the installation of specified safety features. Figure 13 and Figure 14 show the completed project.

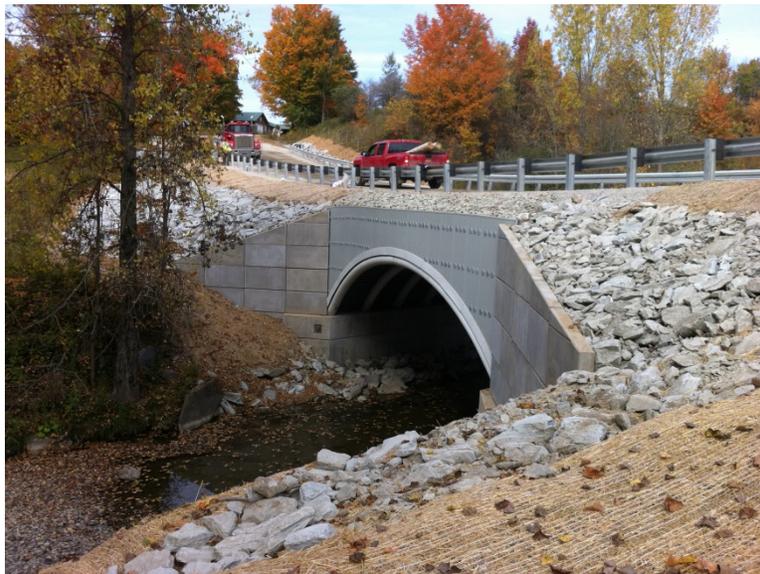
Figure 13: Completed CAB

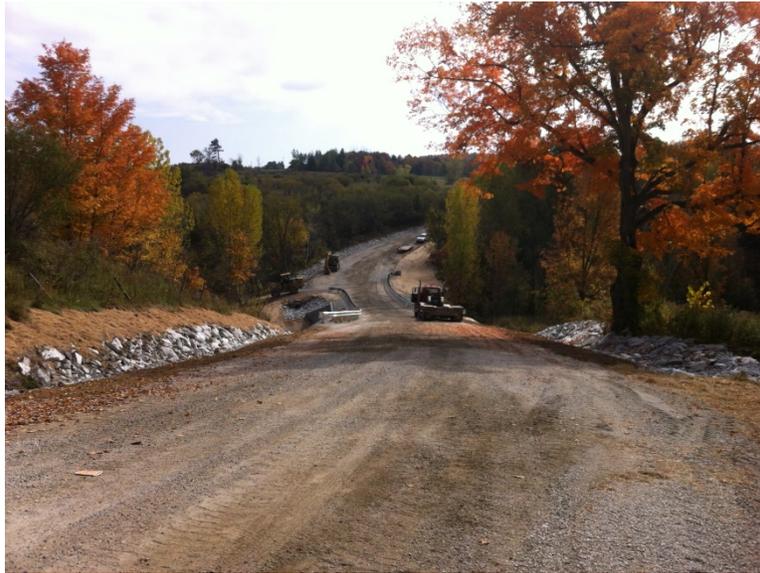
Figure 14: Completed project

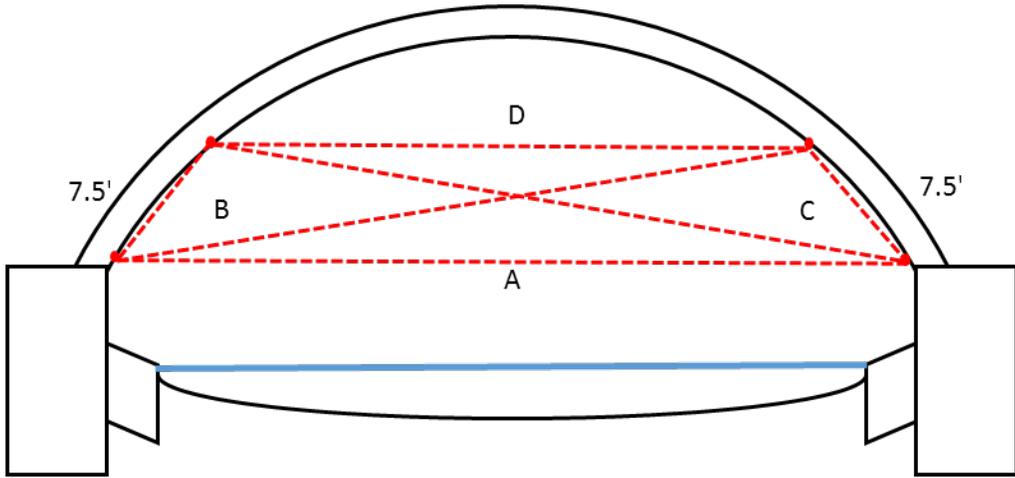
Figure 15: Diagram of Measurements Taken

Observation included measurement of arches 4, 5, and 6 for any deflection or creep (Figure 15), visual inspection of the head walls, and visual inspection of the tubes to detect any oxidation, damage, or UV effects.

Measurements were taken on arches four, five and six, which are located at the center of the structure. In October of 2014, marks were placed on the arches. One mark was located about one inch above the abutment and another mark was placed where a straight 7.5 foot line intersects the arch, from the first mark. The measurements were taken between the two upper marks, the diagonals from the upper marks to the lower marks and between the lower marks. The 7.5 diagonal measurements were checked. A diagram of the measurement patterns can be seen in Figure 16. Table 2 shows the measurements taken over three site visits spanning from 2014 to 2018.

The overall measurements averaged about 0.5 inch different from the measurements taken in 2014, well within the capacity of the arches to redistribute loads without harm. These observations show that overall, the arches are performing well, with little deflection or creep.

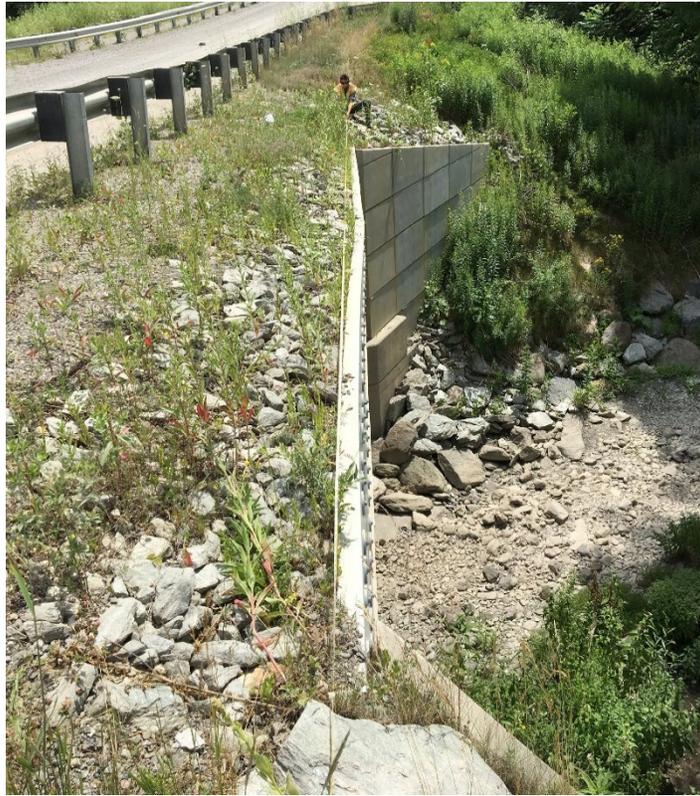
Figure 16: Bowing on Western Headwall

One area of close observation identified in 2015 was the headwall, which were noted to be bulging and bowing from lateral earth pressures. The western headwall is bowing throughout its entire length in a smooth curve, while the eastern headwall is showing shoving in some areas and not others. The westerly headwall appears to have a maximum deviation of 4 inches from straight. Bowing of the westerly headwalls can be seen in Figure 16. These deflections have been stable since 2015, with no increased spread detected in 2018.
