Transportation Flood Resiliency Tool (TRPT)

FEBRUARY 9, 2023

Fitzgerald Environmental Associates, LLC.
Applied Watershed Science & Ecology

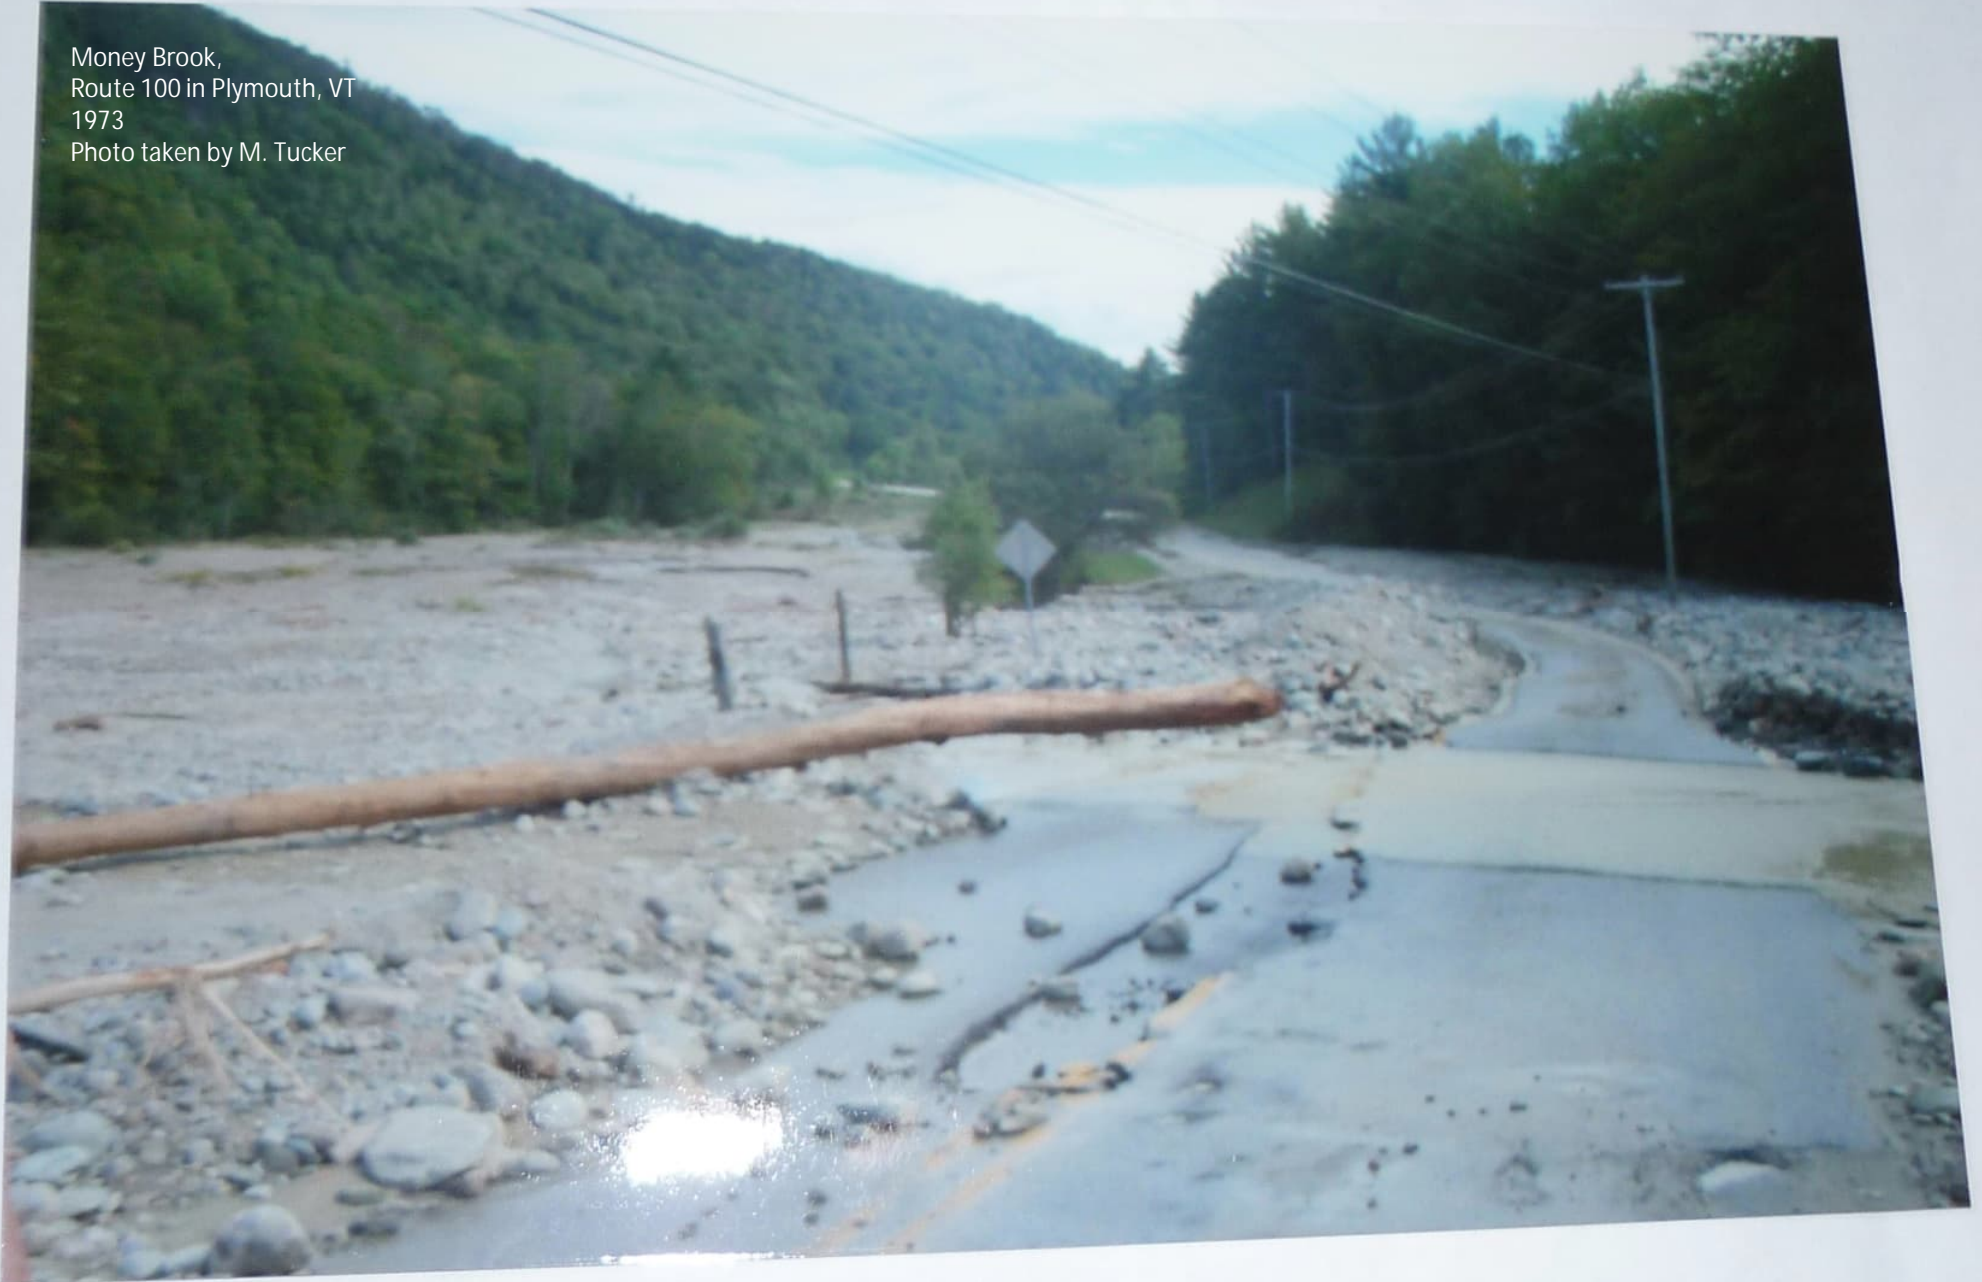
Deposition

Money Brook,
Route 100 in Plymouth, VT
1973
Photo taken by M. Tucker

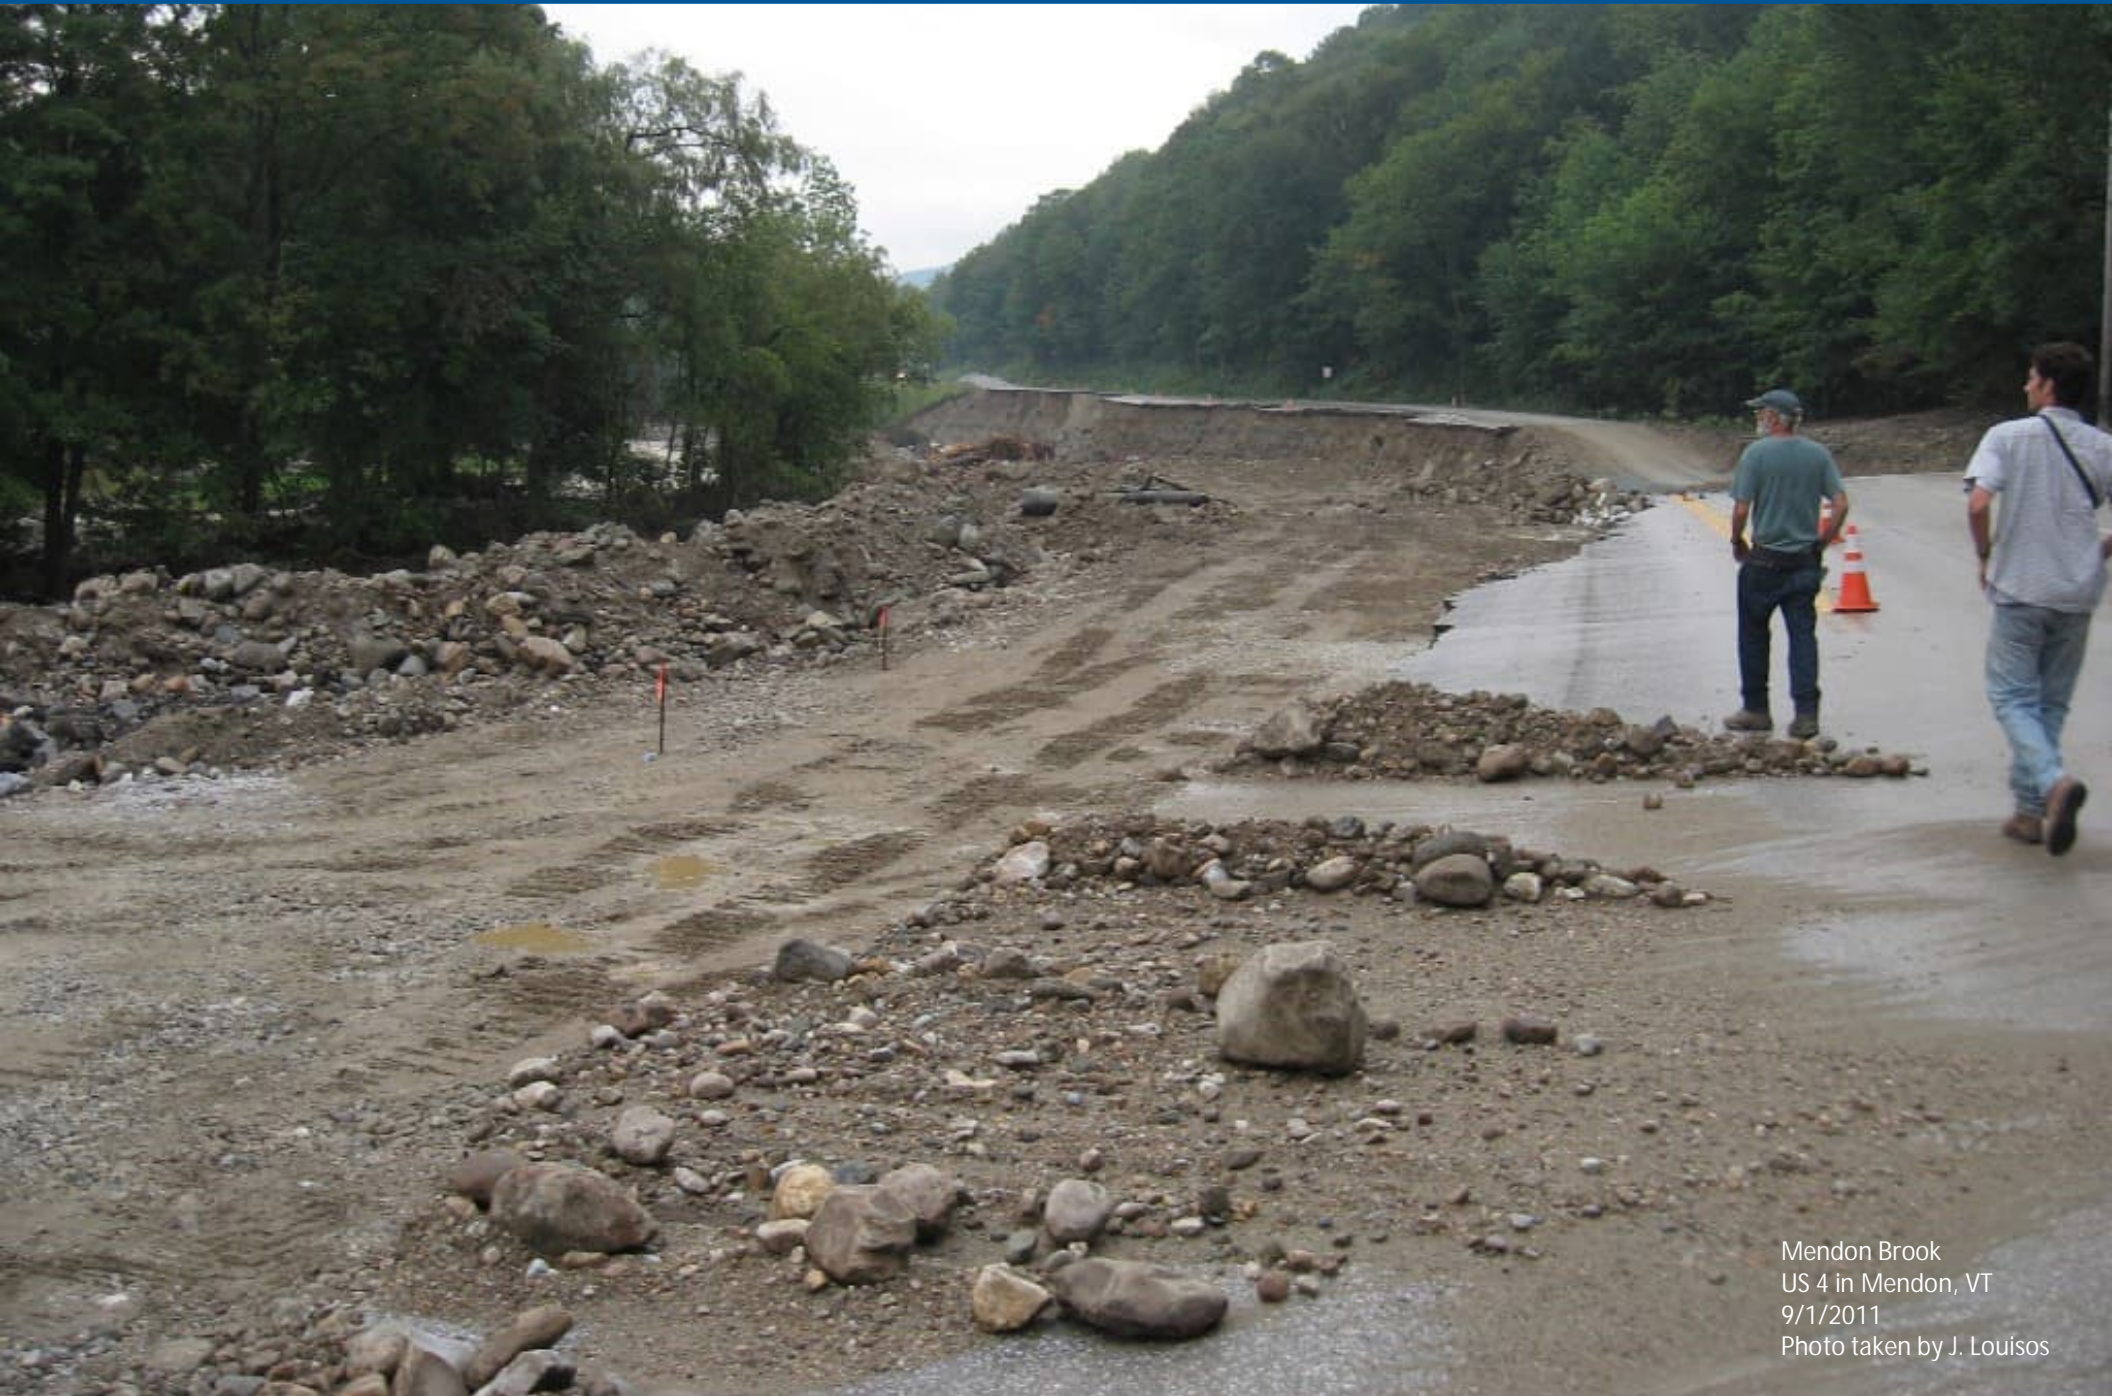
Erosion

Mendon Brook
US 4 in Mendon, VT
9/1/2011
Photo taken by J. Louisos

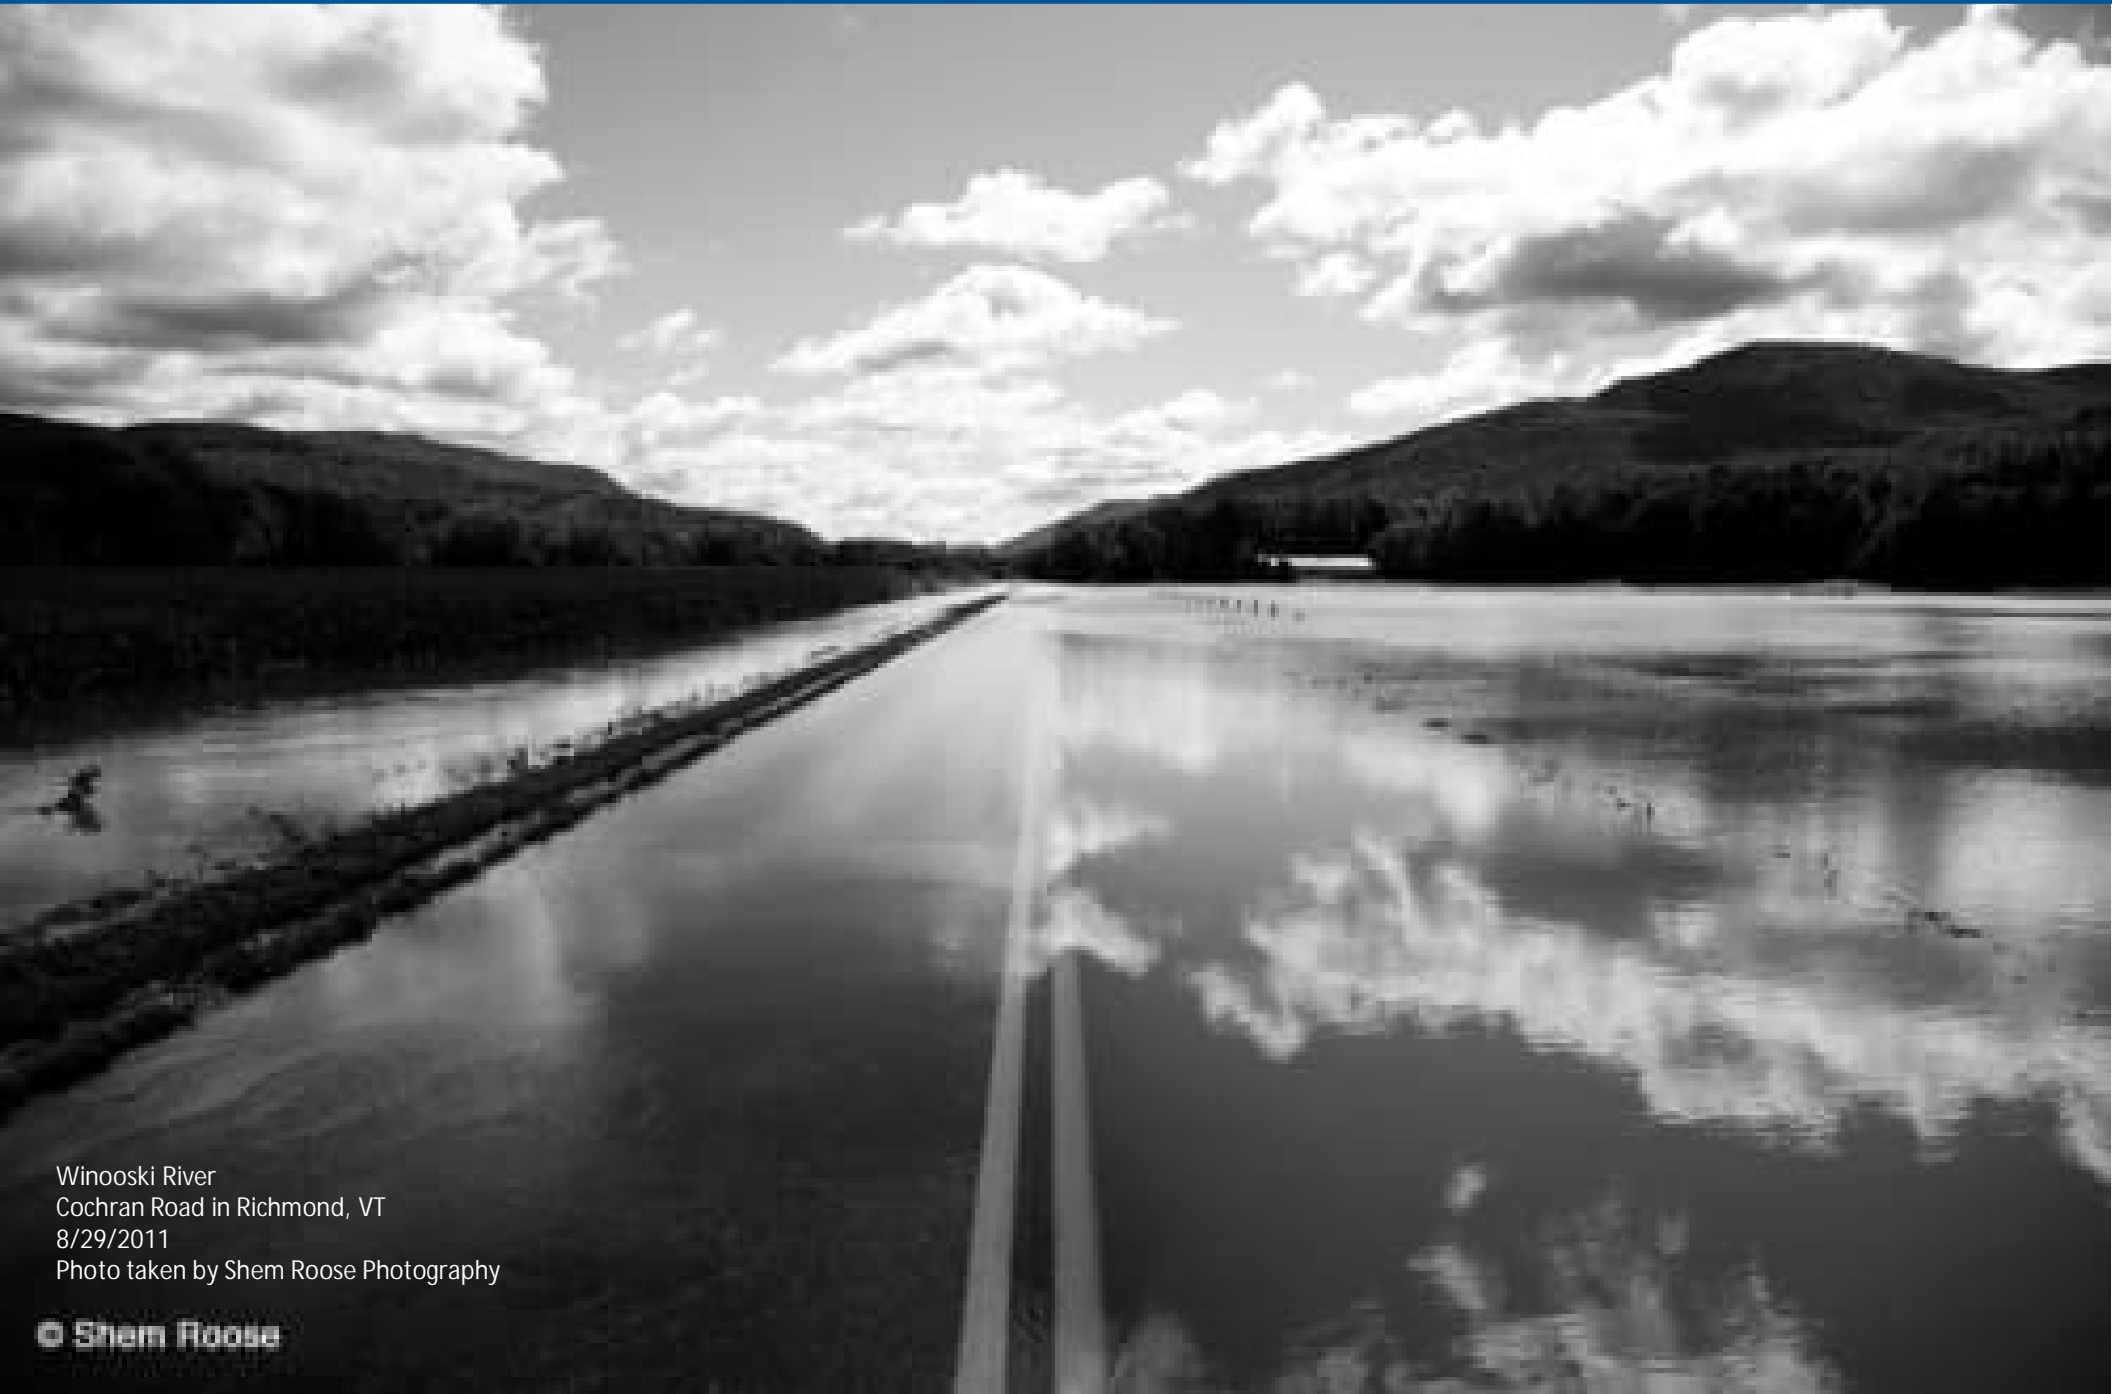
Inundation

Winooski River
Cochran Road in Richmond, VT
8/29/2011
Photo taken by Shem Roose Photography

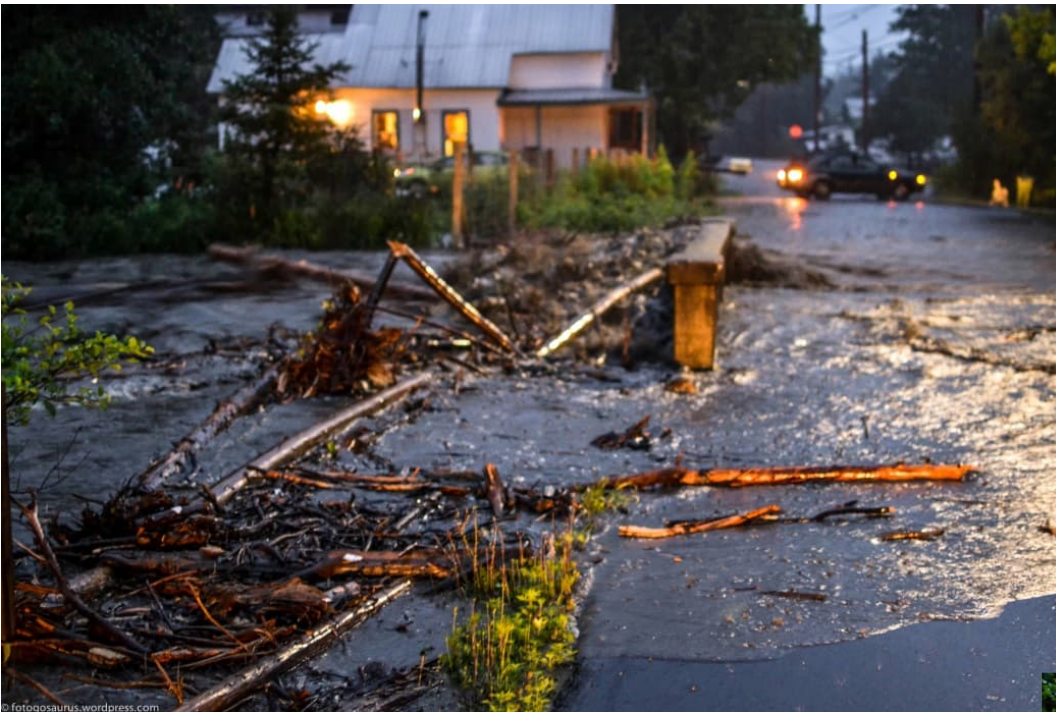
Inundation, Erosion, Deposition

Great Brook
Brook Road Damage, 10-Year Flood
Plainfield, VT
7/20/2015
Photo taken by B. Towbin

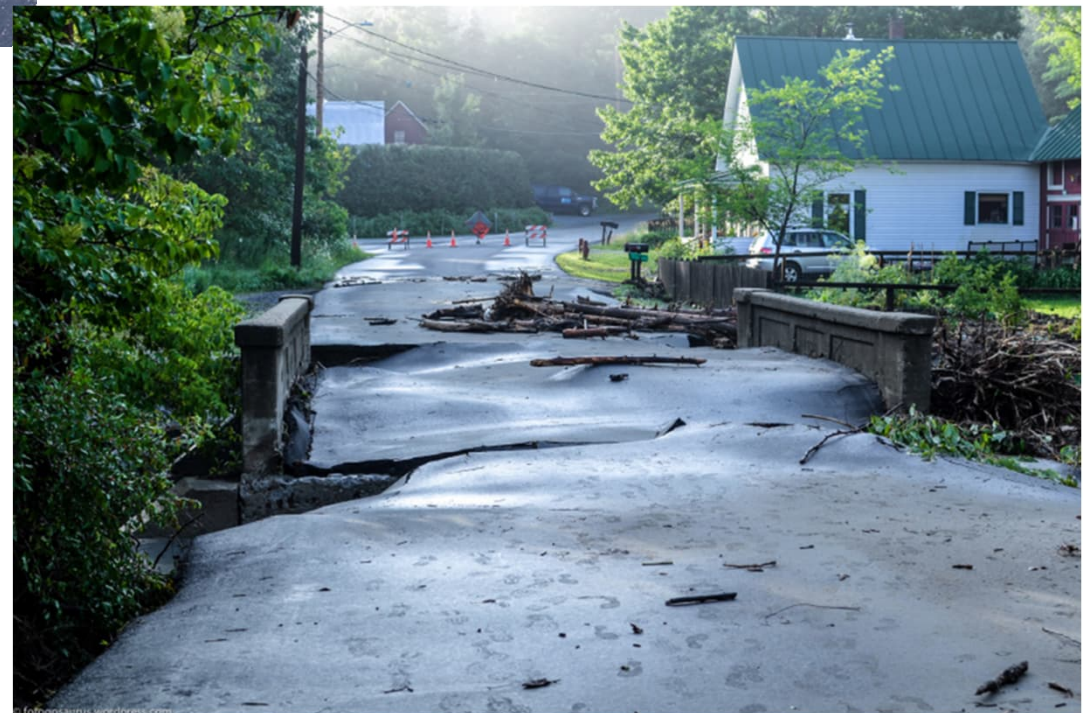
Great Brook
Brook Road Damage, 10-Year Flood
Plainfield, VT
7/19/2015
Photo taken by B. Towbin

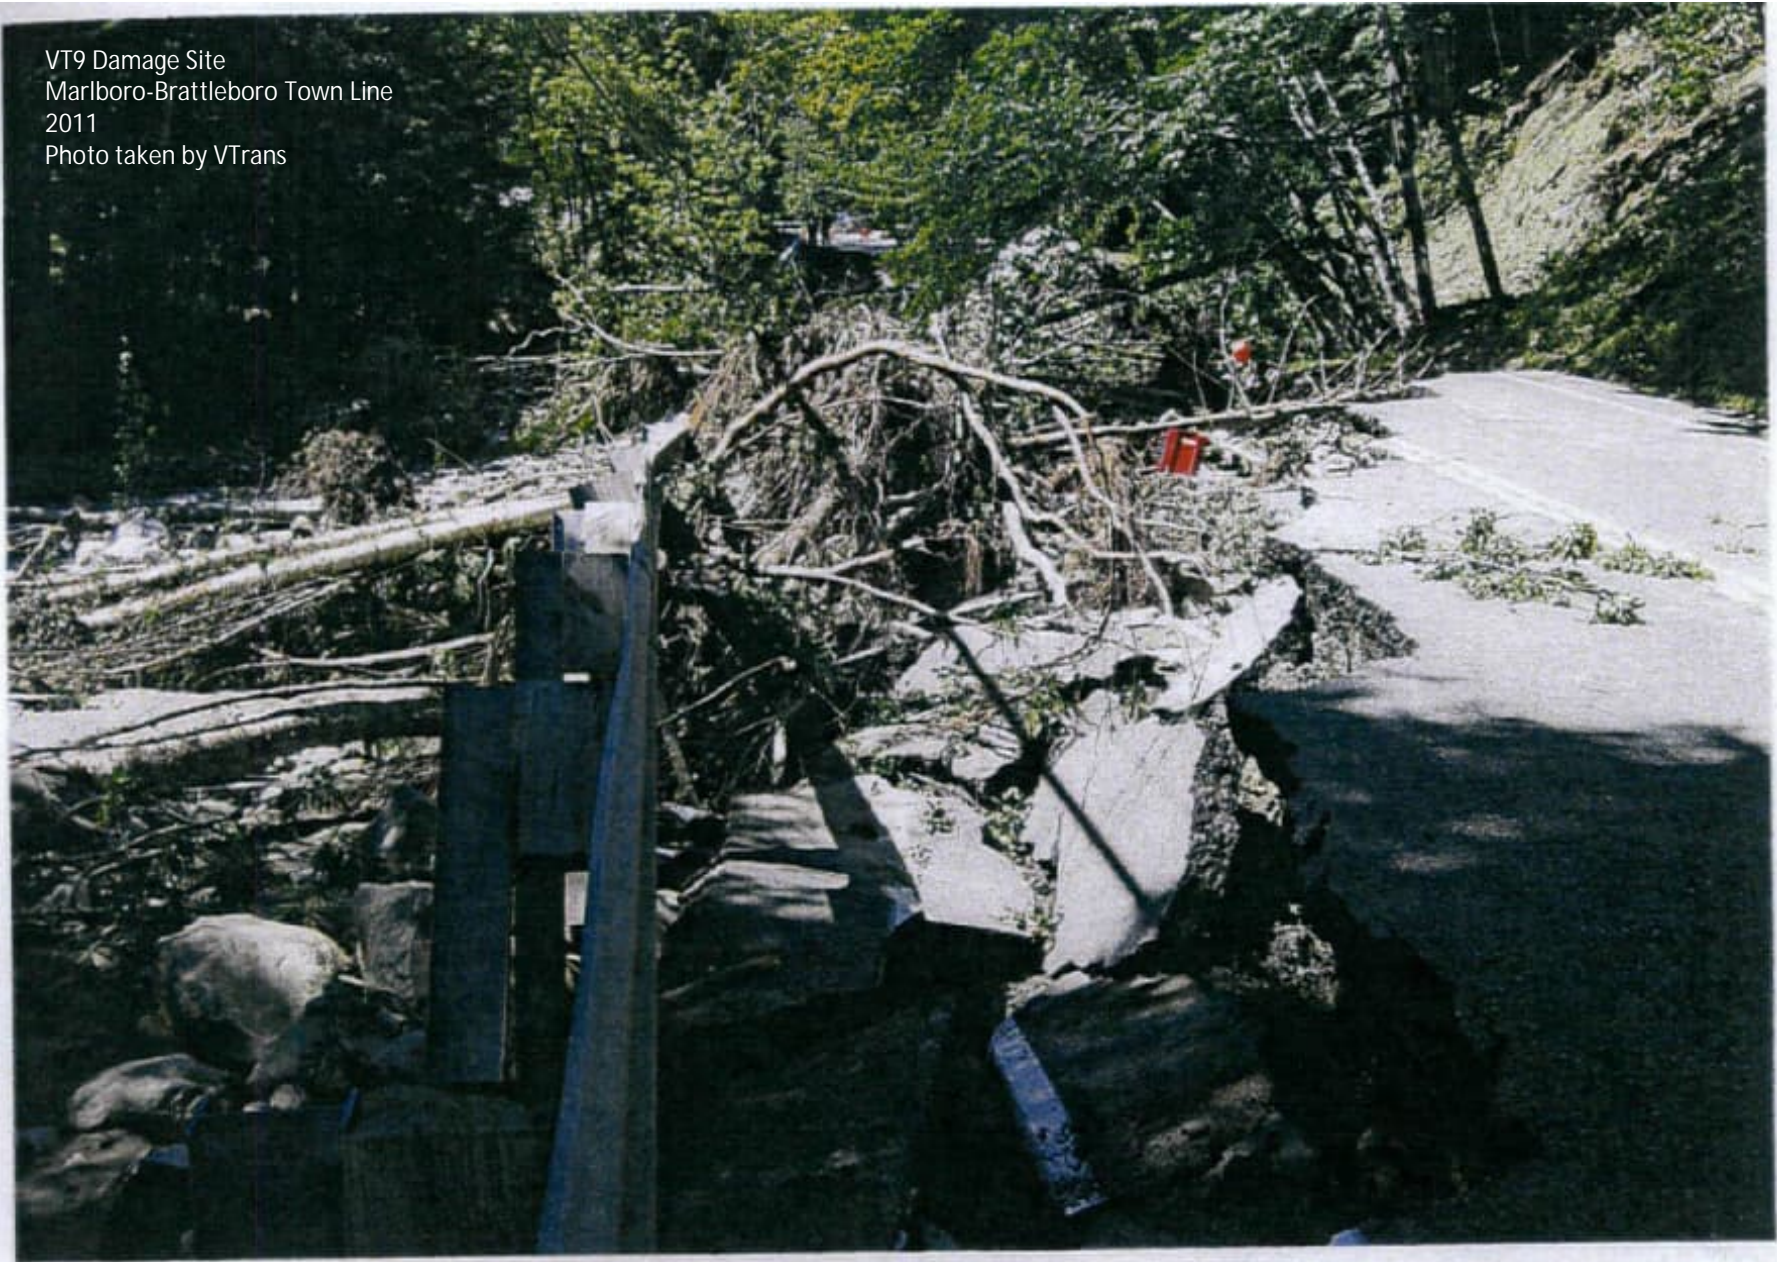
Extreme Erosion at Town Line

VT9 Damage Site
Marlboro-Brattleboro Town Line
2011
Photo taken by VTrans

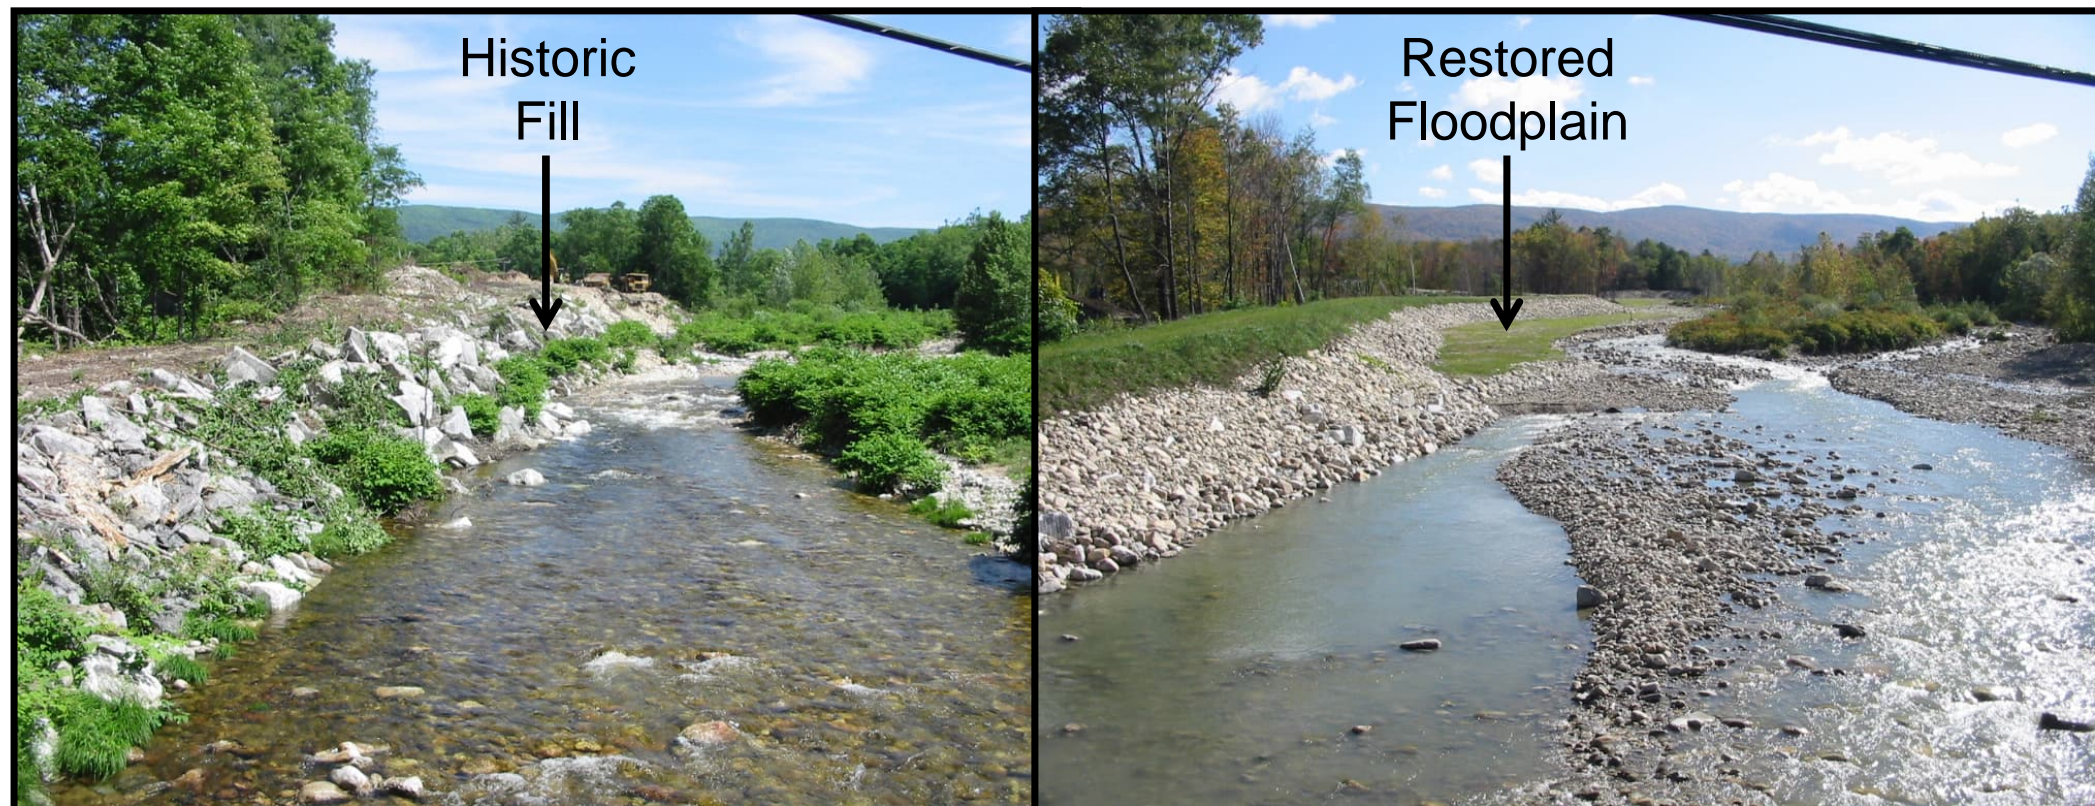
Floodplain Restoration Example

Roaring Branch
Bennington, VT
2008

Roaring Branch
Bennington, VT
2010

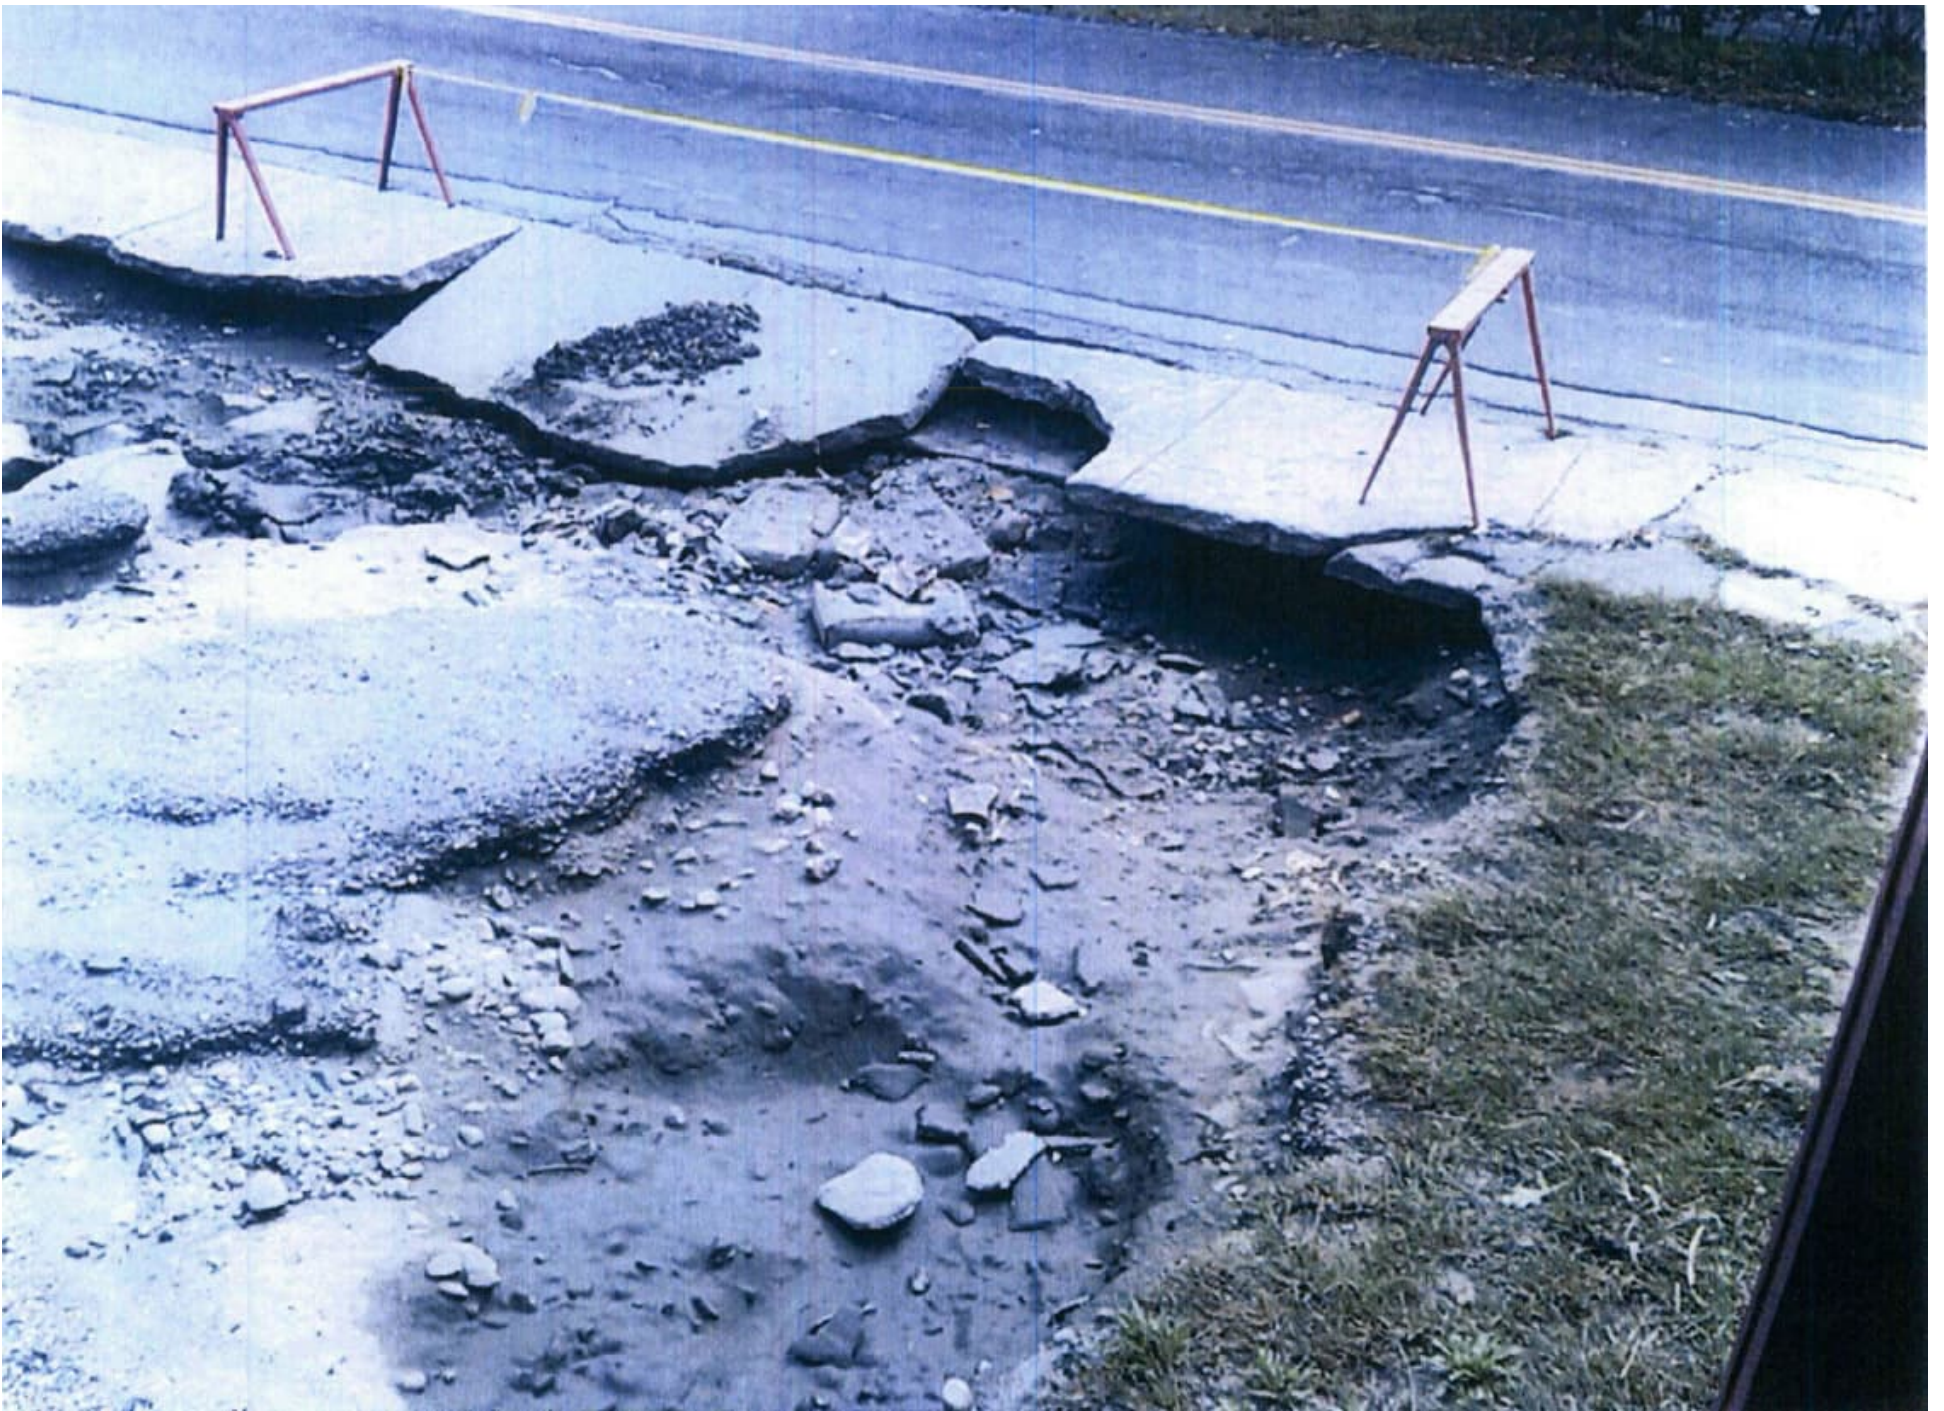
Williams Street Inundation, Brattleboro – just west of Elliot St

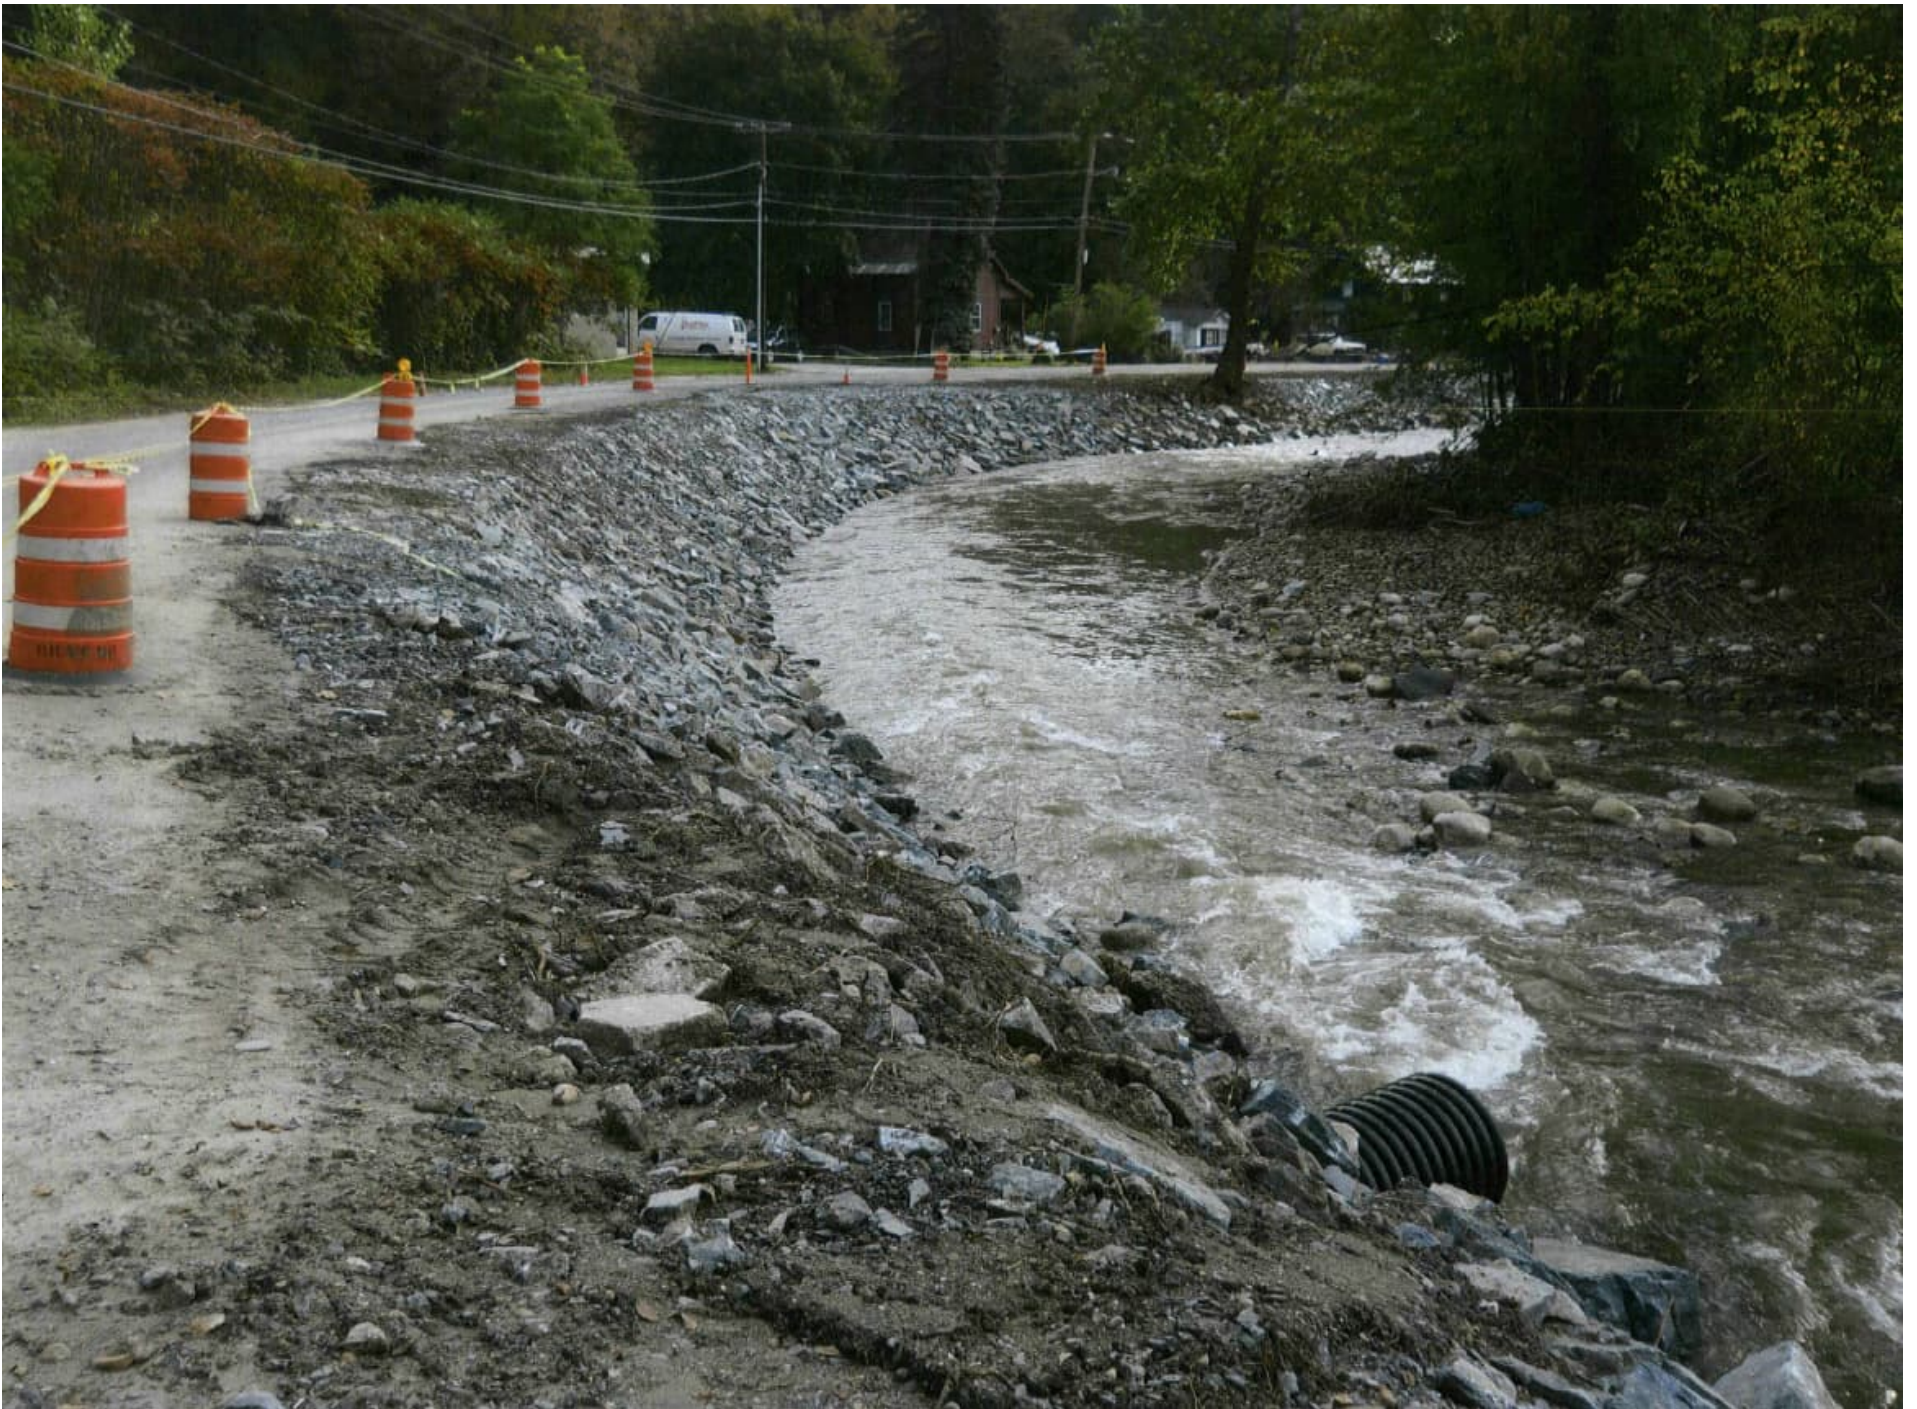
Williams Street, Brattleboro – just west of Elliot St

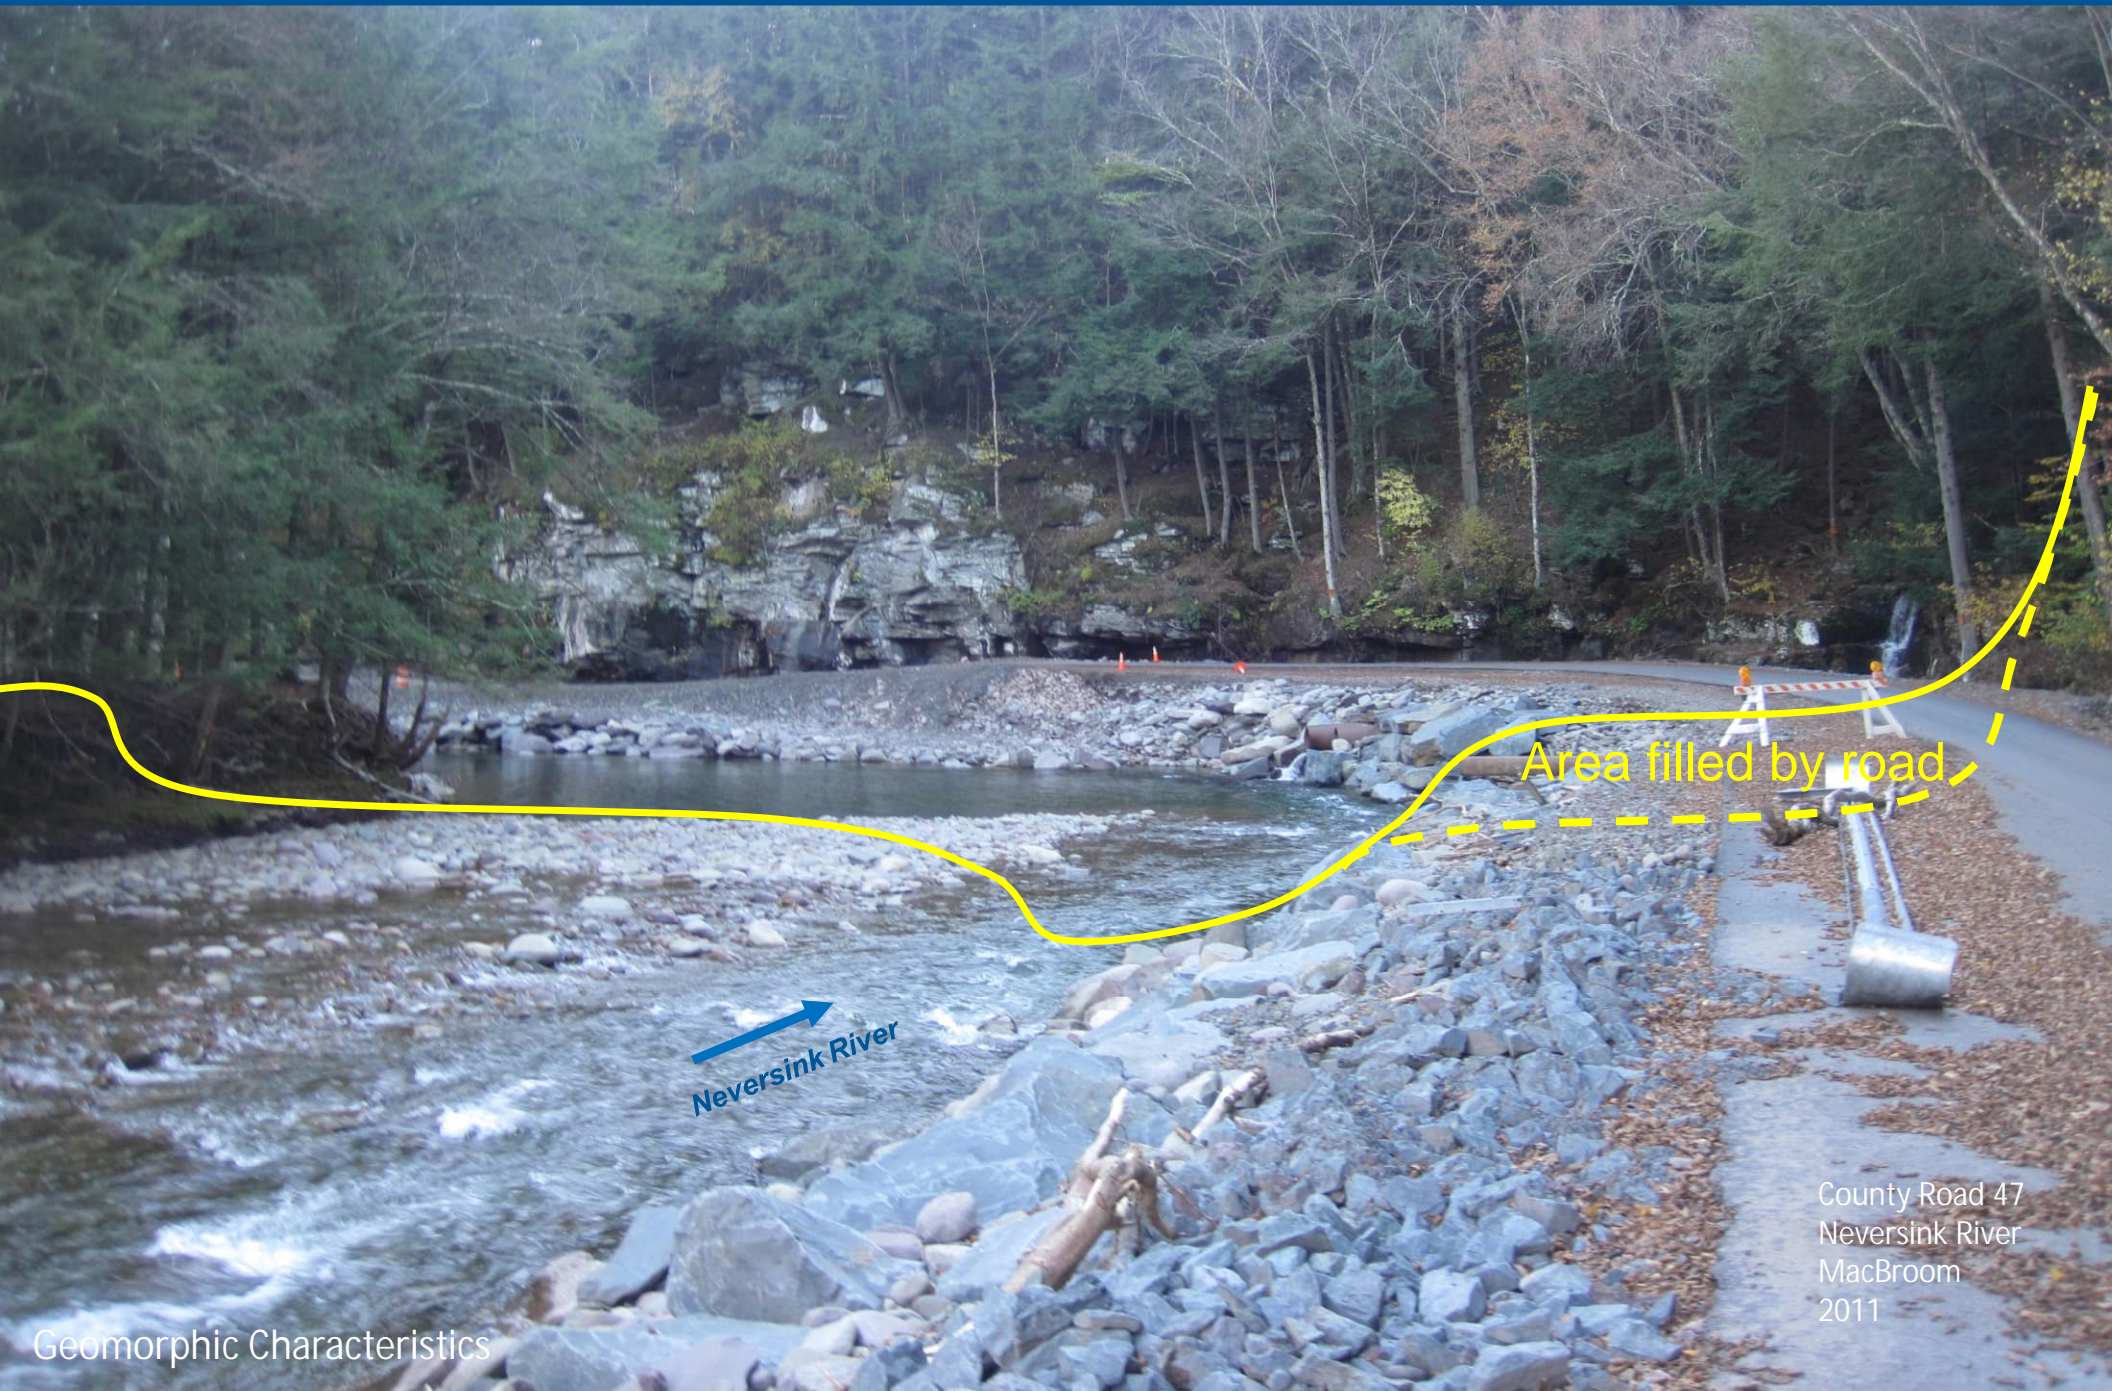
Confinement Increase due to Roads

Area filled by road

County Road 47
Neversink River
MacBroom
2011
