Transportation Flood Resiliency Tool (TRPT)

FEBRUARY 9, 2023

Fitzgerald Environmental Associates, LLC.
Applied Watershed Science & Ecology

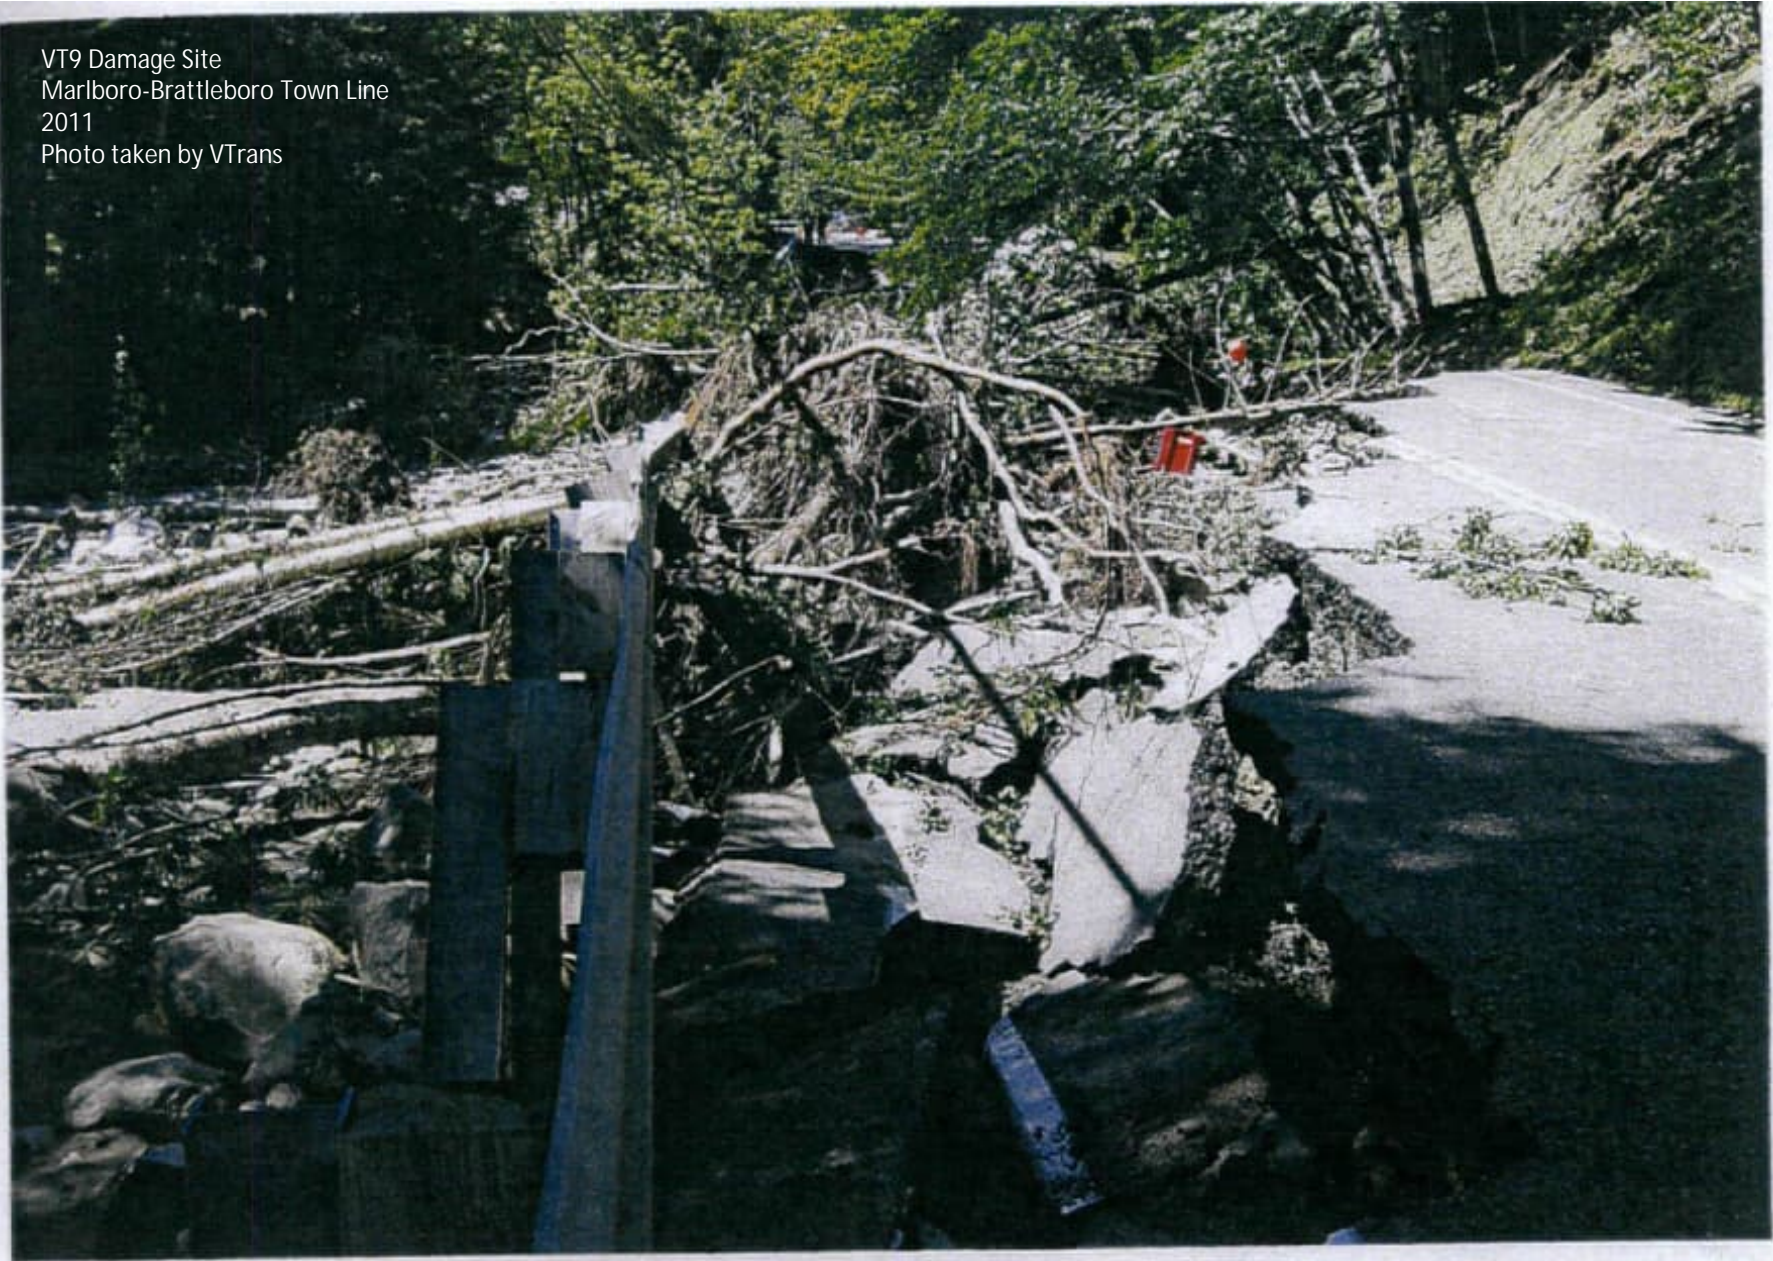
VT9 Damage Site
Marlboro-Brattleboro Town Line
2011
Photo taken by VTrans

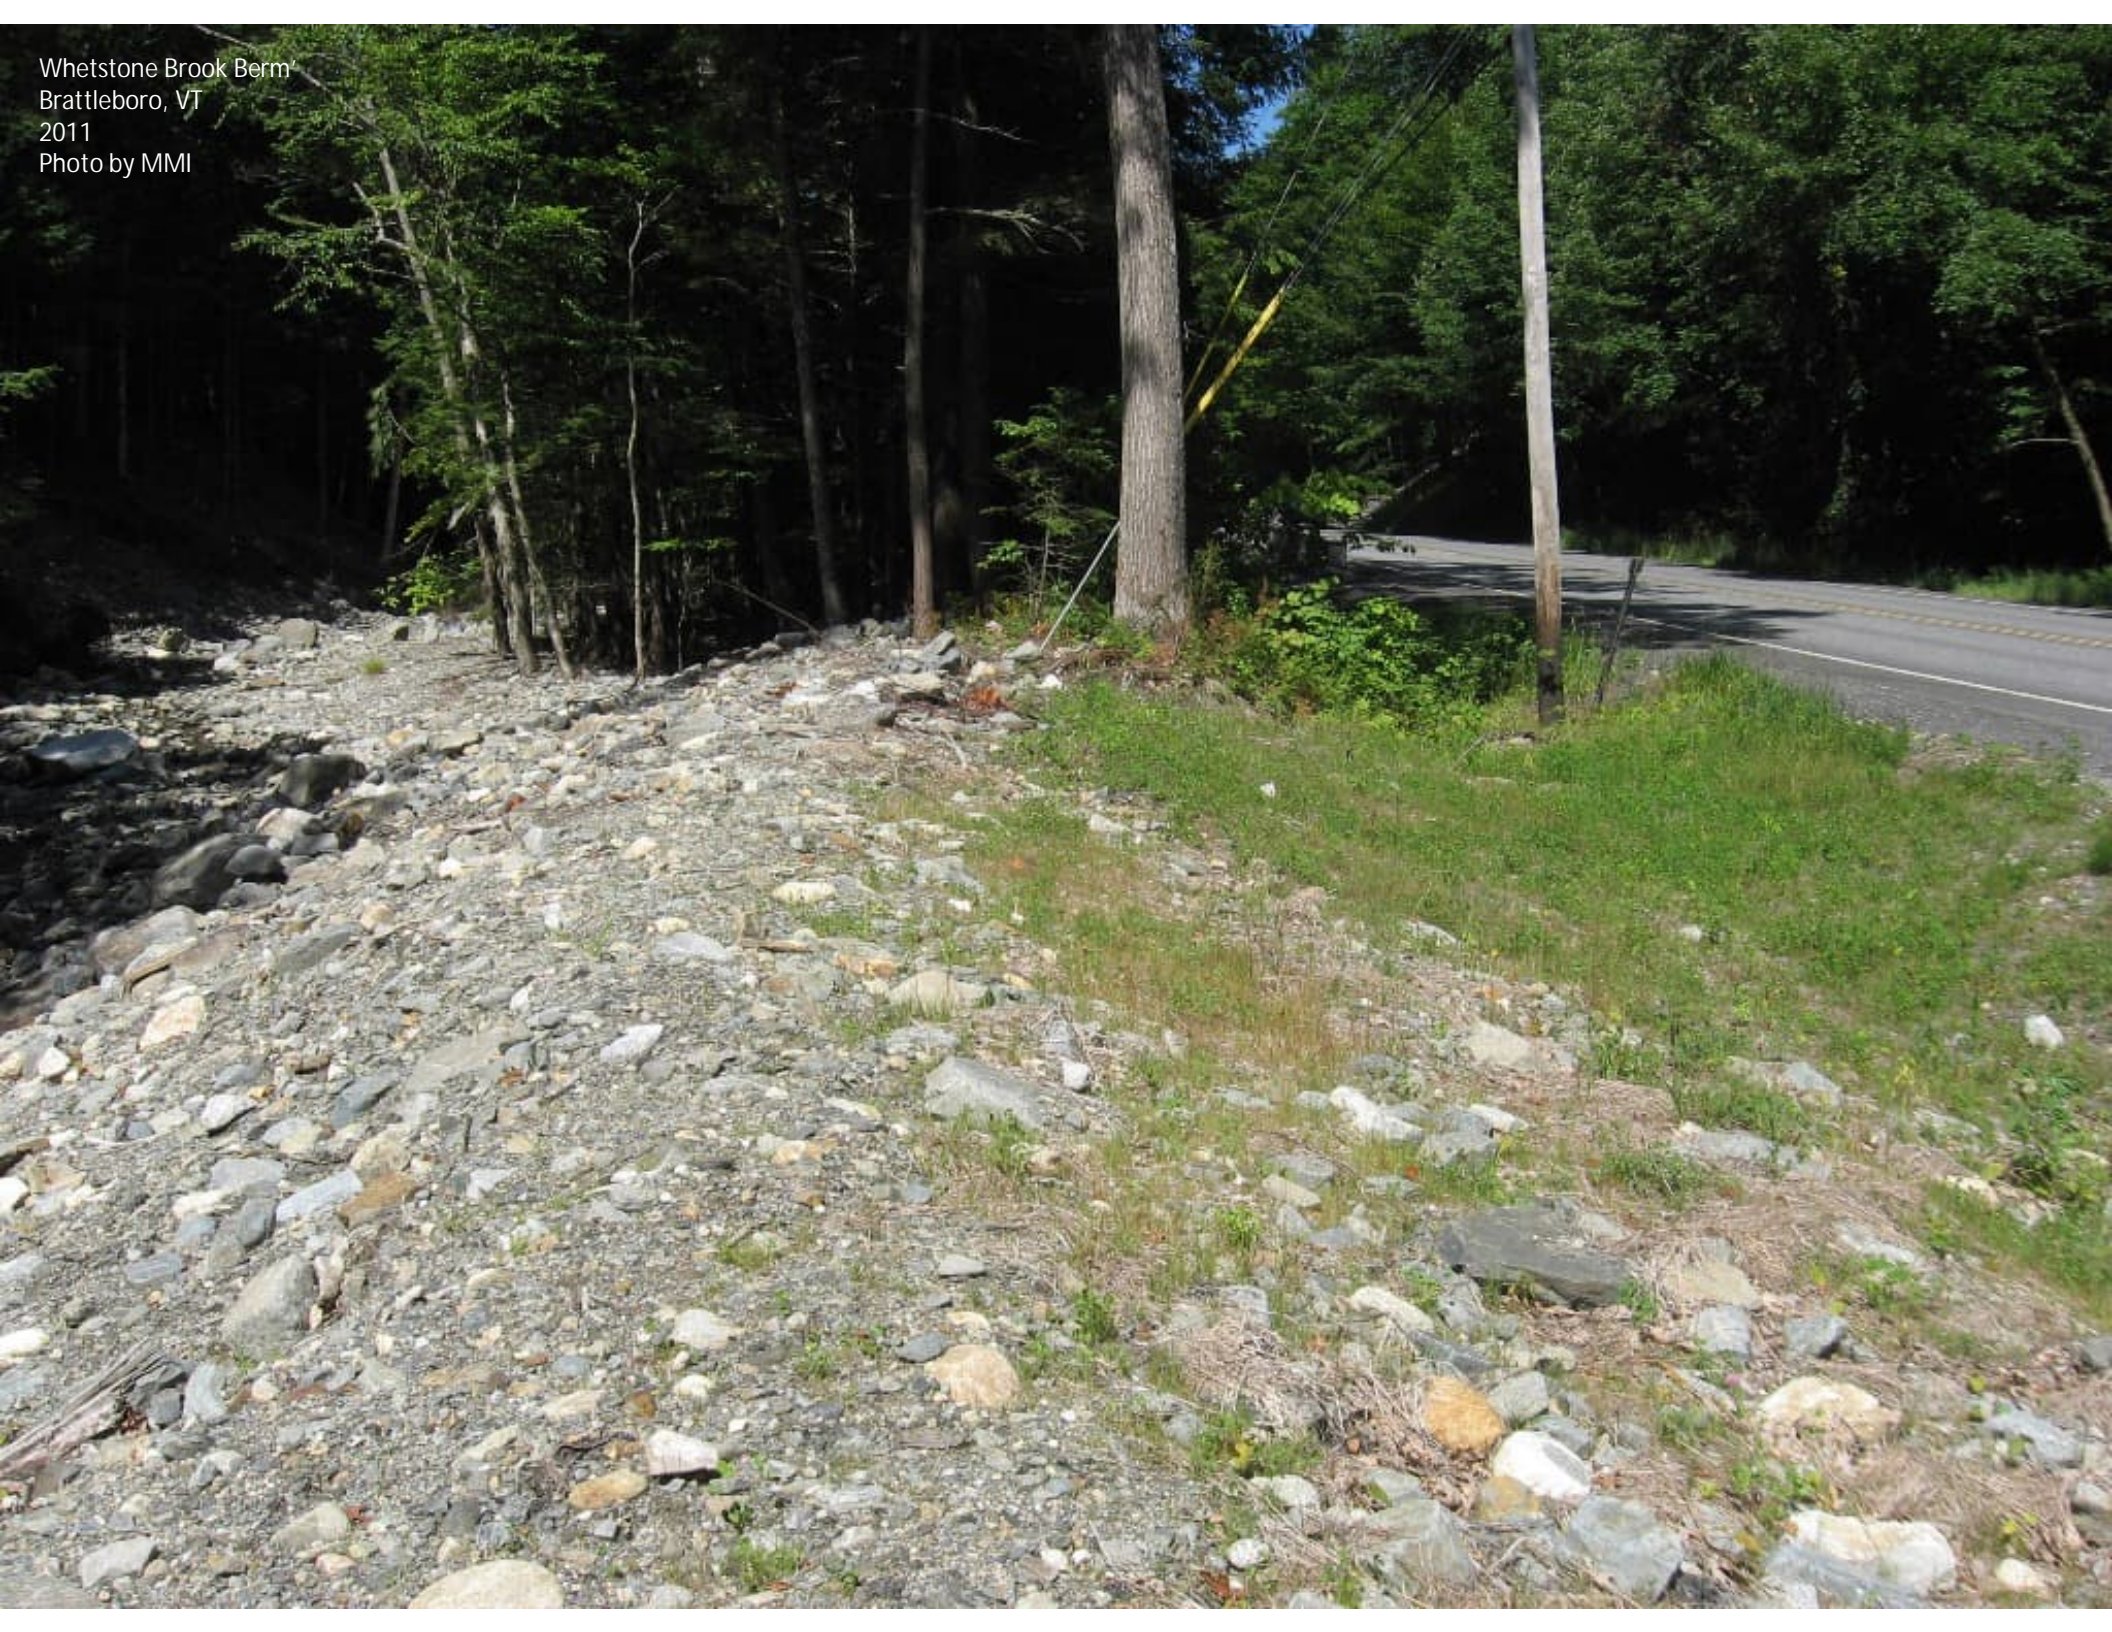
Whetstone Brook Berm
Brattleboro, VT
2011
Photo by MMI

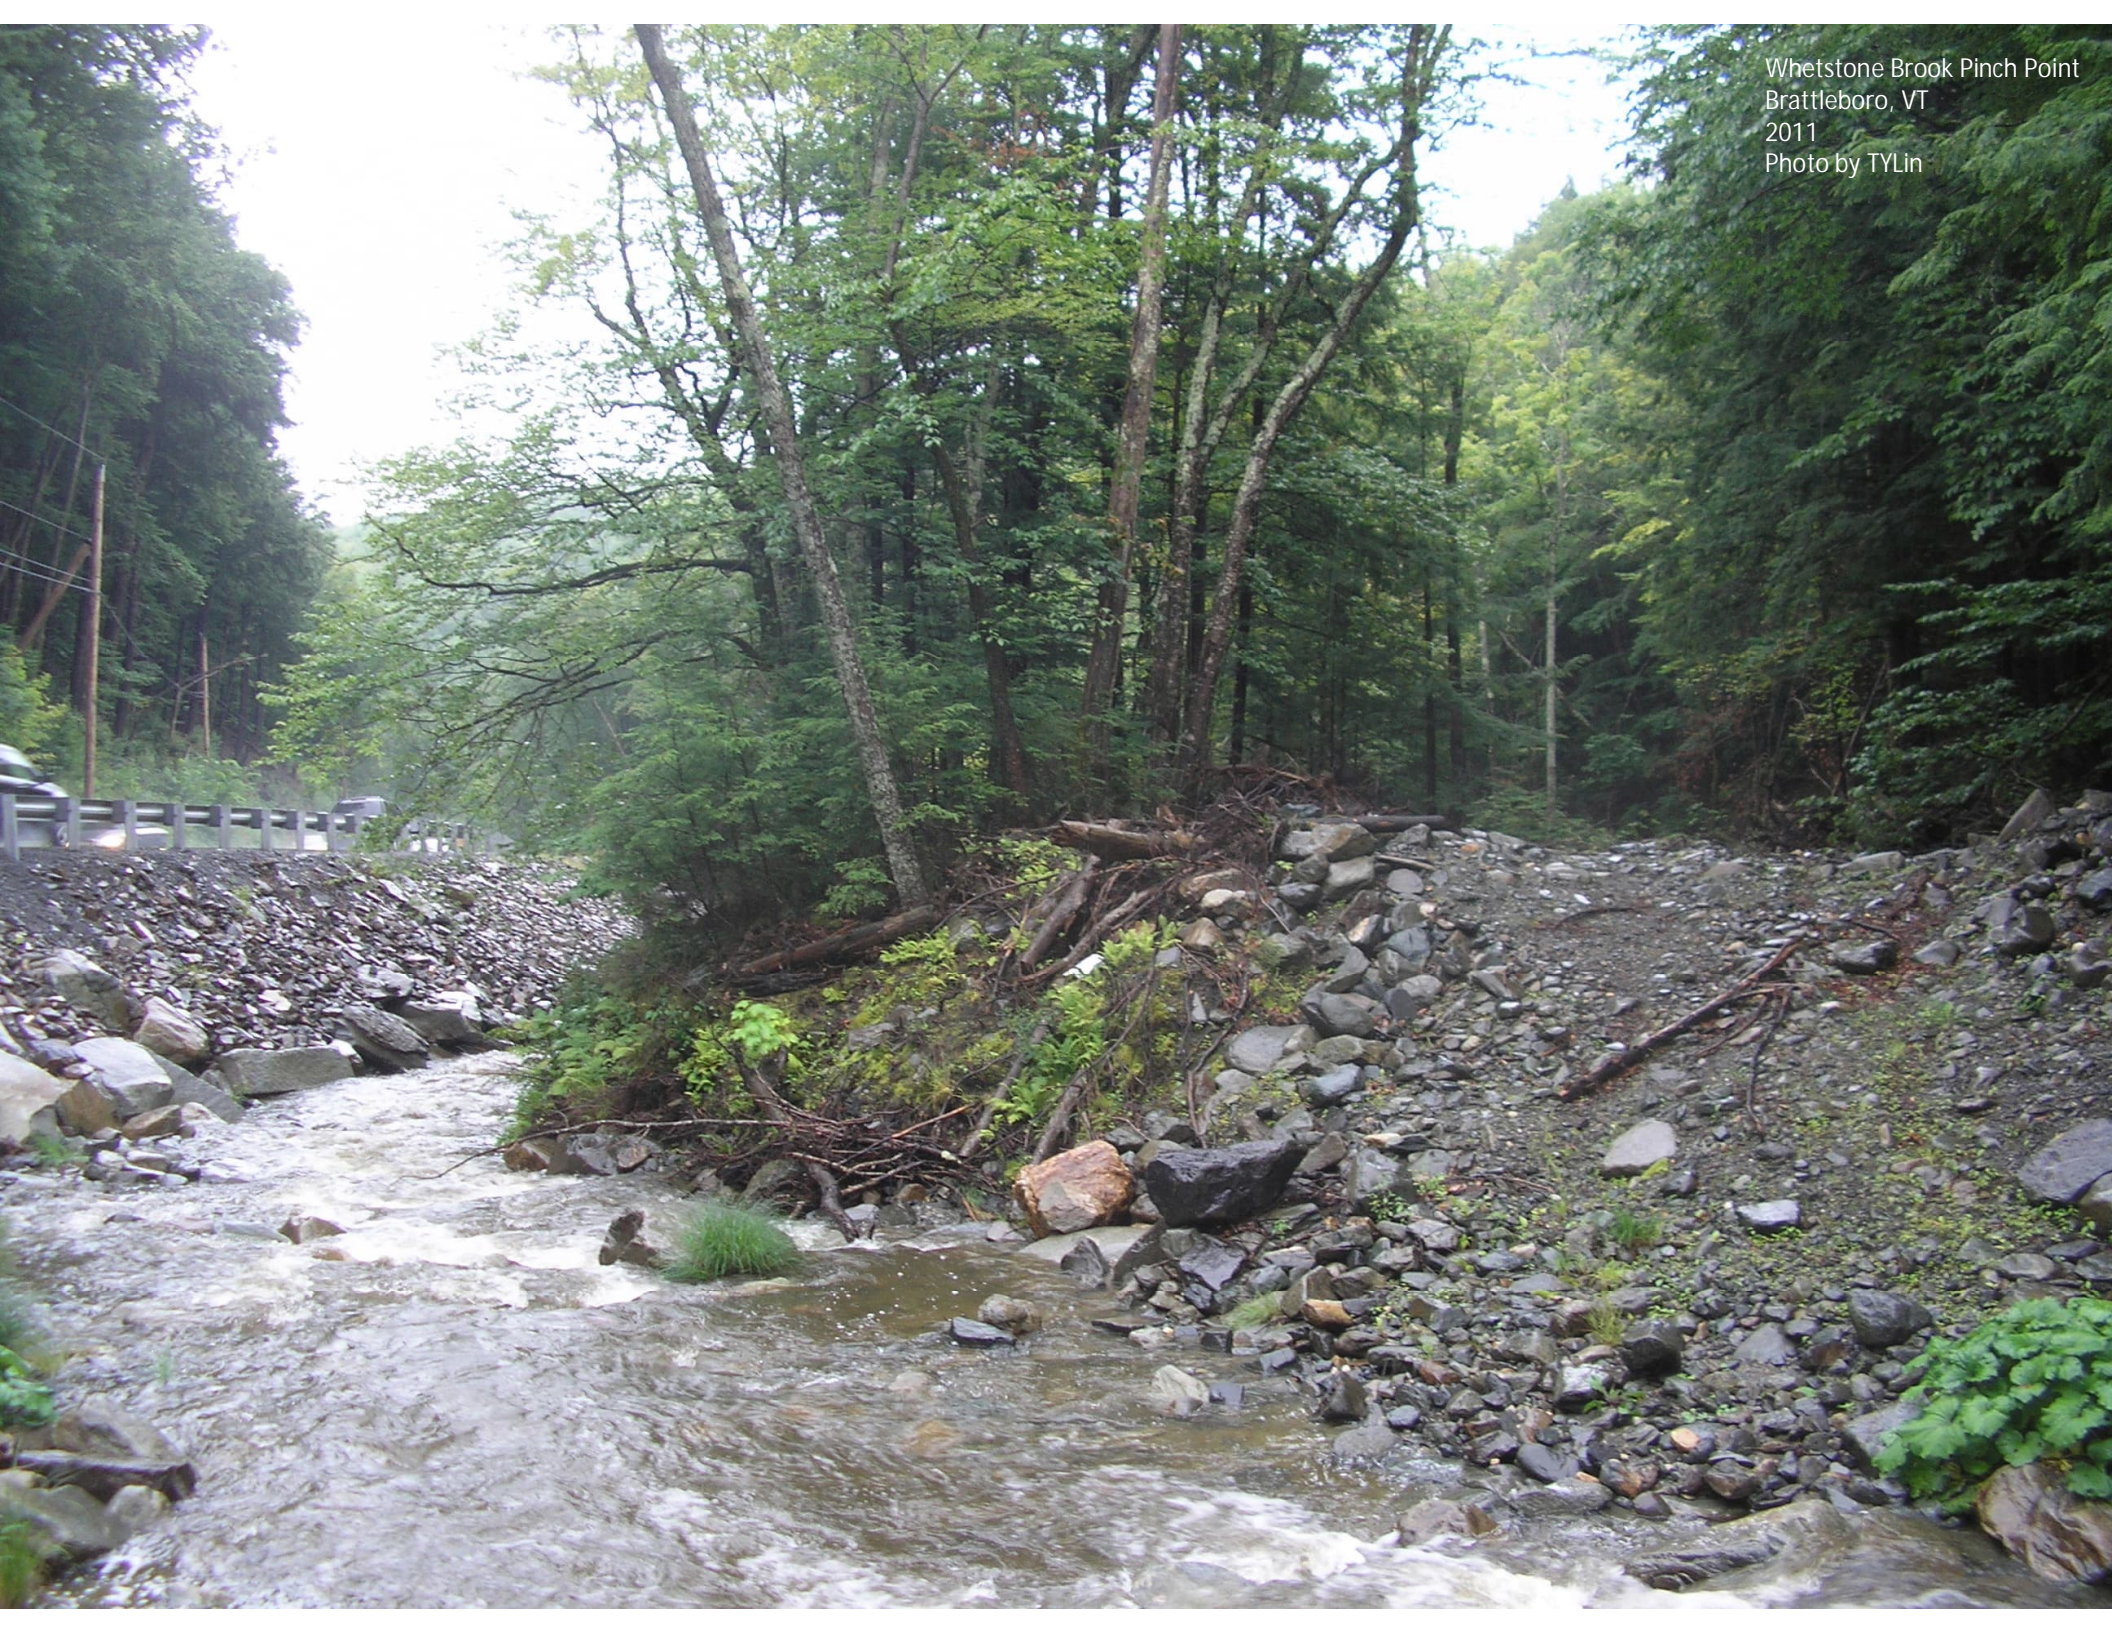
Whetstone Brook Pinch Point
Brattleboro, VT
2011
Photo by TYLin

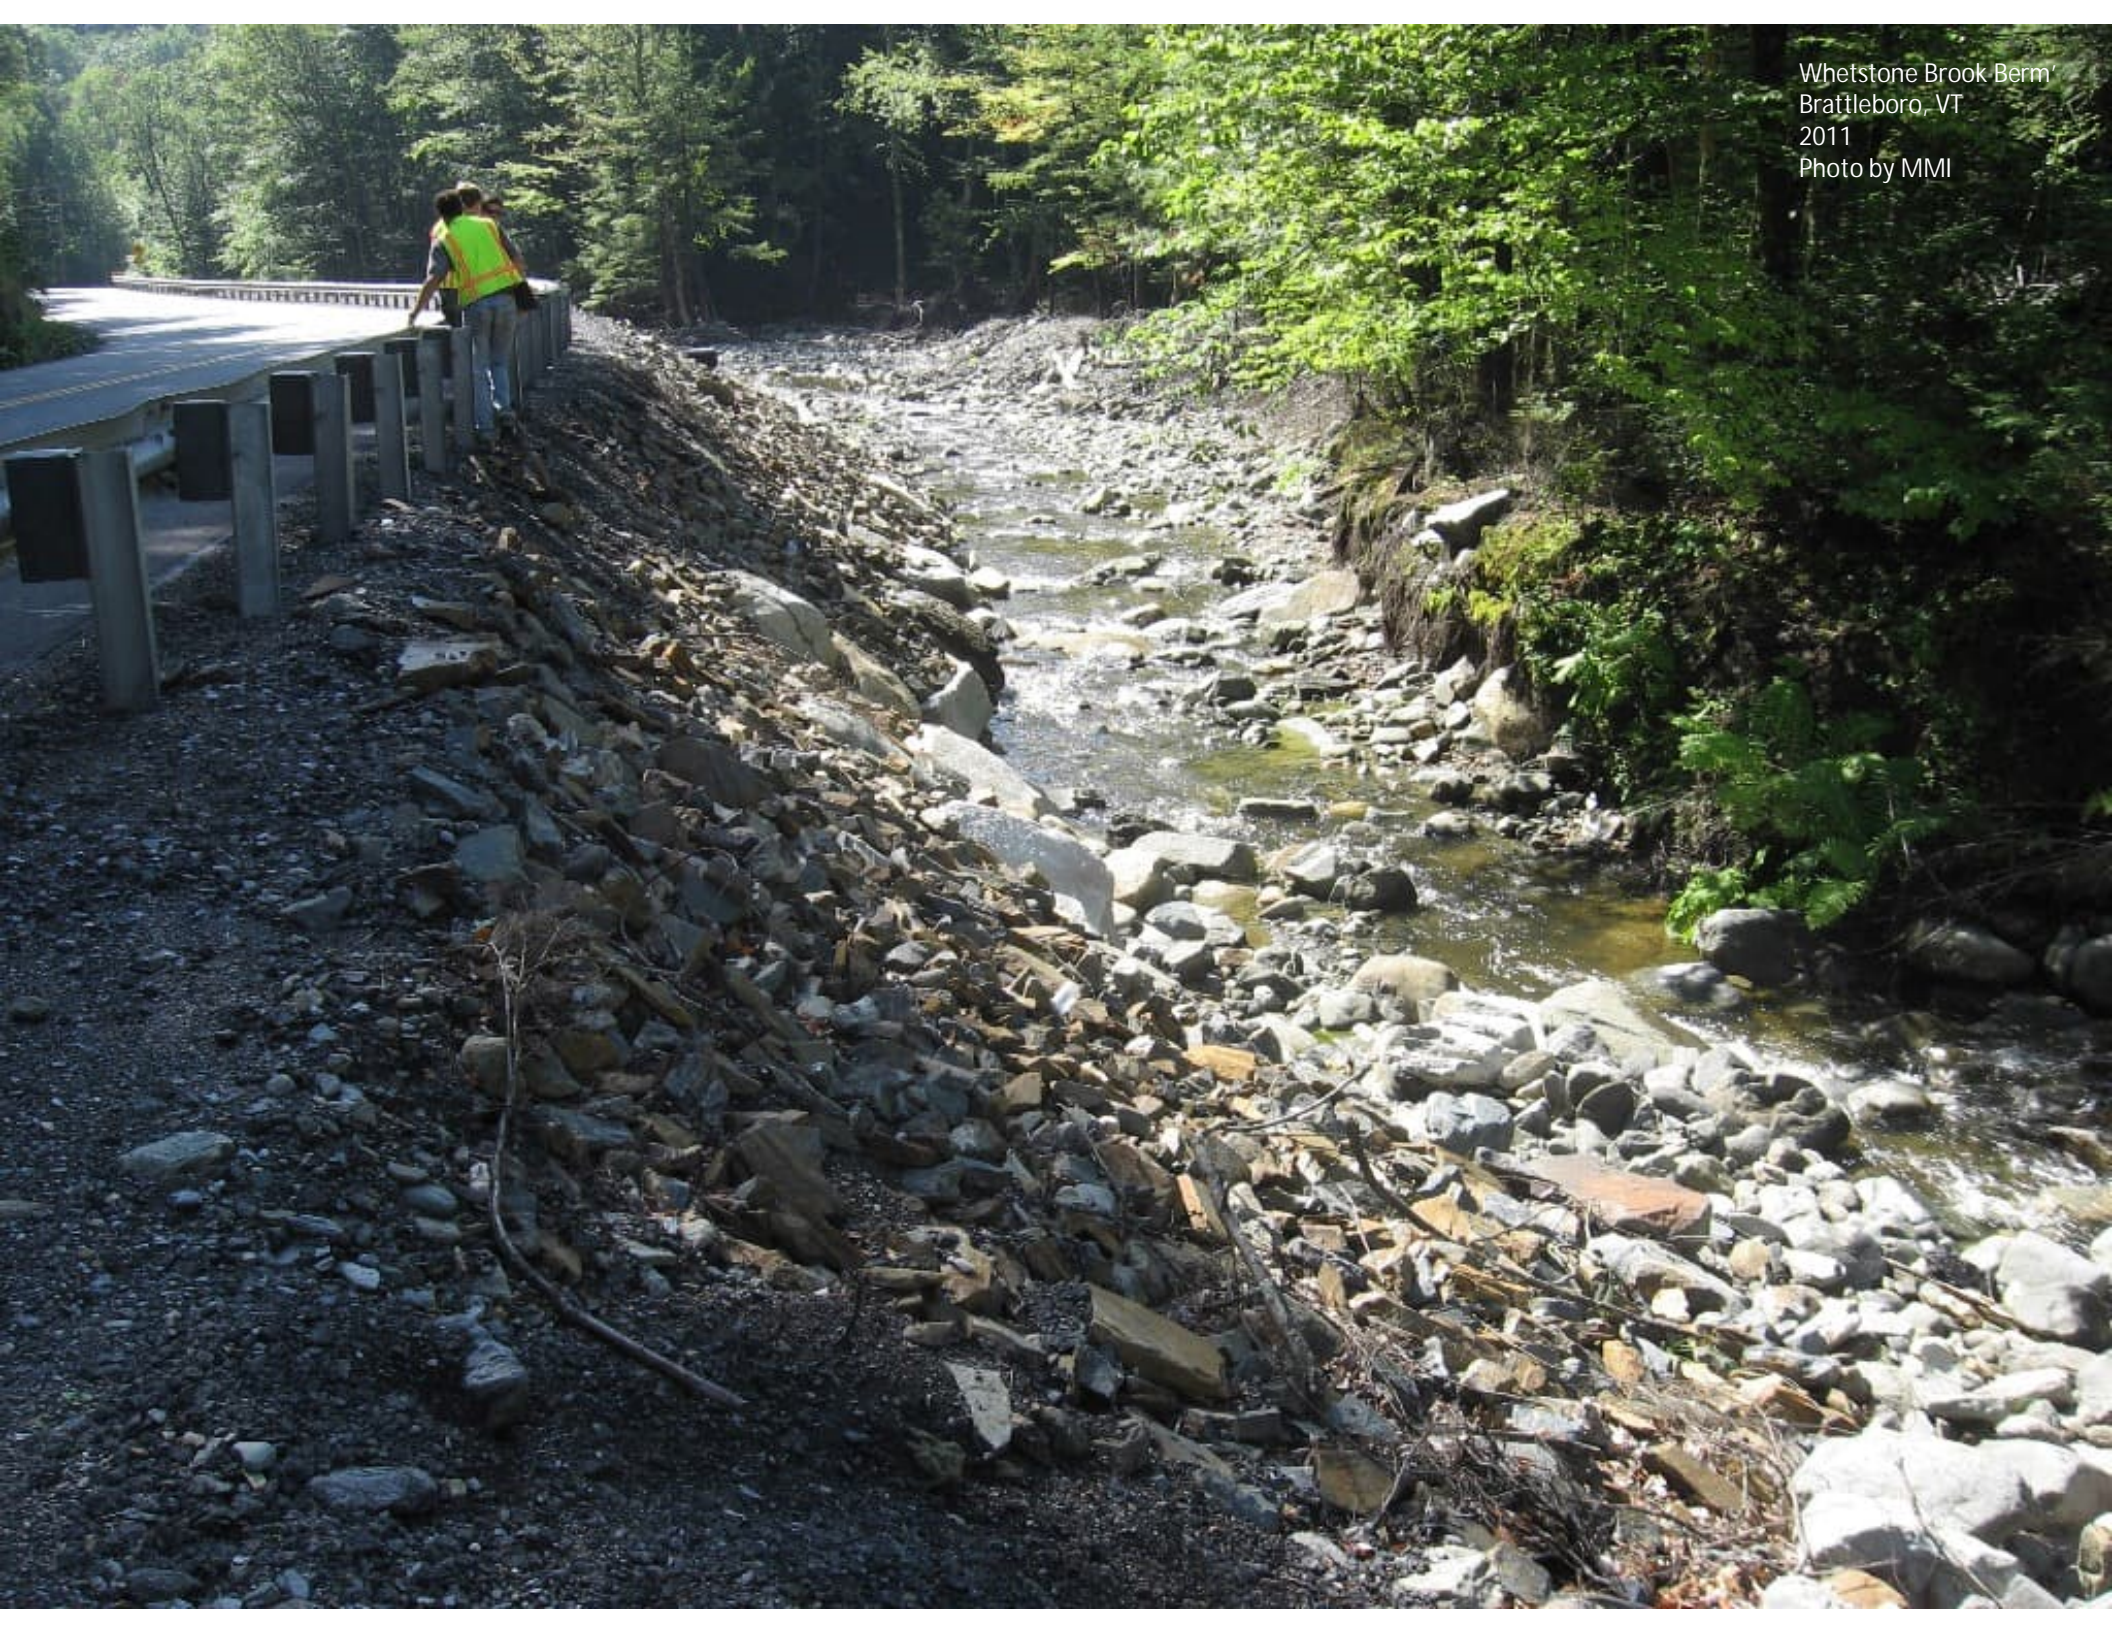
Whetstone Brook Berm
Brattleboro, VT
2011
Photo by MMI
