# Recycled Asphalt Shingles (RAS) in Town Gravel Roads-Progress Report

## 1. INTRODUCTION

## 2. TEST SITE SUMMARIES

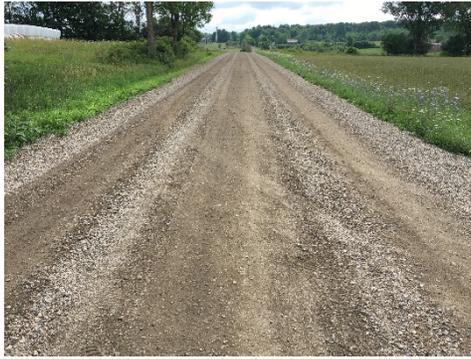
Figure 1: Location of Cornwall/Shoreham Test Section, Wooster Rd.

The towns of Cornwall and Shoreham, in central Vermont, acquired 271 tons of RAS from Myers Recycling in Colchester. The town of Cornwall mixed the RAS and gravel from Acker Excavating at their town garage using a front-end loader and a ratio of 4 bucketsful of gravel to 1 bucketful of RAS, resulting in a 20% mix by volume. This mix was used to resurface 1450 ft of roadway on Wooster Rd in Shoreham and 4900 ft of adjoining roadway on Wooster Rd in Cornwall, (TH 5), location shown in Figure 1. The roadway has a varying width of 20-21 ft, 5-6% crown, and a slope between 0-10%.

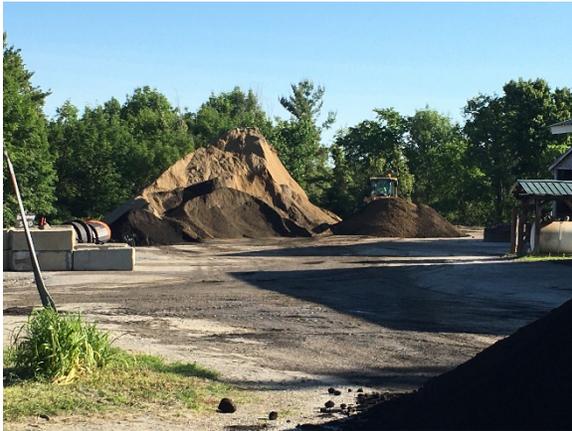
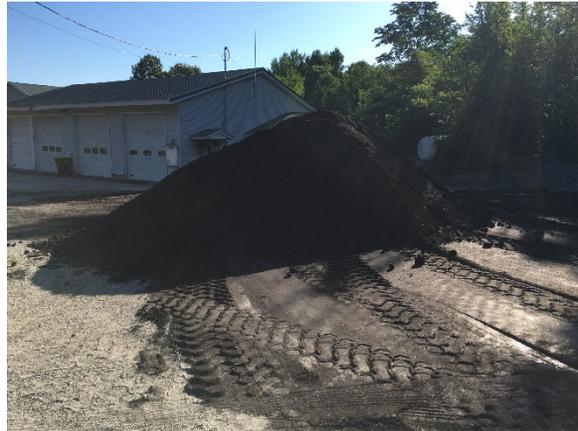
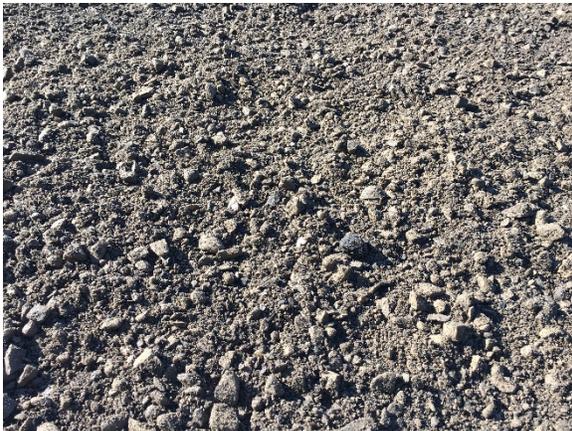
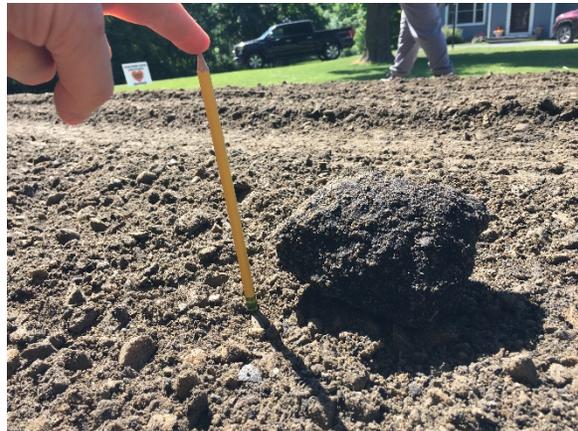
Figure 2: Cornwall/Shoreham Materials to be used in test section

The RAS used in the Cornwall/Shoreham test section had a few small agglomerations, some as large as 4" in diameter. Photos of the material are available in Figure 2.

Cornwall Gravel Pile

Cornwall RAS Pile

Cornwall 80/20 Gravel/RAS

RAS Clump

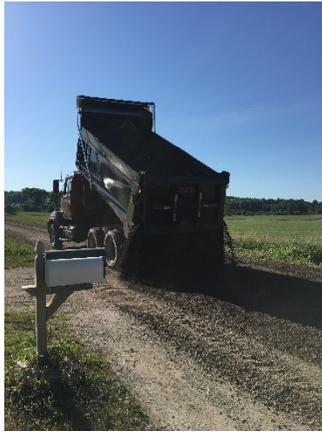
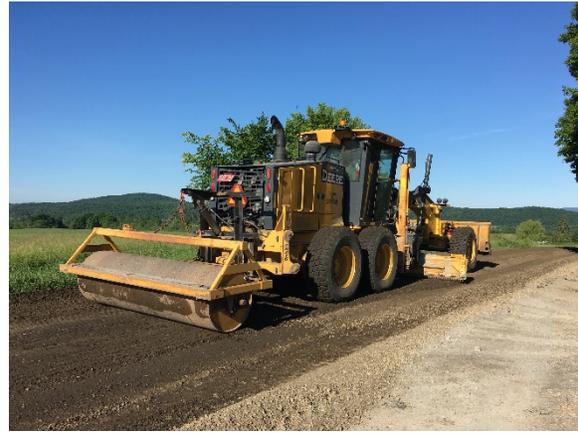
Figure 3: Test Section Construction

Gravel was mixed with RAS at the town of Cornwall garage, trucked to the site and deposited onsite using town of Cornwall and Shoreham dump trucks. Construction of the road followed typical procedures used by the Town. The town of Shoreham grader with an attached roller was used to grade and compact the road surface. Construction took place on June 15, 2020 and June 16, 2020. After the first day of construction approximately 1,200 gallons of calcium chloride were applied to the road surface. On the morning of June 16, 2020 approximately 4,500 gallons of water was applied to the roadway. After construction had concluded another 2,400 gallons of calcium chloride was applied. The day after construction had finished another 4,500 gallons of water was applied. The resurfacing process can be seen in Figure 3.

Truck dumped material

Grader spreading and rolling

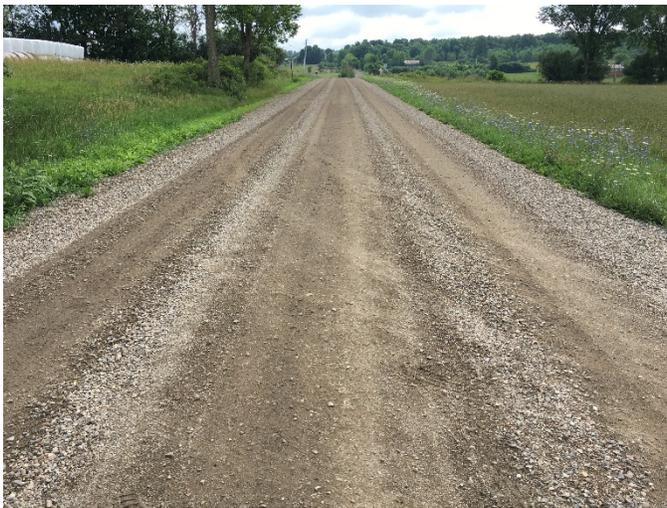
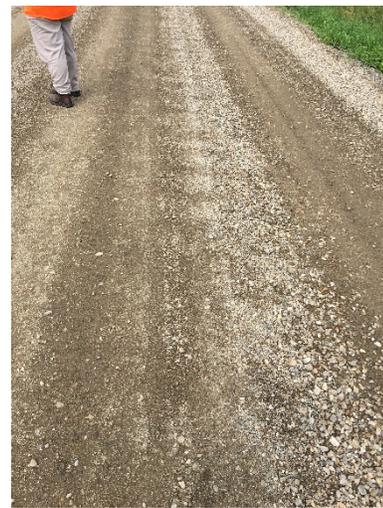
Figure 4: RAS Test Section during 7-14-20 Site Visit

The town of Cornwall has been pleased with the performance of the RAS/gravel test section. Typically, the Town has to grade the road five or six times per year; however, the RAS/gravel may necessitate grading only three or four times per year. The Towns have graded once and added 1,000 gallons of calcium chloride since the installation of the test section. As Cornwall is pleased with the performance of the test section, they plan to install the RAS/gravel on two other town roads. The Town would consider a higher ratio of RAS to gravel in future, suggesting a ratio of 1:3 RAS/gravel or even a 1:1 mix. During a site visit on July 14, 2020 Wooster Road seemed to be in good working order. However, some larger gravel had worked its way to the surface and off to the shoulders, and there was corrugation at the intersection with Buttolph Rd. All in all, the town of Cornwall is satisfied with the RAS/gravel mix and the performance of the road. Photos of the roadway are shown in Figure 4.

RAS Test Section

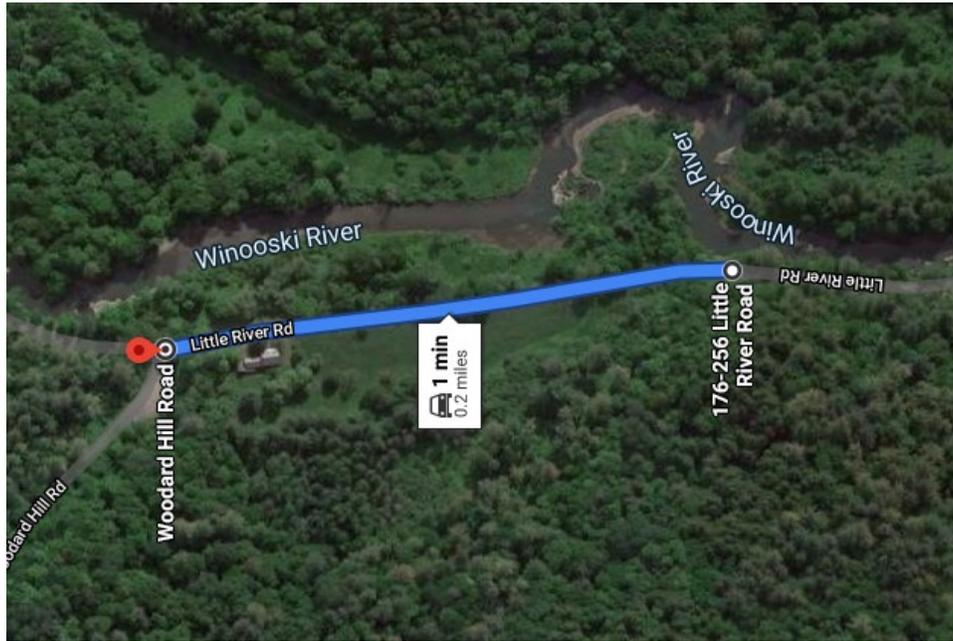
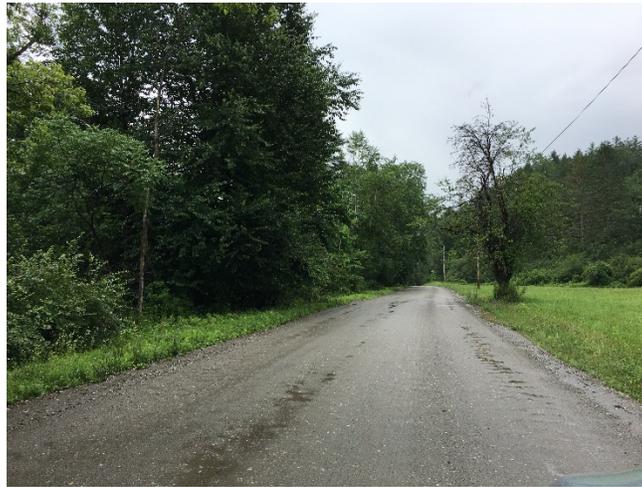
Figure 6: Location of Waterbury Test Section, Little River Rd.

The Town of Waterbury, in central Vermont, acquired 30 CY of RAS from Myers Recycling in Colchester. The Town mixed the RAS with 200 tons of gravel from Varens Gravel of Bolton resulting in an approximate 15% mix by volume, a lower percentage than recommended. This mix was used to resurface 900 ft of roadway on Little River Rd, (TH 7), location shown in Figure 6. The roadway has a uniform width of 24 ft, 5-6% crown, and a slope consistently between 0-3%. After the road was graded, approximately 150 gallons of calcium chloride was applied to the road surface.

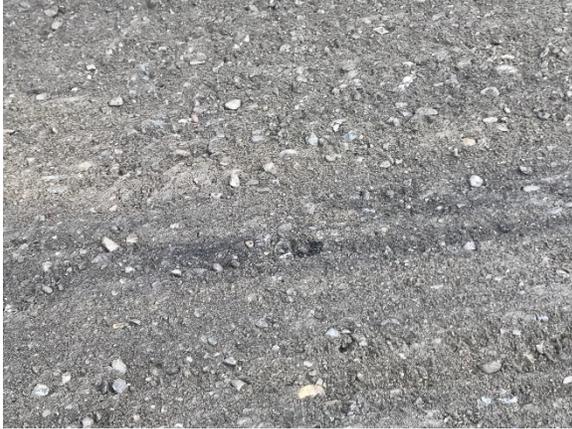
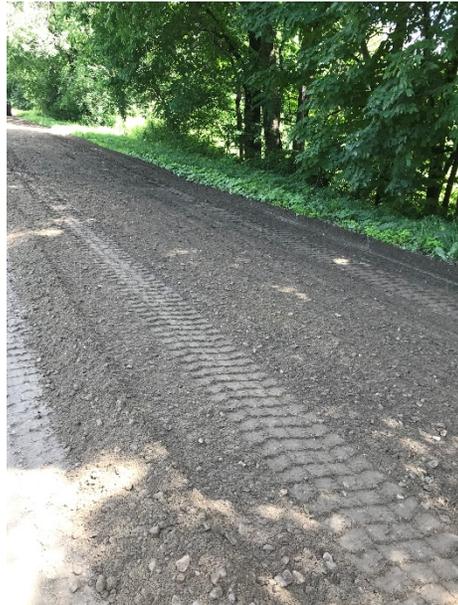
Figure 7: Waterbury Materials to be used in test section

The RAS used in the Waterbury test section had a few small agglomerations, some as large as 3" in diameter. Additionally, the gravel the Town's gravel source had some larger stones, mostly smooth river rocks along with a large quantity of fines. Photos of the material are available in Figure 7.

Waterbury 85/15 Gravel/RAS

RAS/Gravel mix

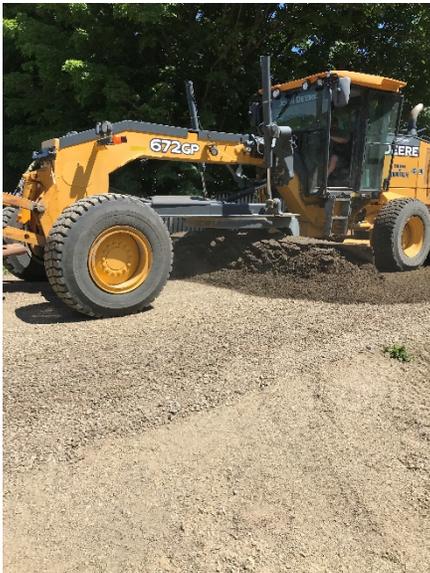
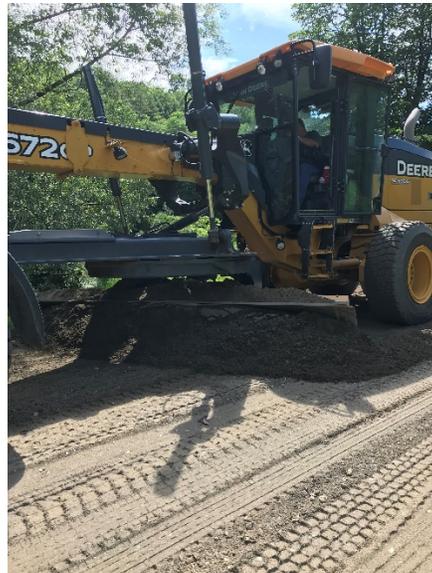
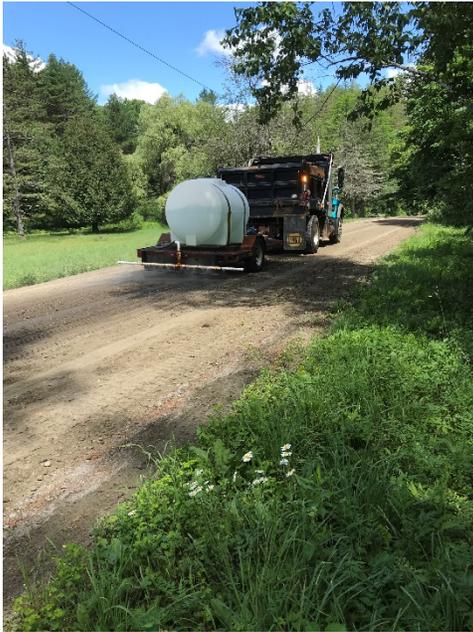
Figure 8: Test Section Construction

Resurfacing of the road followed standard procedures used by the Town. Gravel was mixed with RAS onsite near the parking lot on Woodard Hill Rd and deposited on the road with a dump truck. A Town grader was used to spread and grade the RAS/gravel with a crown, but no roller was used for compaction. Construction took place on June 30, 2020. The resurfacing process can be seen in Figure 8.

Grader shaping of existing roadway materials

Grader spreading

Chloride application

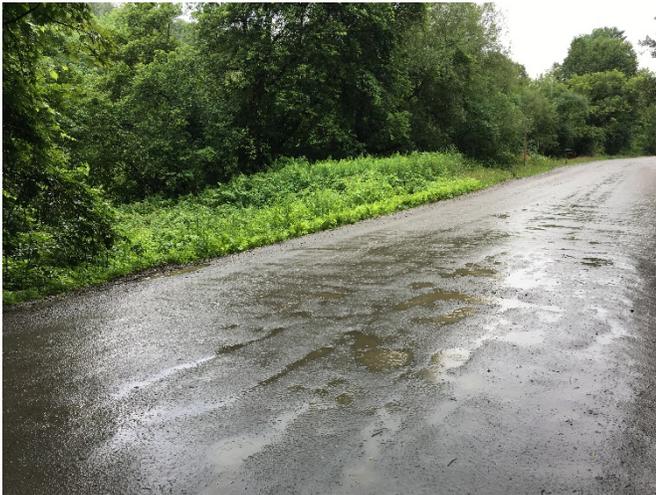
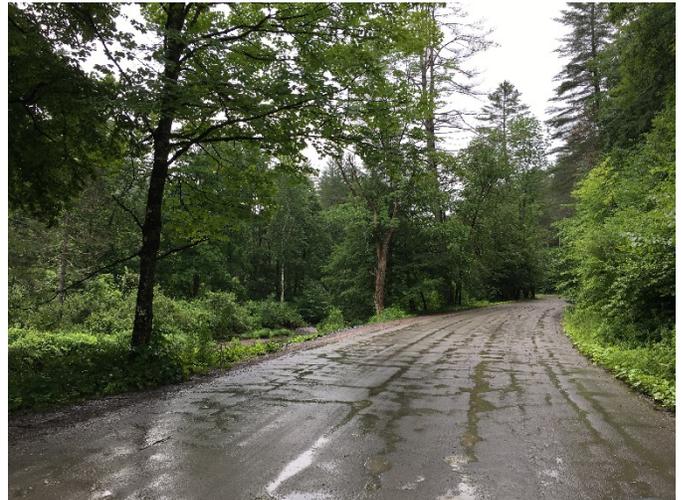
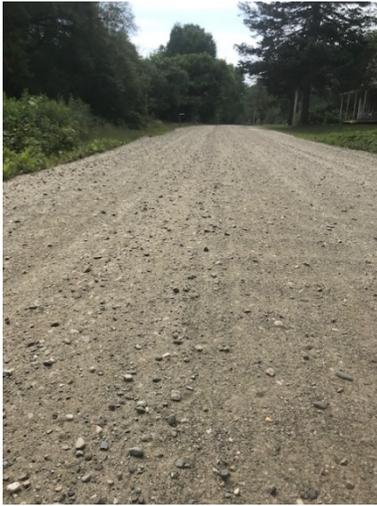
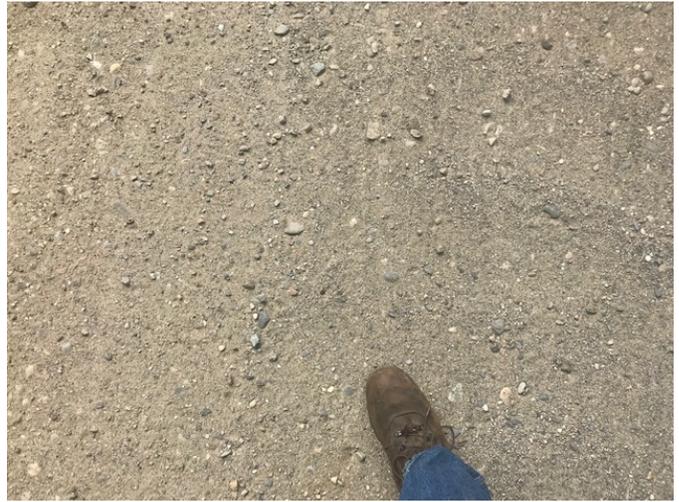
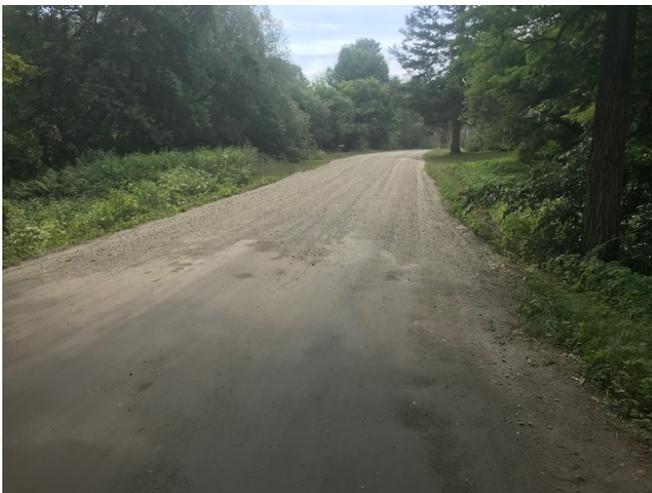
Figure 9: Failure of the RAS Test Section compared to the All-Gravel Control Section

Historically the Town has had drainage, washboarding, and potholing problems with Little River Road. Initially, the installation of RAS/gravel did not lessen any of those problems, potentially because of the low percentage of RAS in the mix. After installation and several rain events the RAS/gravel section of the road is very loose with many stones rose to the surface. There are the beginnings of washboarding and there was a lot of airborne dust when traffic went past. Photos of the roadway during a site visits on July 14, 2020 and July 24, 2020, respectively, are shown in Figure 9. However, by early August the Town regraded the RAS/gravel section and reported a more homogeneous and cohesive surface.

Potholing on 7-14-20

Washboarding on 7-14-20

Washboarding on 7-24-20

Loose Gravel on Surface on 7-24-20

Gravel vs. RAS section on 7-24-20

The Waterbury site showed significant deterioration two weeks after construction, likely because the larger aggregates in the gravel were prevented from binding because of the low RAS content. Another contributing factor is the poor drainage of the road that has historically led to the road surface condition issues. The Cornwall/Shoreham site shows slight segregation of larger gravel which floated to the top of the road surface, but otherwise the road is in good condition. The Waltham road shows no significant deterioration. Further inspections will take place in early spring to determine the surface condition in Cornwall/Shoreham, Waterbury, and Waltham after one winter of exposure.

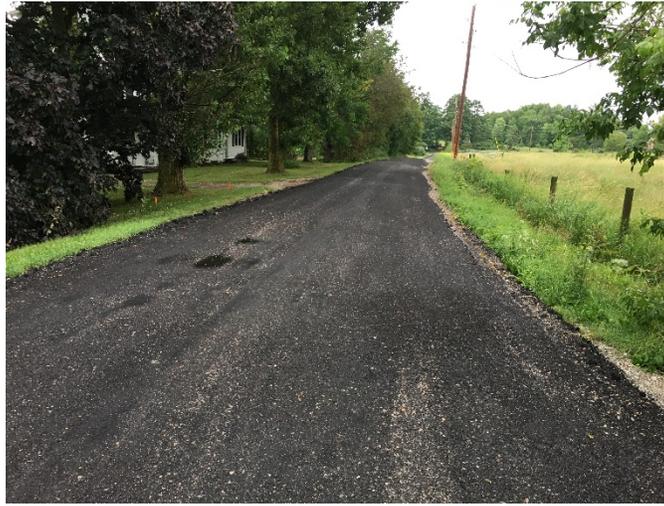
Figure 11: Location of Waltham Test Section, Burnham Rd.

The Town of Waltham, in central Vermont, acquired 42 tons of RAS from Myers Recycling in Colchester. The town placed 136 tons of gravel on Burnham Rd, (TH 4), using a dump truck and deposited 42 tons of RAS with a dump truck on top of the gravel resulting in a 24% mix by weight. This mix was used to resurface 815 ft of roadway in the location shown in Figure 10. The roadway has a uniform width of 16 ft, 3-4% crown, and a slope consistently between 0-3%.

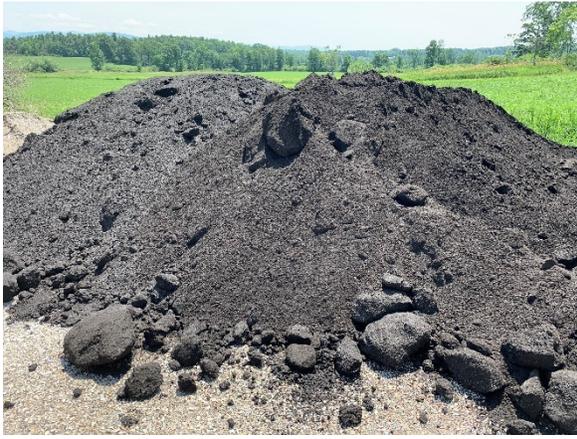
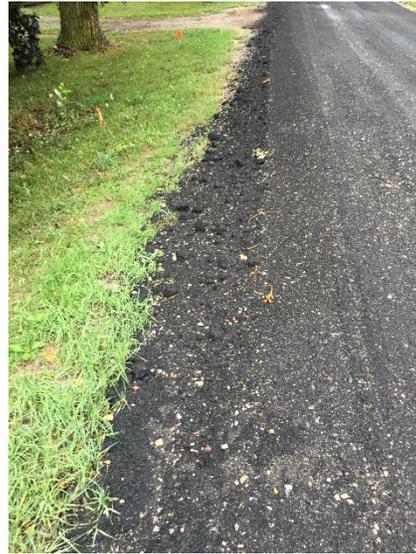
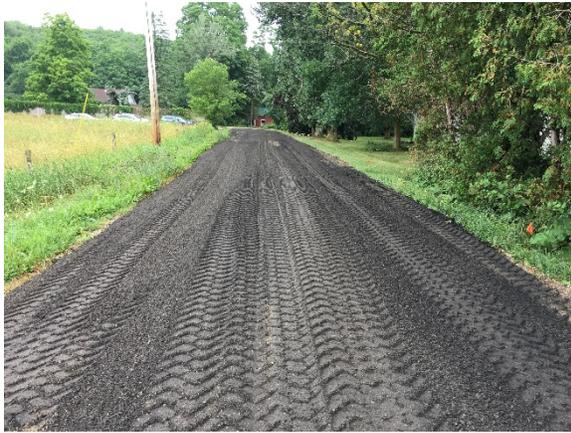
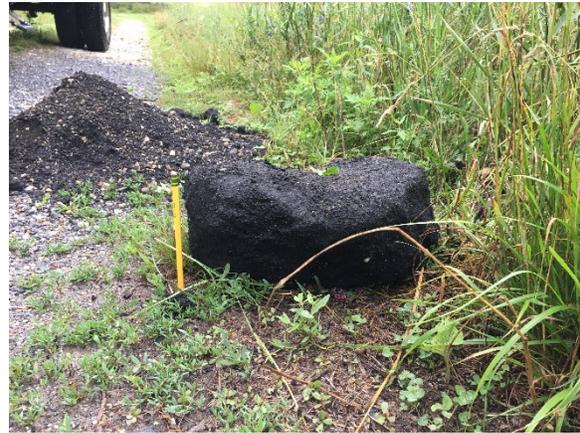
Figure 12: Waltham Materials to be used in test section

The RAS used in the Waltham test section had large agglomerations, some as large as 1' in diameter that were very difficult to break down. To break up the clumps they were driven over with a front end loader multiple times. Photos of the material are available in Figure 12.

Waltham RAS pile

RAS Clumps

Waltham 76/24 Gravel/RAS

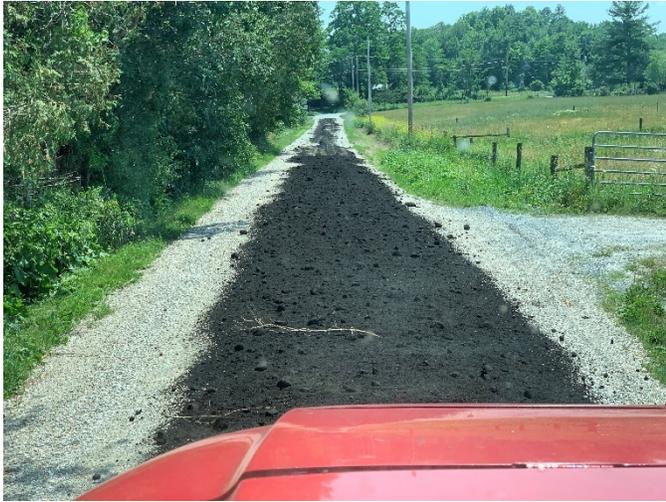
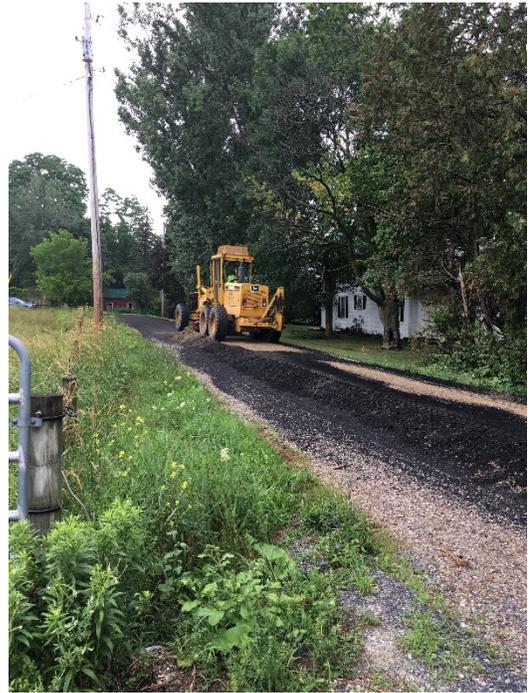
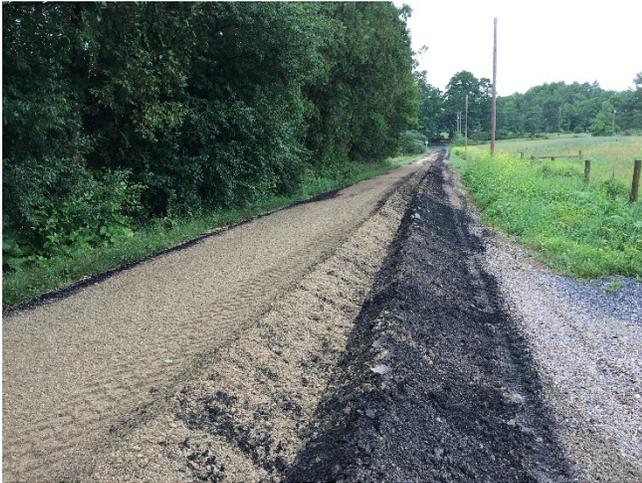
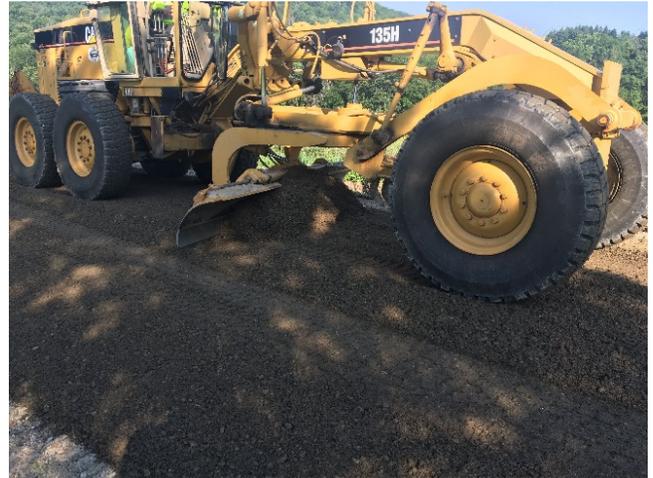
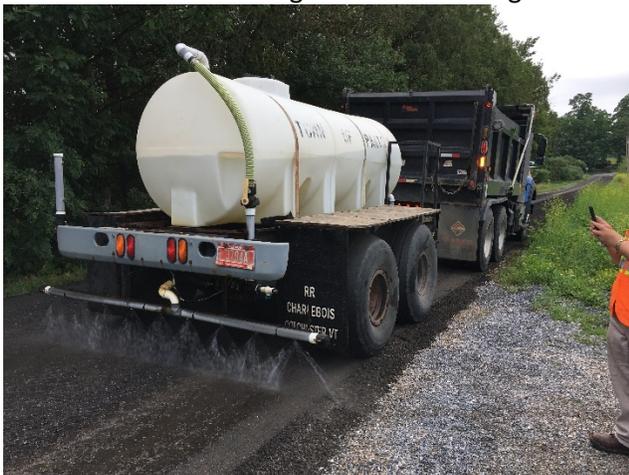
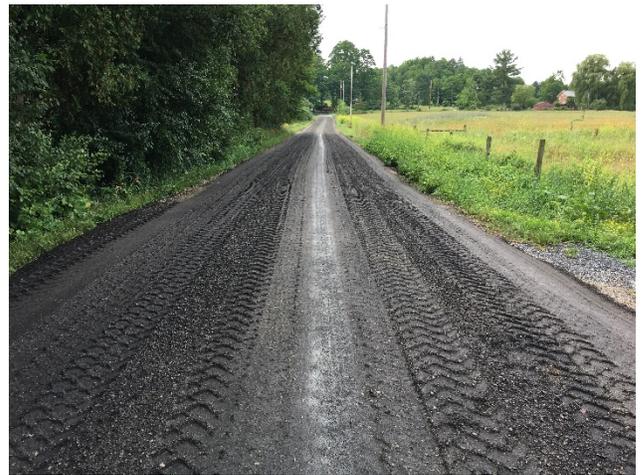
Figure 13: Test Section Construction

Resurfacing of the road followed typical procedures used by the Town of Panton and suggested to the Town of Waltham's Public Works General Contractor. In early June 2020, 4-6 inches of new gravel was placed on Burnham Road, and four weeks after that the gravel was overlain by two inches of RAS. Two weeks afterwards, on July 14, 2020, the RAS and gravel were blended in situ. As the Town of Waltham possesses no equipment, the Town of Panton was on-site to mix the gravel and RAS in situ, and then grade the road. After the RAS/gravel was graded, the surface was sprayed with 600 gallons of calcium chloride. This technique was different than both the other 2020 projects. However, this technique was used for the Panton project in 2019 and was suggested by the Town of Panton to the Town of Waltham. The resurfacing process can be seen in Figure 13.

Depositing RAS over Gravel

Grader Mixing RAS and Gravel

Material Mixing and Road Grading

Road Grading

Chloride Application

Final Product

The Town of Waltham reports good working condition of the road surface. The Town has said that the road looks great and the surface has tightened up nicely. As of July 31, 2020 there had been no additional work done on the road surface.

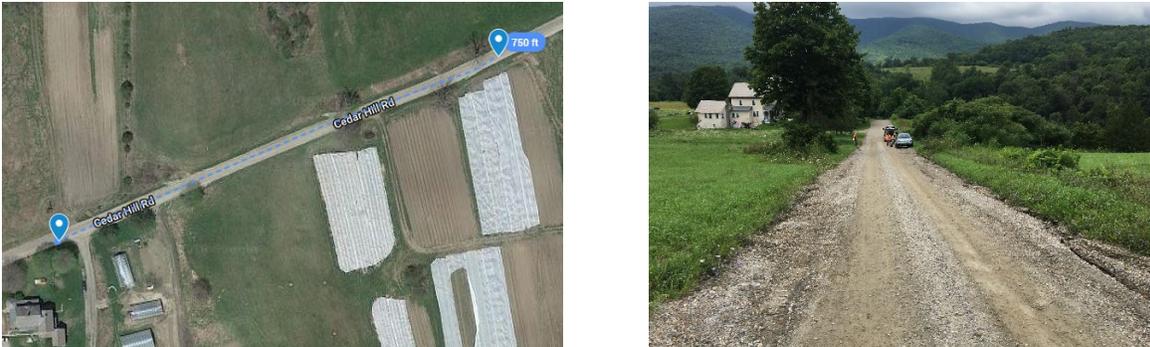
Figure 15: Location of Pownal Test Section, Cedar Hill Rd.

The Town of Pownal, in southwestern Vermont, was sent 64 tons of RAS from Myers Recycling in Colchester in 2018. The Town mixed the RAS with their own gravel, at approximately 22-25% by volume, and used it to resurface 750 ft of Cedar Hill Rd, (TH 28), the location shown in Figure 15. The roadway has a uniform width of 19 ft, 5-6% crown, a slope consistently between 10-15%, and at the time of the project, rill erosion on the roadway edges.

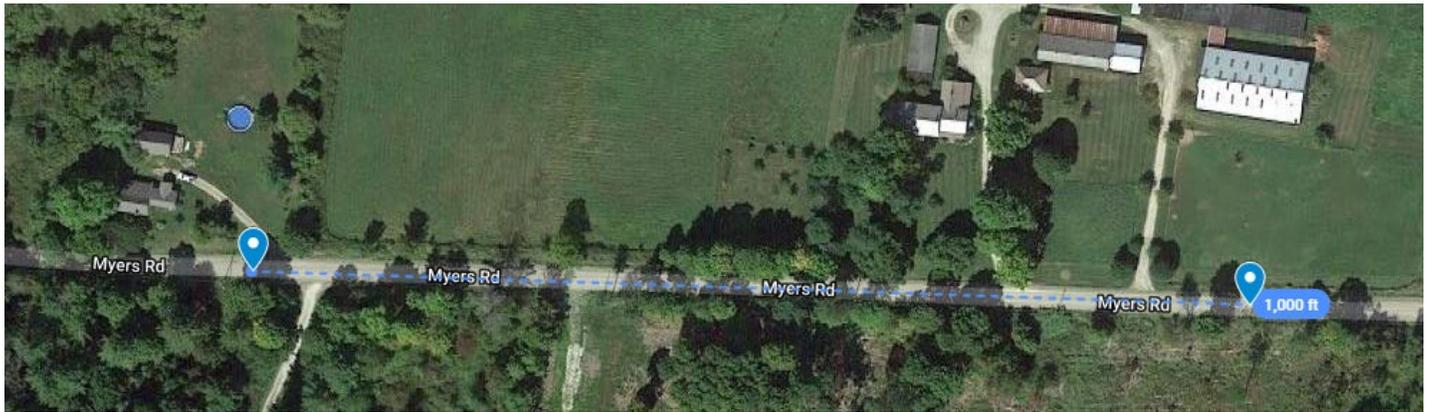
Figure 16: Shaftsbury Resurfacing location

The town of Shaftsbury, in southwest Vermont, was sent 64 tons of RAS from Myers Recycling in Colchester in 2018. The RAS was mixed at 20% by mass with gravel from William E. Dailey, Inc. (Peckham Industries subsidiary). The test section (Figure 8), located on Myers Rd, (TH 7), (unrelated to Myers Recycling) is approximately 1000 ft long, with a 600 ft section of between 6-7% grade, and a flat 400 ft section. The roadway is uniformly 20 ft wide. The existing roadway had a 3-4% crown, with several sections being noticeably flatter. Location of the roadway can be seen in Figure 16.

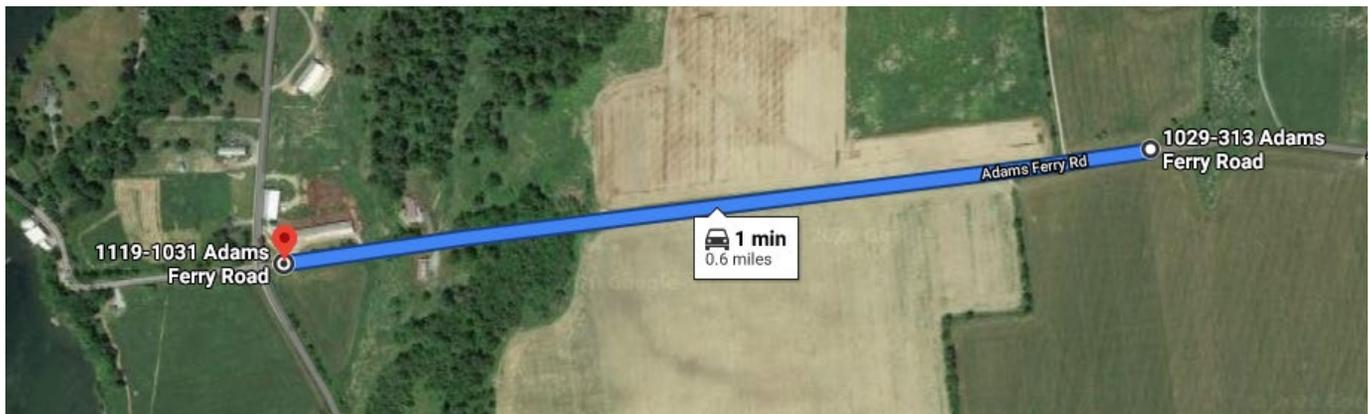
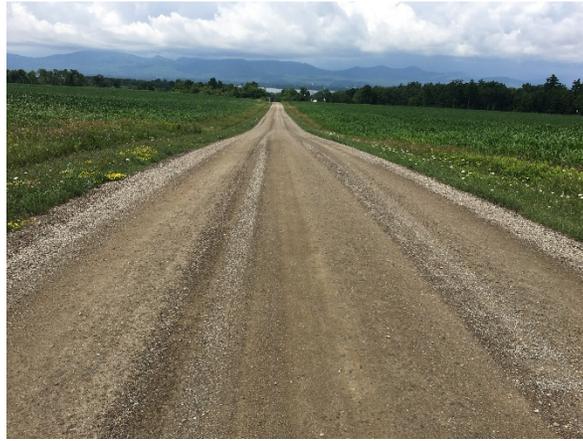
Figure 17: Location of Panton Test Section, Adams Ferry Rd.

The town of Panton, in southwestern Vermont, acquired RAS in 2019 which they mixed with gravel from Acker Excavating. The Town mixed the RAS with gravel at approximately 20% by volume and used it to resurface 1,000 ft of Adams Ferry Rd, (TH 3), location shown in Figure 16. The roadway has a uniform width of 23 ft, 5-6% crown and a slope consistently between 8-12%.
