Field Metalizing of a Steel Beam Bridge

HARDWICK VERMONT - VT RTE. 16 BR. 1

J. B. McCarthy, P. E.
VTrans Project Manager

2022 Hybrid Research and Innovation Symposium
September 14, 2022
Berlin, VT

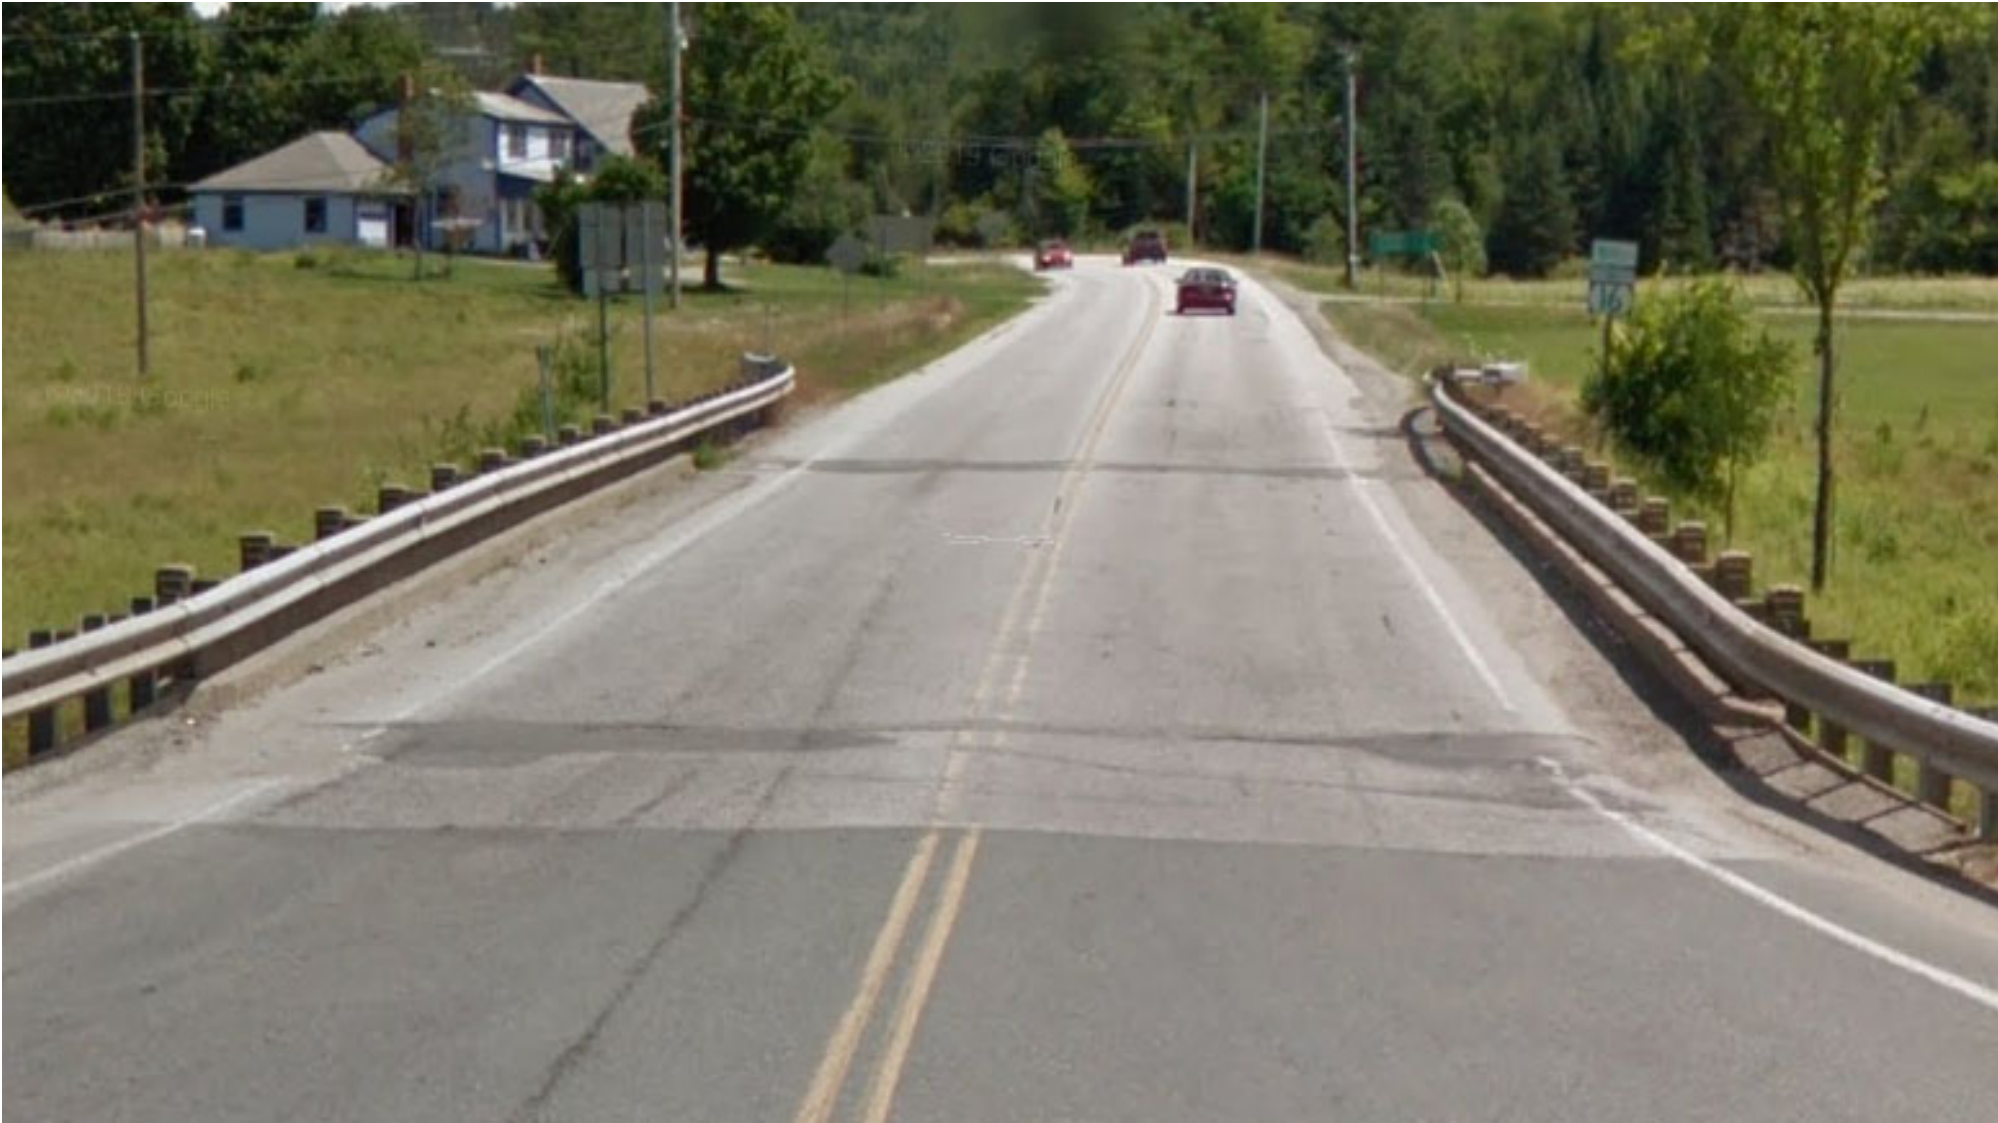
Looking North

Bridge provides a 3-12-12-3 Typical Section

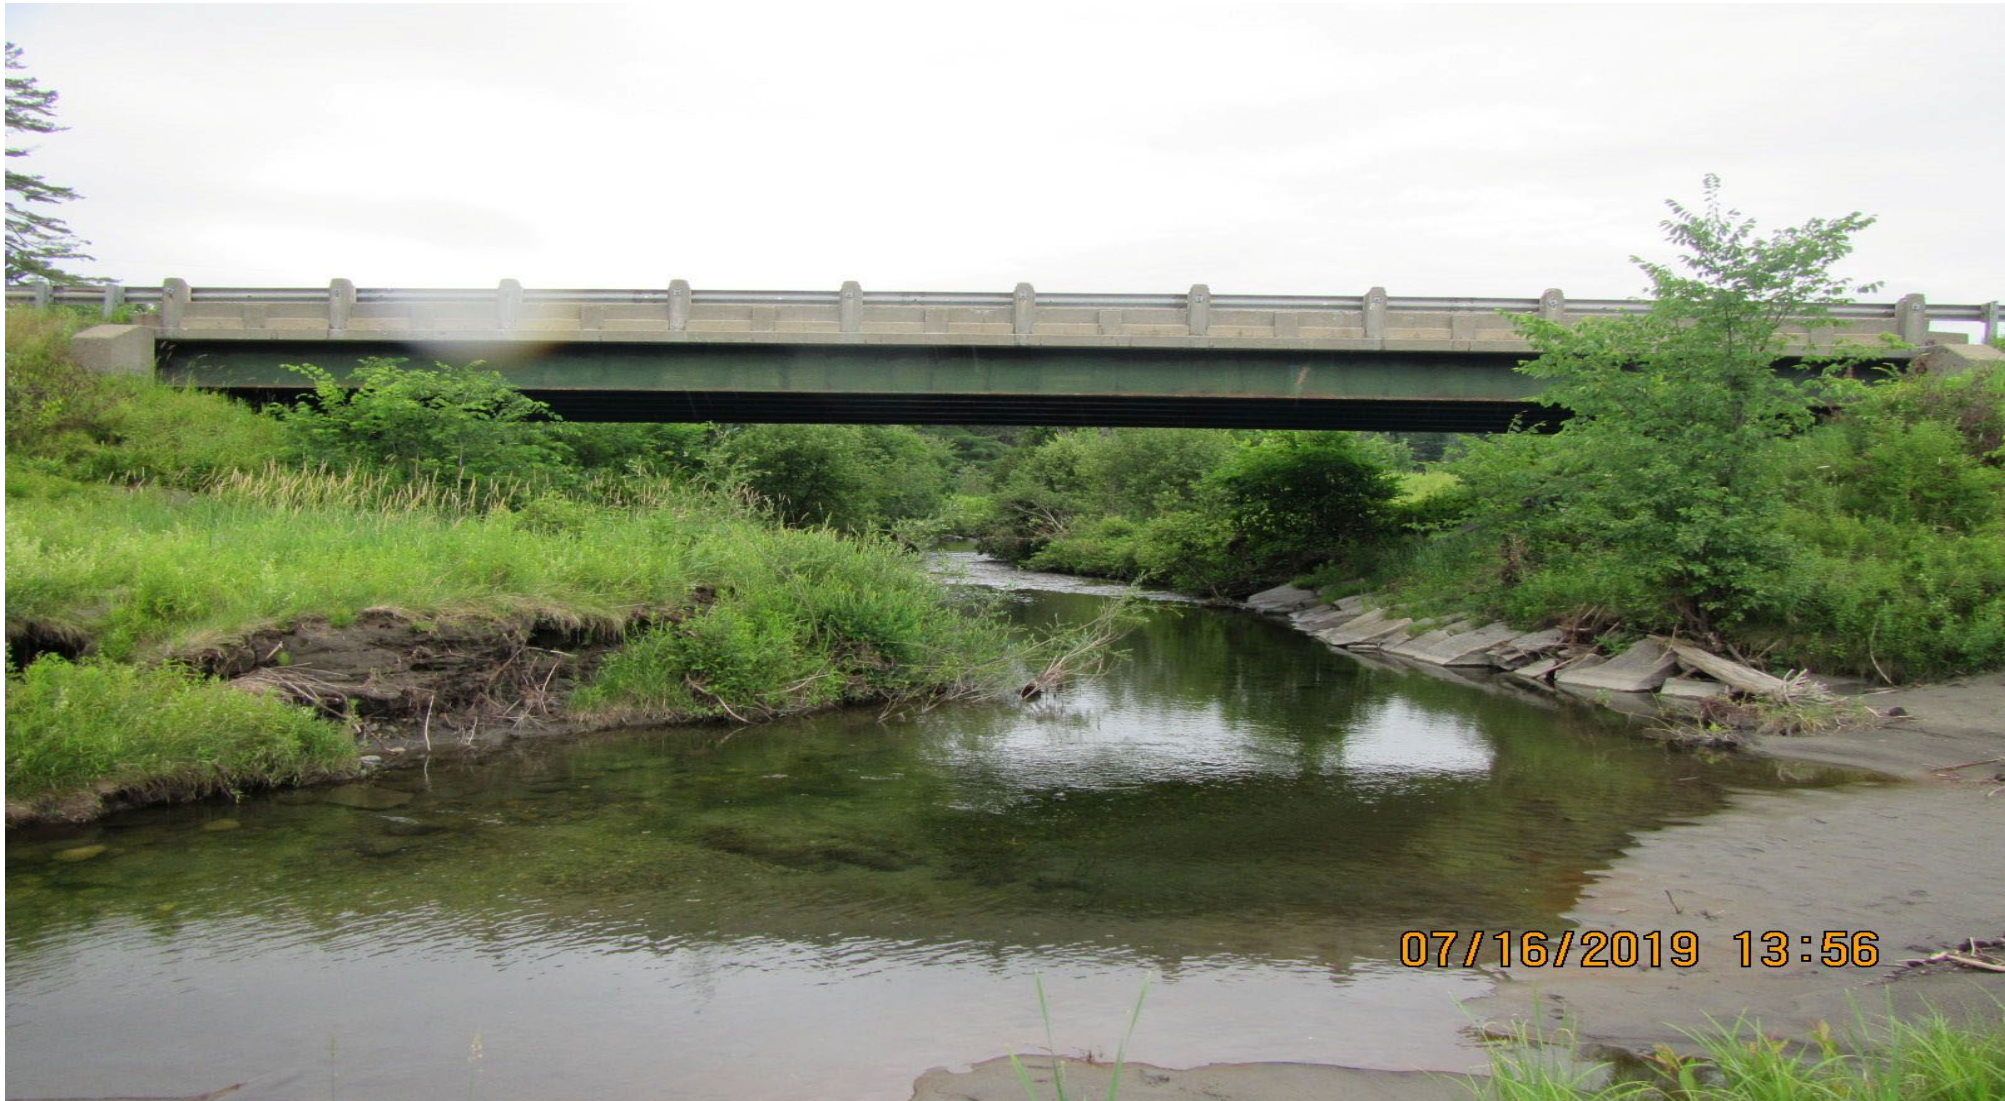
Elevation View

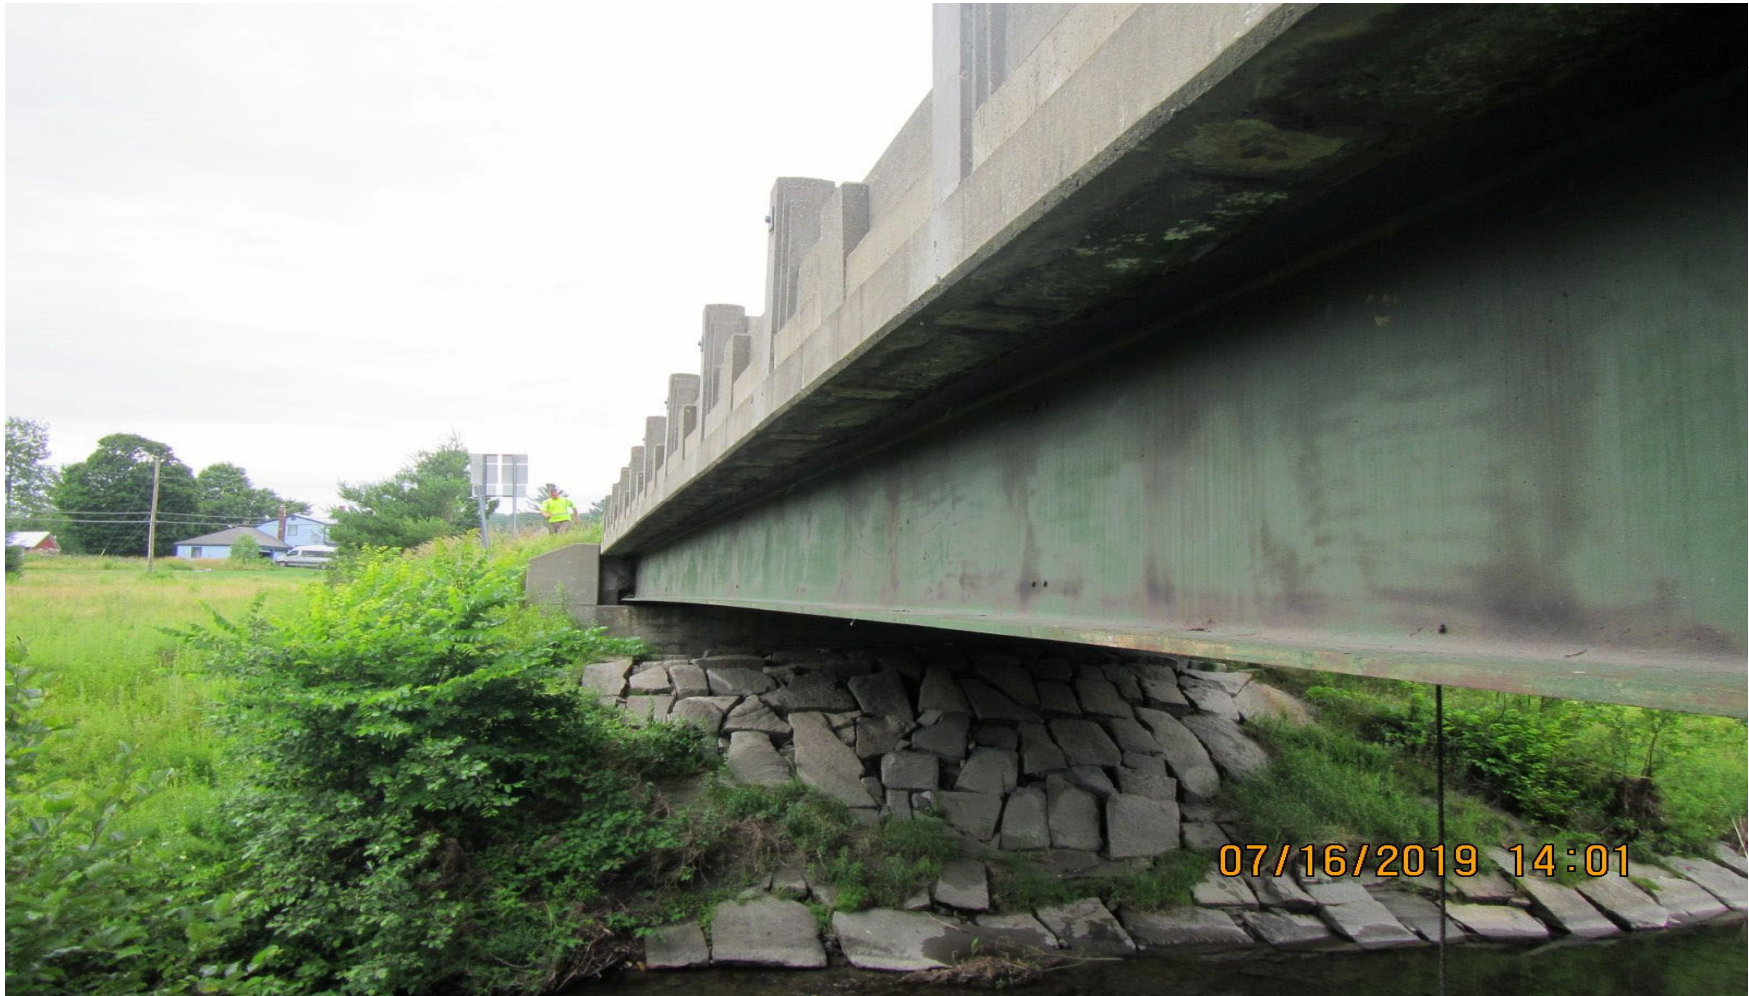
Fascia Beam

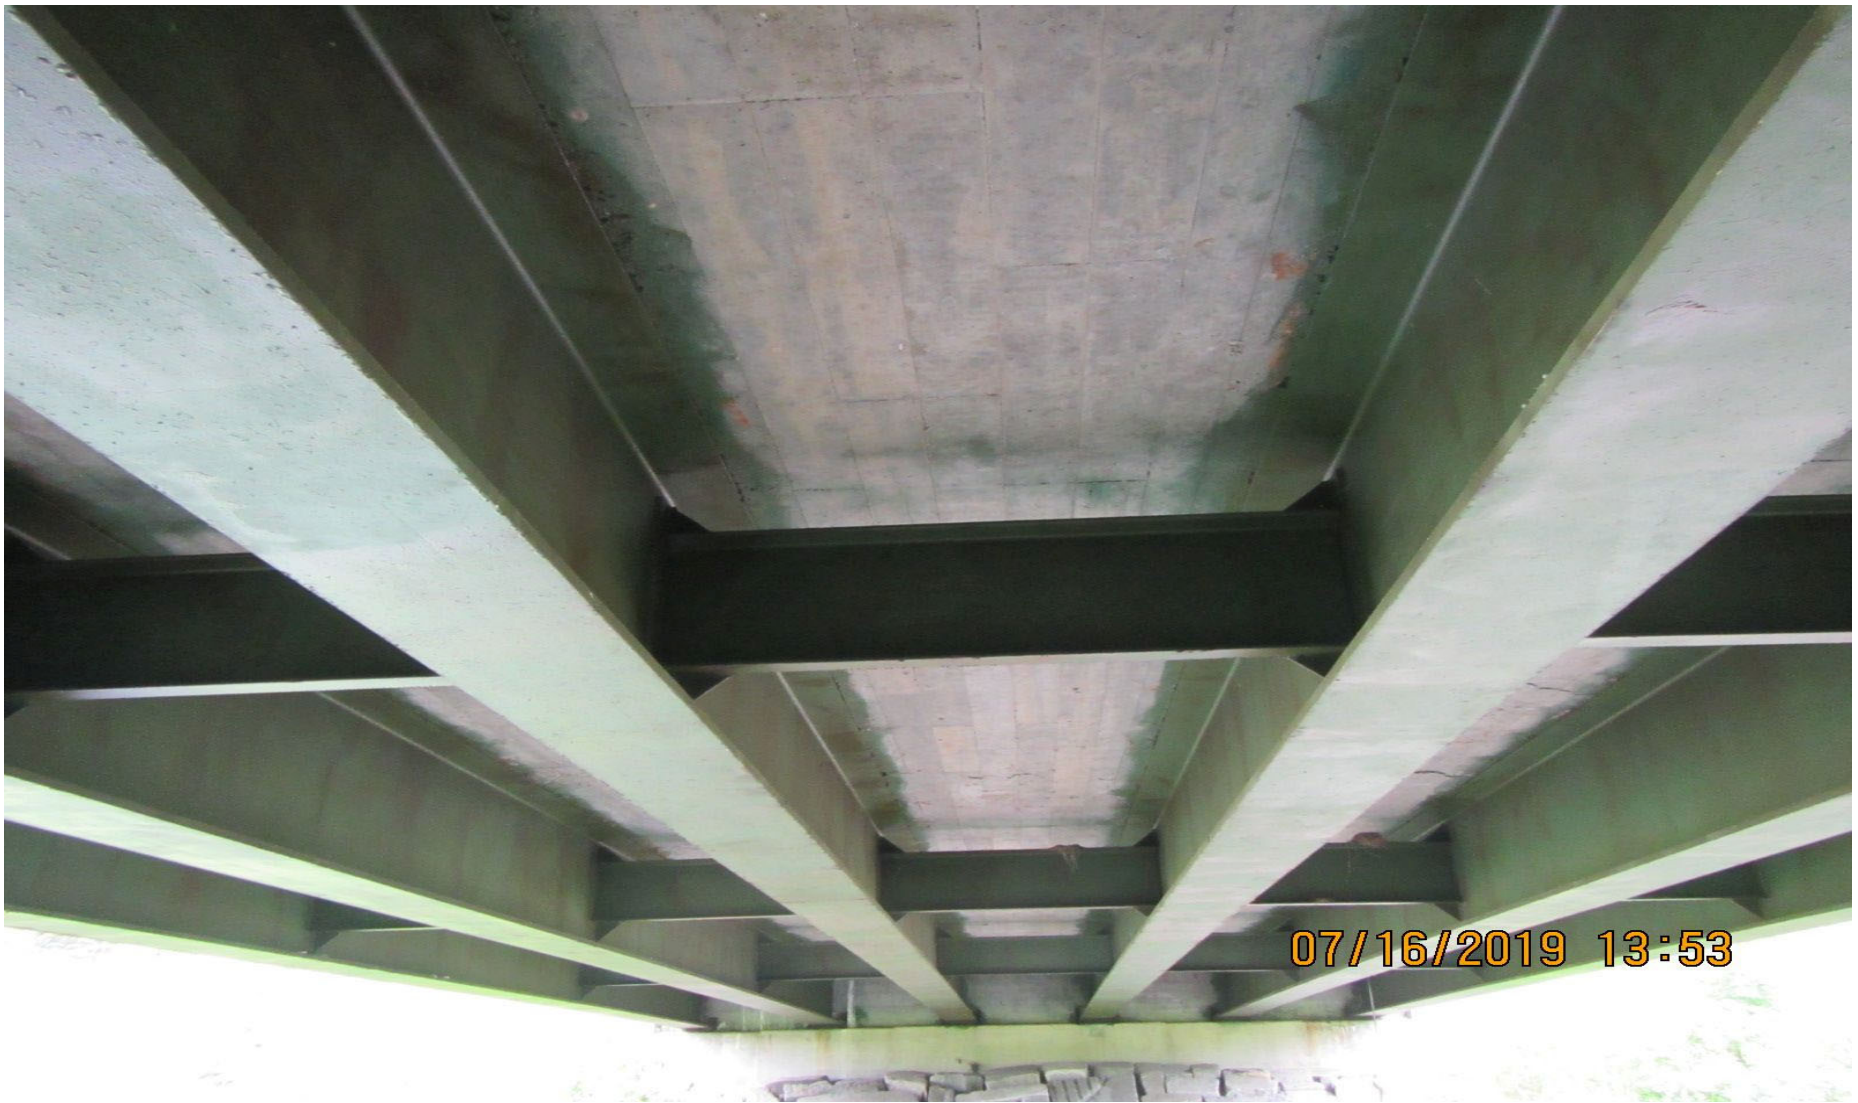
Interior Steel Beams

- 3 Coat Paint System applied in 1995
- Operations applied subsequent green grease coating

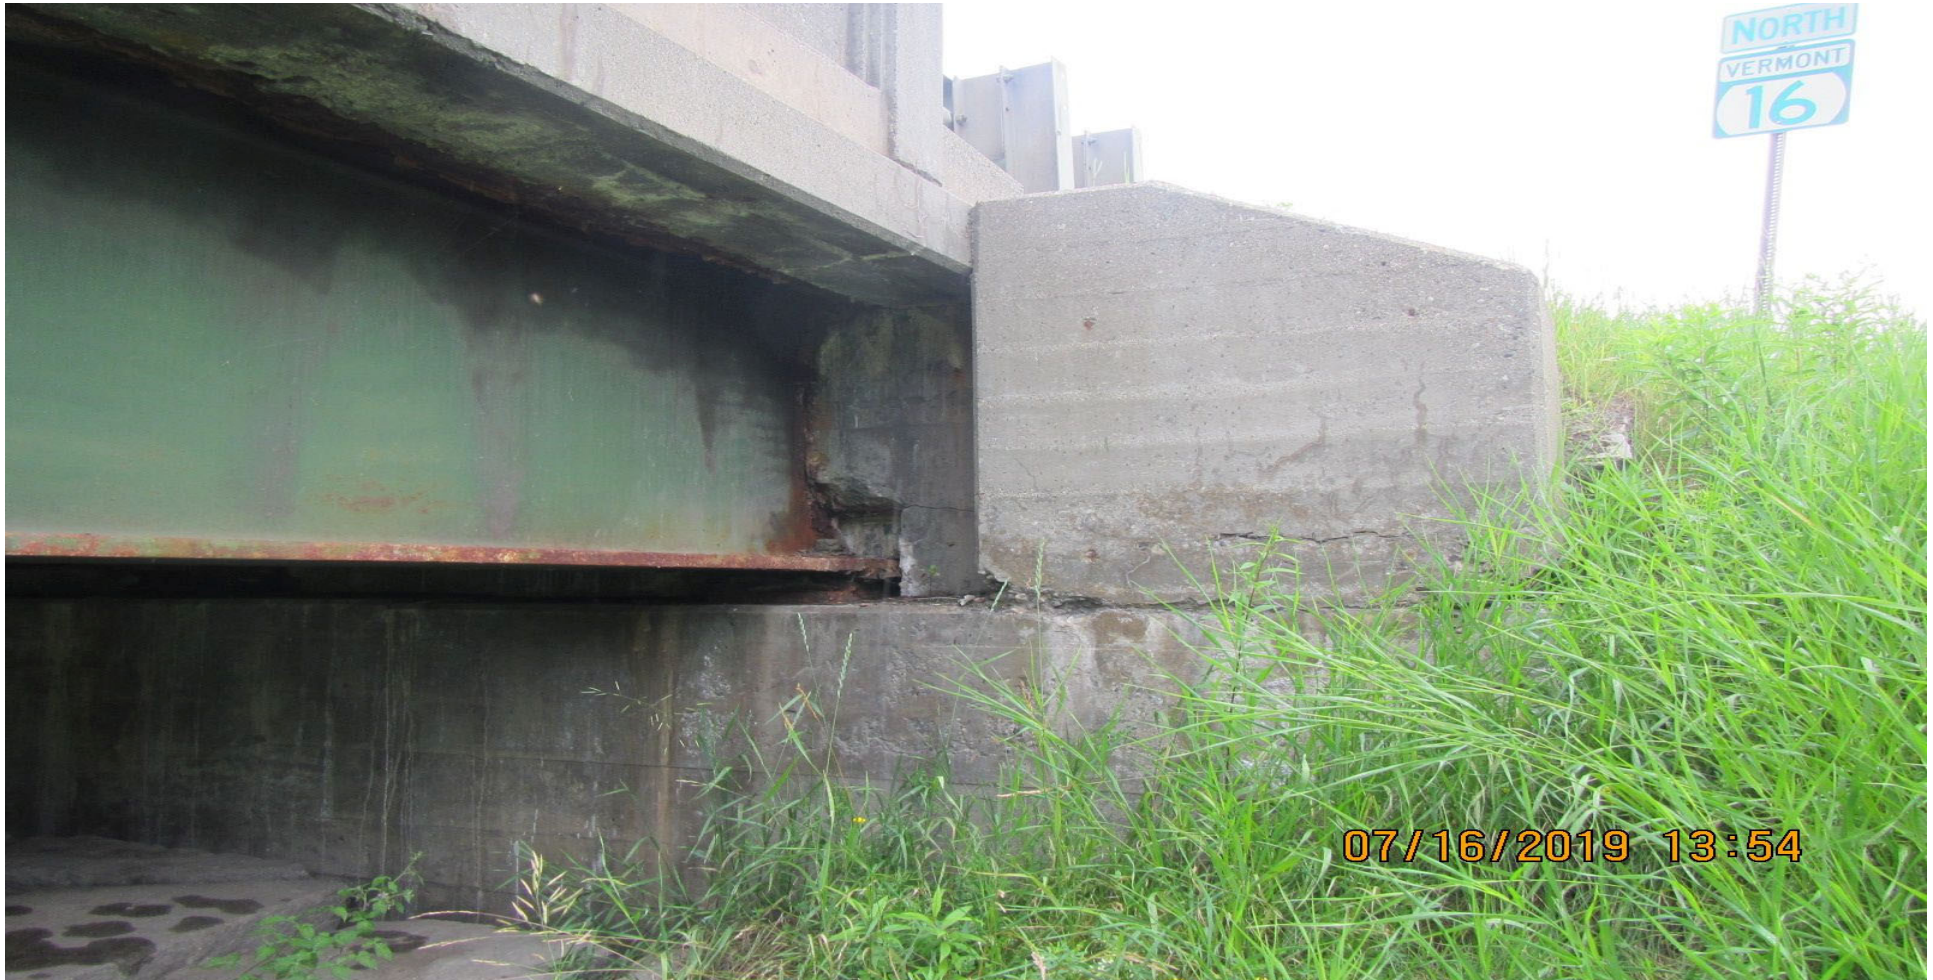
Paint System Deterioration

- Beam Ends and Bottom Flange
- No significant section loss to date

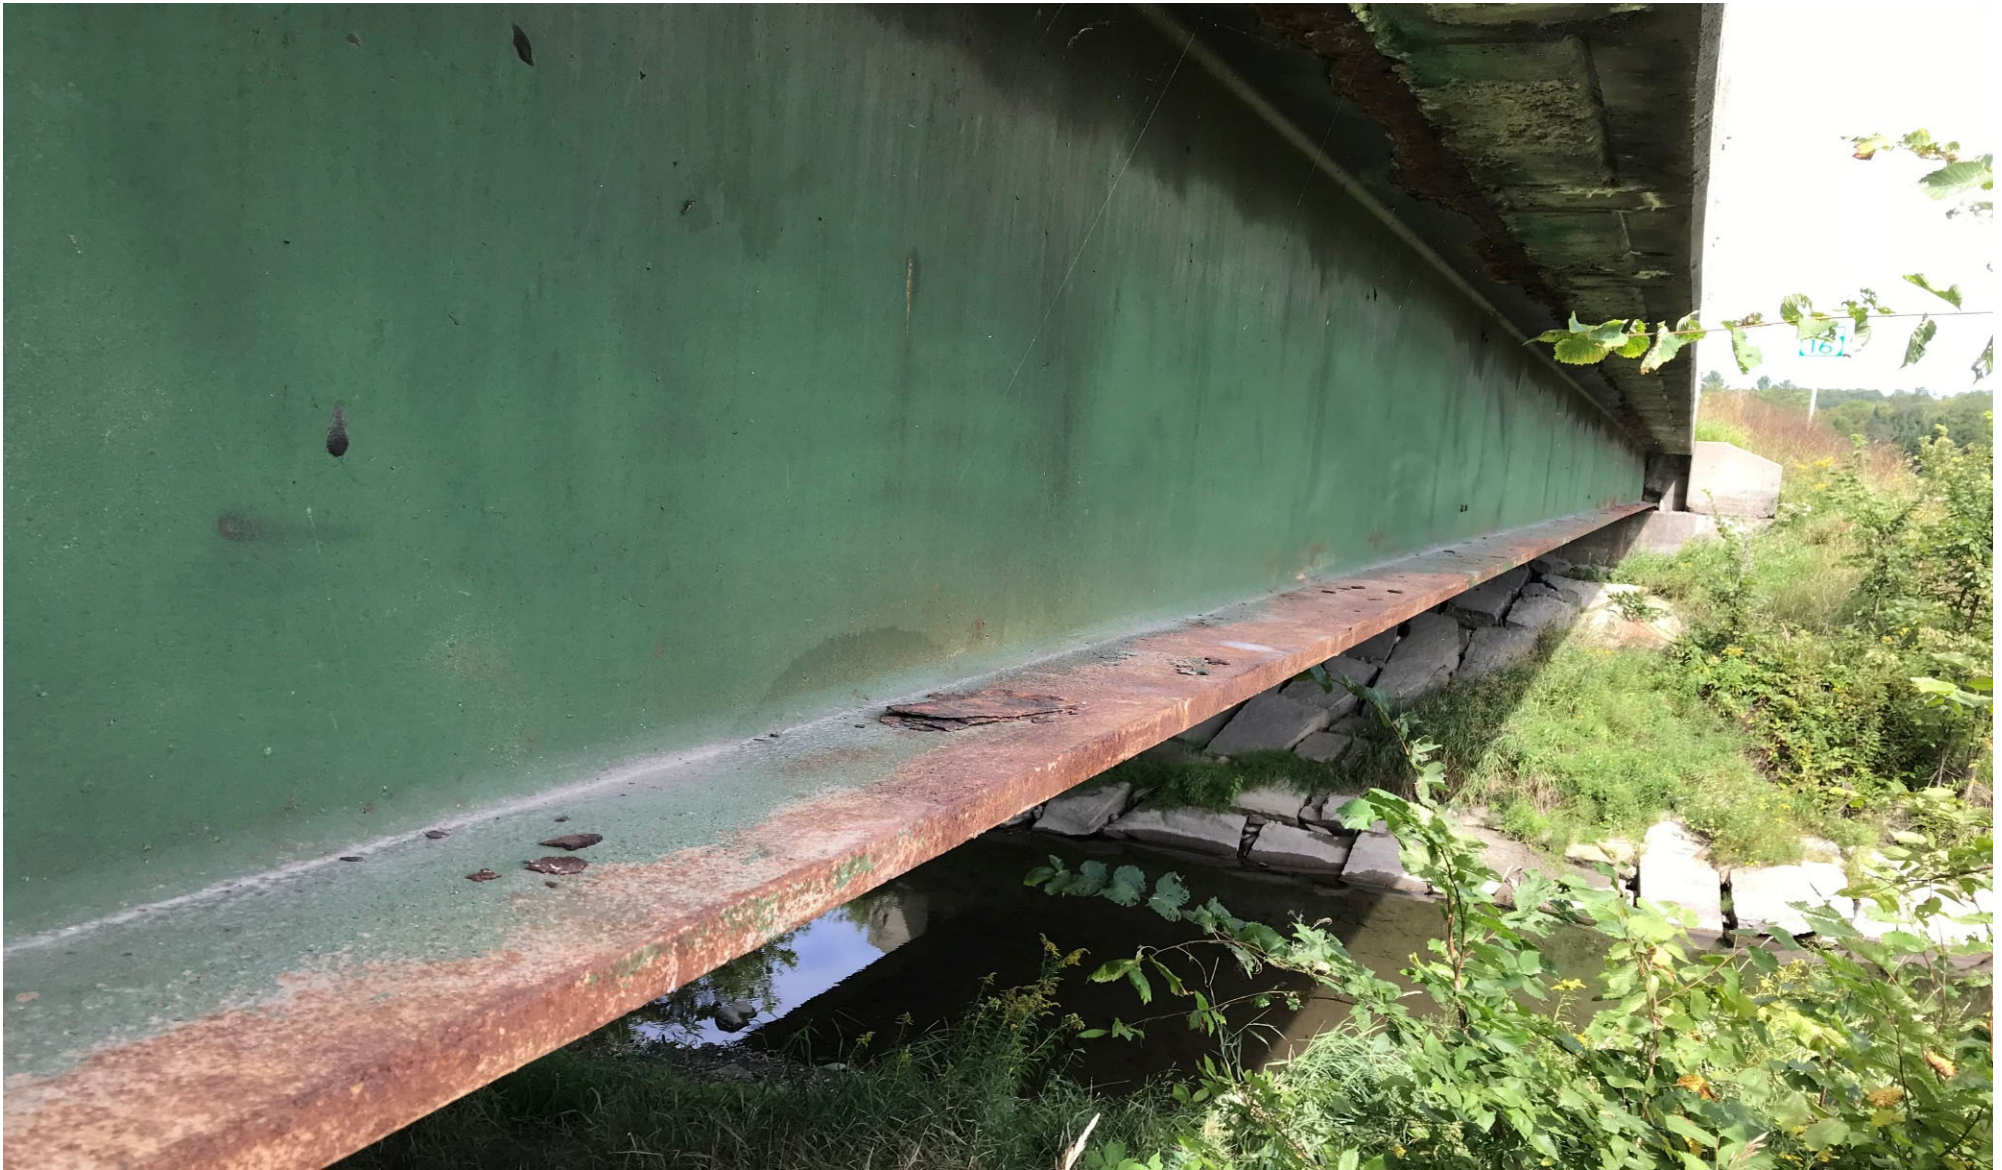
Loss of Paint System — Bottom Flange

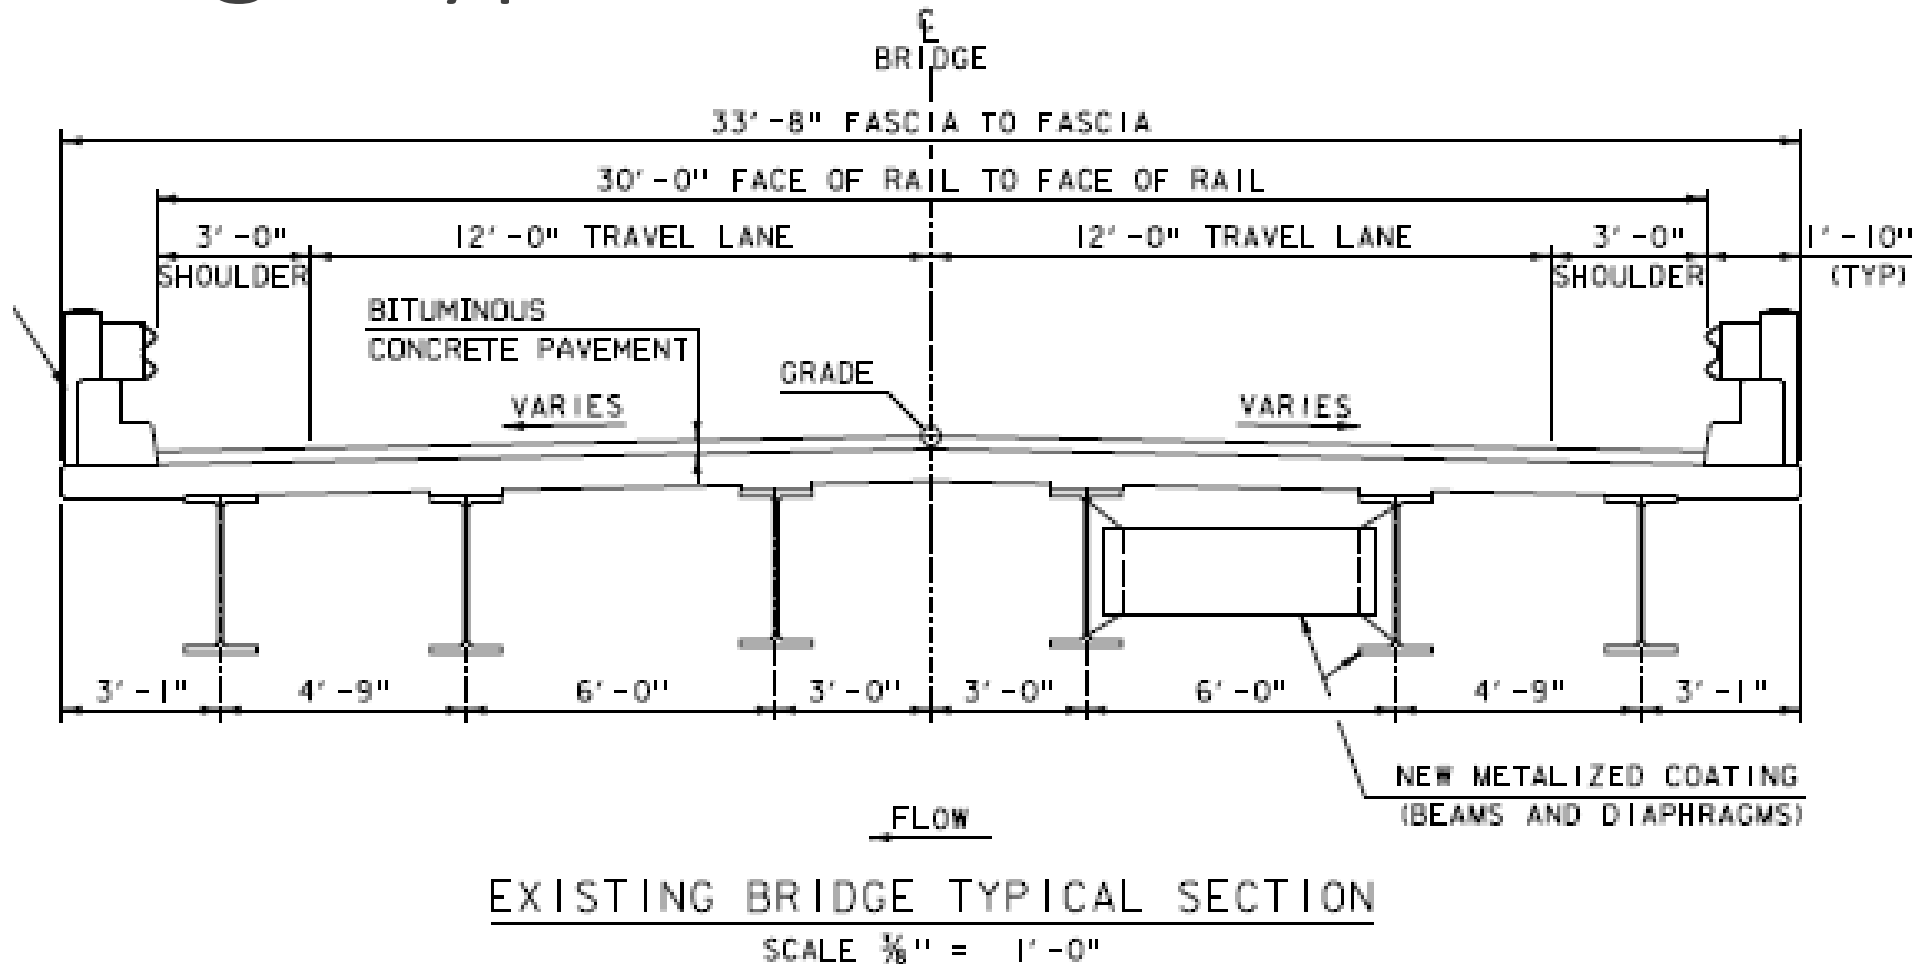
Bridge Typical Section

Span – 82 ft.

6 – 36WF280 Rolled Beams

15 - MC 18 x42.7 Diaphragms

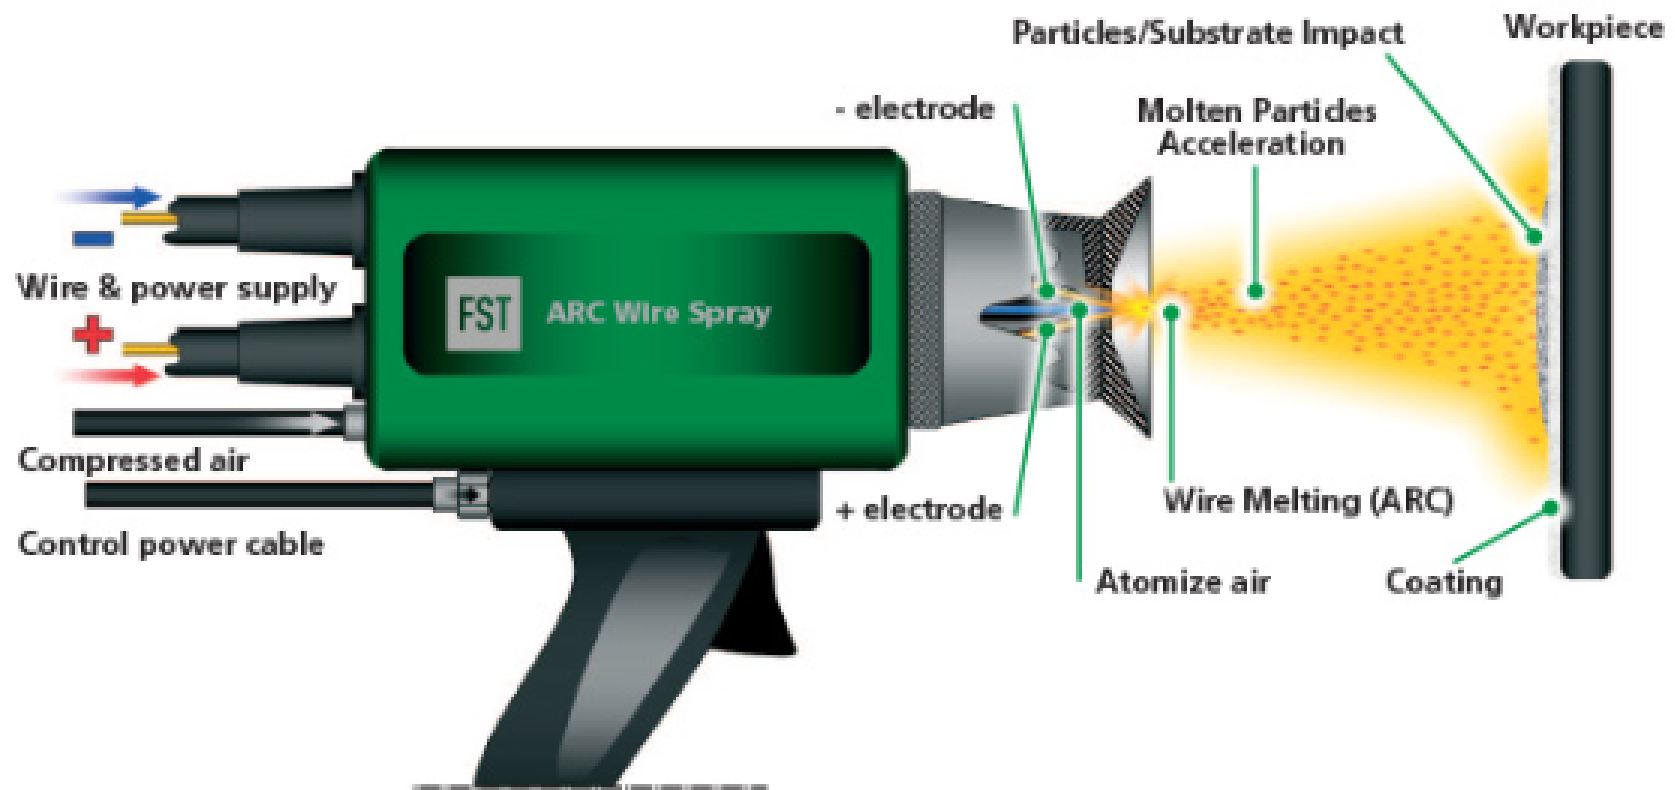
Metalizing Spray Gun

Metalizing is the process of thermal spraying molten zinc on a prepared abrasively blasted surface. Metalizing creates an impermeable, non-porous, abrasion resistant and well-bonded, corrosion resistant coating for steel.

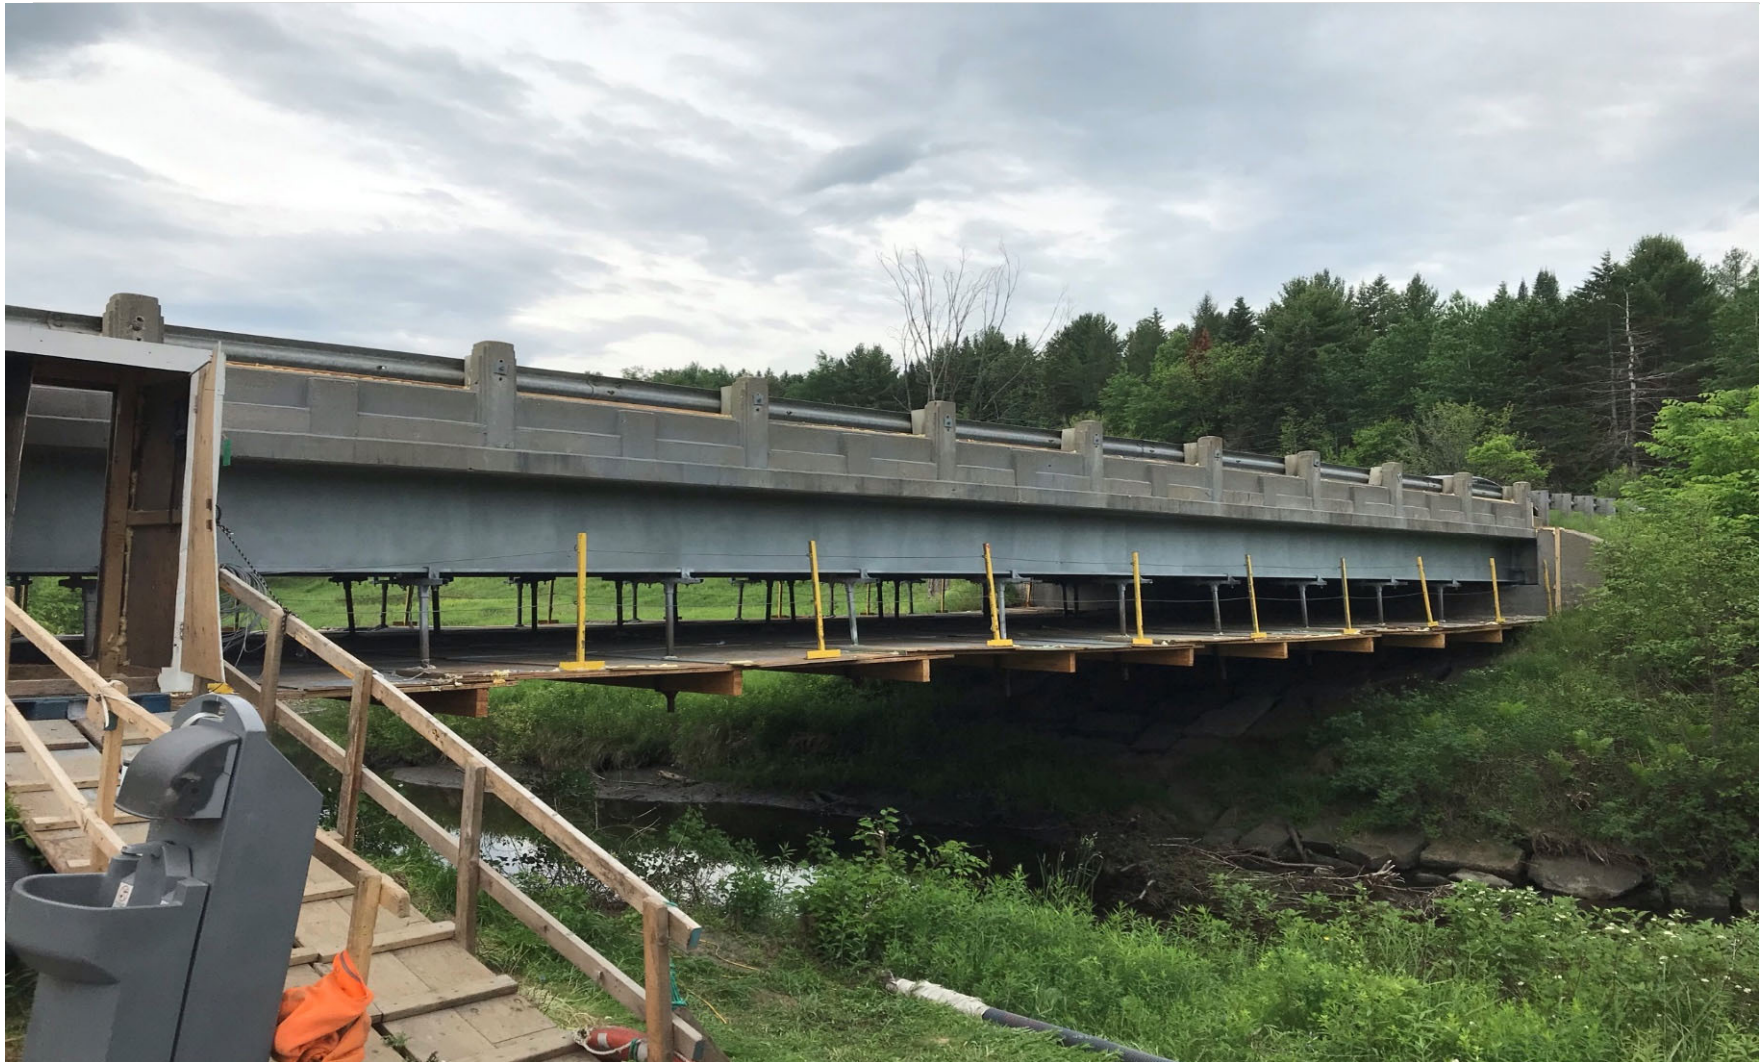
Work Platform hanging from bottom flange

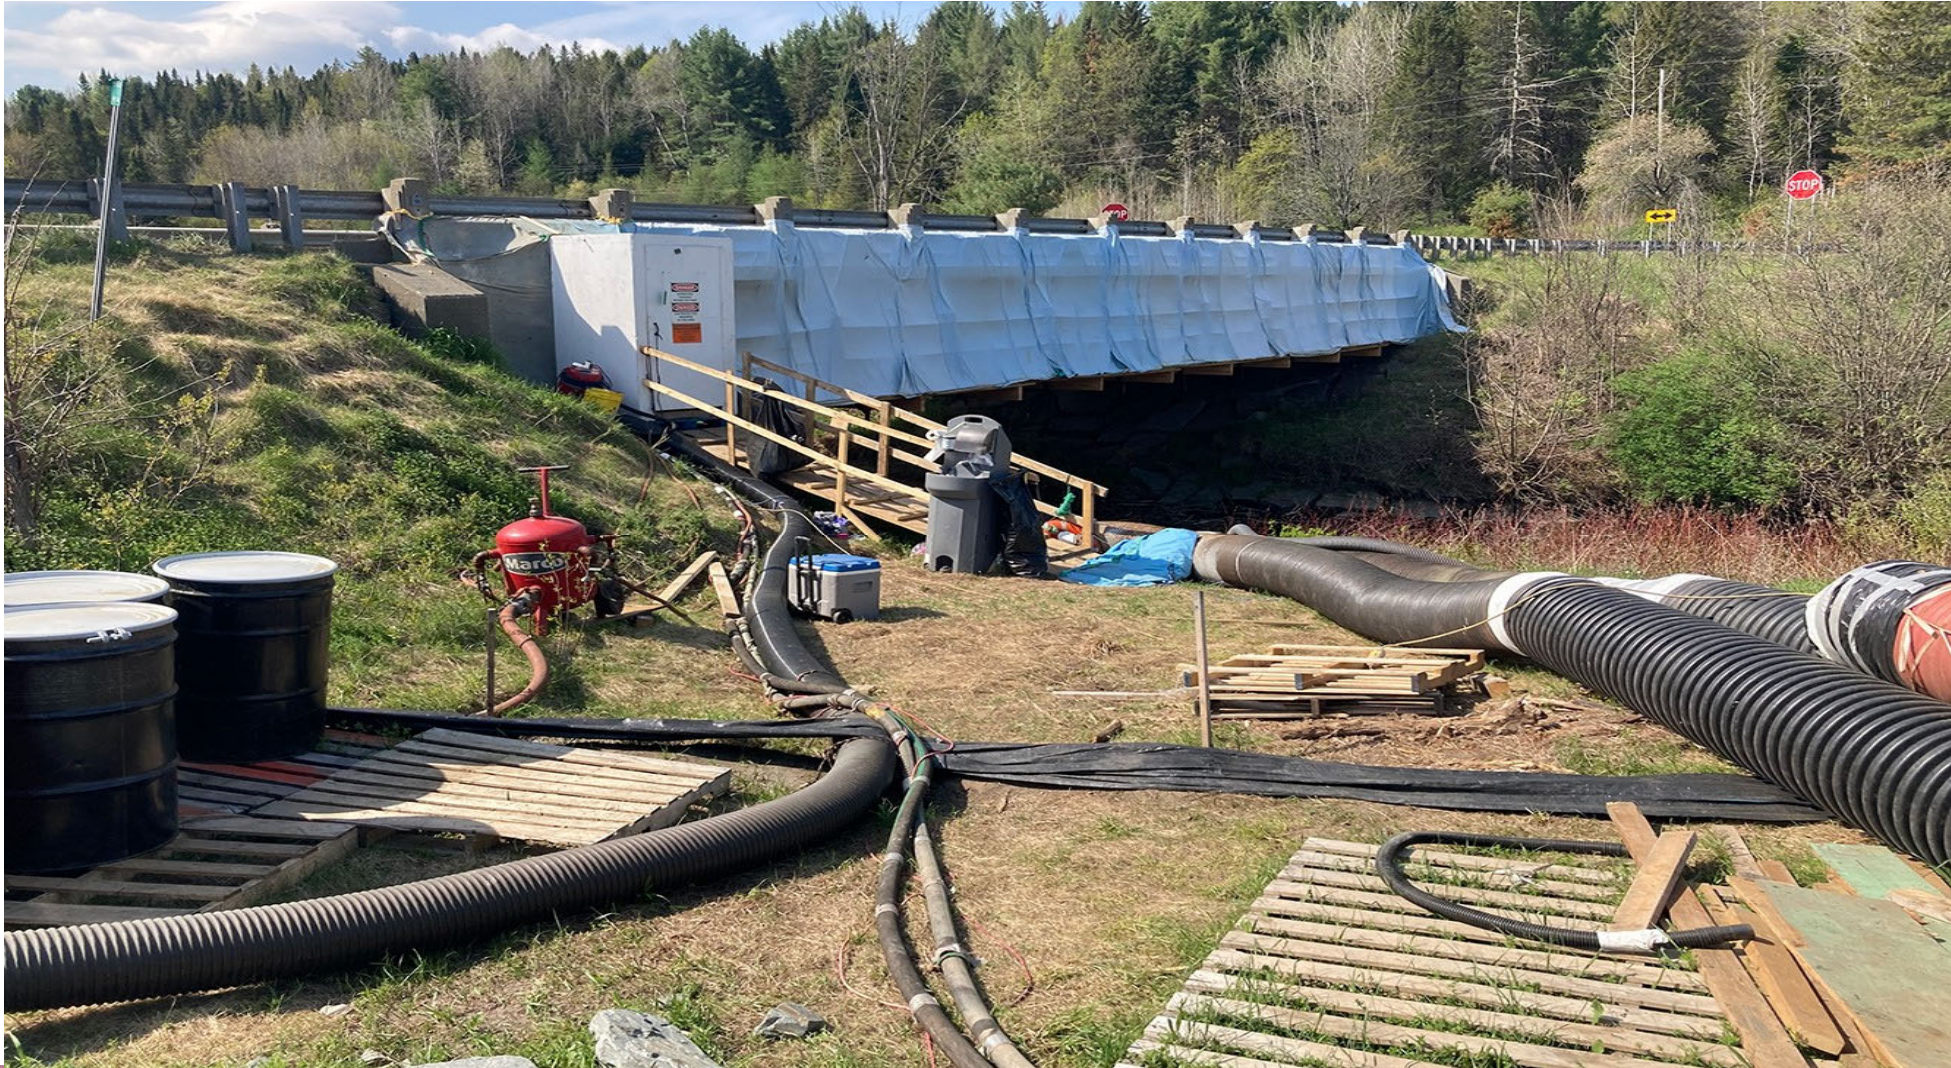
Enclosure completed with one access door

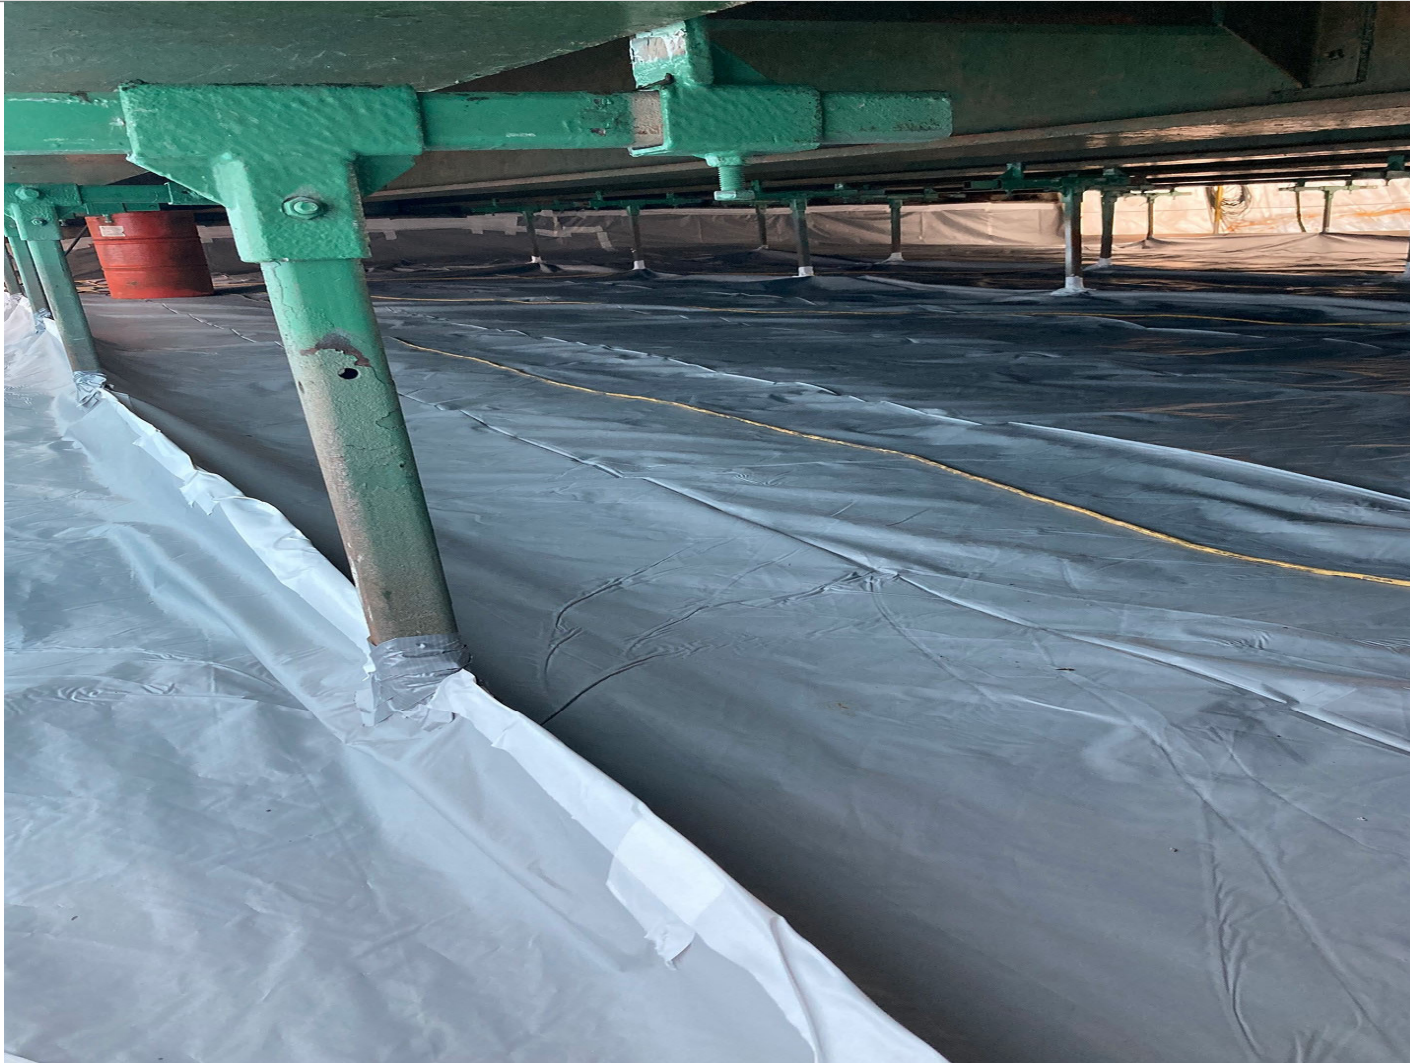
Hangers for work platform

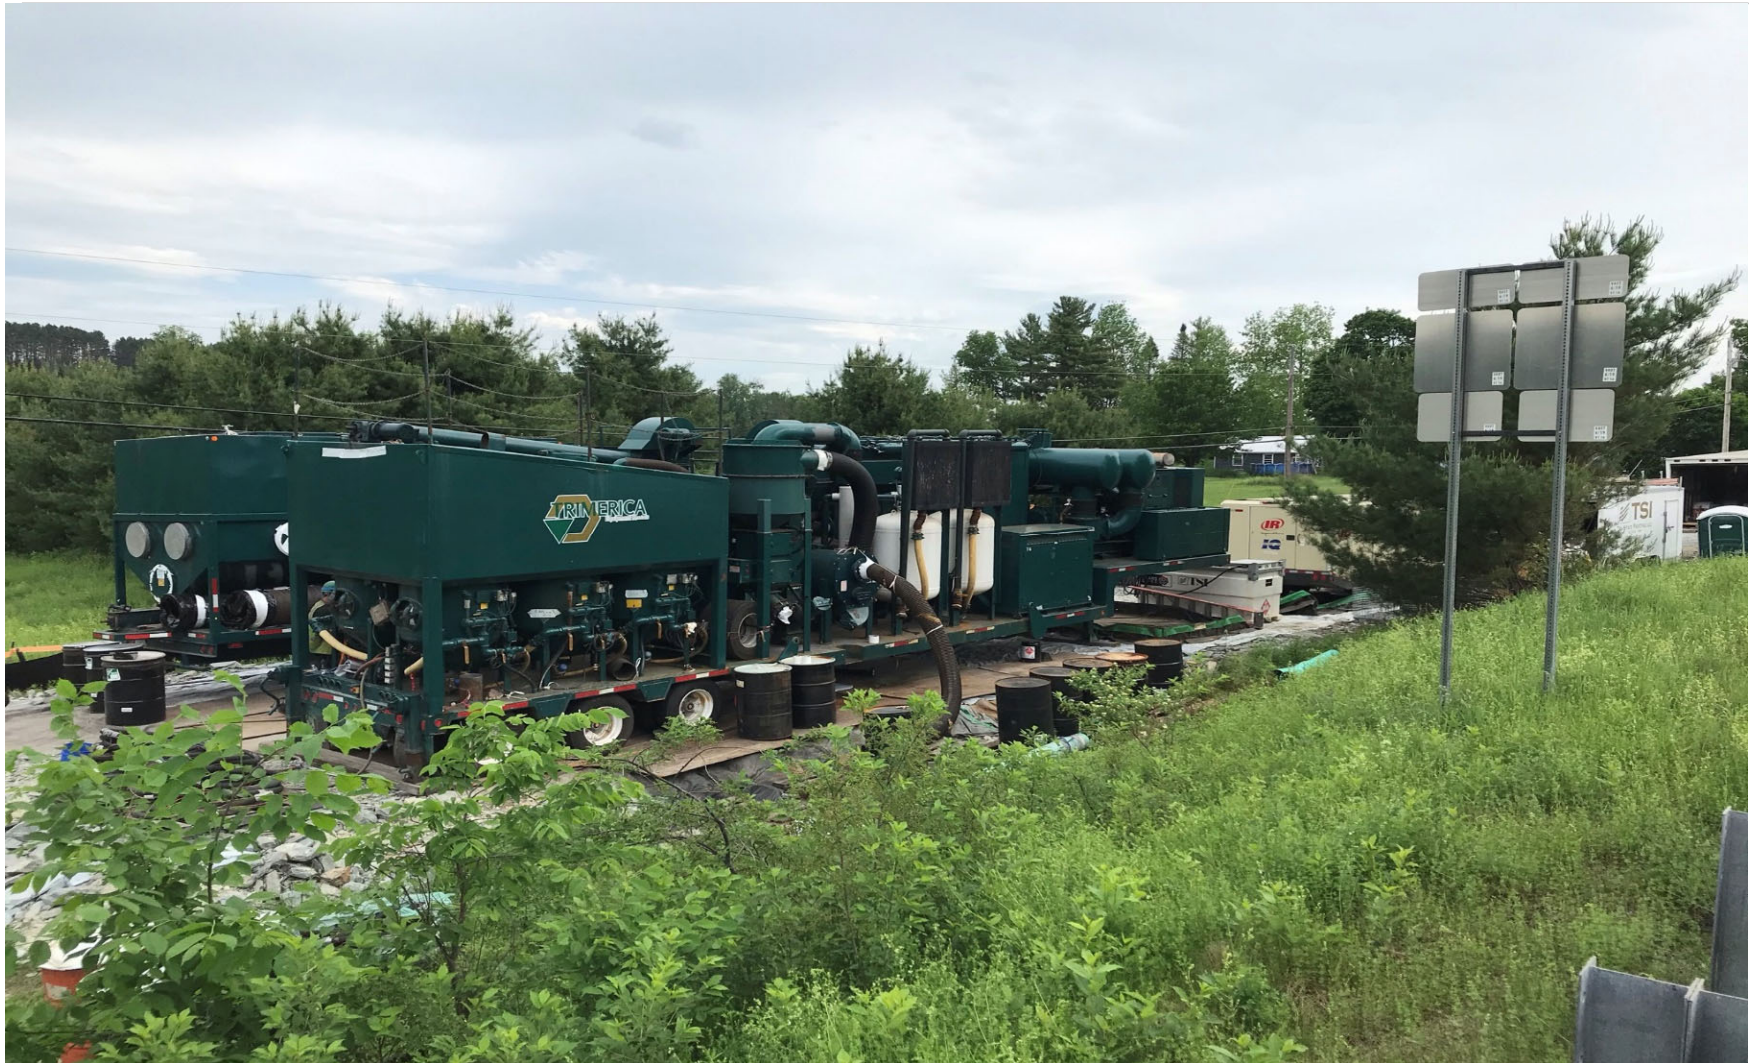
Equipment to collect the lead paint and filter the air in the enclosure
